REPORT#: 19MA072

REPORT DATE: December 18, 2023

Rigging Crew Leader Crushed by Light Tower Weight — Massachusetts

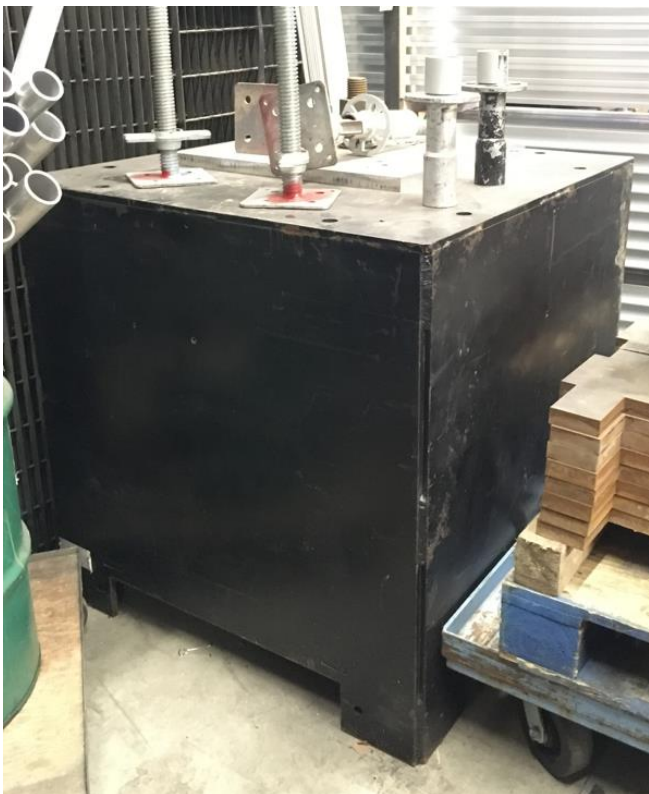
Figure 2 – Ballast weight (FACE investigator photo)

The ballast weight that was involved in the incident weighed 3,200 pounds (Figure 2). It was a 36" cube consisting of concrete with rebar reinforcement within a welded steel plate shell. The sides of the steel shell were 3/8" thick and the top was 5/8" thick. Holes and connections for anchoring the rigging components were built into the ballast. Various connection pieces are visible in Figure 3 which shows the ballast in storage at the company. While some weights used by the company had cutouts or holes that ran through the weight for use when lifting with a forklift, the weight involved in the incident had four feet and a gap between the feet for lifting, as seen in Figure 2.

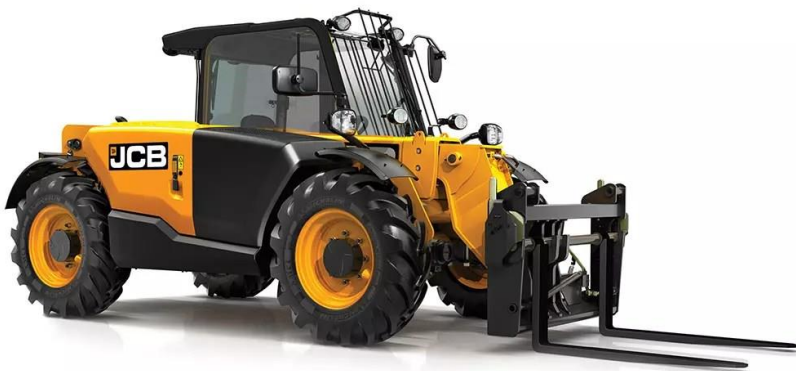
Figure 4 – Telehandler (manufacturer image)

Also involved in the incident was a diesel-powered four-wheel steer/four-wheel drive all-terrain telehandler (Figure 4). This type of equipment is a [class 7](#) rough terrain forklift with variable reach. It had a maximum lifting capacity of 5,500 pounds with the boom retracted. It had a lifting height of 20 feet and a load capacity of 3,900 pounds for vertical lifts. With the boom extended to its full reach of 11.5 feet, the lifting capacity was 1,750 pounds. The vehicle was six feet and two inches tall and six feet wide at its widest point at the tires. The wheelbase was seven feet and ten inches from axle to axle, and the overall length of the base unit was 13 feet and one inch plus the length of any attachment. The telehandler was equipped with a fork attachment.

In this case, the equipment operator was appropriately trained to operate a different type of forklift and not the all-terrain telehandler. The ground conditions at the site consisted of paved areas, pavers, and packed soil. It may have been appropriate to use a different forklift class, on which the operator was trained, at the site instead of the telehandler. The scope of the project and materials, as well as available equipment and trained operators, should be considered during project planning and implementation. Ensuring that equipment operator training is complete is a critical component of an employer's safety and health program.

Recommendation #3: Employers should ensure that employees who operate equipment are properly trained.

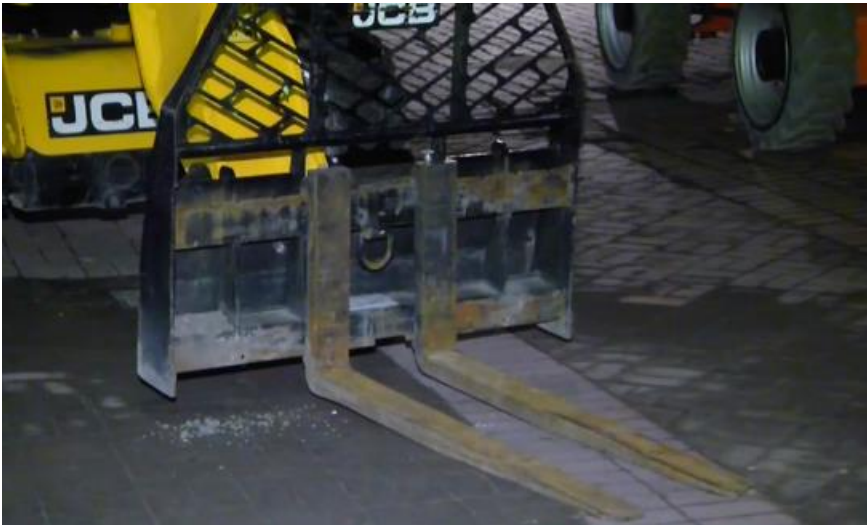
Figure 6 – Telehandler forks and backrest (scene footage)

In this case, the telehandler operator was attempting to move the ballast approximately four feet from its initial position. The telehandler had lifted the ballast approximately two feet from the ground. The weight of the ballast and its position on the forks made it unstable, resulting in the ballast sliding off the forks. It is unknown if the span of the forks on the telehandler had been adjusted to optimize stability when moving the larger weight. It is also unknown if the forks had been appropriately tipped backward in order to stabilize the load against the backrest. In addition, the load could have been moved at a lower height, close to the ground.

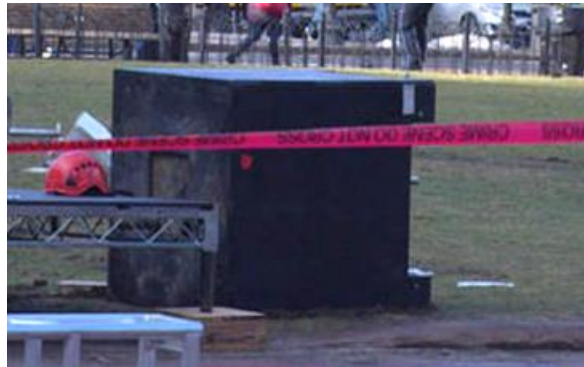
Figure 8 – Ballast weight on its side (scene footage)

The weight of the ballast and its position on the telehandler caused the ballast to slide or tip off of the tines. The ballast first struck the victim in the head and then fell on the victim's torso. Multiple workers at the site were able to roll the

Recommendation #1: Employers should ensure that employees are not within the fall zone of material being transported.

way to reduce the fall zone and hazard. Additionally, employers should ensure that transported materials are properly secured and stable prior to transport.
