FACE IT: Report Visual Extension

Oil and Gas Delivery Driver Crushed Between a Dozer and a Semi-truck While Connecting Towline—West Virginia (FACE 2015-01)

REPORT#: 2015-01 REPORT DATE: April 18, 2018

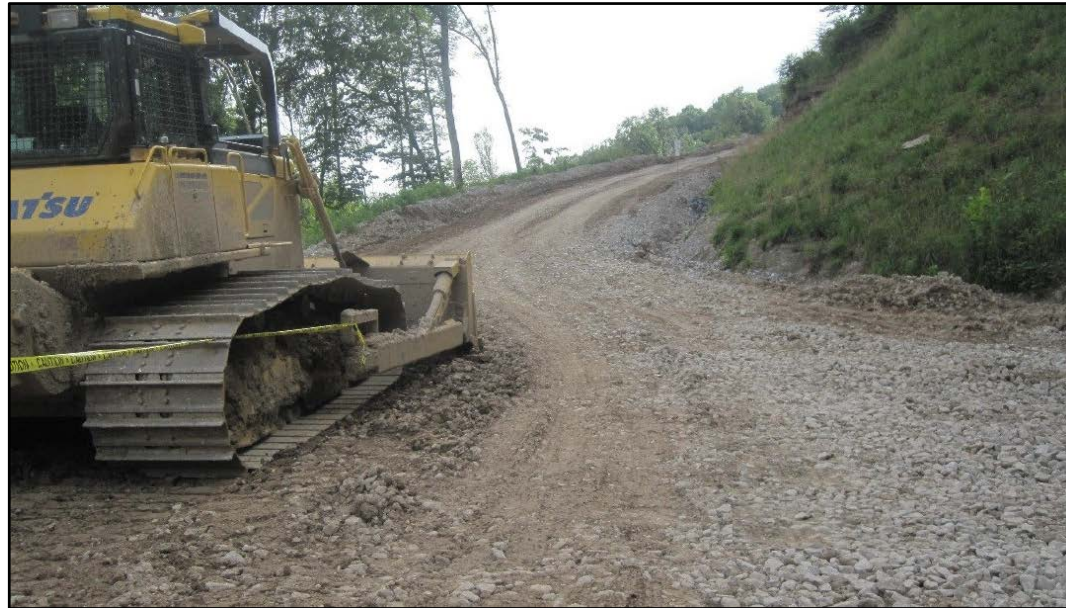
Incident scene, showing terrain and hill accessing the well site.
(Photo courtesy of WV OSHA.)

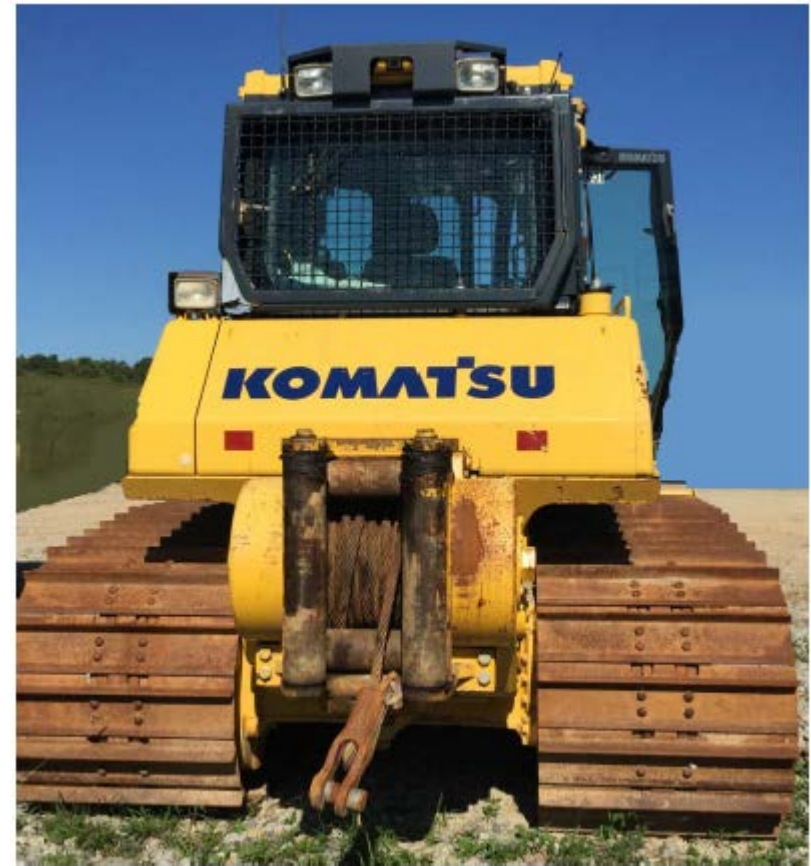
Dozer involved in the incident. Note: The tow hook and tail chain have been removed.

- The towing dozer operator backed to the front of the driver's semi-truck and exited his cab to connect to the dozer's towline.
- When the dozer operator was exiting the cab of the dozer, it is believed his foot hit the parking brake lever and the dozer rolled backward, crushing the driver between the two vehicles.

- Dozer equipment manufacturers should:
 - Consider providing an engineering control, such as an interlock or other safeguards, to prevent parking brake levers from disengaging.

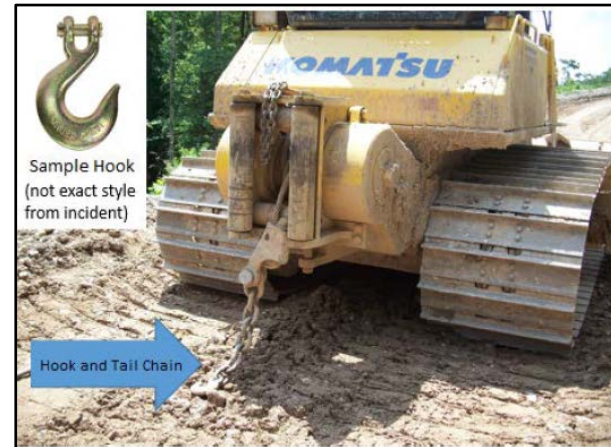
Tow hook and tail chain, showing length of towline at time of incident.
(Photo courtesy of WV OSHA.)

- Lack of safety training or standard operating procedure for towing vehicles
- Lack of appropriate safeguards for equipment
- Lack of spotter or designated hookup personnel
- Steep terrain
- Short length of chain being used; winch cable and chain not spooled out
- Truck not properly equipped ahead of time for towing (i.e., no D-ring pre-mounted on hitch pin)

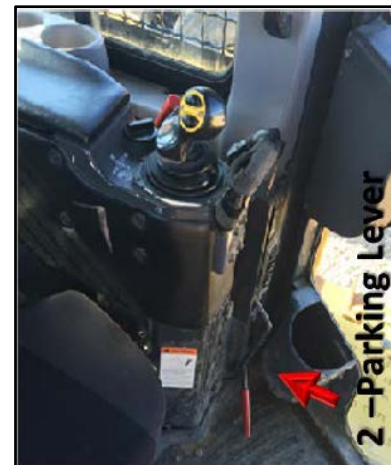
Parking lever (2).
(Photo courtesy of WV OSHA)

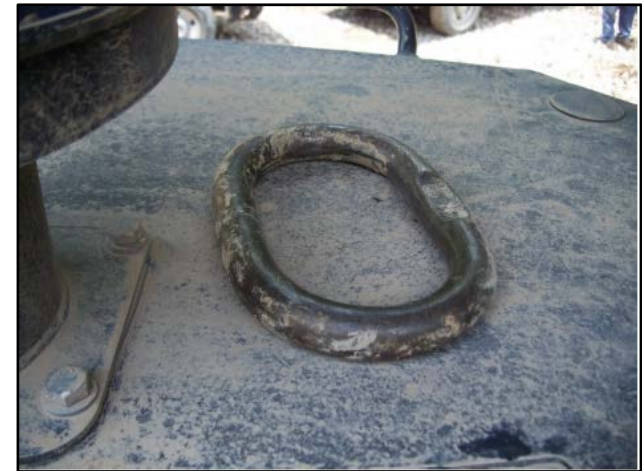
D-ring needed for connection between hook and hitch pin.
(Photo courtesy of WV OSHA.)

- **Employees should:**
 - Ensure vehicles are properly equipped for towing prior to initiating the towing connection procedures (either have a D-ring pre-mounted on the truck's hitch pin or have a D-ring in the truck).
 - When possible, ensure a designated area is flat prior to making towing connections.

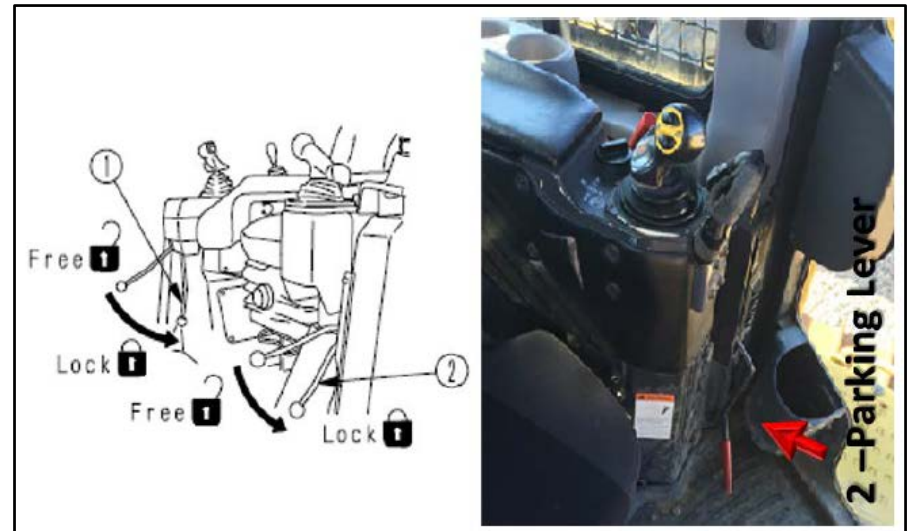
Safety lock lever (1) and parking lever (2).
(Illustration adapted from Komatsu [2004].)
