FACE IT: Report Visual Extension

City Electric Maintenance Worker Electrocuted While Installing Lines for Security Cameras – Ohio (FACE 2019-01)

REPORT#: 2019-01 **REPORT DATE: July 29, 2021**

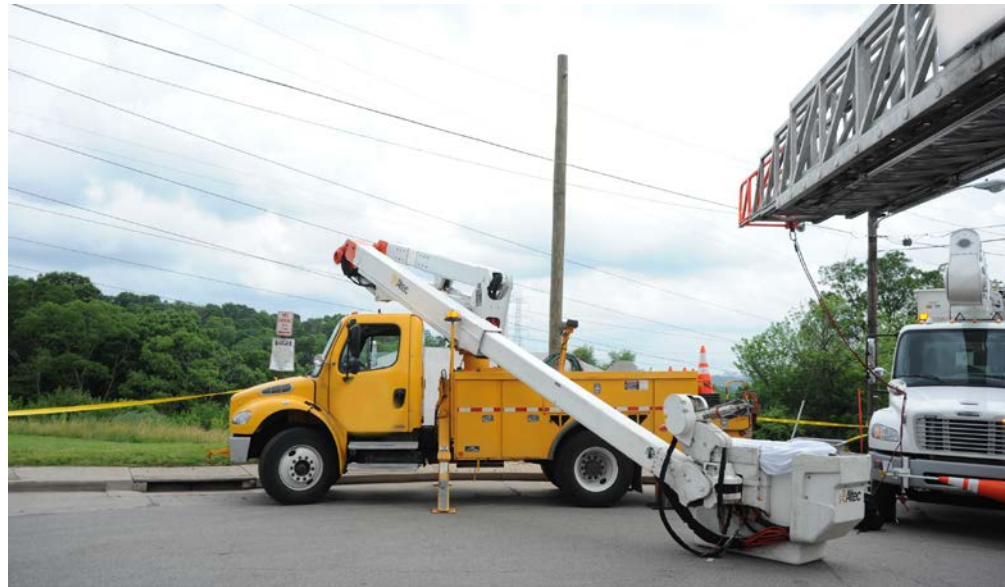
Freightliner M2 Aerial Lift Boom Truck
(Photo courtesy of the City)

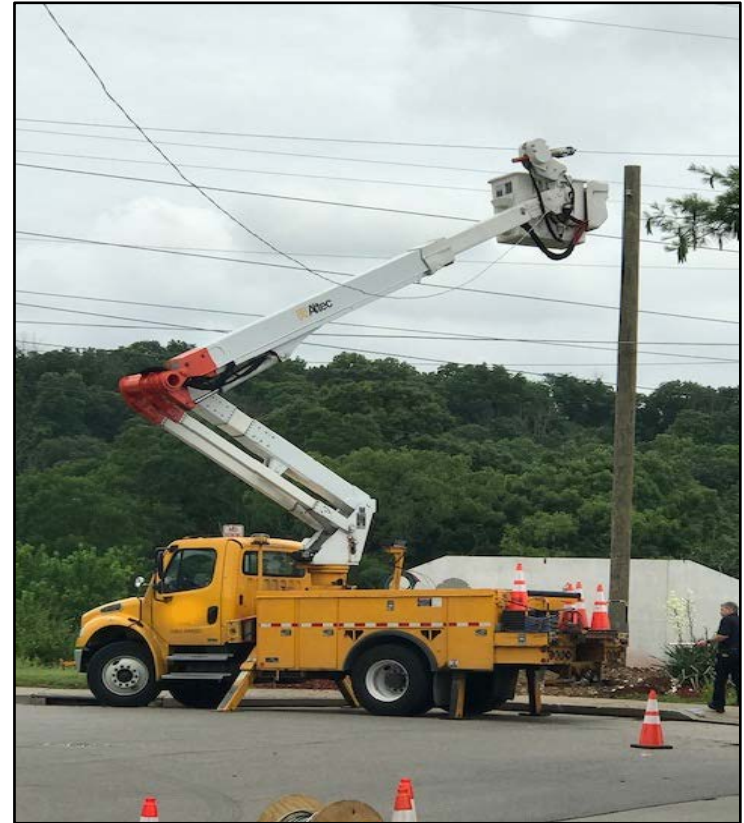
- A 48-year-old city electric maintenance worker was electrocuted, while installing lines for security cameras along a residential area cul-de-sac
- The electric maintenance worker got in the basket and raised it to begin pulling some triplex service wire and installing it on the security pole

Position of bucket truck in cul-de-sac at the time of the incident. (Photo courtesy of the City)

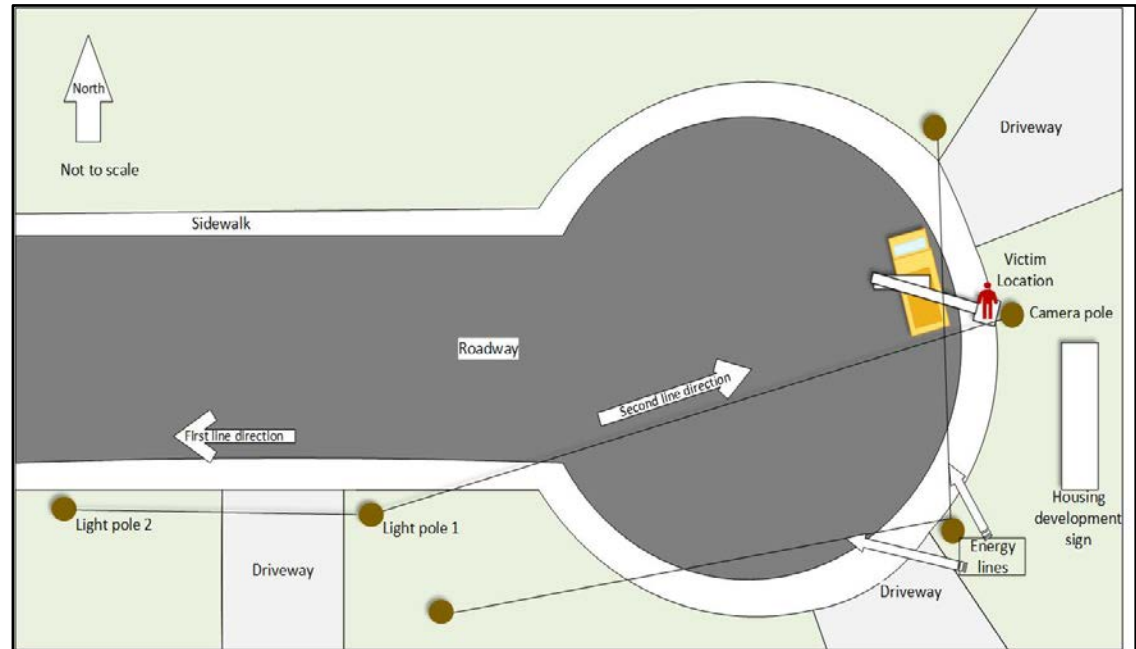
- It is believed the worker did not realize his proximity to the power lines while performing this task and contacted his right shoulder with the energized power line

Drawing of incident location.

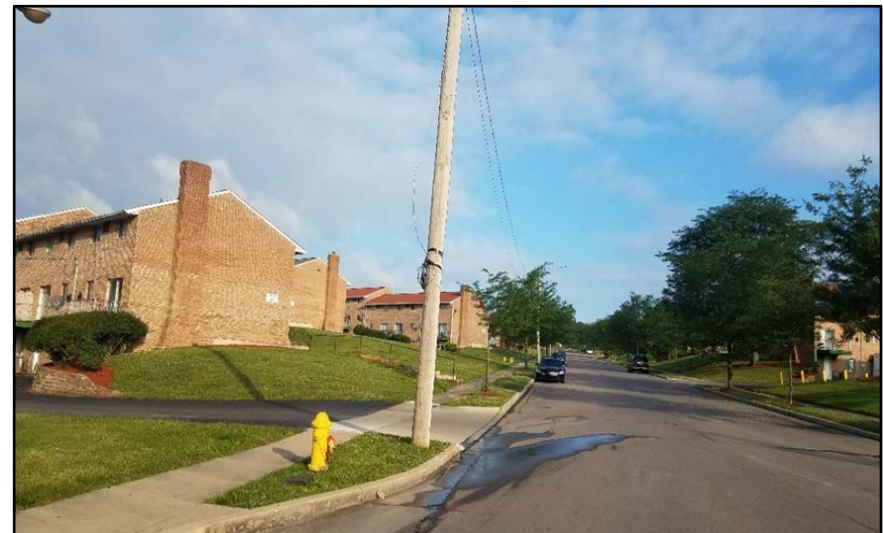
Lighting poles along street

- **Employers should:**
 - Determine appropriate safety distances while working near electrical power line hazards
 - Develop, implement, and train on hazards, safety, and communication plans for lone workers

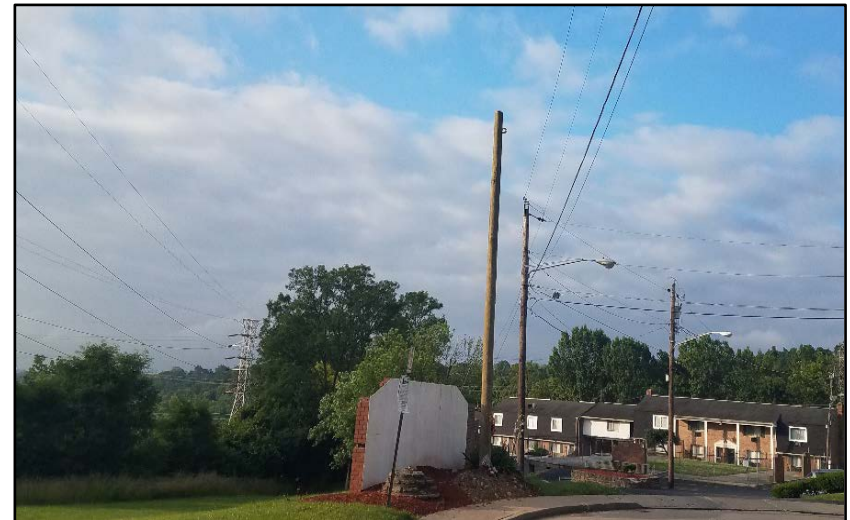
New camera pole at end of cul-de-sac
(Photo courtesy of the Public Employment Risk Reduction Program)

- **Employers should:**
 - Provide competent and qualified person training to enable workers in high-risk occupations to assess routine and non-routine job tasks for job site hazards to determine appropriate safety precautions and PPE
