**LINE OF DUTY  
DEATH REPORT**  
VISUAL EXTENSION

**F2018-03 PA**

**Career Lieutenant Killed in Building  
Collapse While Fighting Row House Fire -  
Pennsylvania**

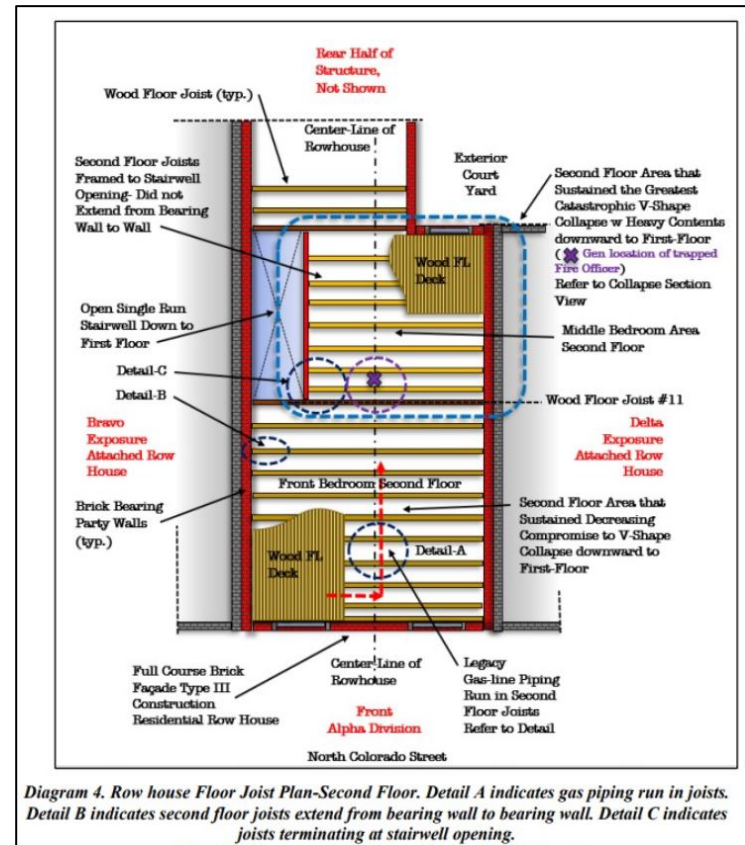
Diagram 4. Row house Floor Joist Plan-Second Floor. Detail A indicates gas piping run in joists. Detail B indicates second floor joists extend from bearing wall to bearing wall. Detail C indicates joists terminating at stairwell opening.

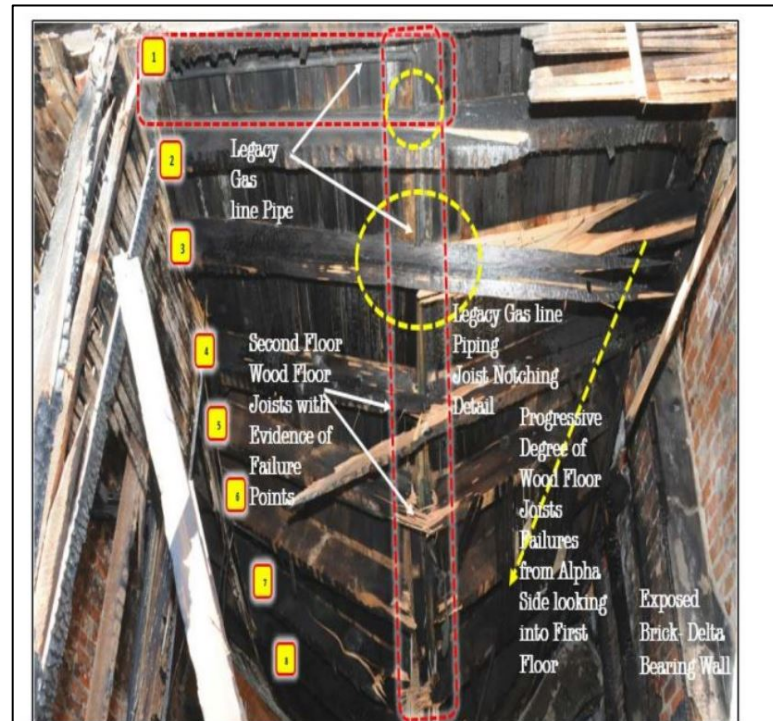
Diagram 11. Joists numbered from side Alpha toward side Charlie detailing the joist breaking points along the notched cut out for the gas pipe installation.

- Fire Departments should ensure that firefighters are trained to understand the influence of inherent building performance characteristics, unique row house variation (modifications and construction) on structural collapse, and consider defensive operations when dilapidated/excessive clutter conditions are encountered
