4 Career Fire Fighters Killed and 16 Fire Fighters Injured at Commercial Structure Fire – Texas

Executive Summary

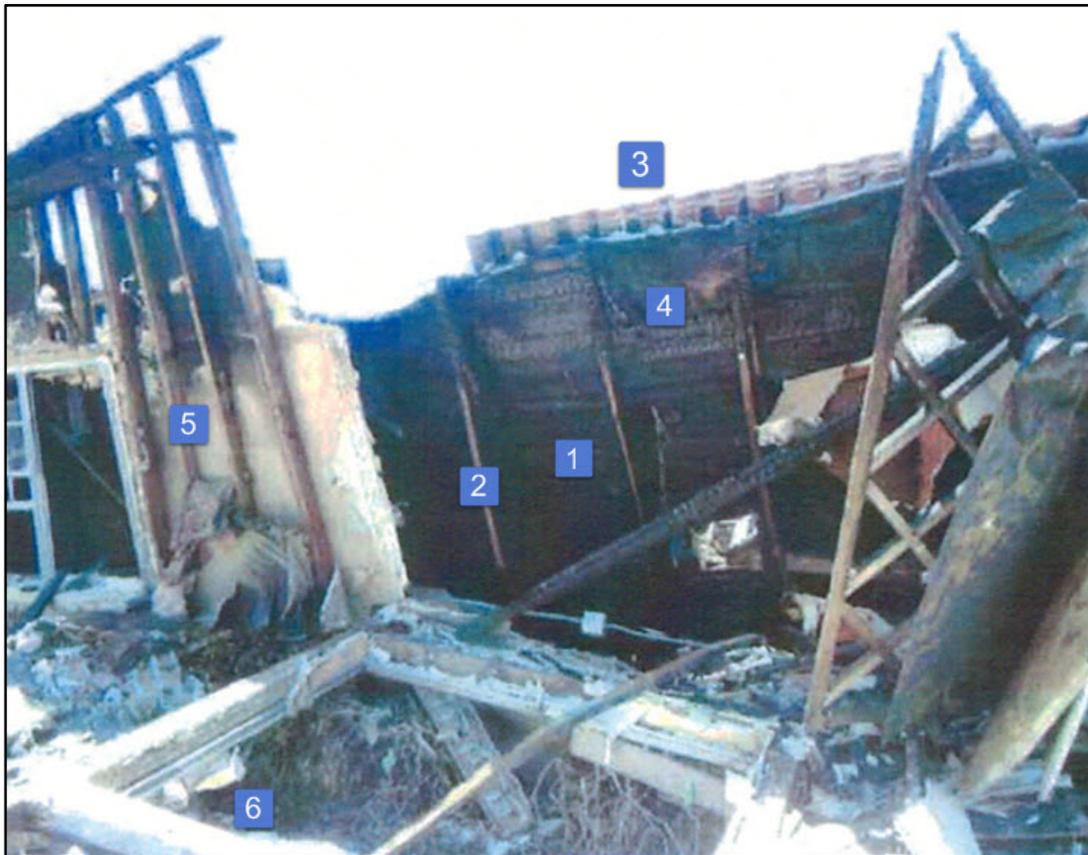
The restaurant's perimeter wall (resulting secondary collapse) is visible with the underside of the roof decking and the remnants of roof truss bottom cords. The edge of the roofing tiles can be seen along upper lateral roof edge. (See **Photo 1**.)

Photo 1. View of Division Alpha Perimeter Wall & Lean-To Roof Collapse
(Fire Department Photo/ Diagram Courtesy of Buildingsonfire.com)

- [1] Roof Sheathing-underside
- [2] Edge of Roof Truss Bottom Cords (24 inch on-center)
- [3] Edge of Roofing Tiles
- [4] Charring from flame impingement
- [5] Restaurant Perimeter wall
- [6] Secondary Collapse Management Zone (SCMZ)

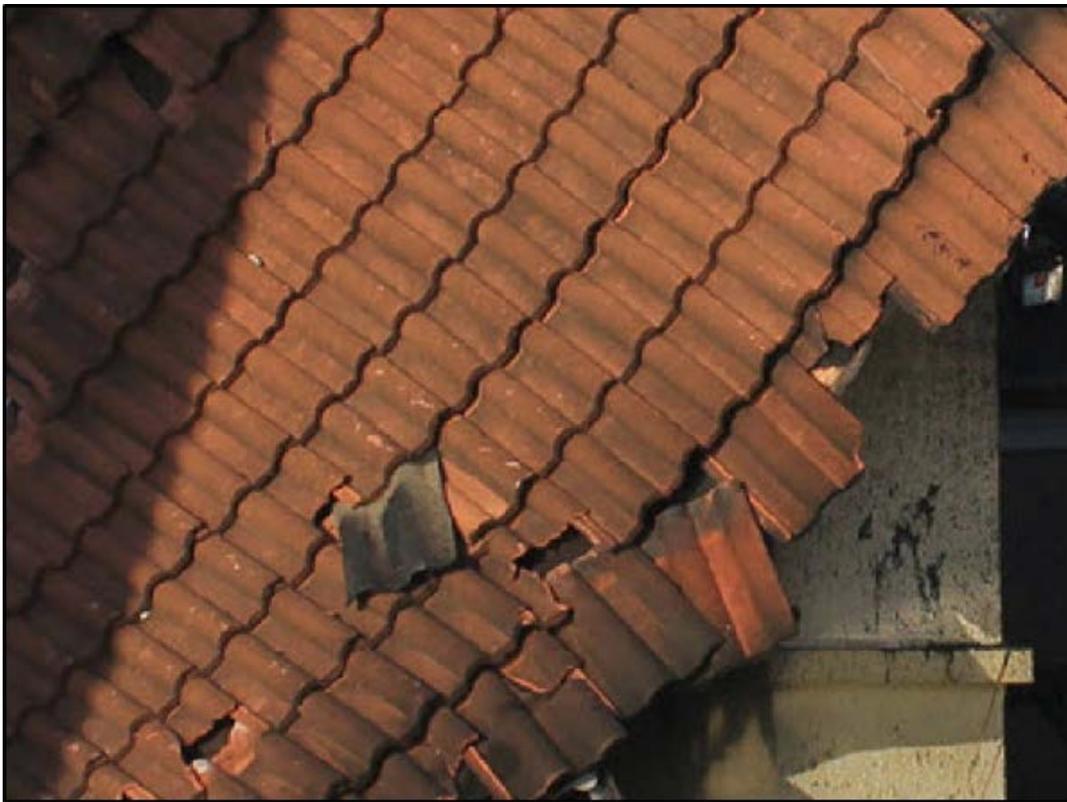
Interlocking ribs are provided on the longitudinal edges of the tiles to restrict lateral movement and provide a water stop. In addition, transverse bars are provided on the underside to serve as weather checks. Mineral coloring oxides are either applied to the exposed surface in a cementitious material or mixed integrally with the tile mix to produce a through-colored product. Concrete interlocking roof tile profiles and details are provided based on technical literature. [10](#), [11](#), [12](#) (See **Photo 2** and **Diagram 3**.)

Photo 2. Concrete Roofing Tiles - Post Fire
(NIOSH Photograph)

Due to the absence of historical construction records and specifications, the roofing tile was identified based on the roofing tile manufacturer imprint. This is typically found on the underside of each tile unit. A likely tile unit style was identified, which is consistent with the figures developed and specifications.

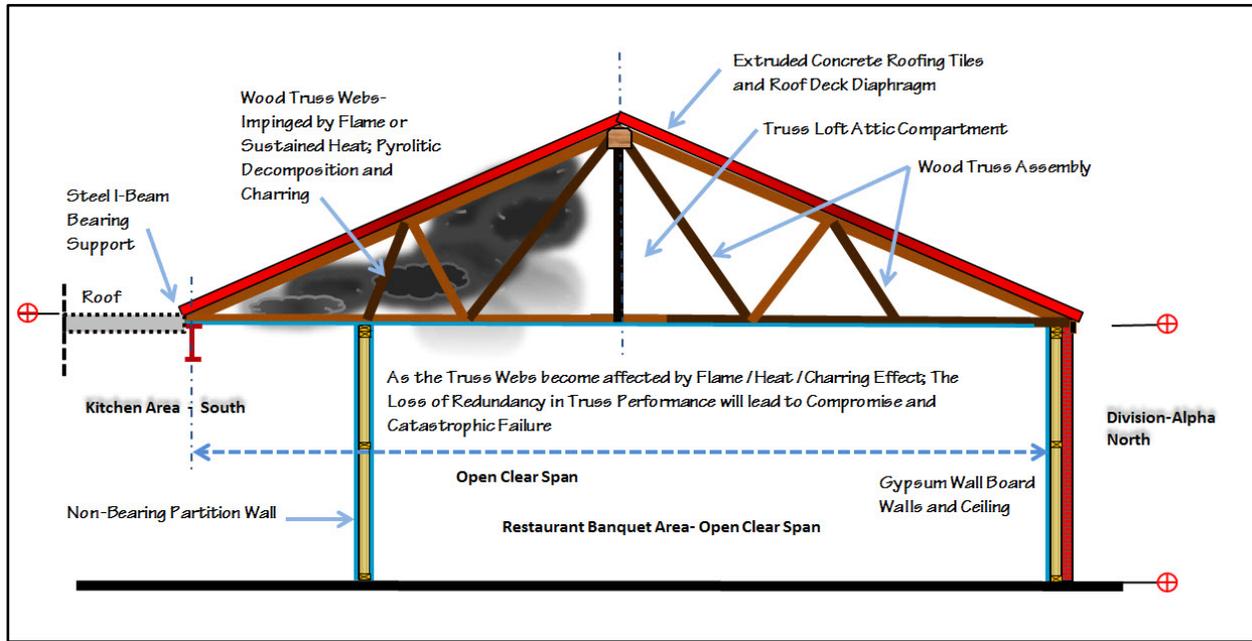
- Based on the postulated mechanism of collapse and the resulting lean-to collapse configuration of the partial roof diaphragm along the Alpha Division (North perimeter wall), the condition of post-fire truss components likely generated uneven burning and increased structural compromise of the truss components occurred along the south perimeter or area of the restaurant roof than did along the north perimeter.

- This increased level of deterioration and/or loss of web performance or materials (due to fire) would cause the wood truss to fold in on its self-downward, and forward toward the front perimeter wall. This series of structural compromise and failure results in a mechanism of collapse that pulls and deflects the roof diaphragm downward, bucking remaining truss components with momentum that results in a pancake collapse of the southern roof deck from the ridge to the south eave line and a lean-to collapse of the roof deck from the ridge to the north eave line. (**See Diagrams 8, 9, 10, and 11.**)

Diagram 8. Anatomy of the Restaurant Roof Collapse
(Diagram Courtesy of Buildingsonfire.com)

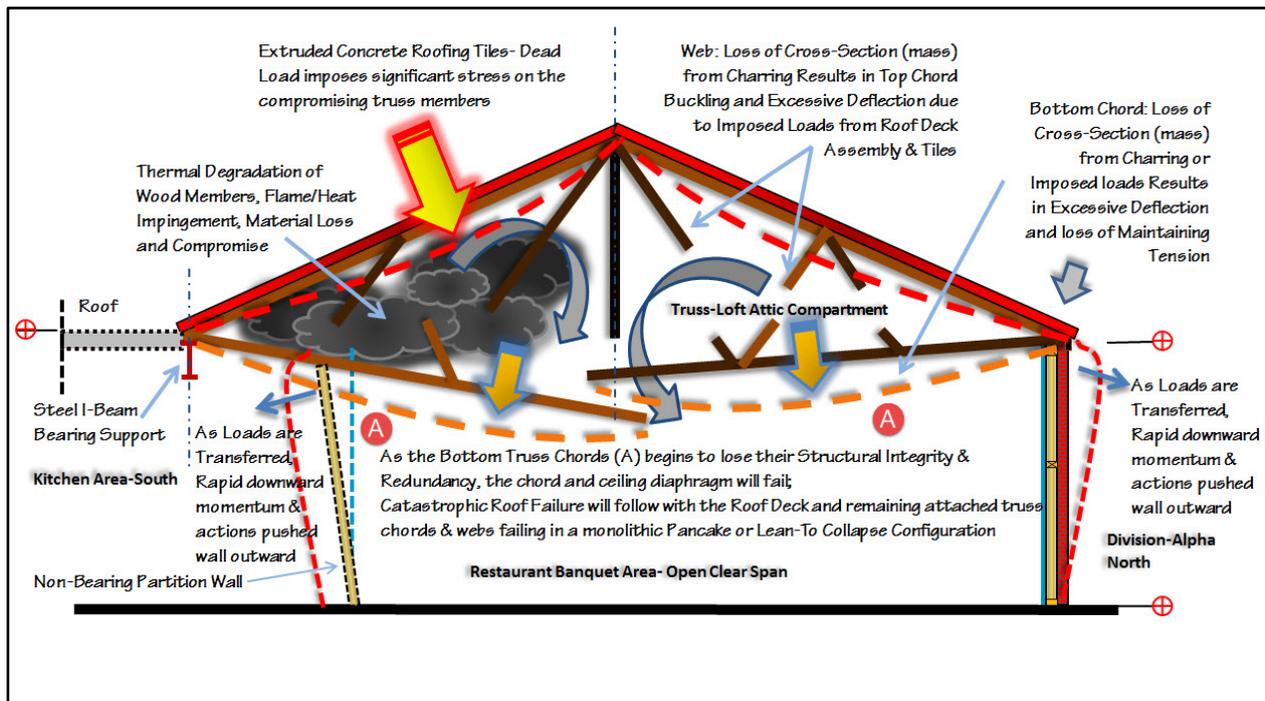
Diagram 9. Anatomy of the Restaurant Roof Collapse
(Diagram Courtesy of Buildingsonfire.com)

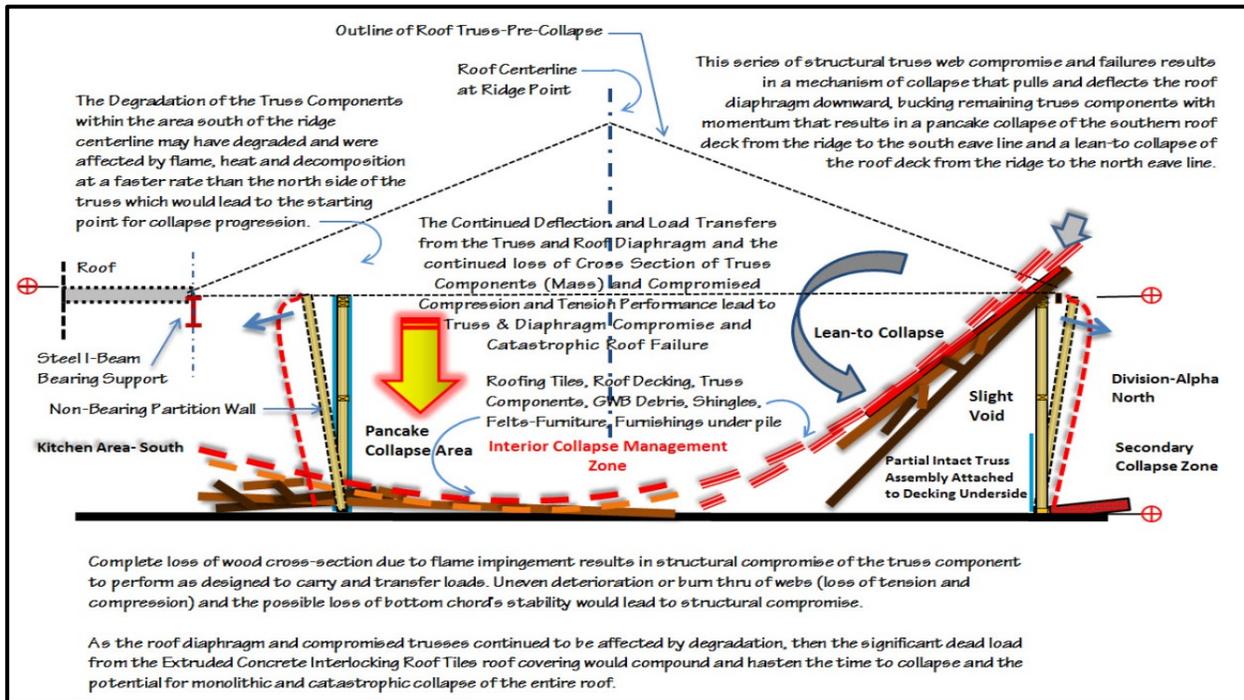
Diagram 10. Anatomy of the Restaurant Roof Collapse
(Diagram Courtesy of Buildingsonfire.com)

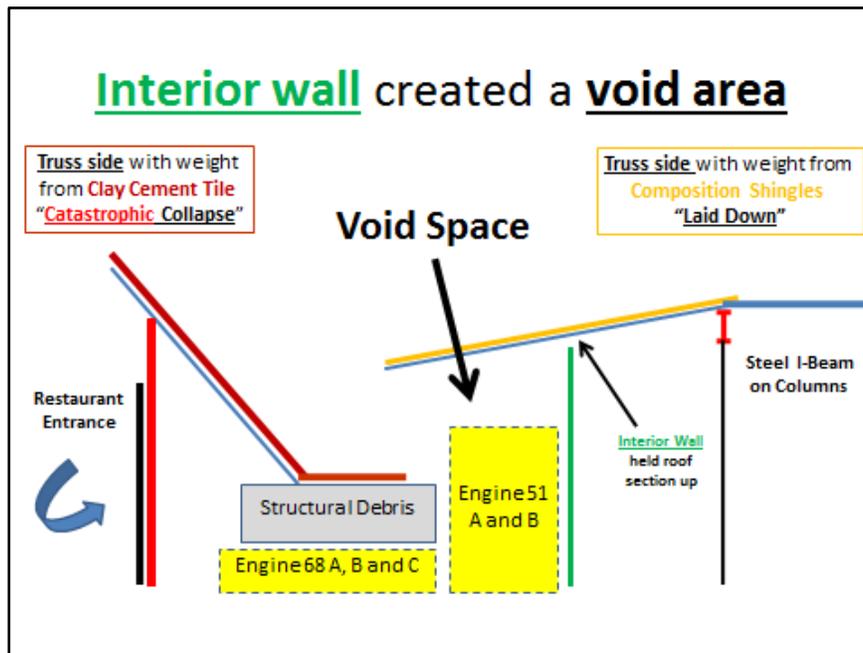
Diagram 11. When the collapse of the roof occurred, it formed a void area trapping fire fighters from E51 and E68
(Diagram courtesy of the fire department)

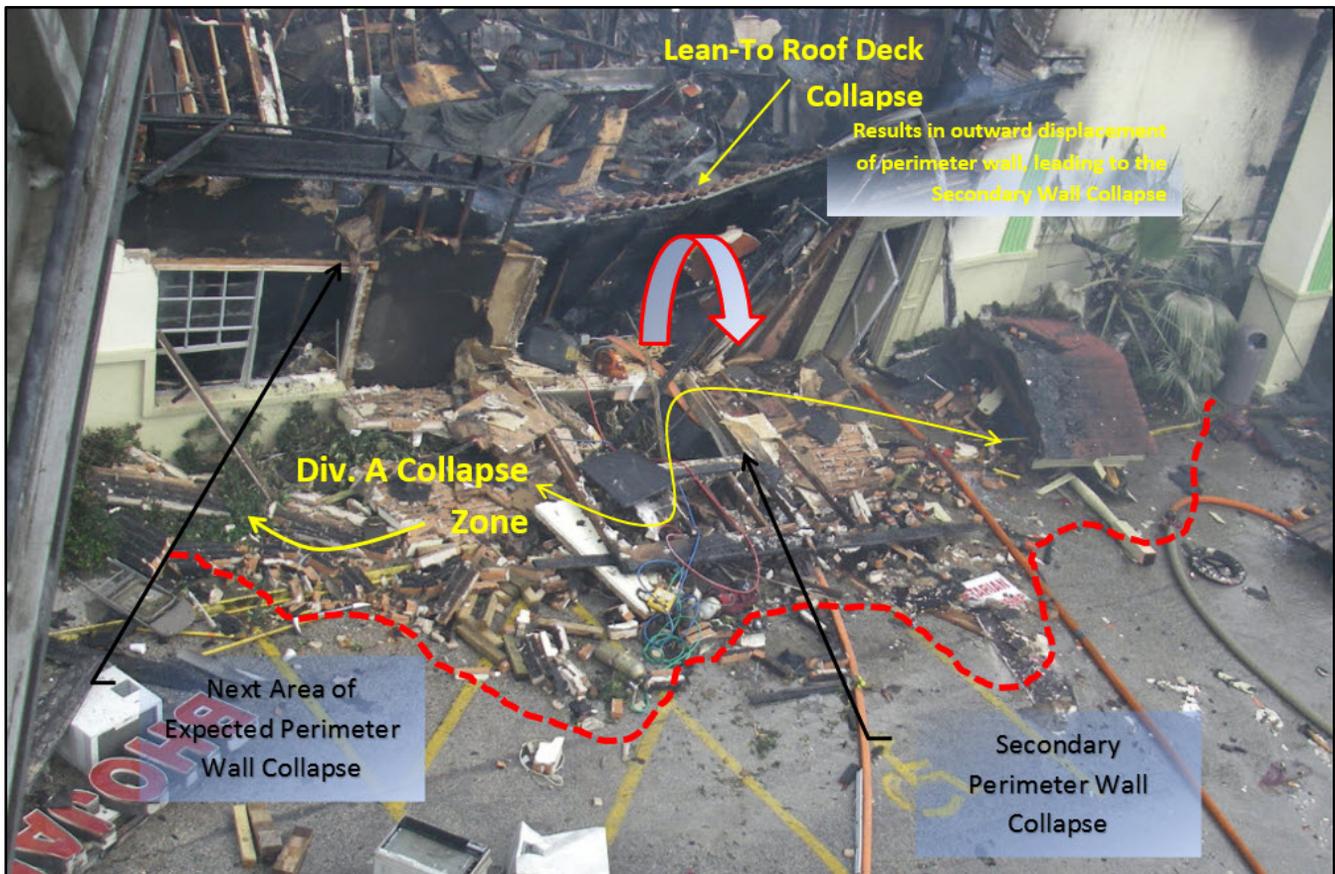
The roof deck came to rest in a slight lean-to configuration creating lateral forces acting upon the outer (north) perimeter wall. This degraded the integrity of the gypsum wall board and wood stud frame wall and caused cracking along the outer wall. Since the primary entry point to the interior of the restaurant was located on the Side Alpha, this was the entry point for the initial handline taken in the building.

Photo 3. Details of the secondary collapse on Side Alpha.
(Photo courtesy of the fire department/Analysis Diagram Courtesy of Buildingsonfire.com)

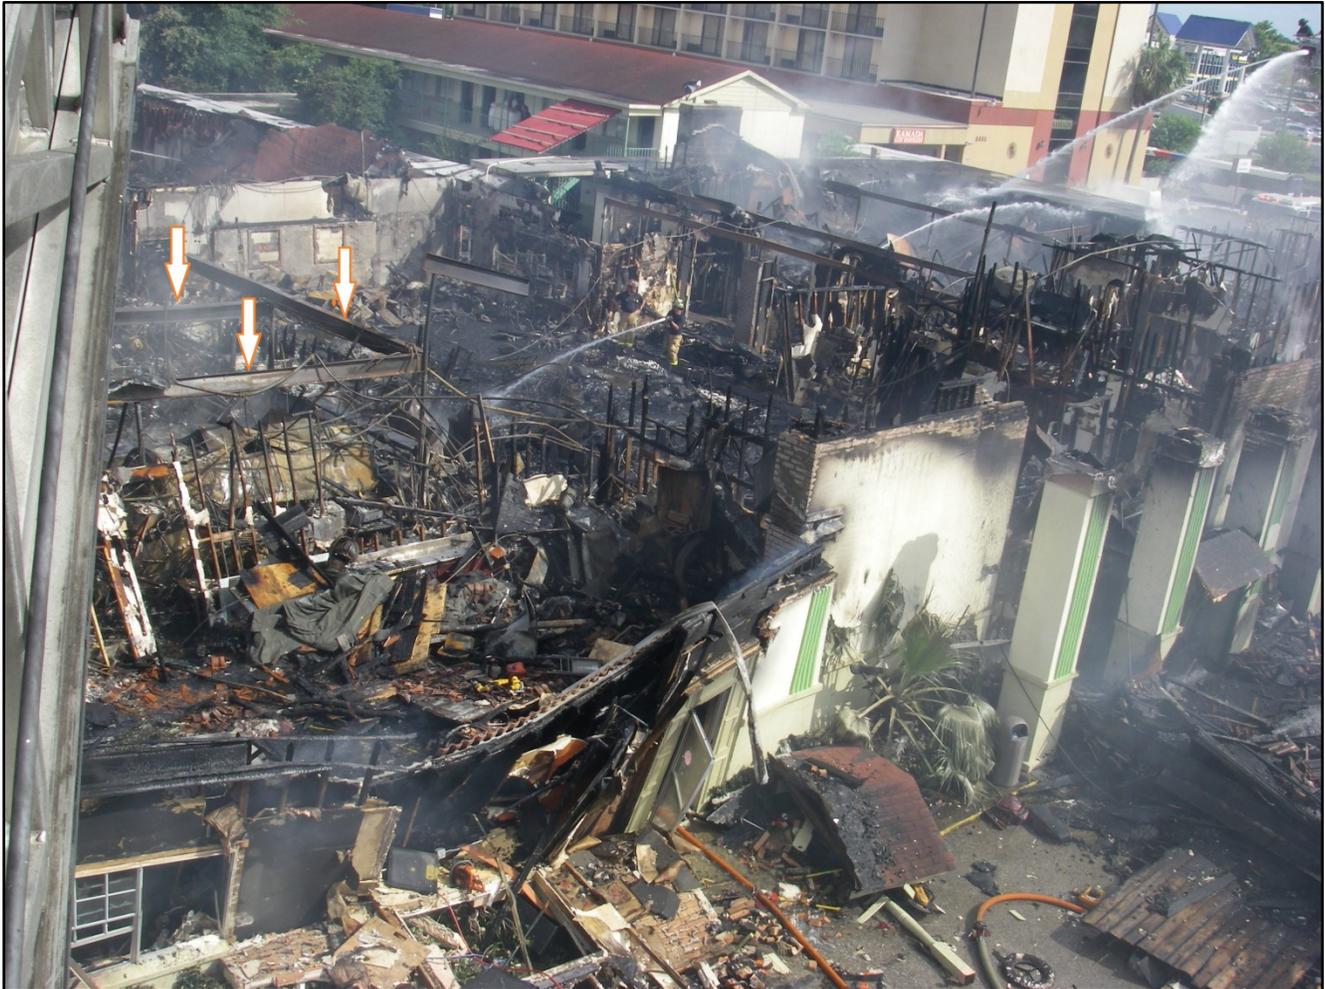
Photo 4. The arrows indicate the support system for the 2nd floor and void space above the restaurant and lobby area of the motel.

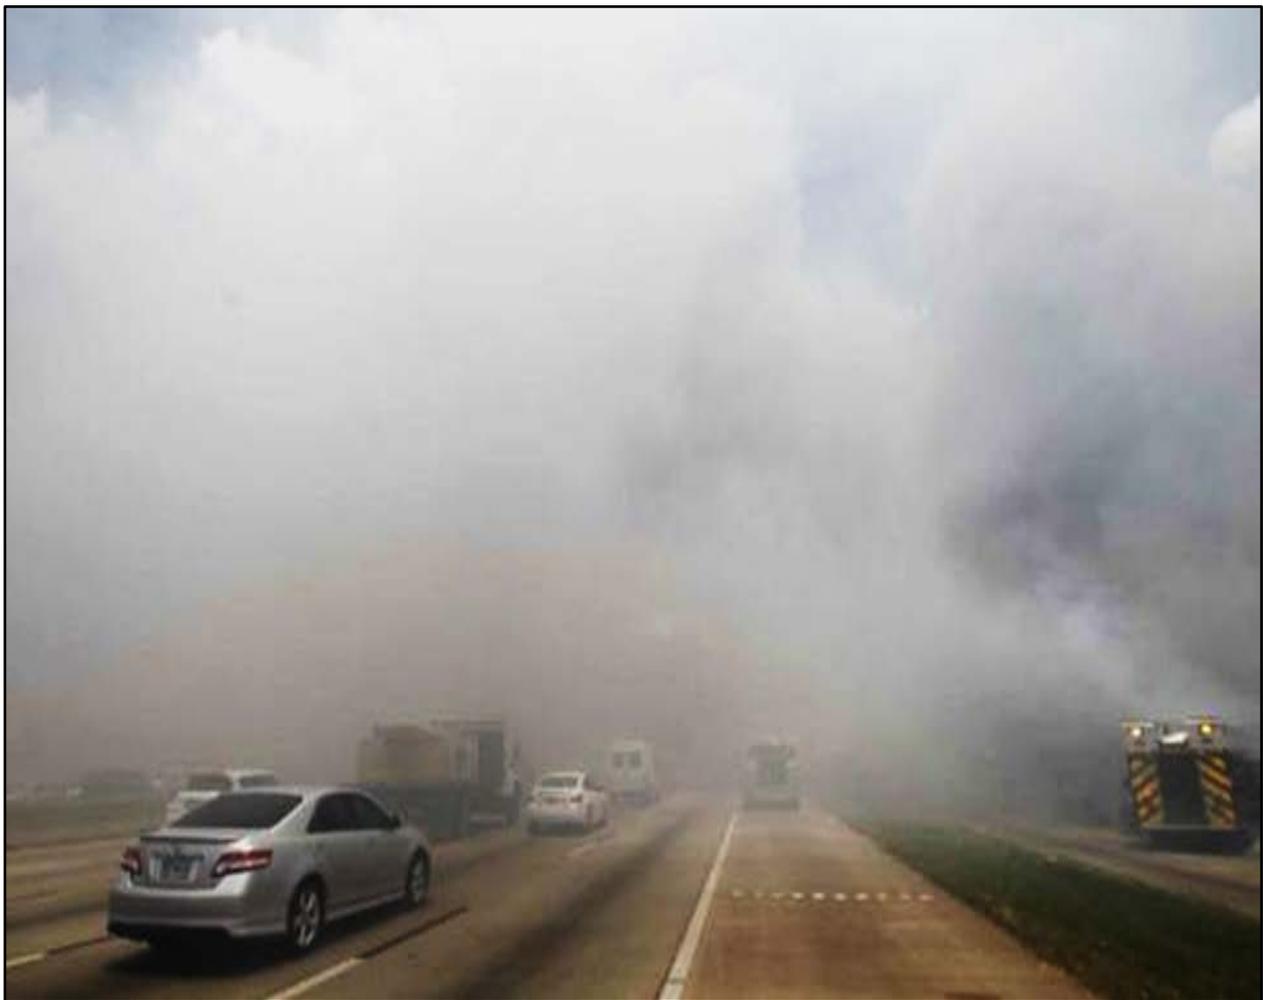
During the initial attack, and well into the rescue, the direction of these strong winds made Division Charlie the intake side of the structure and placed Division Alpha as the exhaust point. The smoke was blowing across the fireground vertically limiting the visibility of members conducting fire attack, ventilation, and rescue. Crews were faced with extreme heat and smoke conditions that would continue to increase and hamper their efforts. (See **Photo 5**.)

Photo 5. The smoke conditions encountered by the 1st Alarm companies. This picture is looking north on the feeder road and the freeway. E82 is parked on the shoulder of the freeway and Rescue 10 is on scene. The time is approximately 1224 hours.

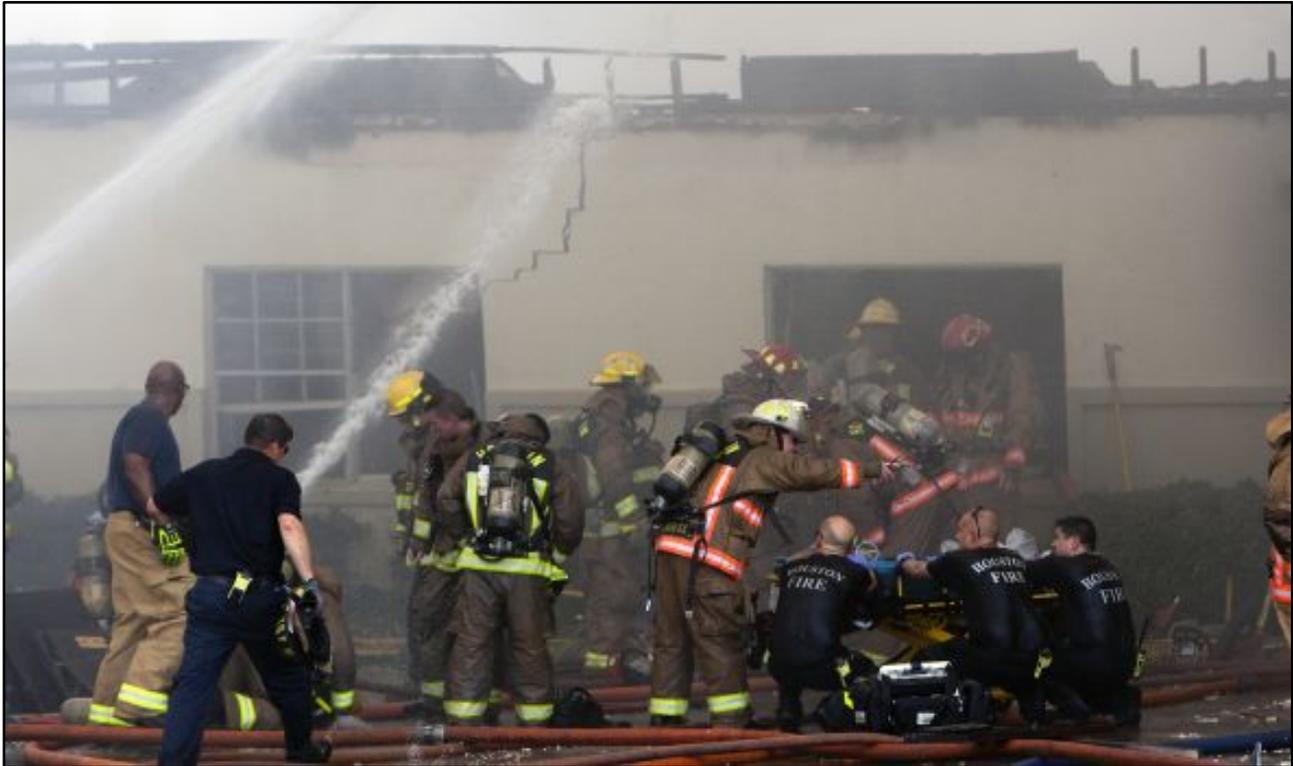
Photo 6. A 20 ft. x 8 ft. foot section (160 SF) of compromised perimeter wall collapse into the immediate area directly in front of the structure. Three members from the Rescue Group became trapped under falling debris that resulted from the secondary collapse. These firefighters were quickly removed by other members in the immediate area and then taken to awaiting EMS crews. The time is approximately 1225 hours.

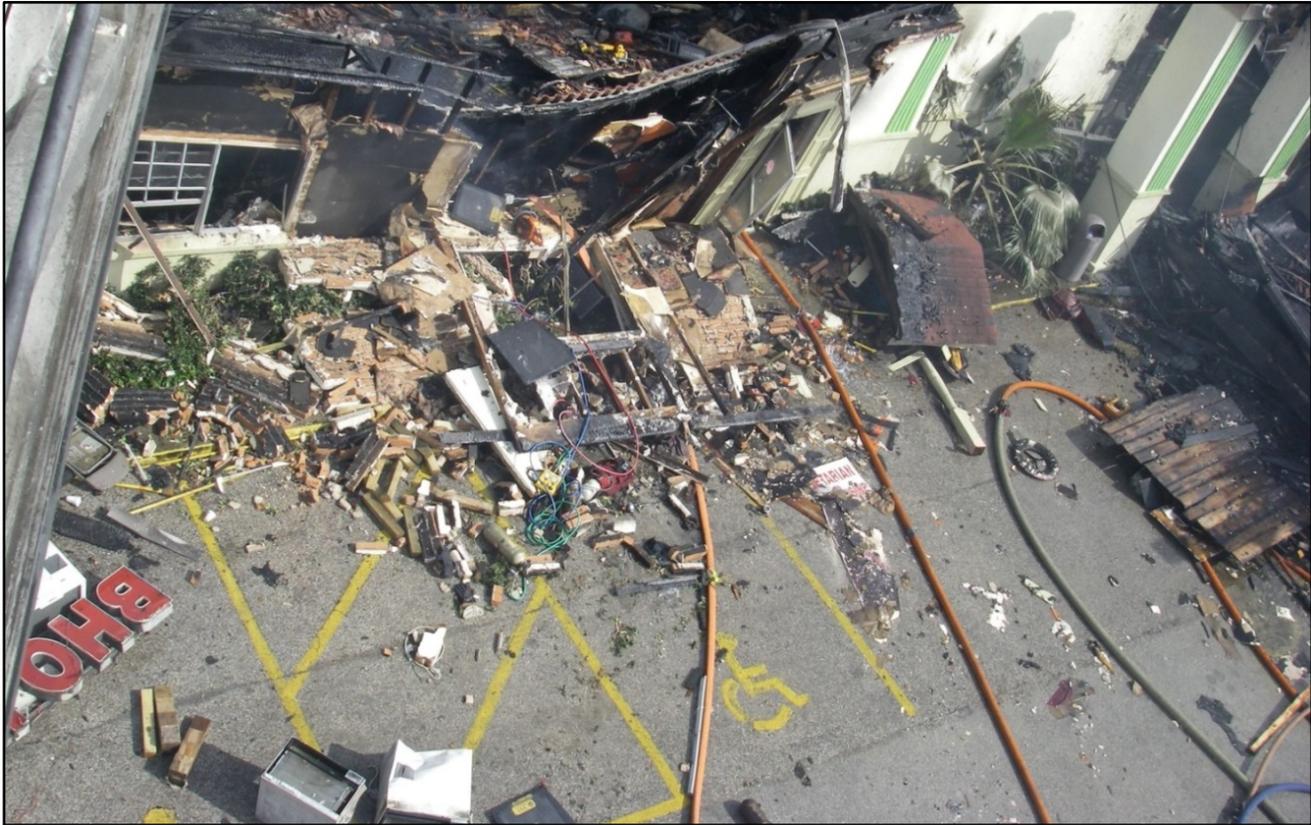
Photo 7. The front façade collapsed at 1303 hours striking fire fighters and officers assigned to the Rescue Group. These members were quickly removed by other fire fighters who picked up the façade and pulled the trapped fire fighters and officers out.
(Photo courtesy of the fire department)

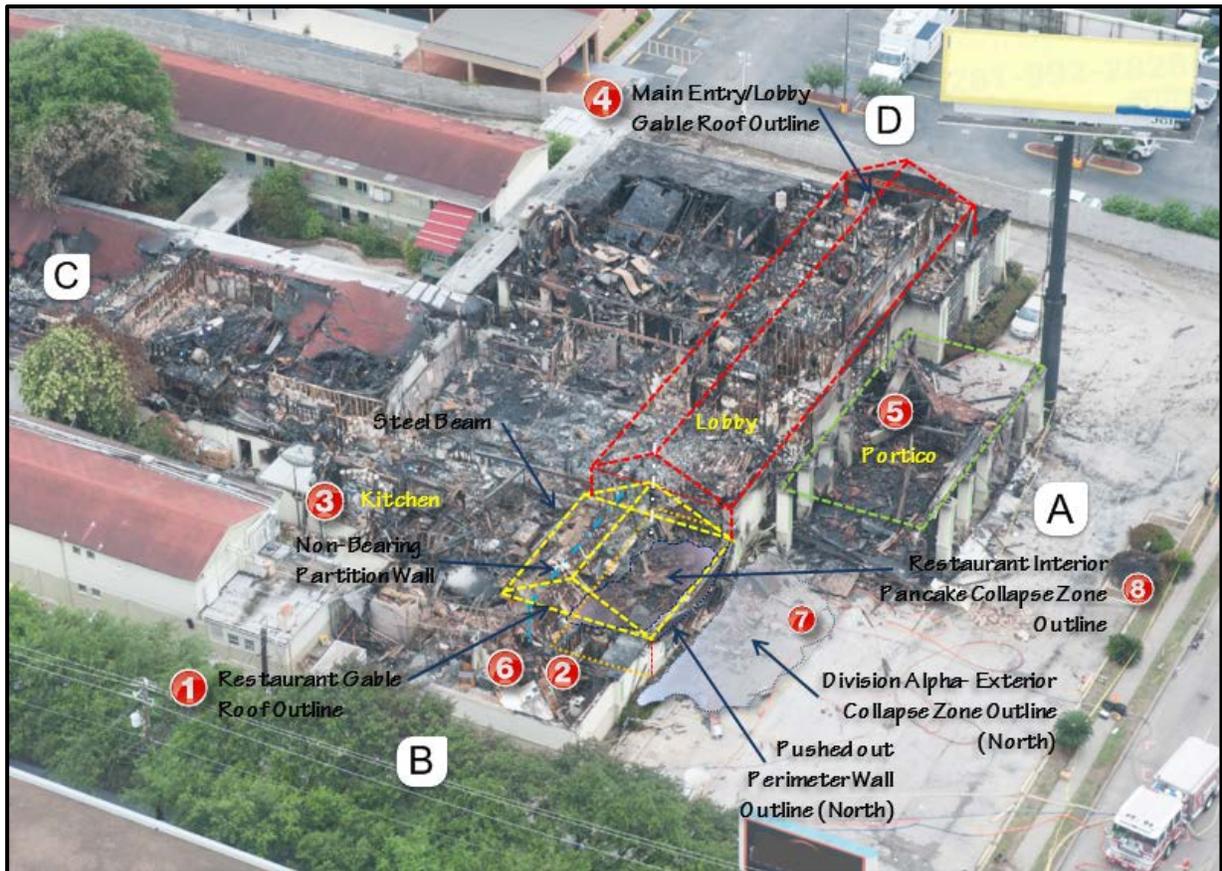
The post-fire profile of the complex after the collapse of the roof and walls focusing on Side Alpha and Side Bravo of the structure. (See Photo 12).

Photo 12. Post Fire-Collapse Aerial View of Building Complex
(Photo courtesy of the fire department/ Diagram Courtesy of Buildingsonfire.com)

- [1] Restaurant Gable Roof - Outline
- [2] Restaurant Floor Outline
- [3] Kitchen Area
- [4] Main Entry and Lobby Gable Roof-Outline
- [5] Main Portico - Canopy Roof Destroyed
- [6] Adjacent Rooms
- [7] Secondary Wall Collapse Zone
- [8] Interior Pancake Collapse Zone
