Ground Failures in Coal Mines with Weak Roof

Greg Molinda, MS

Chris Mark, PhD

ABSTRACT

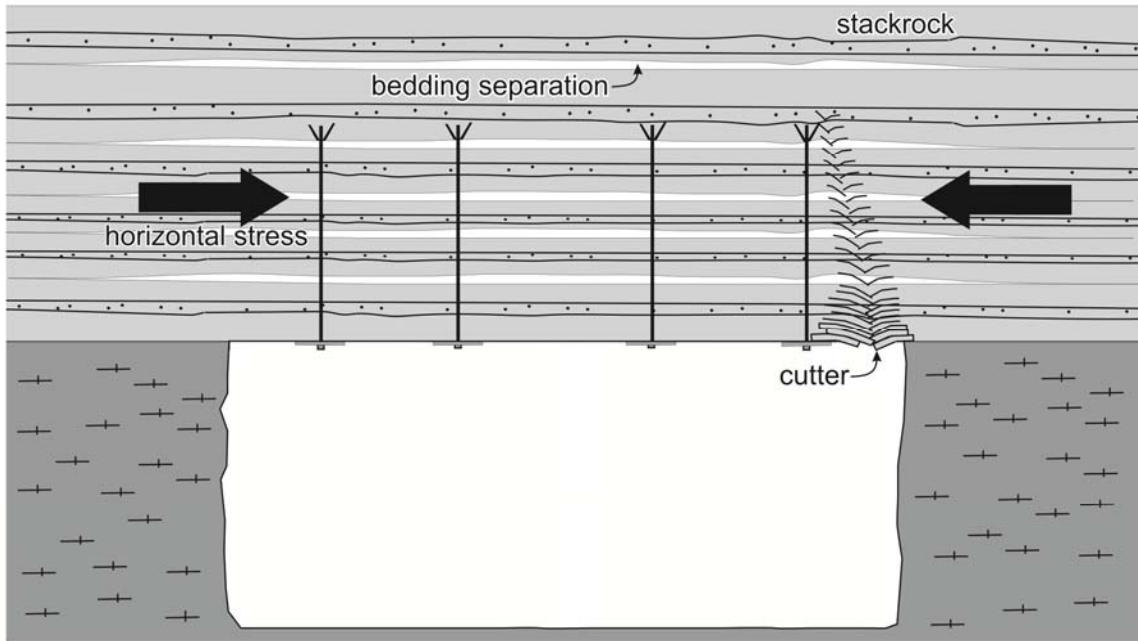
Figure 2: Stackrock delaminates and cutters form when roof is subjected to horizontal stress

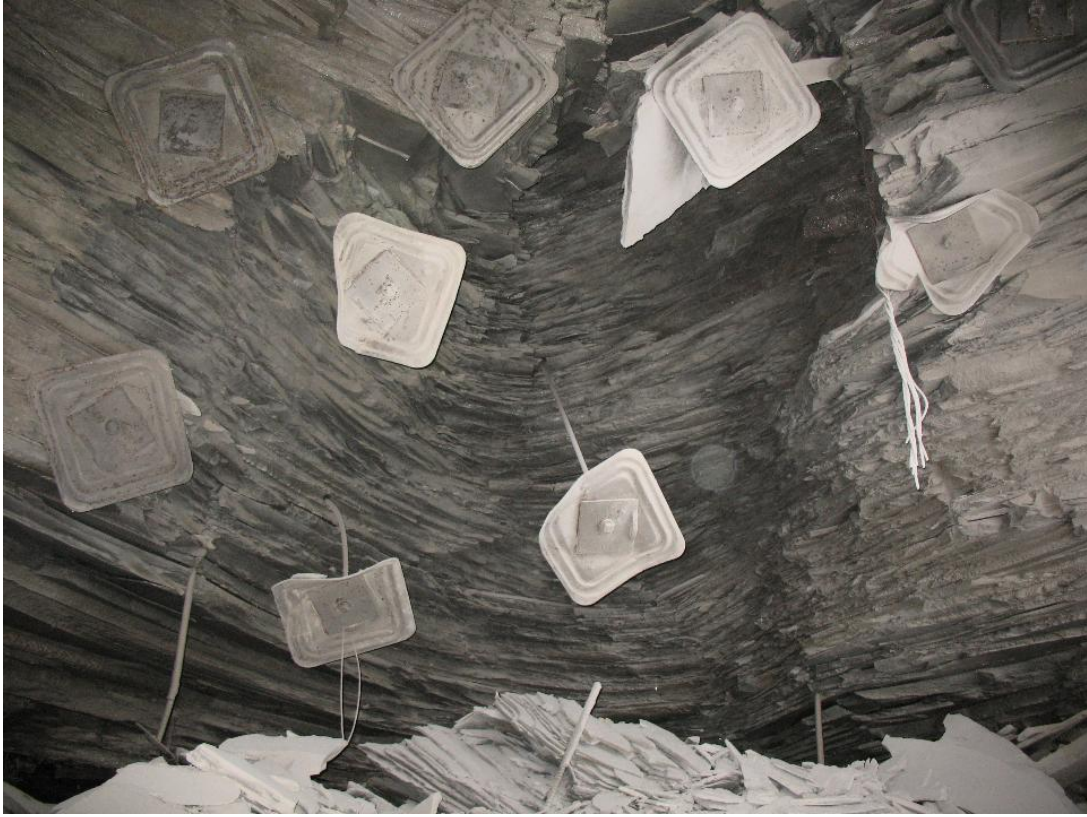
Figure 7: Roof buckling and cutter roof due to horizontal stress.

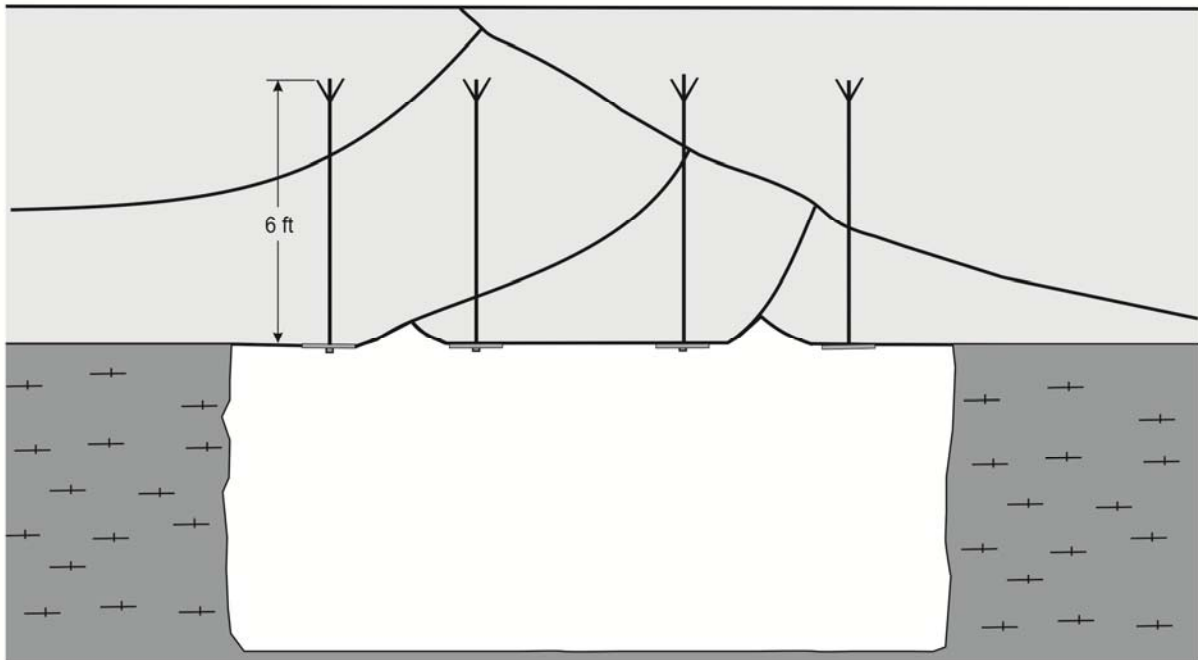
Figure 8: Roof shears can destroy the continuity of the roof beam.

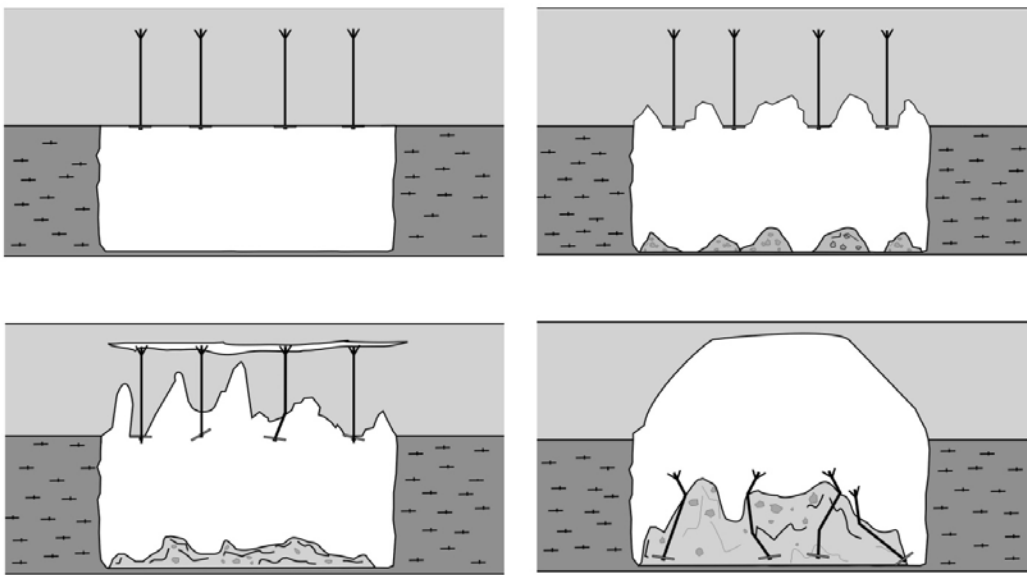
Figure 19: Unraveling of rock between bolts leads to roof fall.

Roof spalling is the fall of rock between bolts. It can progress upwards, eventually above the roof bolt anchorage (Fig. 19). Rock spalling between bolts can be due to several factors. Poor bedding cohesion or a weak rock matrix can allow separation and scale to form between bolts (Fig. 20, 21). The separation can be driven by horizontal stress or by gravity. Roof separation above bolt anchorage then compromises the roof beam and can lead to roof fall. The other mechanism is weathering of moisture-sensitive rocks. Moisture can weaken clay-rich shales and cause swelling, creating downward pressure on the roof, fracturing already-weak rocks [Molinda *et al.* 2006]. This unraveling can eventually progress to a roof fall. A number of mines in the Illinois Basin have time-dependant deterioration of the roof leading to roof falls. Roof falls can continue to happen years after mining. Many studies show that mudrocks weaken with exposure to moisture [Mark *et al.* 2004a; Huang 1986; Cummings and Singh 1981; Aughenbaugh and Bruzewski 1976]. It may be this moisture-deterioration which explains some long-term roof falls.

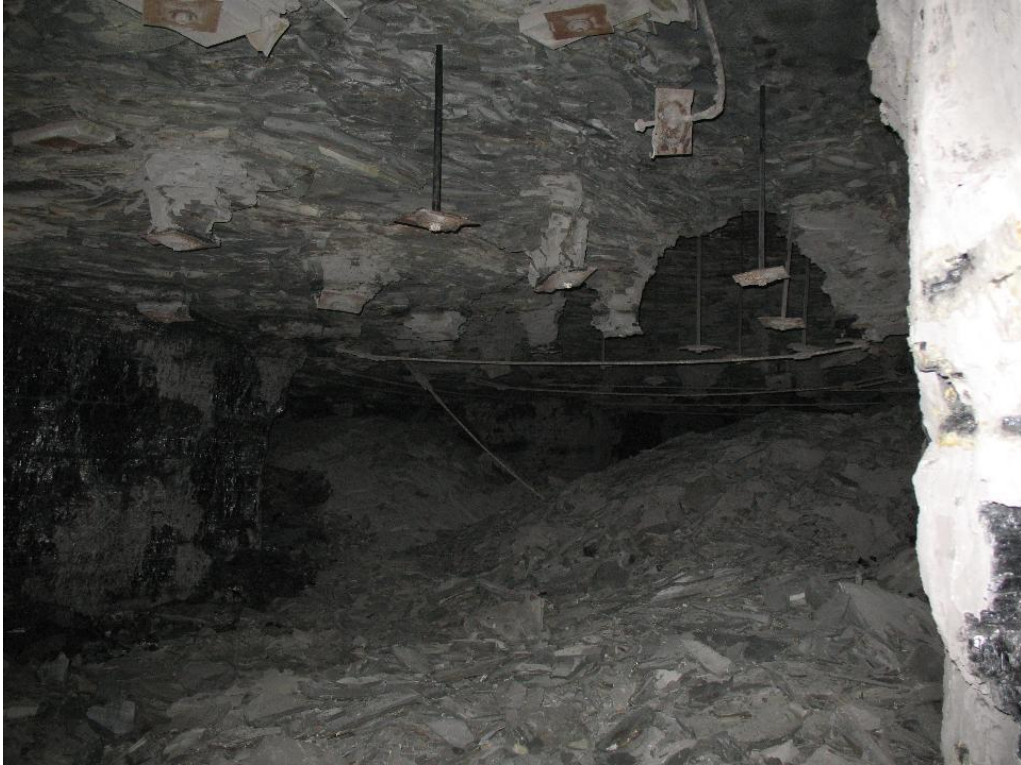
Figure 22: Progressive spalling between roof bolts in a moisture-sensitive roof shale.

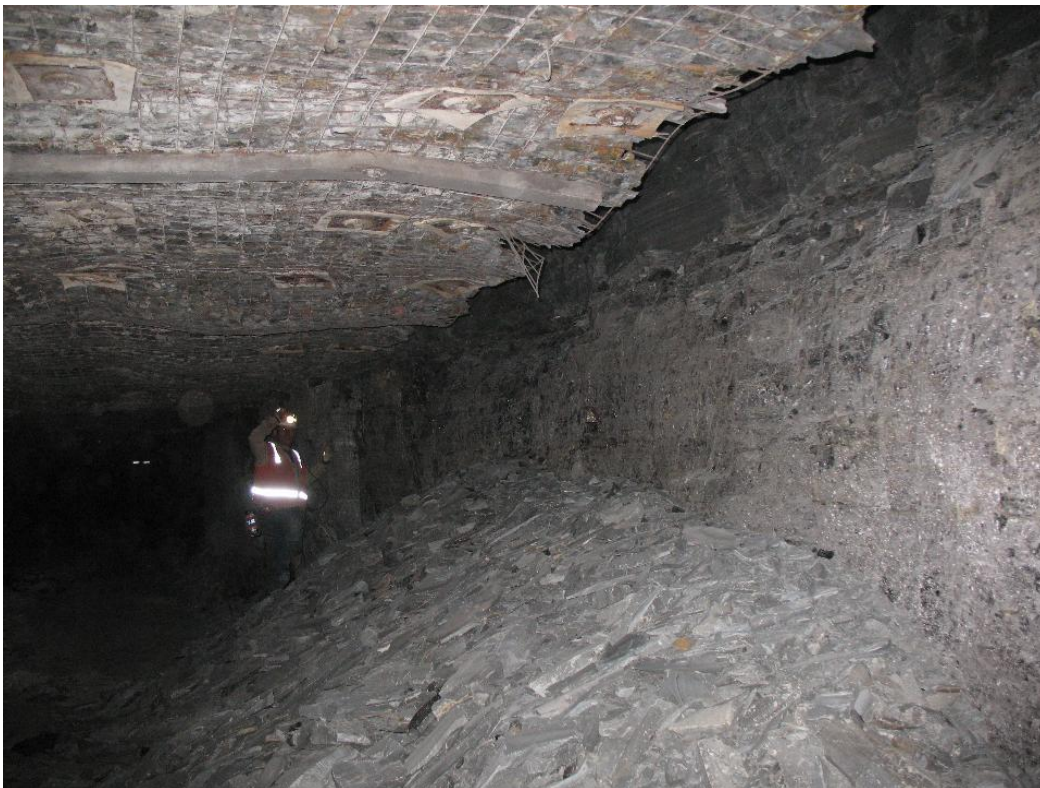
Figure 23: Rock pile below rib gutter is due to disaggregation of weak roof shale.

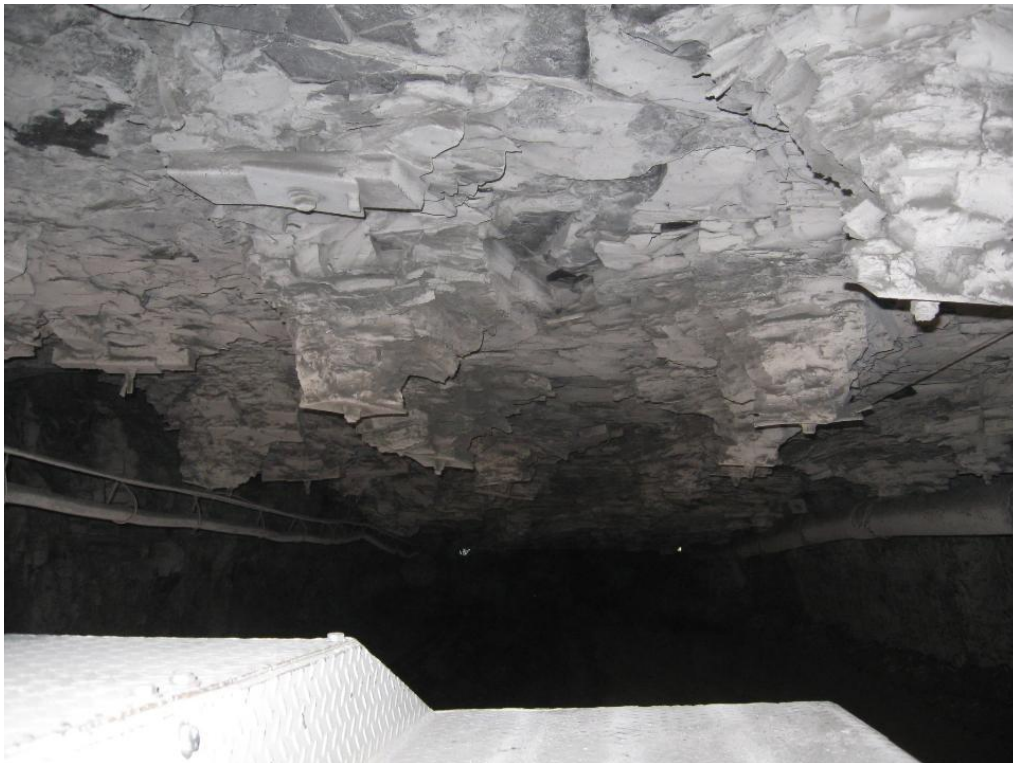
Figure 25: Deterioration of black shale exposing moisture-sensitive gray shale in a western Kentucky mine.

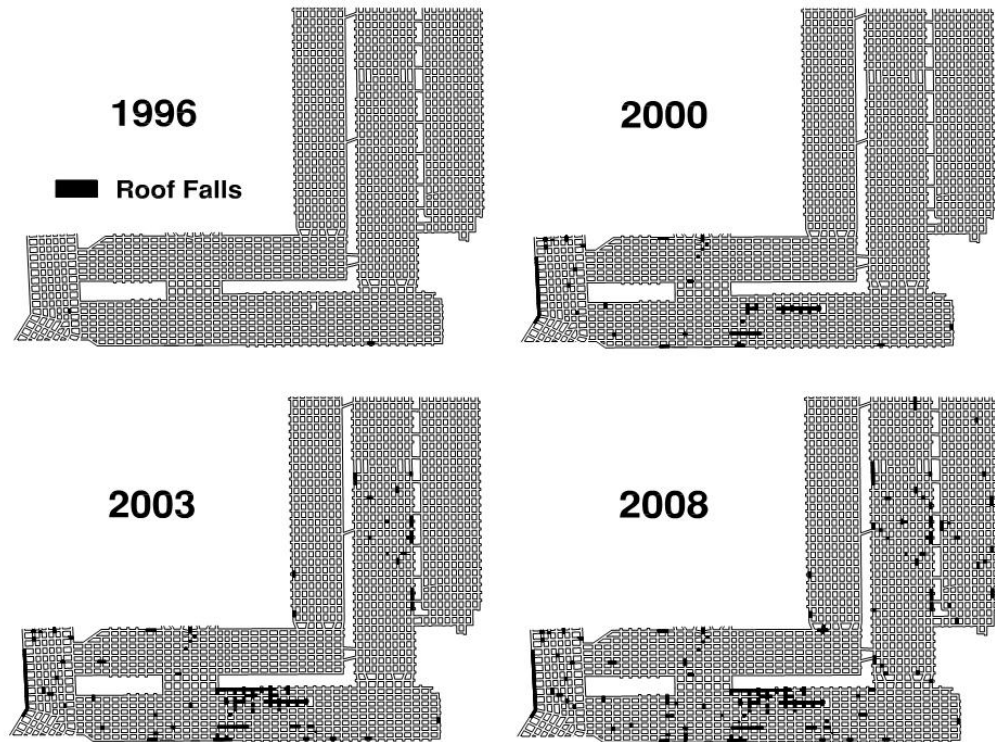
Figure 26: Time-dependent roof deterioration in an Illinois basin coal mine.

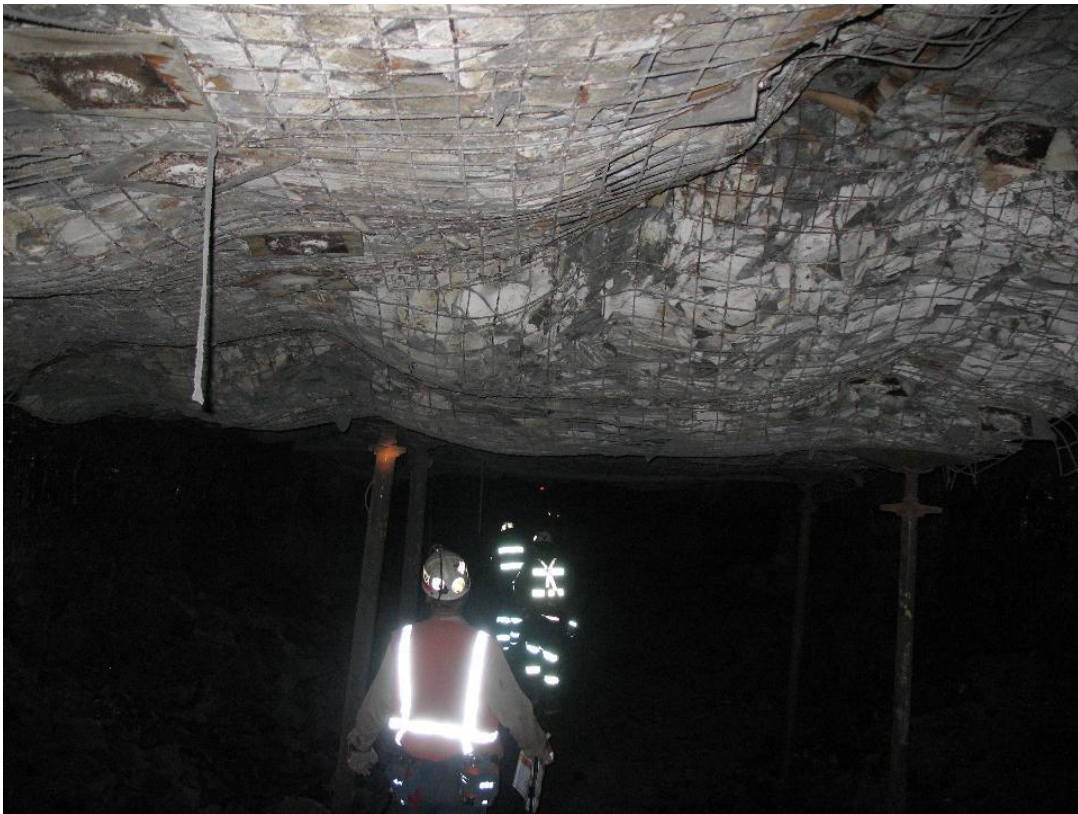
Figure 27: Roof screen holding a large amount of broken rock.

Both of the rock types are extremely weak (breakable by hand) and moisture-sensitive (complete disintegration within one hour of water immersion). There is a weak-moderate horizontal stress field, oriented E-W, attacking the roof. Roof falls are oriented N-S. The biaxial stress field is not overwhelming but strong enough to cut the weak roof shale (UCS = 1,200 psi). A small stress cutter develops on the ribline in entries oriented N-S and again on the box cut in the entry center. Once these cutters open up the roof, infiltrating moisture begins to deteriorate the roof. Weathering begins to occur within one month of roof exposure and is worst nearest the intake shaft and intake entries. Roof screens bag and are holding a large amount of broken rock (Fig. 27). Without the screen, much of the roof would likely be on the floor.

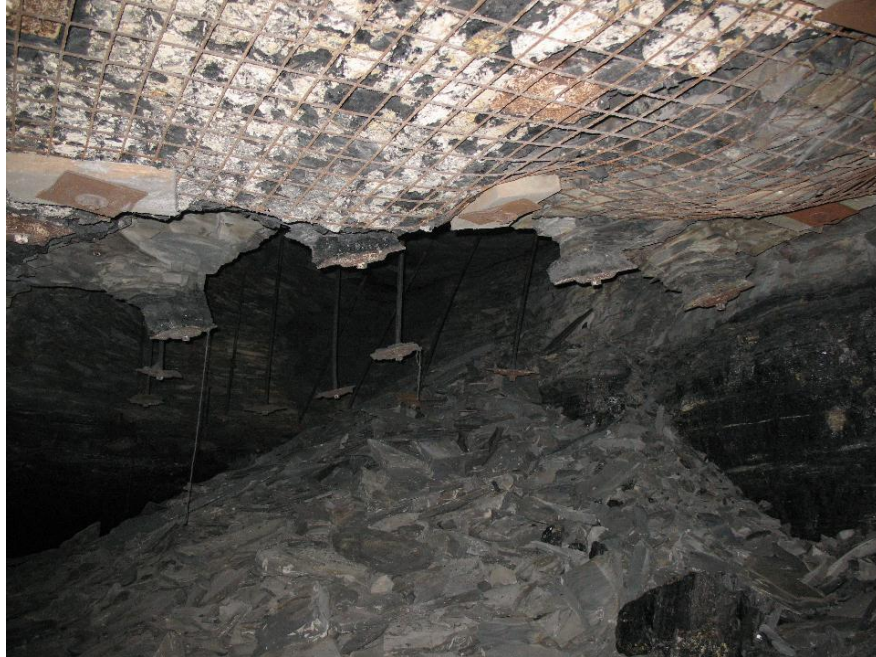
The effectiveness of the roof screen in preventing roof falls can be demonstrated by contrasting the screened area with one that was not been screened. This area is four years old. Extreme deterioration around roof bolts leading to roof falls has occurred. Rock piles on the floor from roof deterioration are 4-5 ft high. The adjacent workings were fully screened after mining, and, even though these screened workings are over 14 yrs old, the entry is intact. Figure 30 shows the contact between screened and unscreened areas. The area that is not screened is impassible. The screened area, even though the roof is extremely broken, is still intact. The adjacent belt entry was screened and stands perfectly in contrast to the unscreened entry. The roof screen provides the confinement between bolts to arrest upward unraveling and transfer rock load to the roof bolts.

Figure 30: The screened entry is stable and the floor is clear. The unscreened entry is impassable.

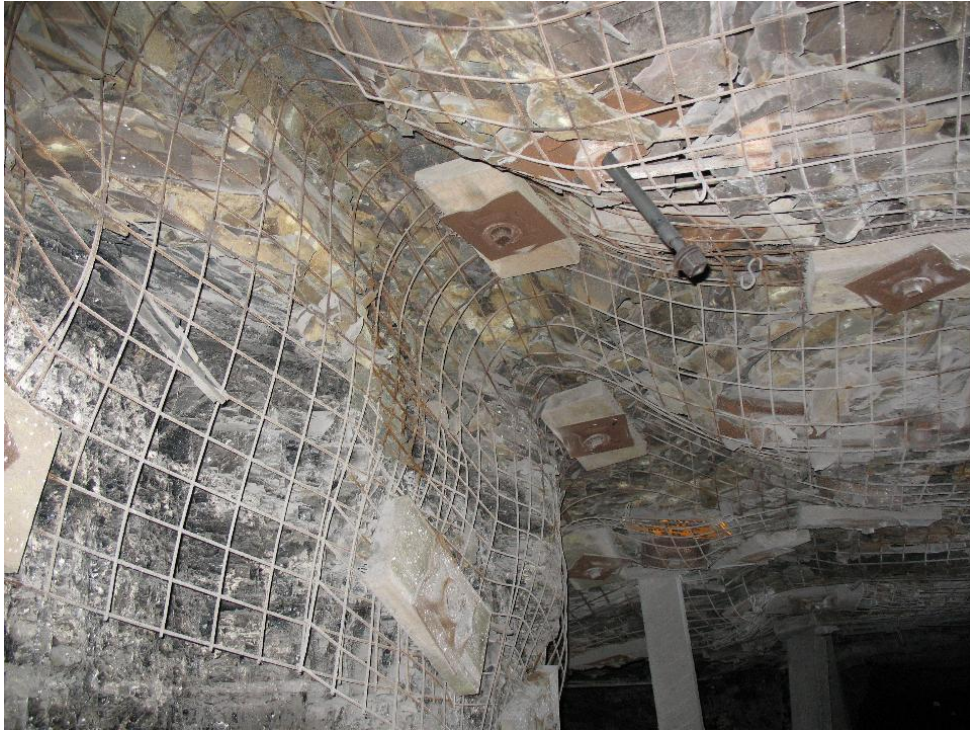
Figure 32: Rib and corner screening controls rib line guttering.

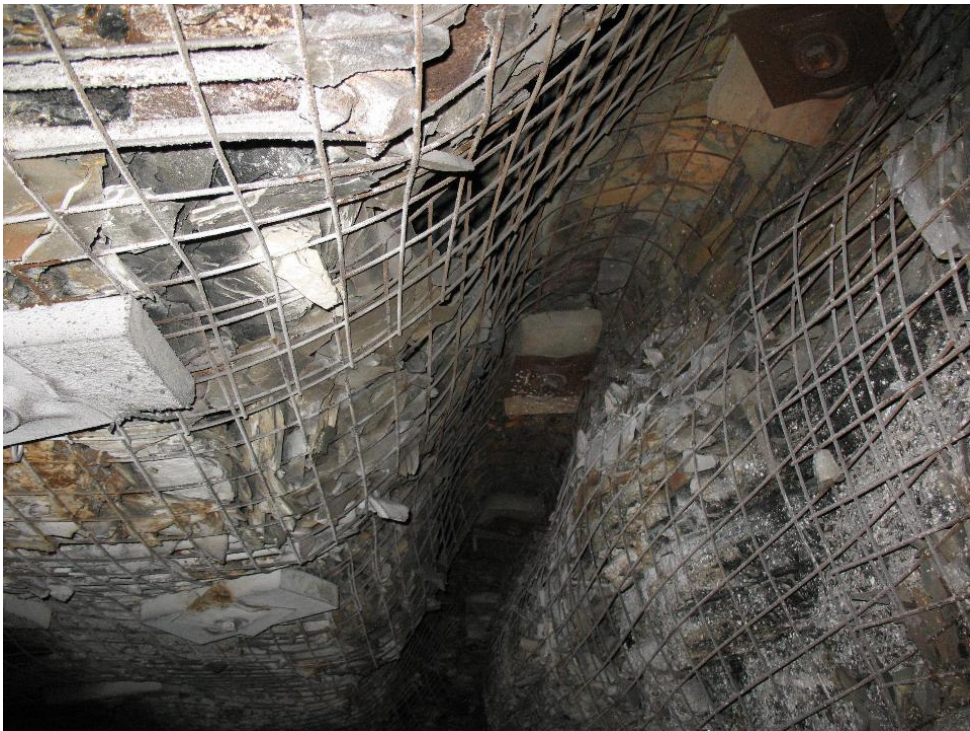
special tool to push screen up into gutters to allow fallen rock piling up on the screen to confine the gutter (Fig. 33). After full roof and rib screening was introduced, roof falls were essentially eliminated.

Figure 33: Screening of rib gutters can stop further deterioration.

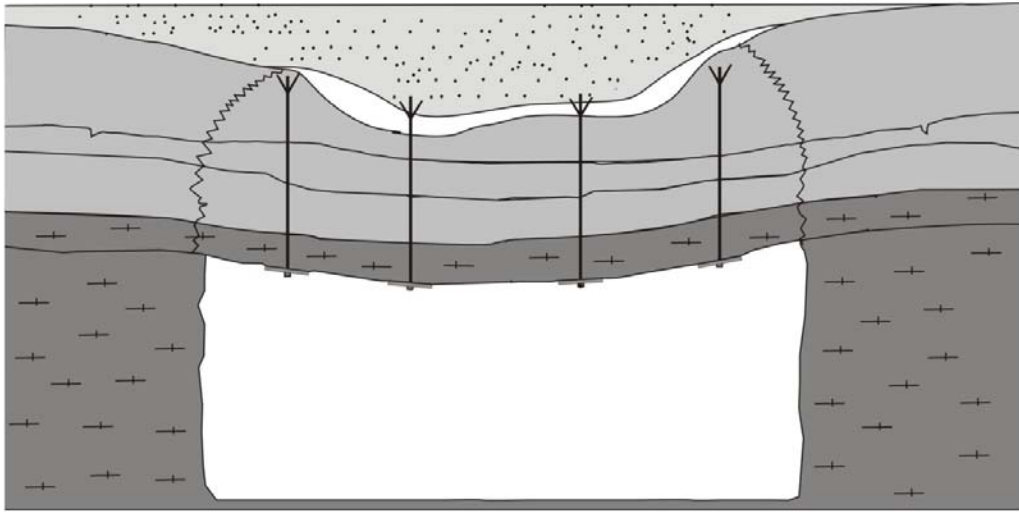
Figure 34: Failure to reach a stable anchorage with roof bolts can result in a roof fall.

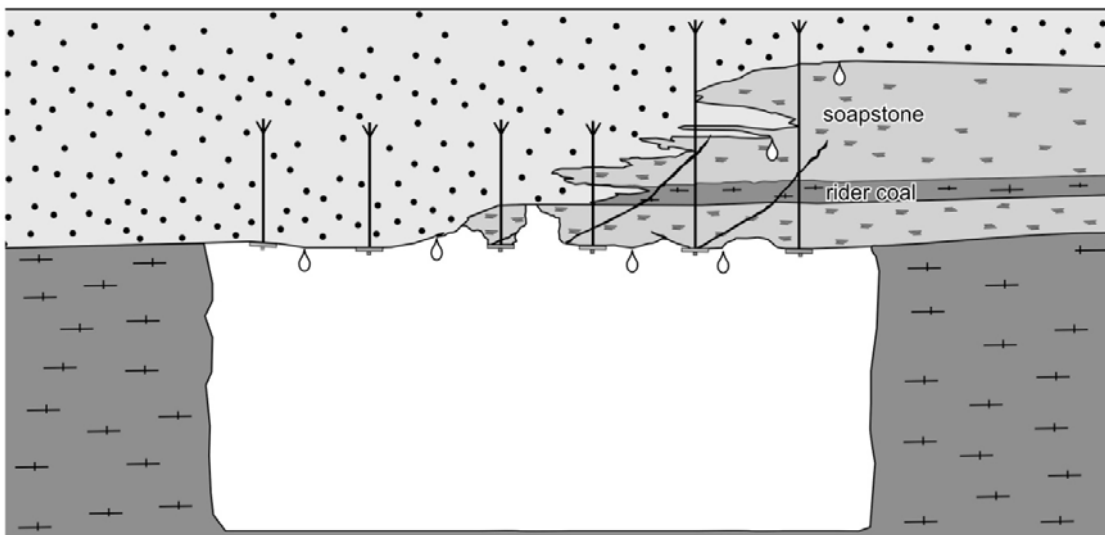
Figure 35: Hazardous roof conditions occur on the margins of a sandstone channel at a West Virginia mine.

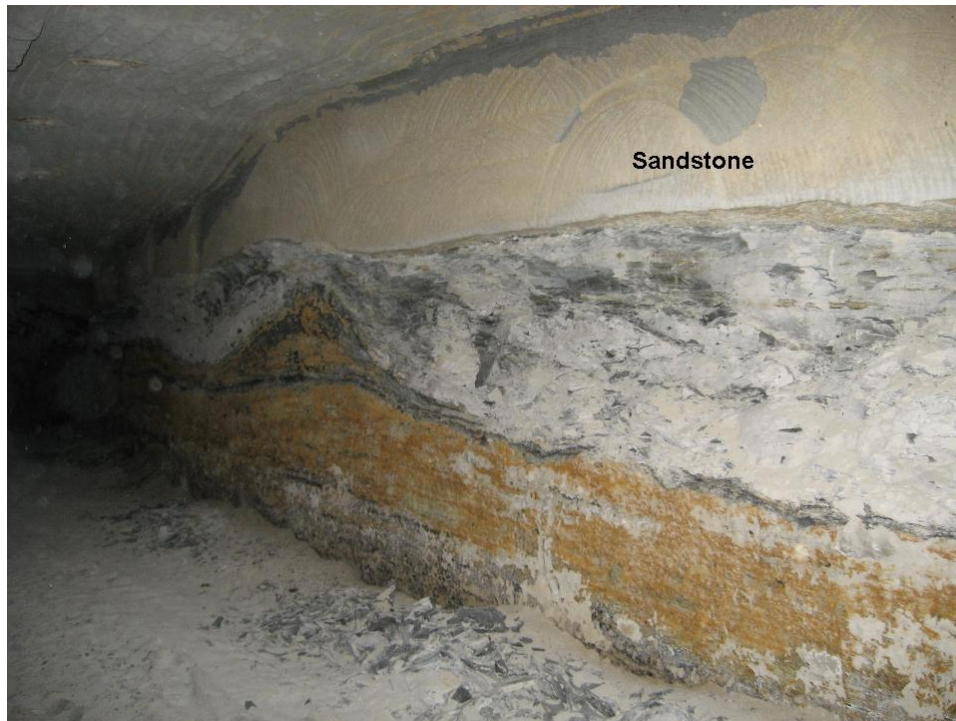
Figure 36: Sandstone layer is the roof bolt anchorage when close to the coalbed.

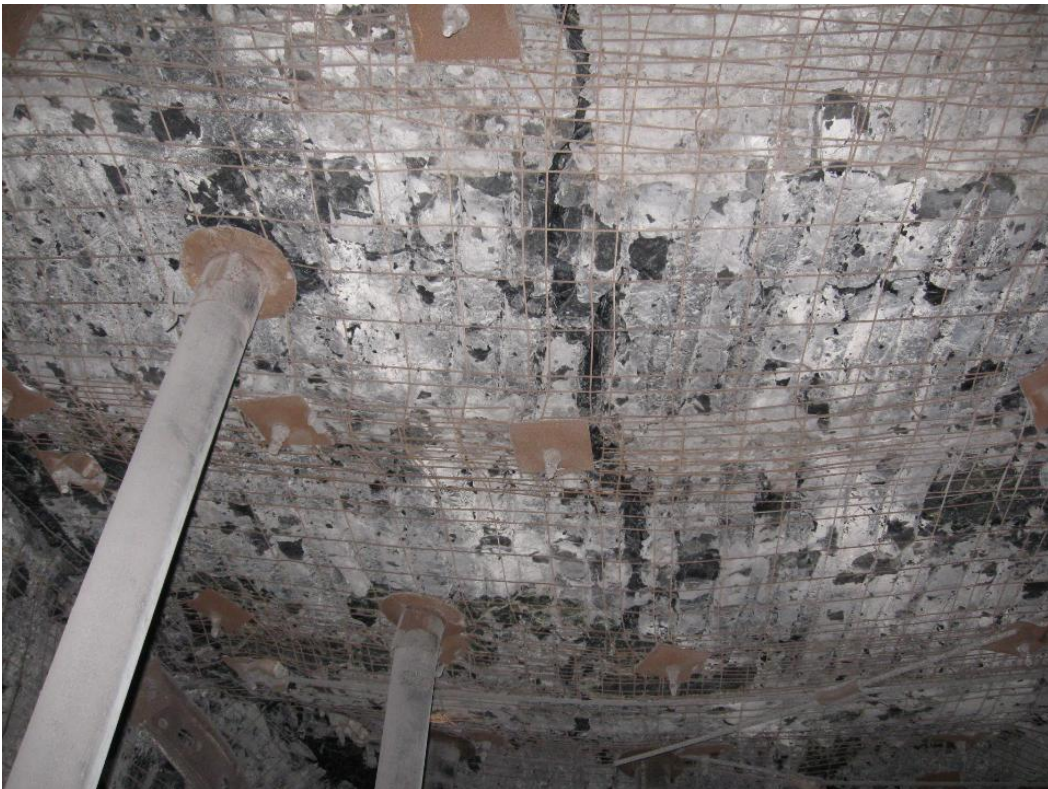
Figure 40: Tension crack in the entry center.

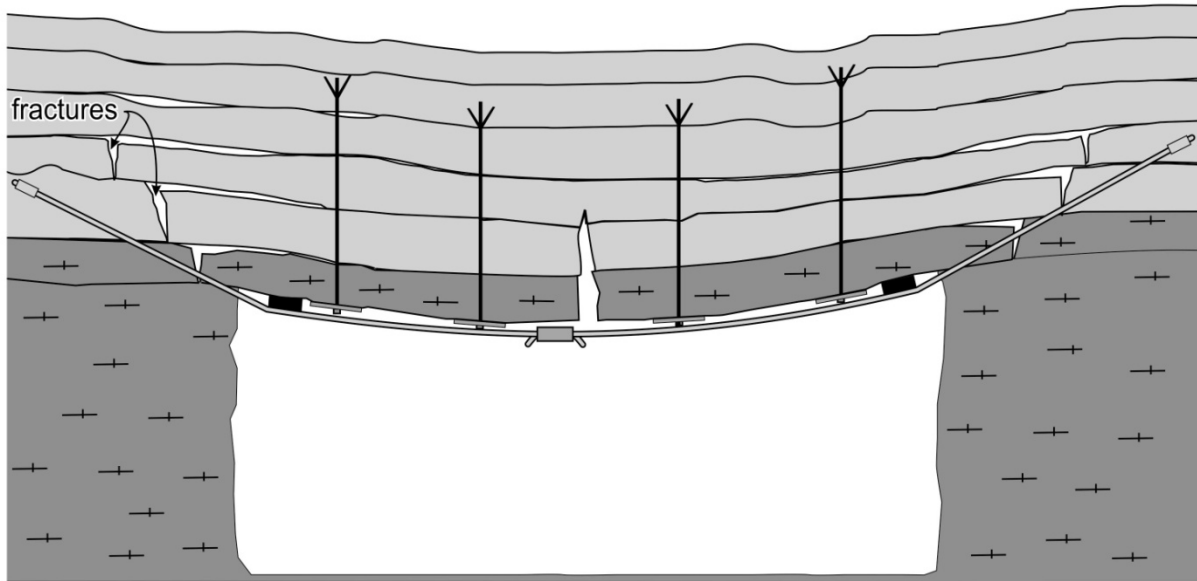
Figure 41: Stairstepping tension fractures begin at the rib abutment and extends over the pillar.

The roof coal has a Unit Rating of 36 and the overlying claystone has a Unit Rating of 32 for an overall ground water-adjusted Coal Mine Roof Rating of 30. The swelling claystone causes significant loading on the roof coal and causes damage to the roof when the roof coal is thinner than 2 ft. A large tension crack, often (3-4 in wide), can open in the entry center as the roof sags (Fig. 40). The roof beam also fails in tension and stair stepping tension fractures occur out and over the rib (Fig. 41). A similar failure was observed at another mine (Fig. 42).

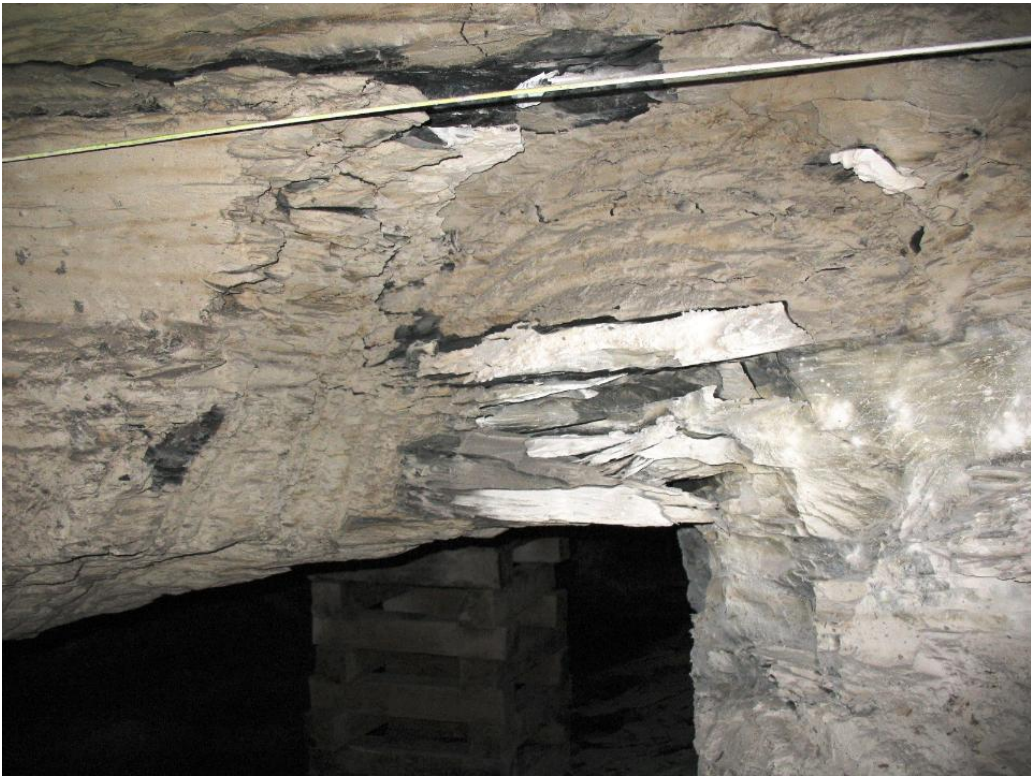
Figure 42: Stairstepping fractures extend over the pillar.
