IC 9149

Bureau of Mines Information Circular/1987

Coal Mine Bumps: Five Case Studies in the Eastern United States

By Alan A. Campoli, Carla A. Kertis, and Claude A. Goode

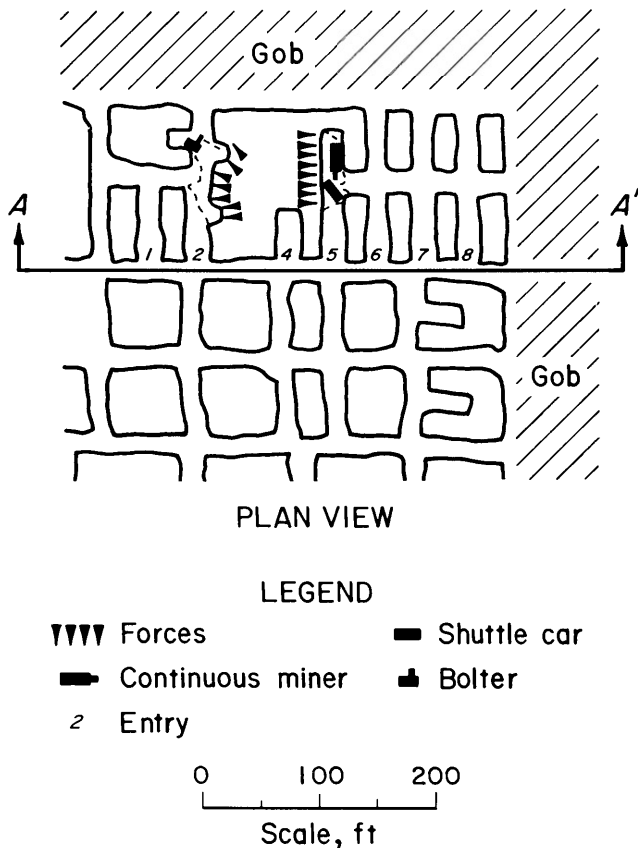
On October 18, 1983, two miners were killed by a bump accident on a continuous miner section, located as marked on figures 7 through 9. No deviations from the general structural trend were evident in the area (fig. 7). Therefore, unusual structural conditions did not lead to the occurrence of the bump. Overburden thickness was in excess of 900 ft (fig. 9). Additionally, data from a Mine Safety and Health Administration (MSHA) accident report (5) and in-mine observations indicated that a hard sandstone approximately 60 ft thick was present immediately above the coalbed (fig. 7). The bump occurred during the mining of the 140- by 350-ft No. 3 barrier pillar. Figure 10 illustrates the conditions directly after the accident. Eight entries on 39-ft centers were planned to divide the pillar. Forces from the bump moved the continuous miner against the right rib and the shuttle car into the crosscut between entries 5 and 6 (fig. 10). The left rib in the No. 5 entry was displaced approximately 8 ft and coal filled the rest of the entry to a depth of 42 in for a distance of approximately 86 ft. The displaced coal is indicated by a dashed line on figure 10. The roof bolting machine was not moved by the forces; however, coal was expelled, filling the No. 2 entry with coal from 3.5 to 5 ft deep, for a distance of 60 ft (5).

Figure 10.—Plan view of area of bump accident on October 18, 1983, mine 1.

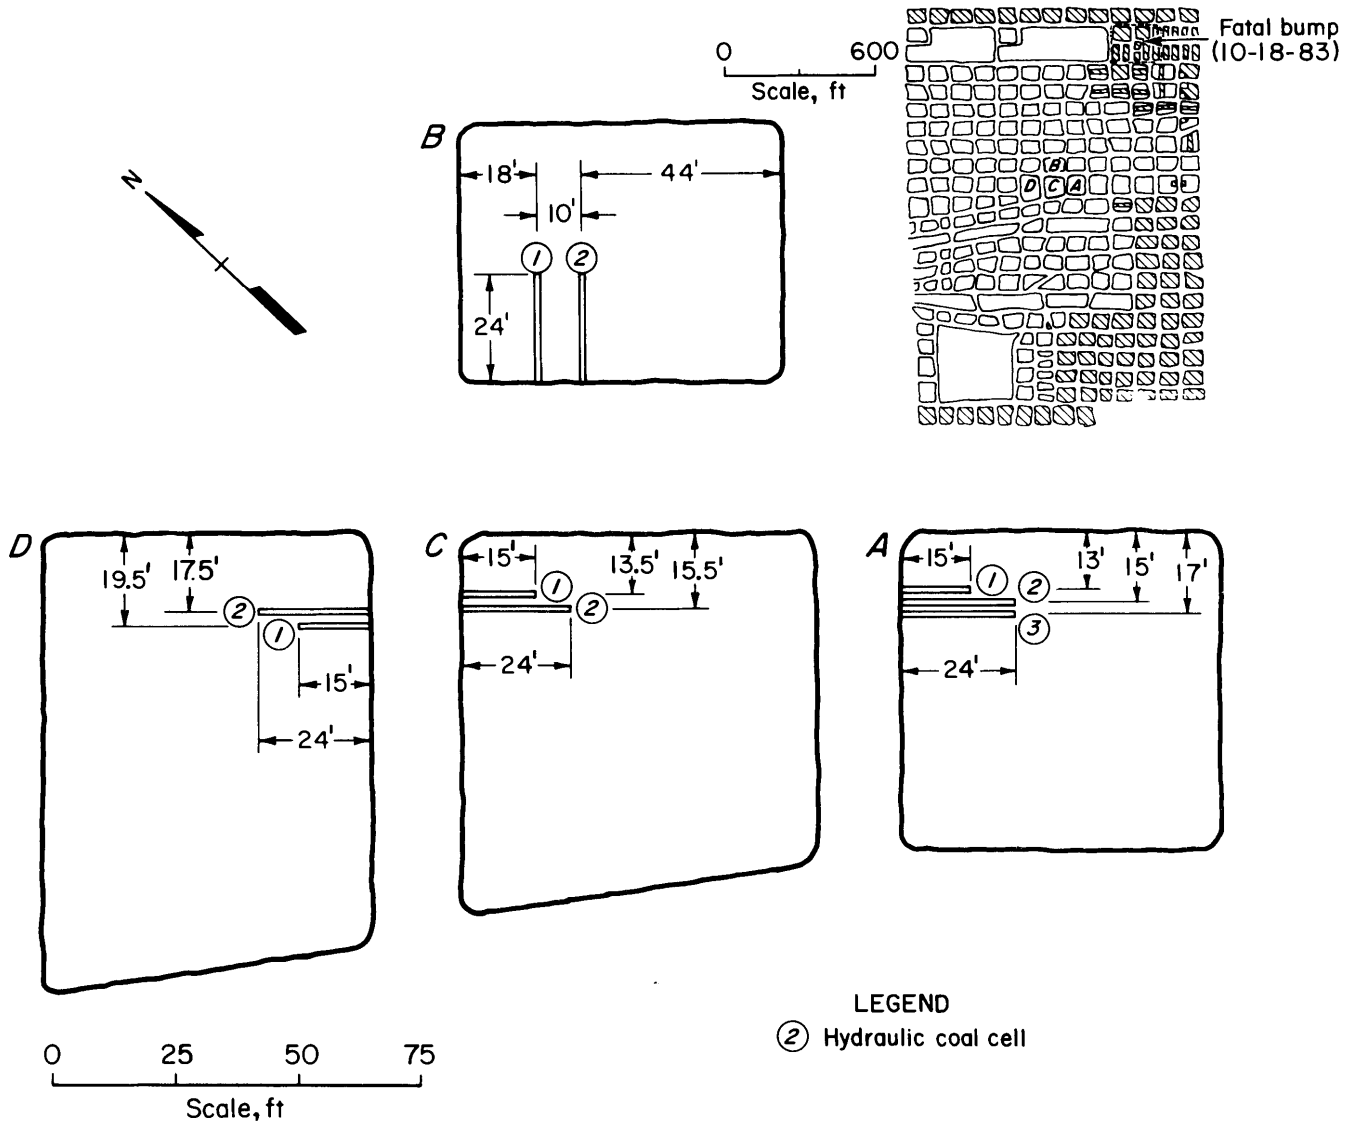
While the cells were not placed uniformly with respect to the pillar geometry, they do demonstrate three trends. Pillars A and D did not load significantly until the nearby inby pillars were split (fig. 15). An increase in cell readings

Figure 13.—Location of hydraulic load cells, in pillars A, B, C, and D, in relation to area of bump accident, mine 1.

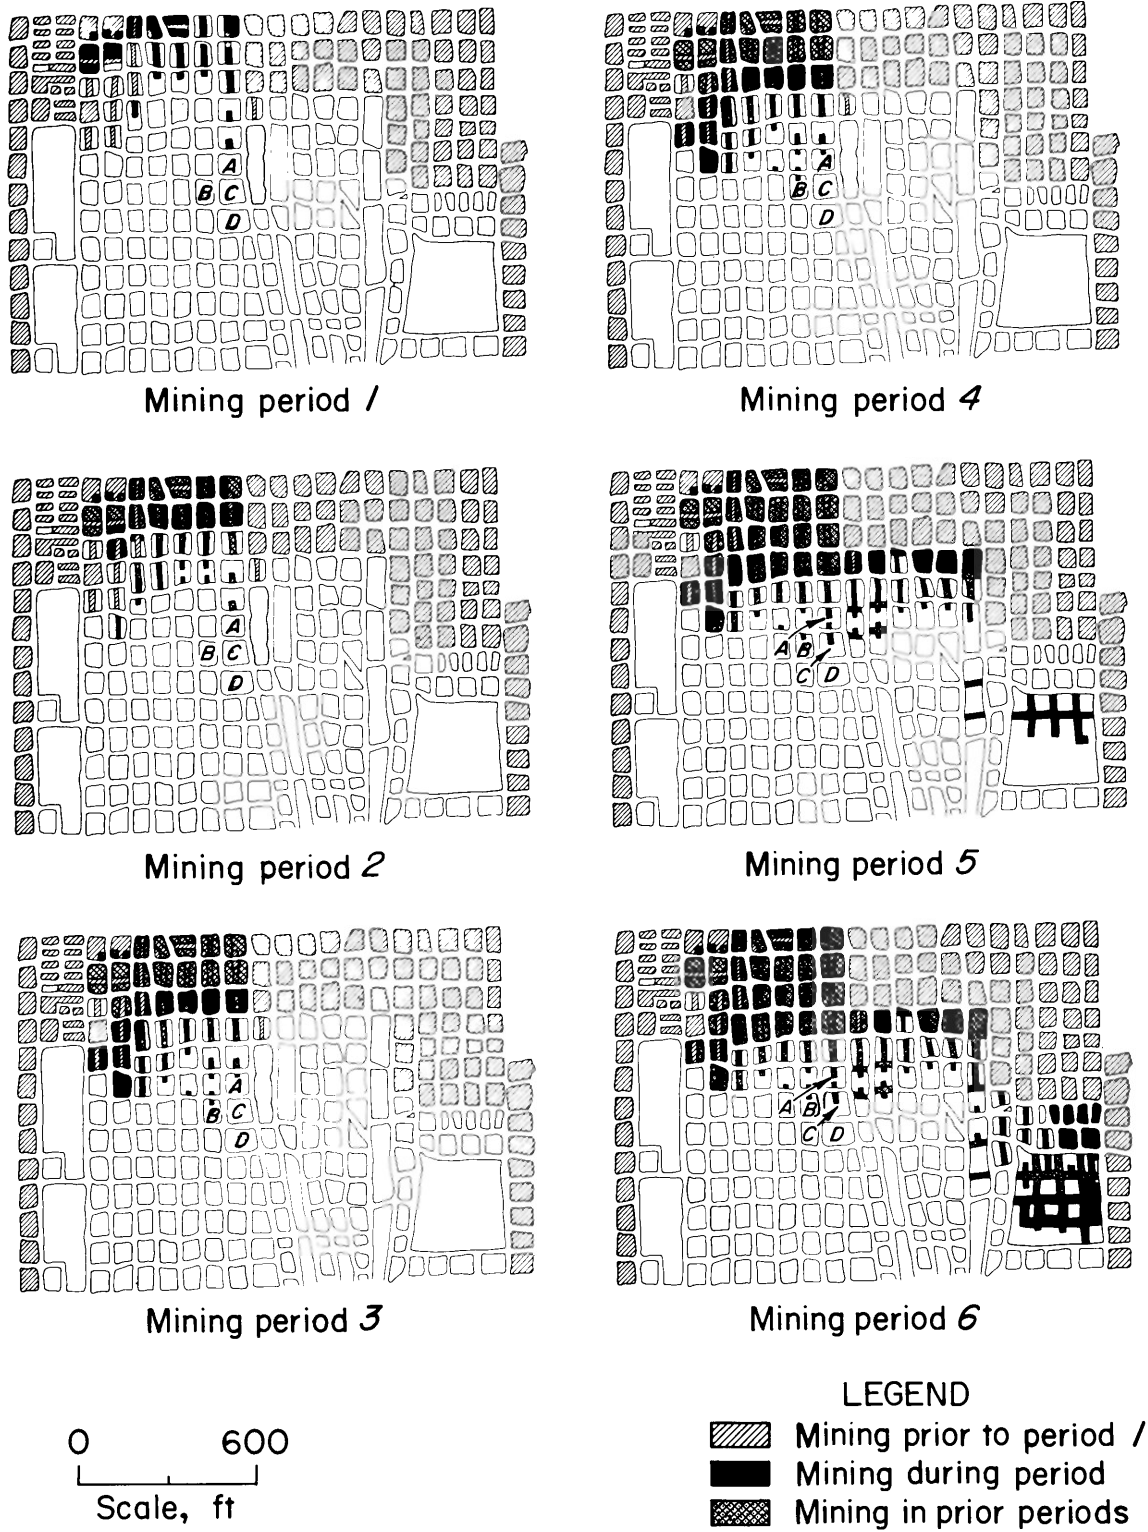
did not take place in pillar D until mining period 5 (fig. 14). At that time pillar C was split halfway and bump cuts were made in a pillar adjacent to pillar A. Second, the cells load evenly up to the point of periphery yield and confined core loading. This phenomenon is verified by all cells except for the data from pillar B. Finally, all four pillars demonstrated an increase in core loadings upon periphery yield.

Figure 14.—Progress of mining maps, for mining periods 1 through 6, of hydraulic load cell readings, mine 1.

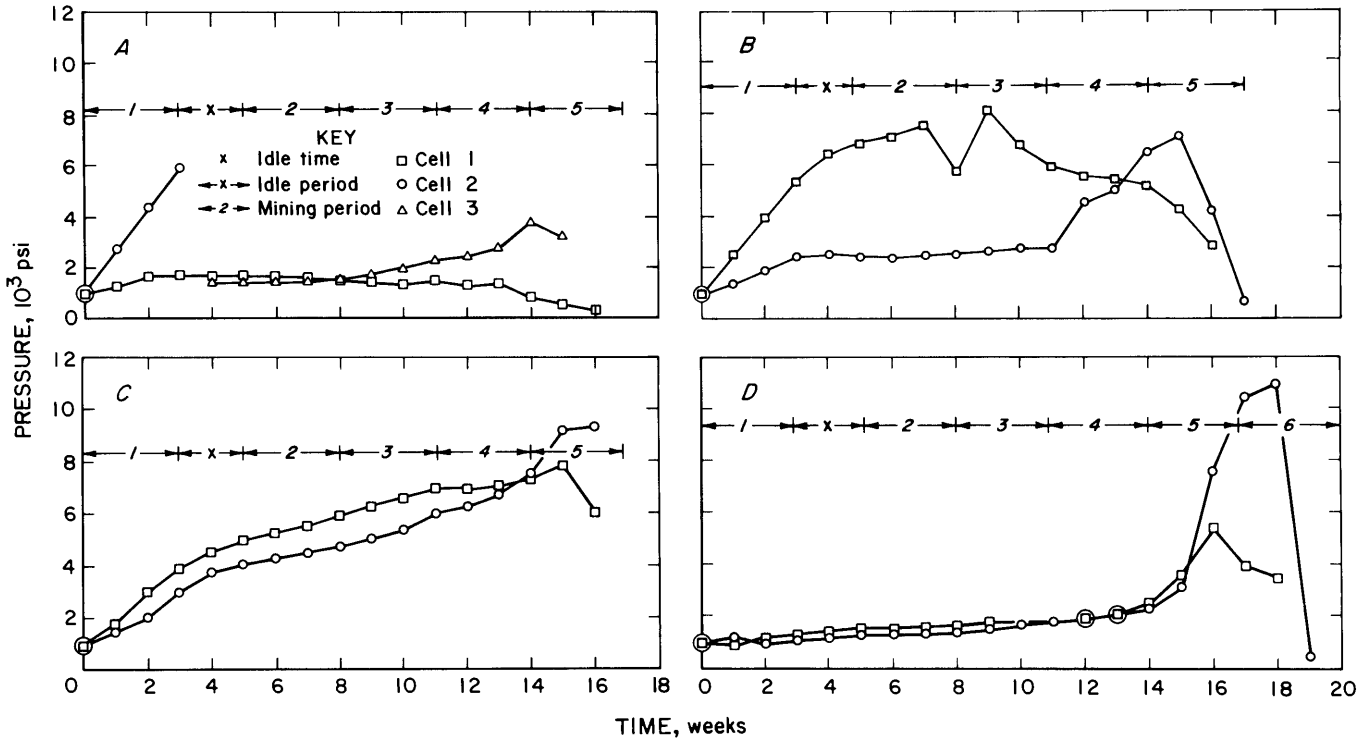
Figure 15.—Graphical display of hydraulic load cell readings, from pillars A, B, C, and D, for mining periods 1 through 6, mine 1.

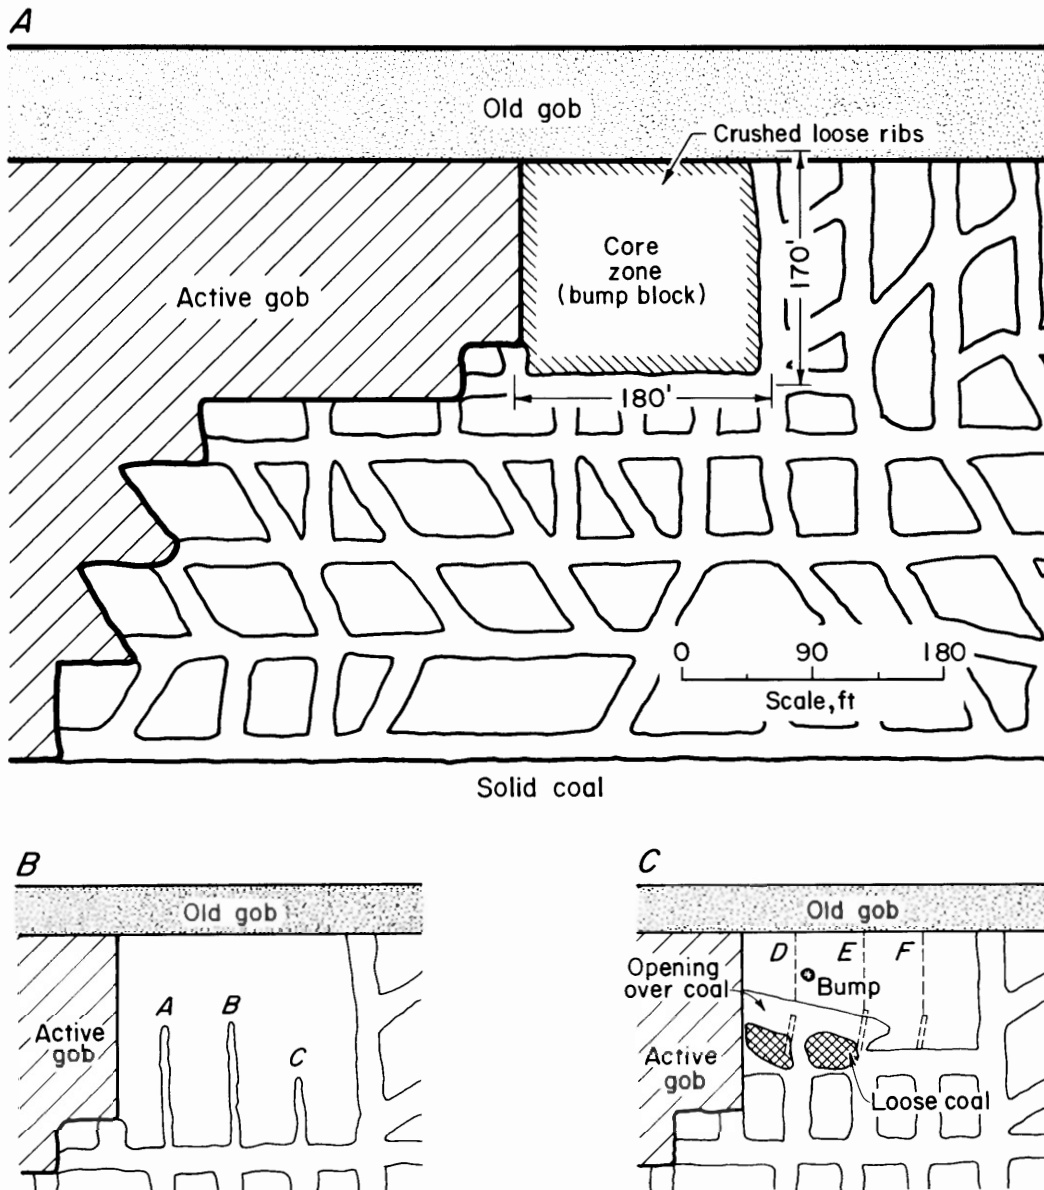
Stress relief drilling experiments were conducted in mine 2 to determine if auger holes (24-in diameter) could be mined safely. Figure 21A displays a 180- by 170-ft bump block that was formed by the removal of a barrier pillar. The coalbed is 7 ft 4 in thick and the depth of cover is 1,100 ft. The bump block was destressed by auger drilling. Holes A, B, and C were drilled to their predetermined depth of 95 ft from behind barricades (fig. 21B). Upon completion of hole C, three entries following the auger holes were advanced 75 ft and connected by a crosscut. As the crosscuts were being driven, the last 35 ft of the holes closed. Prepara-

tions were made to drill holes D, E, and F, which were continuations of holes A, B, and C. Hole D (fig. 21C) was at a depth of 149 ft in the crushed coal area of what was formerly hole A, when a very heavy bump occurred. Approximately 1,000 st of coal was thrown into the entry. An area 100 by 35 ft was opened over the coal pillar by a gap of 8 to 12 in. Because of the extreme precautions taken, no serious injuries resulted. Drilling resumed and another bump was encountered in hole F, which totally destressed the block. The bump block was then retreated without further incident.

Figure 21.—Results of auger drilling of bump block left by thin-pillar mining method, mine 2.

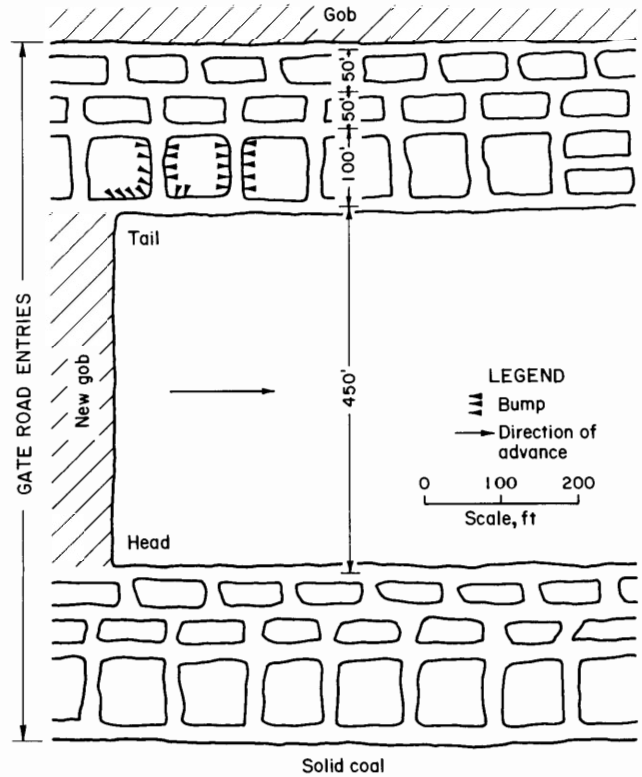
Where strata underlying the Pocahontas No. 3 Coalbed in mine 3 are generally soft, the bottom heaves readily. However, in the area of the bump outlined in figure 27, the bottom was composed of a competent sandy shale, which was generally resistant to heaving. The combination of the load transferred to the tailgate from the adjacent gob area (formed by the previously removed panel), the abutment pressure in advance of the longwall plow face, and the unyielding bottom strata, in the operator's opinion, caused the bump. The 100- by 100-ft block was too large to yield under load. Thus, the pillar stored energy until explosive failure occurred.

Figure 27.—Plan view of longwall gate road entries and location of bump event, mine 3.

Two steps were taken by mine management to prevent further bump hazards: (1) the softening, via shot firing of the large tail entry pillar, and (2) a redesign of the gate roads for subsequent panels. Where firm, unyielding roof and floor strata are present with over 2,200 ft of overburden

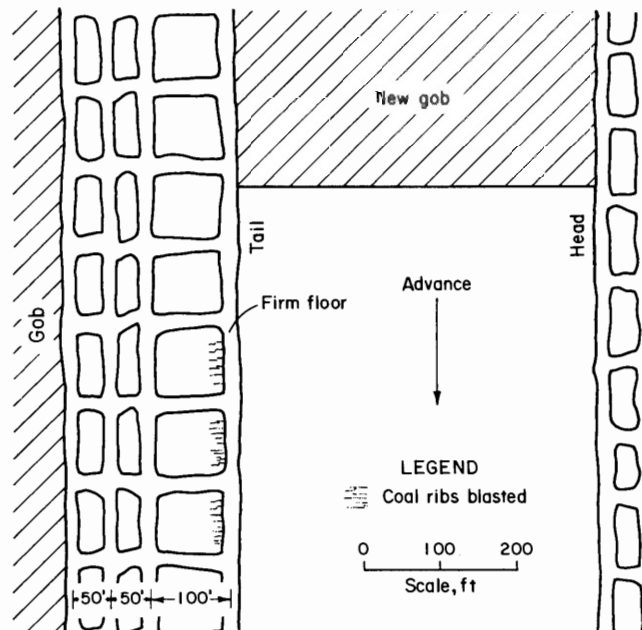
Figure 28.—Plan view of shot-fire softening technique, used on tail entry longwall gate roads for bump control, mine 3.

on the tail entry side of panels employing the old projection (fig. 27), the large pillar is softened. This softening is accomplished by way of volley firing. The ribs of the 100- by 100-ft pillar are drilled and shot (fig. 28). After softening, the pillar stored less than the necessary energy for bumping.

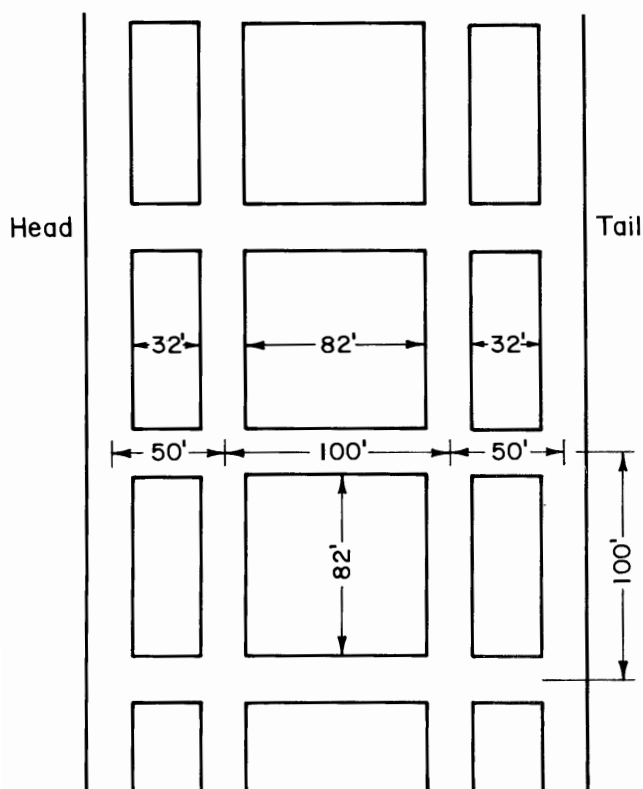
Figure 29.—Plan view of modified bump control gate road design, mine 3.

The modified gate road design is diagramed in figure 29. Two 32- by 82-ft yield pillars are located on either side of an 82-ft square pillar. No shot fire softening of the narrow pillars adjacent to the tail workings is necessary because they fracture and yield upon approach of the longwall face under abutment zone loading. The large pillar, necessary for roof support considerations, is isolated from miners and equipment by the yield pillar. Thus, should the large pillar become overstressed and bump, the working area is shielded. Over 3.3 million st of coal has been mined at mine 3 and adjacent mines operated by the same company, without an injury during a bump occurrence under the modified gate road design.

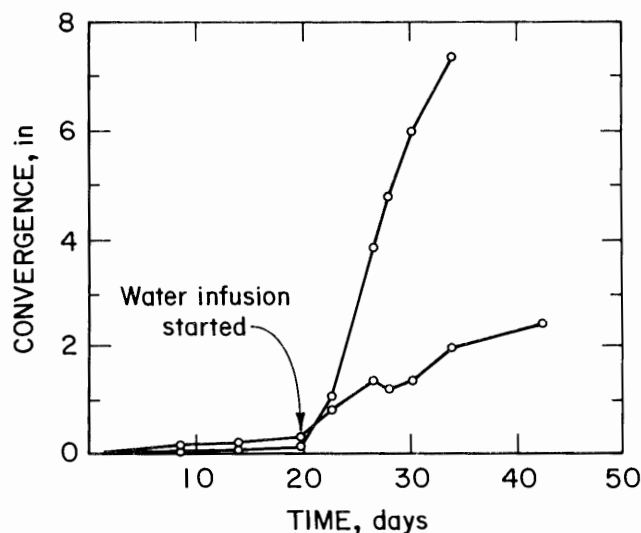
Figure 31.—Graph of convergence effects of water infusion of pillar C (fig. 30), mine 3.

The water infusion of pillar C was accomplished by pumping water at 800- to 1,200-psi pressure, into the pillar at a rate of 10 gal/min. Figure 31 shows the effect on the convergence rate around the infused pillar. The dramatic increase in the convergence rate caused by the water infusion led mine officials to assume that the pillar was destressed. It was then mined without incident. The same test was performed on other pillars. The increases in convergence rate were not as pronounced, but the pillars were mined without incident. Water infusion is not presently conducted for bump control at mine 3.

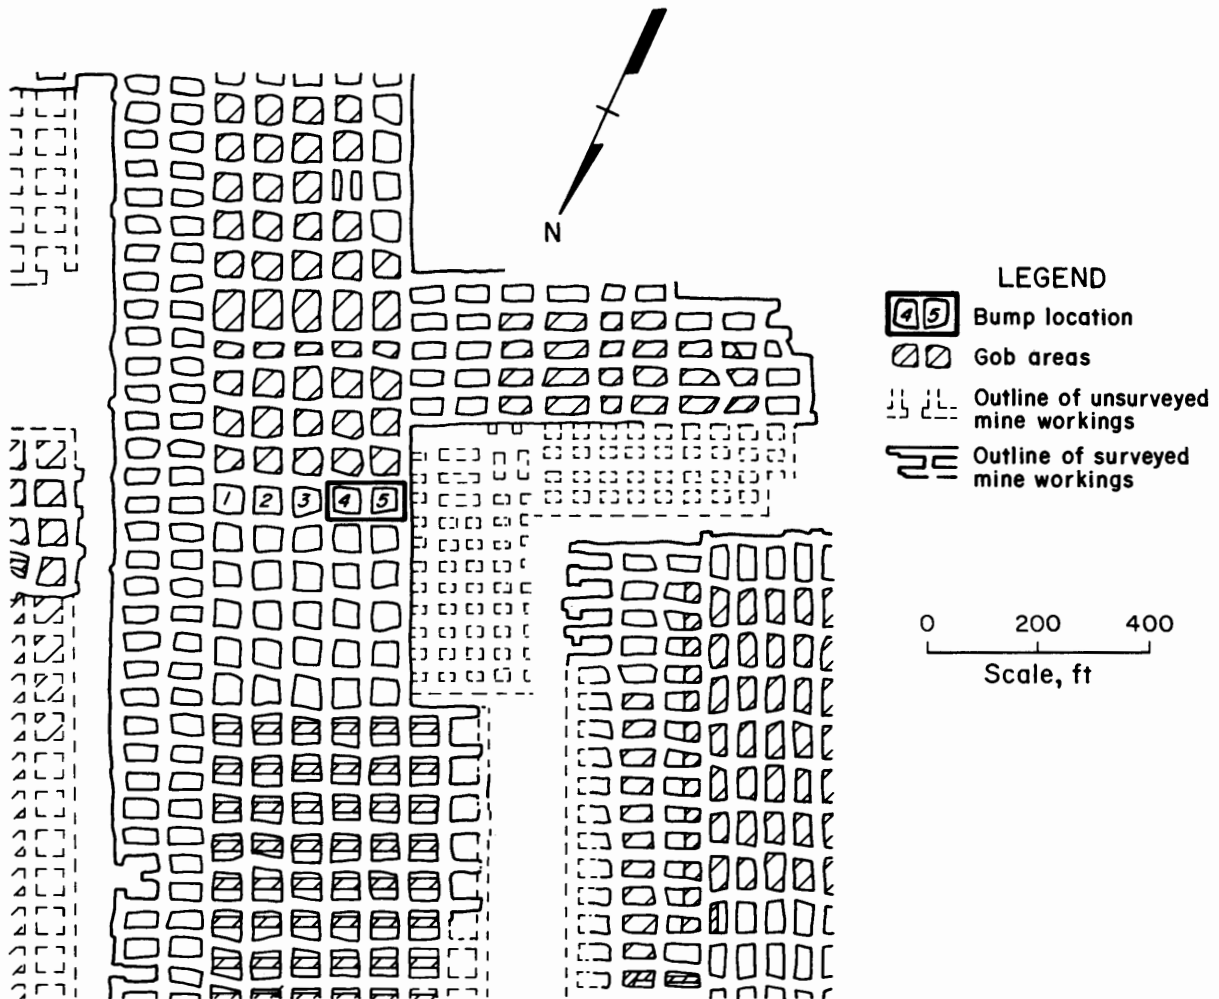
On November 29, 1983, a bump occurred, killing one miner and severely injuring another (11). Retreat mining was underway using the twin-mining method. The depth of cover over this area was 752 ft, which approaches the maximum overburden encountered in mine 4. A map of the bump area is contained in figure 37. Pillars numbered 4 and 5 bumped with sufficient force to move a 26.5-st continuous mining machine 15 ft. The machine was cutting the face of pillar 5 when the accident occurred. Mine officials indicated that a similar bump took place 3 weeks prior to the fatality, during the mining of the pillars in by pillars 4 and 5.

Figure 37.—Overview of bump accident area, mine 4.

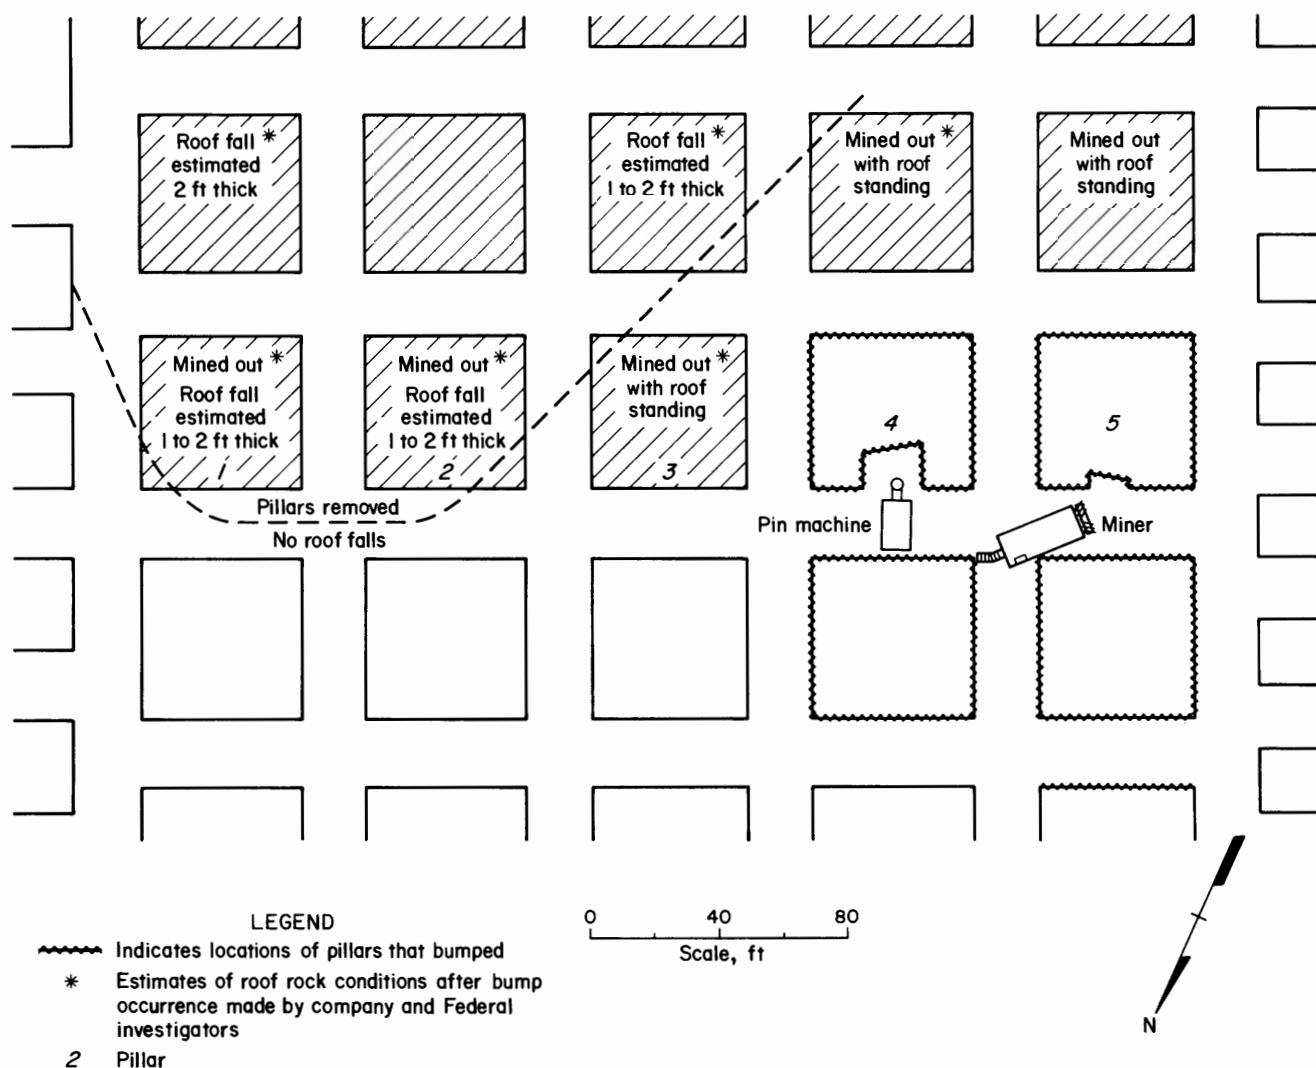
Figure 38.—Plan view of immediate area of bump accident, mine 4.

A closer view of the accident area is mapped in figure 38. Note the standing gob directly inby and to the left of pillar 4, where the pin machine or roof bolter was located. The fall of immediate roof only in the gob area of pillars 1 and 2 also is significant. The combination of the stress transferred from the yield pillars directly adjacent to pillar 5 (fig. 37) by the rigid roof and the standing gob led to the bump event. Five rows of pillars were then left as a barrier (fig. 37), full extraction was discontinued, and a partial extraction procedure was instituted. This pillar splitting reduced the total extraction ratio to less than 60 pct.

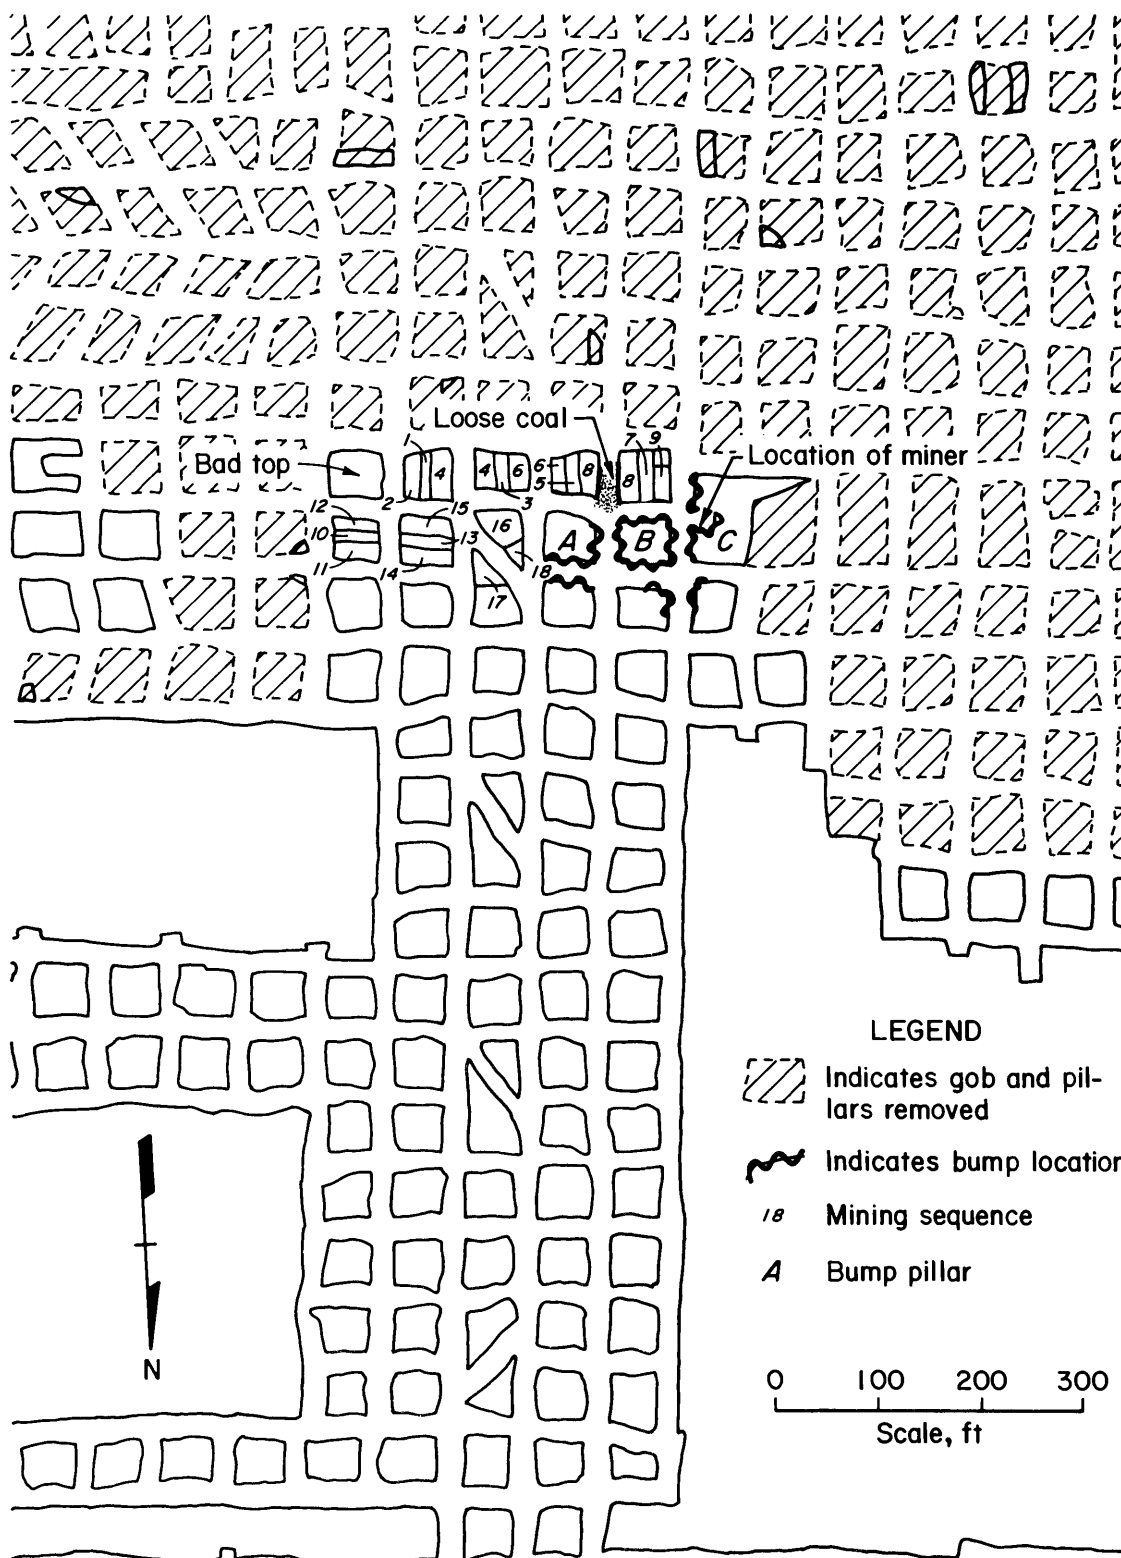
It is theorized that the bump was caused by the extraction of pillars located on a pillar point. A pillar point, as defined by previous researchers (1), is a pillar located at the intersection of at least two gob areas. In this case, the pillars were located between three gob areas (fig. 42). Abutment pressure was transferred from three gobs onto the section. This pressure, combined with unstable roof conditions created by the failure of pillar remnants inby the section, caused the bump.

This event was unique among those studied, for three reasons: (1) The center of the bump was not the pillar containing the working face, (2) a 6- to 12-in separation was formed between the roof and the top of the affected pillars, and (3) roof support timbers were broken into a V-shape, but were loosely held between the roof and bottom. These results seem to indicate that the roof transmitted a hammerlike blow to pillars A, B, and C (fig. 42). This type of failure was defined by previous researchers as a shock bump (1).

Figure 42.—Plan view of area of bump accident, mine 5.
