SUBJECT: A Mechanic Dies When He is Crushed by the Hydraulic Arm of a Recyclable Refuse Collection Truck

SUMMARY
California FACE Report #10CA005

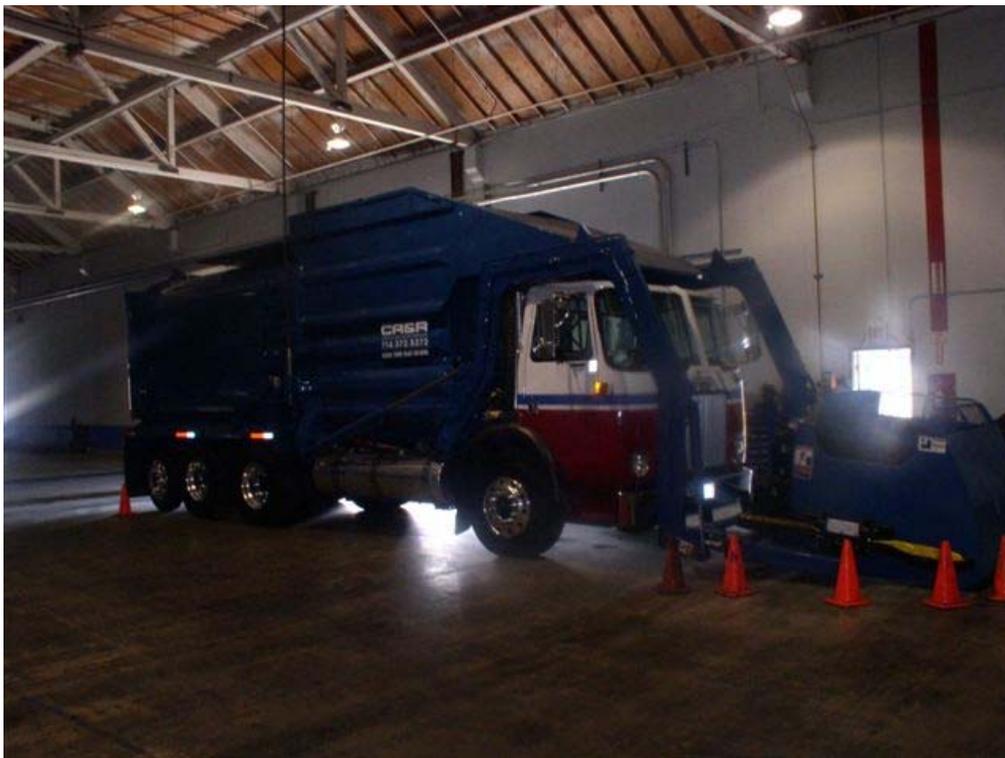
Exhibit 1. The truck involved in the incident

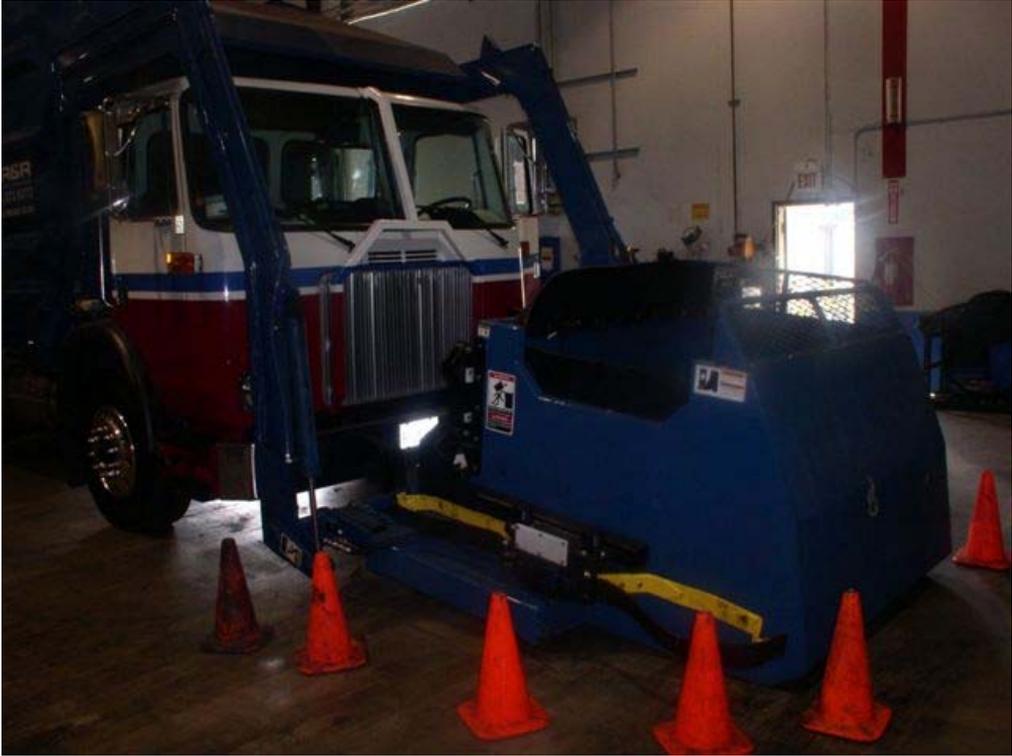
Exhibit 2. The collection bin with attached automated system

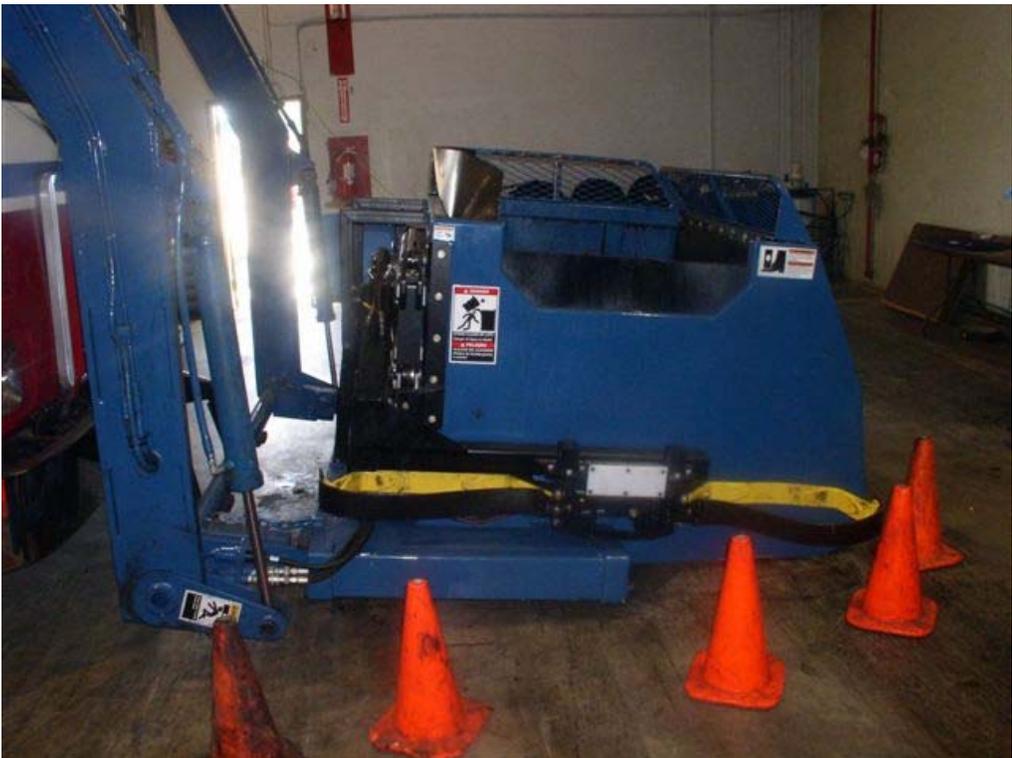
Exhibit 3. A side view of the collection bin and the automated system

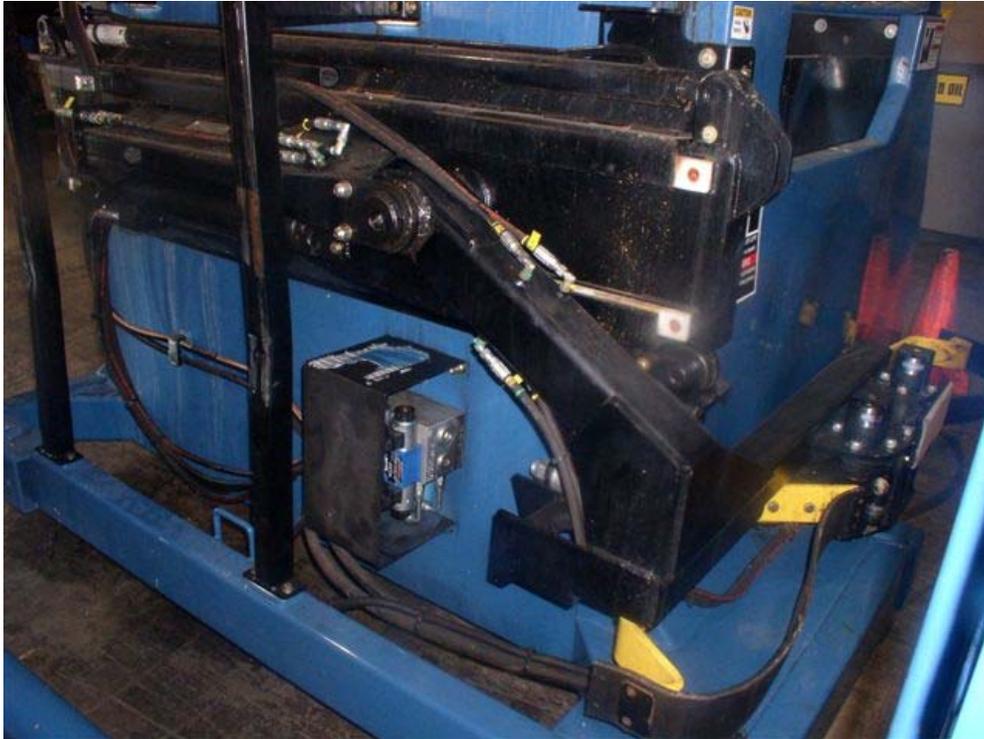
Exhibit 4. The automated systems components mounted on the rear of the collection bin.

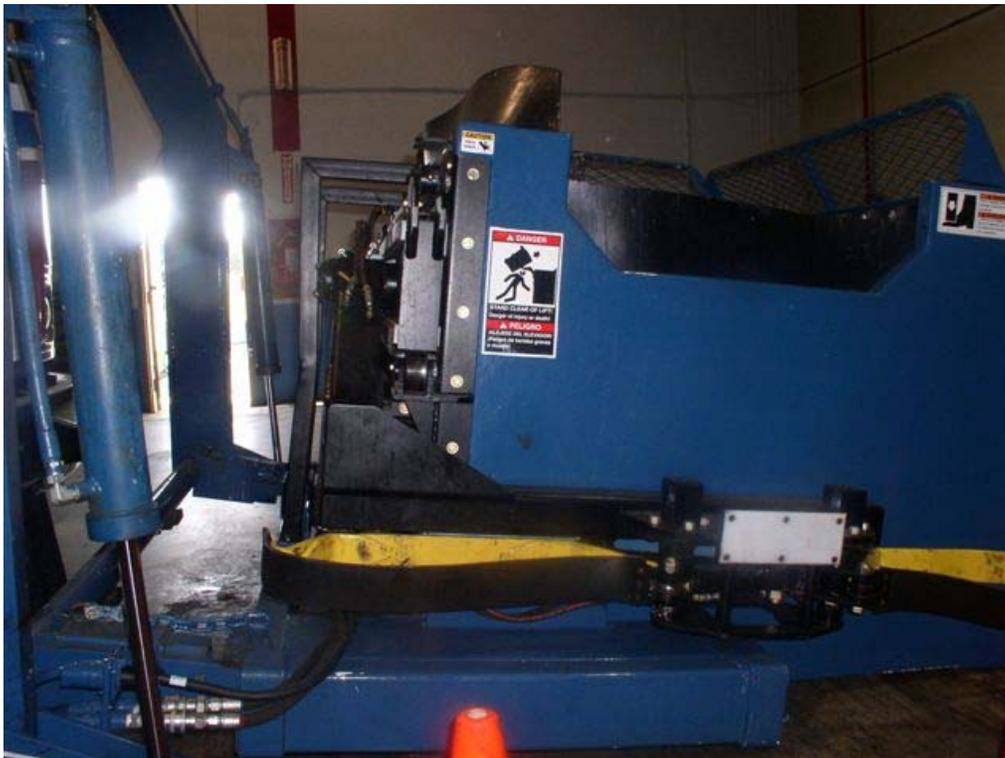
Exhibit 5. The grabbing device that extends and retracts to pick up recyclable containers.

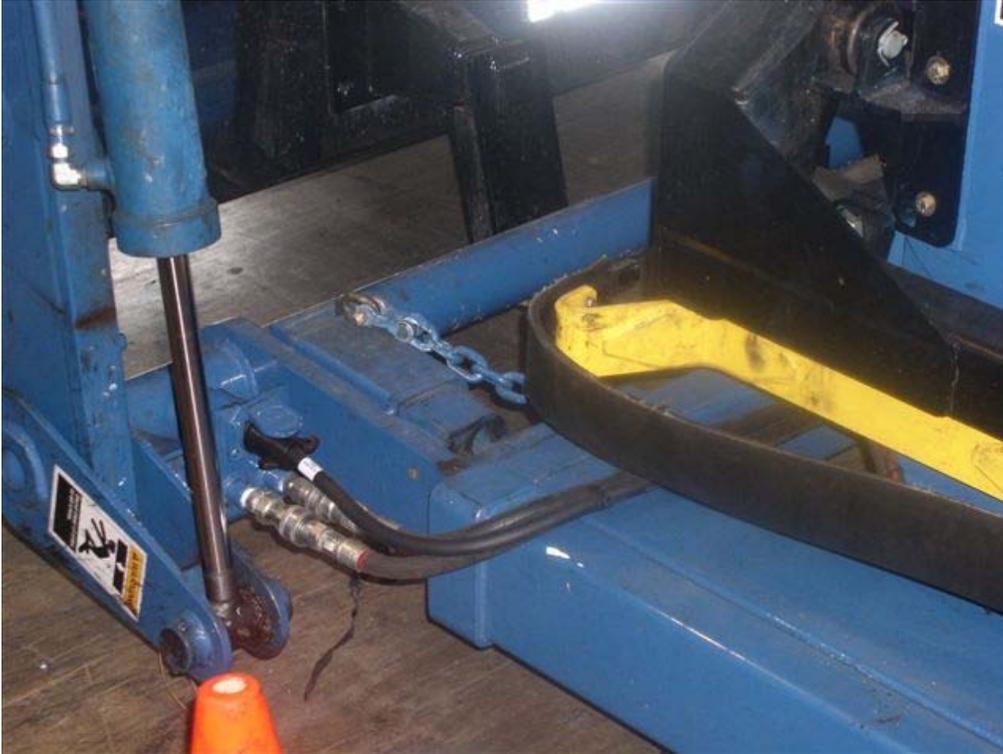
Exhibit 6. The hydraulic and electric connections.
