## **Massachusetts FACE • Occupational Fatality Report**

### **Municipal Electrician Dies after Falling from the Raised Bucket of a Vehicle-mounted Aerial Lift That Was Struck by a Tractor-trailer – Massachusetts**

**Investigation: # 11-MA-043-01**  
**Release Date: October 31, 2012**

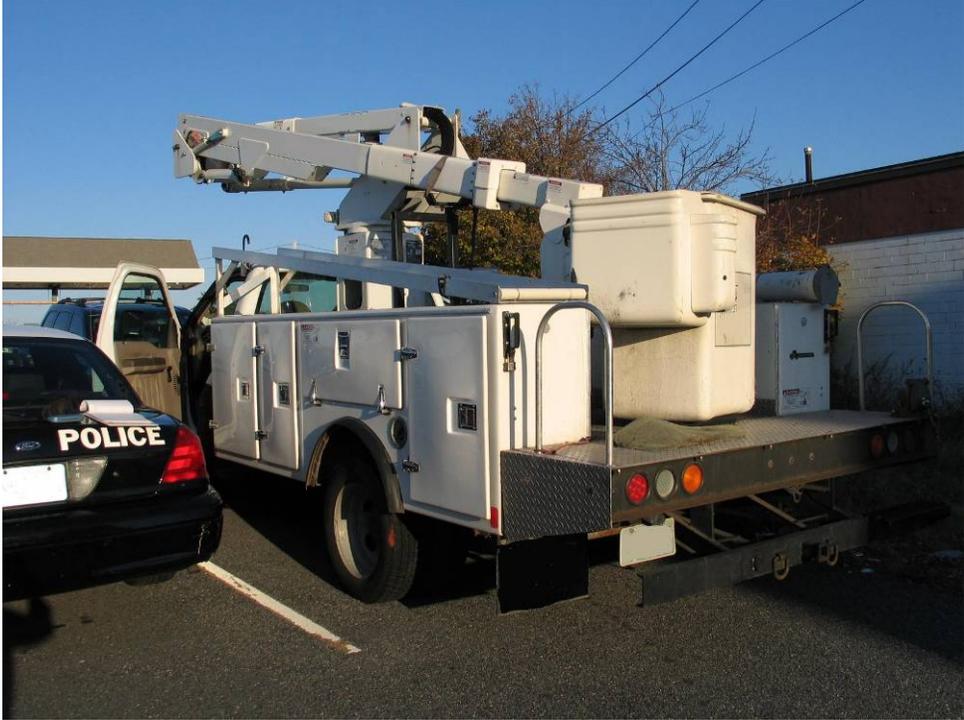
About a year before the incident, the Department of Traffic and Parking had removed their aerial lift truck from service and began renting an aerial lift truck while a new replacement truck was being built. The aerial lift truck that was involved in the incident was the truck being rented and the victim was the only employee assigned to operate it. The rental aerial lift truck's chassis and aerial lift body were both manufactured in 2008 and were white in color (Figure 1). The truck's gross vehicle weight rating was 8,845 pounds, and it was equipped with dual rear wheels and a diesel engine. The telescoping and articulating boom platform had height and weight ratings of 38 feet and 300 pounds respectively. There were two sets of controls for the movement of the truck's boom/bucket. One control was mounted to the bucket and the other control was mounted to the truck's body at the ground level. The vehicle was equipped with yellow light-emitting-diode (LED) strobe lights located in the truck's bumper. There was also a fall protection anchor point located at the truck's bucket along with a danger decal warning of the fall hazard and the need to use fall protection (Figure 2). A body harness and lanyard with signs of past use was observed during the site visit in the side cabinet of aerial lift truck.

Figure 1 – Vehicle-mounted aerial lift involved in the incident

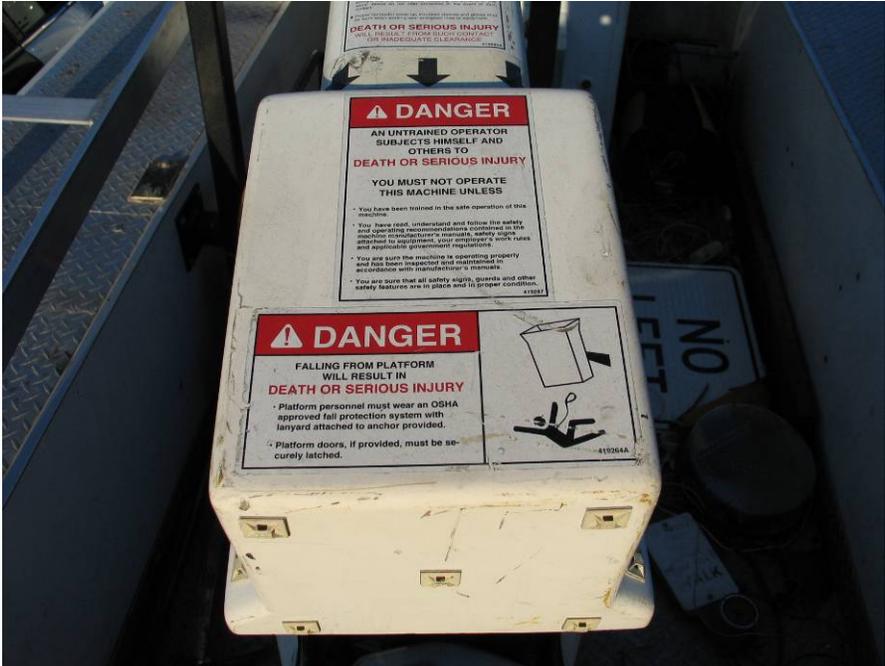
It was reported that the victim was wearing high visibility safety apparel (vest or jacket), but the exact type and class was not known. The victim, without donning personal fall protection equipment, climbed into the truck's bucket and raised and extended the boom and bucket out over the active roadway's left hand southbound travel lane. The truck's boom has two main sections. At the time of the incident, the first section of the boom was positioned vertically and the second section was perpendicular to the first section extending horizontally out to the traffic signal. The bottom of the bucket was raised approximately 12 feet 7 inches from the roadway (Figure 3). At this same time, one of the co-workers was accessing the traffic signal control box that was located on the sidewalk next to the aerial lift truck. The other co-worker was in the cab of the pickup truck located on the side street.

Figure 2 – Vehicle-mounted aerial lift fall hazard danger decal

**Discussion:** In this incident, the victim was working from a raised aerial lift truck without fall protection, although fall protection was available. Fall protection is required to be used whenever working from an aerial lift truck's raised platform.<sup>1</sup> There are two main types of fall protection systems that can be used with aerial lift trucks.

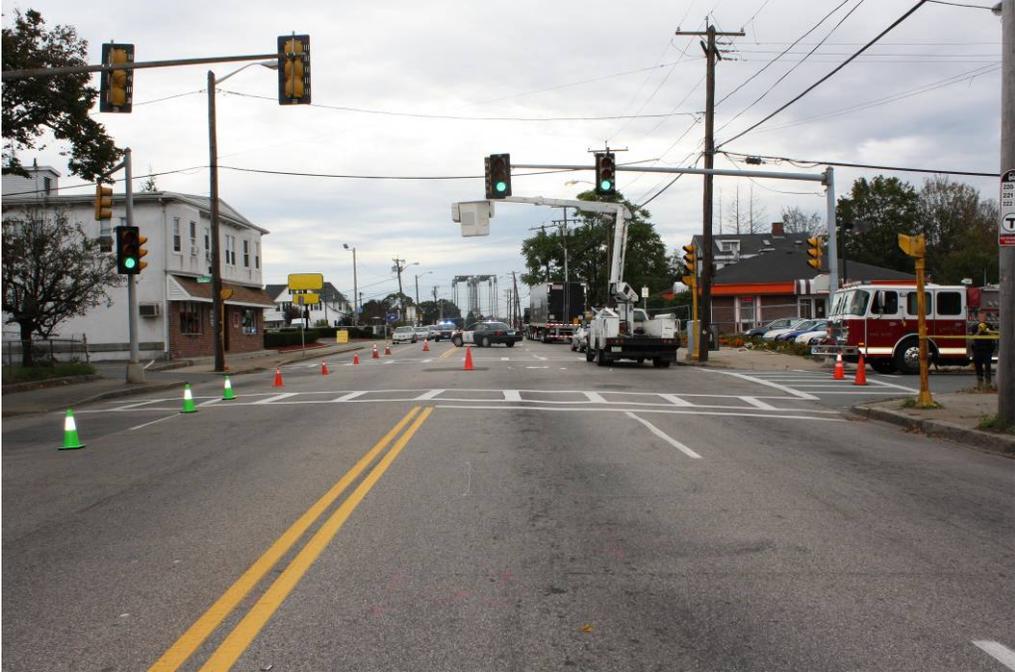
The intersection has multiple cantilevered traffic signal structures. One of these cantilevered structures was the traffic signal that was being accessed at the time of the incident. The base of the cantilevered structure is located on the sidewalk and the vertical section is approximately 18 feet high. The cantilevered section is fastened to the top of the vertical section and extends perpendicularly out over the two southbound main roadway lanes (Figure 3).

The police report suggested that several factors might have contributed to the victim's position being less noticeable to passing motorists. These factors include: the boom of the aerial lift following the same 90 degree angle as the cantilevered traffic signal structure, the lack of contrast between the white truck and boom against the light gray sky, and the strobe lights drawing attention away from the raised bucket and towards the aerial lift truck's bumper.

**Figure 3 – Incident location with vehicle-mounted aerial lift**

- Ensuring that placement and use of vehicle-mounted aerial lifts does not allow roadway traffic to pass underneath the raised aerial lift bucket/platform at any time;
- Determining if assistance in the form of traffic details or flaggers would be beneficial;
- Wearing the appropriate high-visibility safety apparel at all times;
- Facing and watching out for approaching traffic; and
- Spending as little time as possible in and around the roadway.

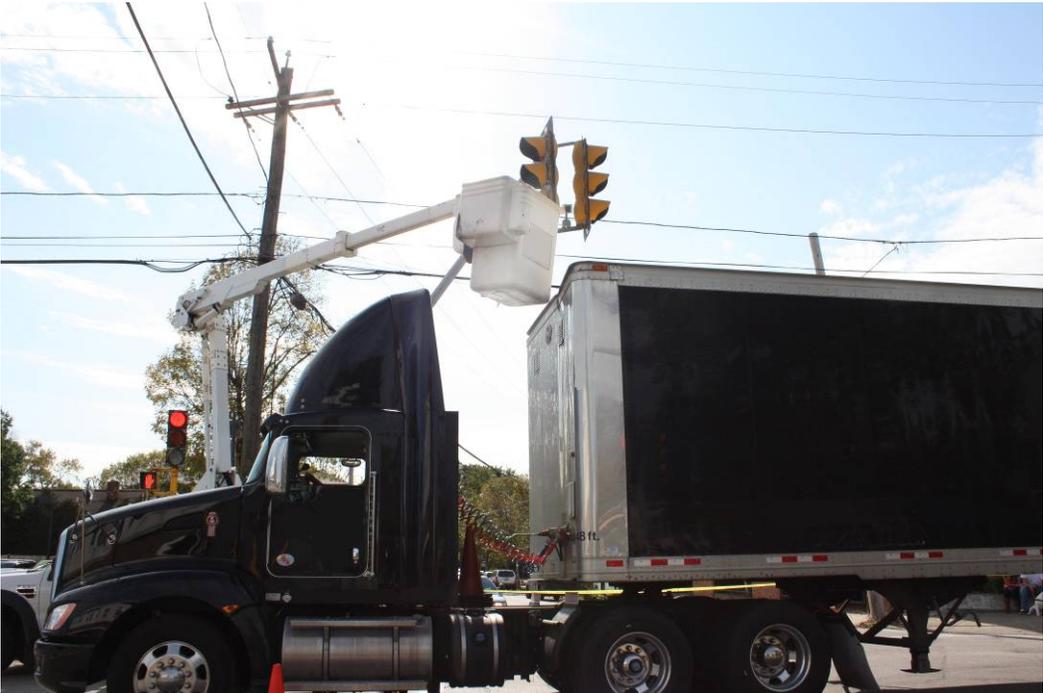
While the victim was in the raised bucket, an 18-wheeled tractor-trailer was traveling on the main roadway heading southbound in the left hand travel lane. The enclosed trailer section of the tractor-trailer is 53 feet long and 13 feet 6 inches high. As the tractor-trailer approached the intersection, the cab with its wind deflector passed underneath and cleared the raised bucket. When the trailer section reached the raised bucket, the trailer impacted the bucket causing the bucket to bounce up and land on top of the trailer's roof (Figure 4). The victim was ejected out of the bucket and fell approximately 17 feet to the asphalt roadway below. The tractor-trailer operator stopped the truck immediately after the incident occurred. A call was placed for Emergency Medical Services (EMS). Within minutes EMS and the local police arrived at the incident location, and the victim was transported to a local hospital where he was pronounced dead.

**Discussion:** The operator of the tractor-trailer indicated that he did observe the aerial lift truck in the roadway and the truck's bumper strobe lights, but that he did not notice the extended boom and the worker in the bucket.

**Figure 4 – Tractor-trailer with raised bucket**

Aerial lift trucks are often used in and around roadways, which can place the truck in close proximity to moving vehicles. To help make aerial lift trucks, including their booms and buckets, as visible as possible, consideration should be given to adding contrasting colors, which could also be florescent and/or reflective, to both the boom, bucket and to some areas of the truck. In addition, adding some light-emitting-diode (LED) strobe lights to sections of the boom, bucket and truck might increase both the visibility of the truck and the actual location of workers when they are working from the truck's raised bucket.
