# Truck Driver Dies after Being Struck by Semi-Trailer Truck In Trailer Lot of Customer Yard

**Investigation: # 11WA012**

**Release Date: November 16, 2015**

**SHARP Report: # 52-35-2015**

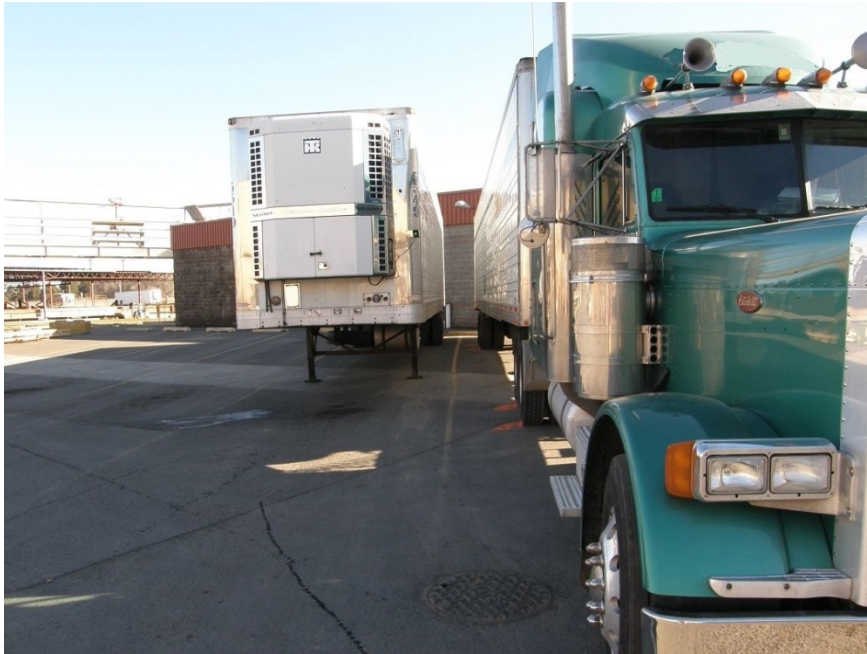
**Photo 1: Loaded trailer lot with refrigeration unit trailer waiting to be hooked-up to a truck next to the victim's semi-trailer truck.**

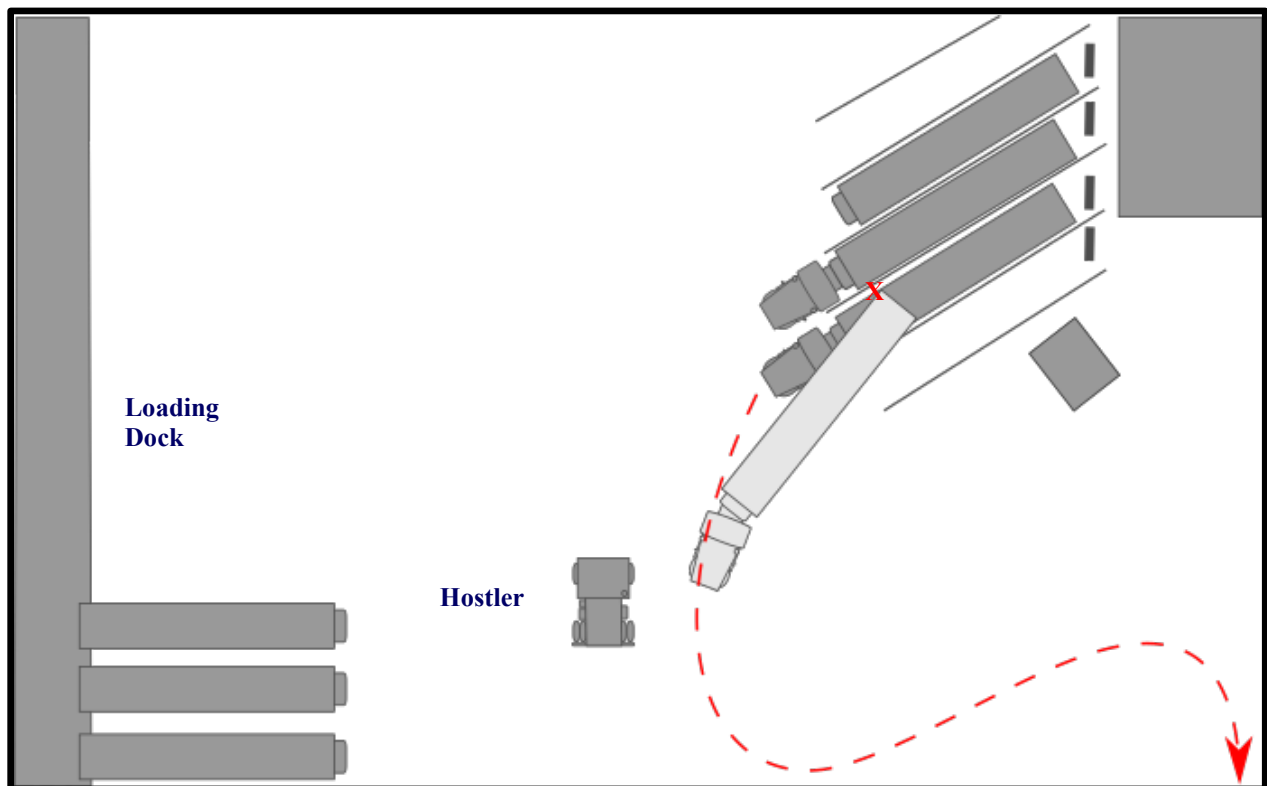
The other driver started his engine, released his air brakes, checked his mirrors, and at 6:37 p.m. began pulling out of the stall. The driver reported that it was about 30-45 seconds between when he last saw the victim and when he started moving his truck. As he moved forward, he made a sharp left turn to avoid a yard hostler temporarily parked in the loading dock area in front of him. (See figure 1).

**Figure 1. Customer truck yard and loading dock area where the incident occurred. The "X" indicates the victim's approximate location when he was struck by the right rear of the departing truck's trailer. The dotted line indicates the semi-trailer truck's approximate path of travel as it exited the parking stall. (Not to scale)**

**Recommendation #2: Take corrective actions to prevent pedestrians from being struck by trucks. Design site layout of yards and internal truck traffic routes to provide adequate space for trucks to safely maneuver, load, unload, and park. Facility design should also provide for safe passage for pedestrians. The level of lighting should be sufficient for safe vehicle and pedestrian activity.**

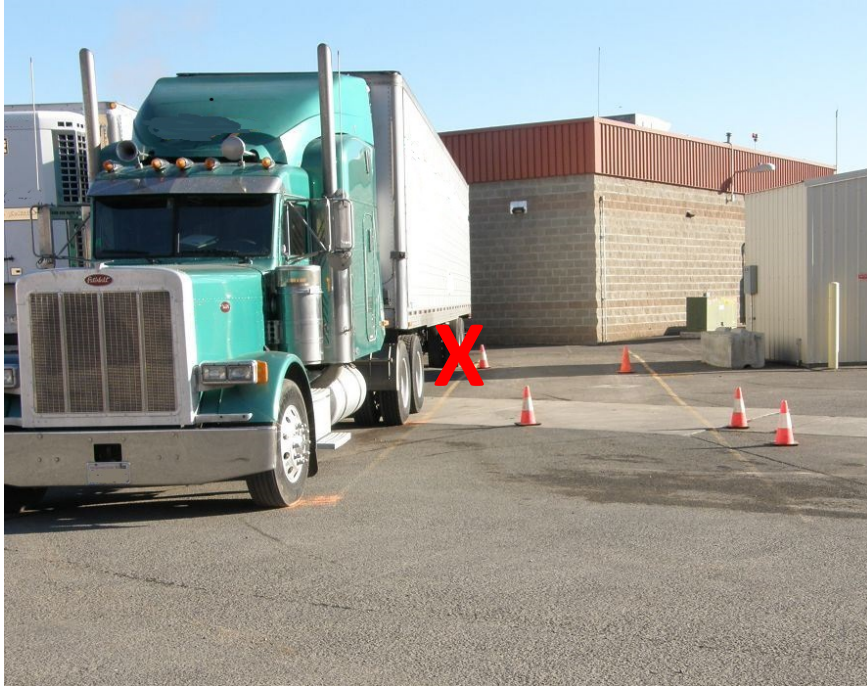
**Photo 2: Incident scene showing the victim's semi-trailer truck and the adjacent parking stall where the semi-trailer truck was parked before it pulled out and its trailer struck the victim. The two trailers may have created a shadowy area and low-light condition between the two parked semi-trailer trucks which may have made it difficult to be seen by either the driver or co-driver passenger from the adjacent truck's cab. The "X" marks the victim's approximate location.**

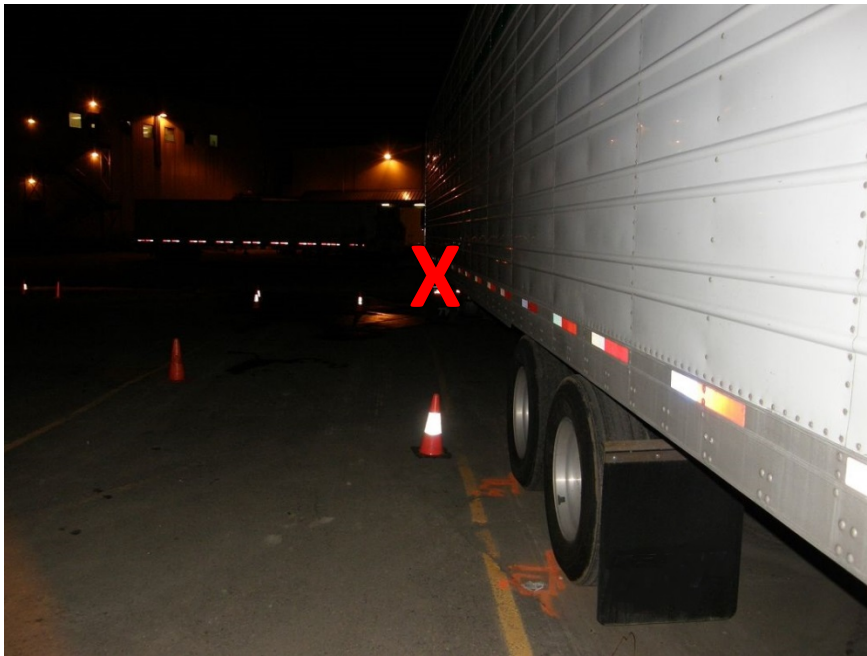
**Photo 3: Incident scene at night. The view is from the left rear of the victim's trailer looking toward the loading dock area. The light in the foreground was supplied by camera flash. The approximate location of the victim is marked by the "X".**

It is uncertain whether in this incident facility lighting was a factor in providing enough luminance for the victim to be visible to the departing driver. The two trailers may have created a shadowy area between the two parked semi-trailer trucks, creating a low-light condition which may have made it difficult to be seen by either the driver or co-driver passenger from the adjacent truck's cab. Placement of yard lighting should take into account the nature of the changing conditions of the working environment in the yard. Parked trucks and their trailers can create light obstructions that reduce the amount of light from lighting fixtures and impair the visibility of pedestrians and workers on-foot to drivers of trucks as they move about the yard.<sup>7,8</sup>

Adequate area lighting for loading docks and truck yards should be planned and provided, not only to allow workers to successfully complete their tasks, but for their safety as well. Current lighting should be assessed to determine whether it is suitable and safe for the type of work being done.

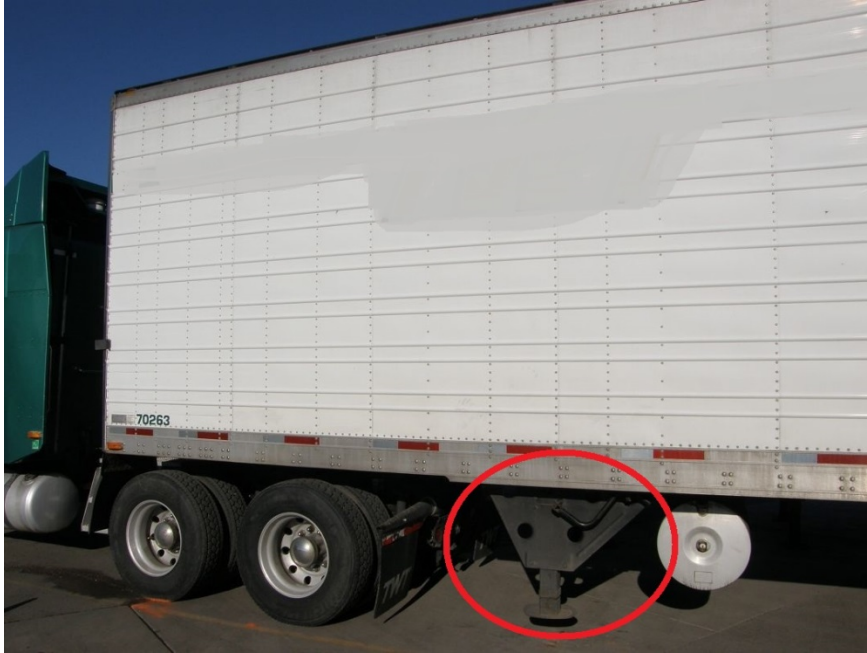
The victim was standing beside his trailer on its left side near the front cranking up his trailer's landing gear as the other truck left the stall. As the other truck moved forward and swung left the right rear of its trailer struck the victim. The driver and his co-driver were unaware that the victim had been struck. They then proceeded to leave the yard and continue down the road.

**Photo 4: Landing gear that the victim was cranking up when he was struck by the departing semi-trailer truck.**

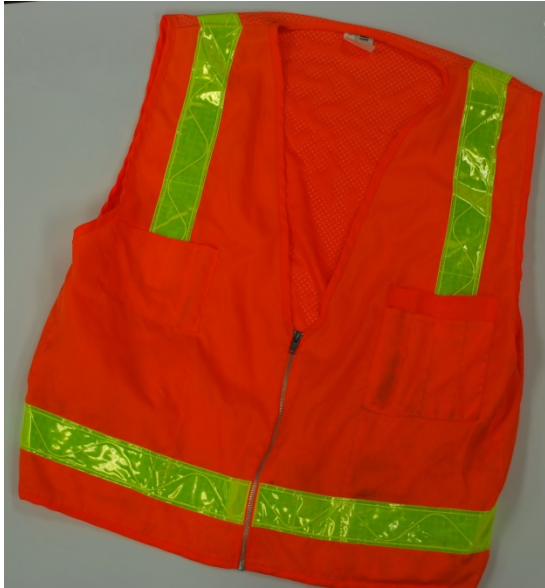
**Photo 5: Example of class 2 safety vest.**

It is recommended that at least a class 2 high-visibility vest should be worn by truck drivers. Additionally, employers should consider issuing LED headlamps/flashlights to drivers to use so as to make them visible to others when they are working outside their vehicles in dark or low light conditions.

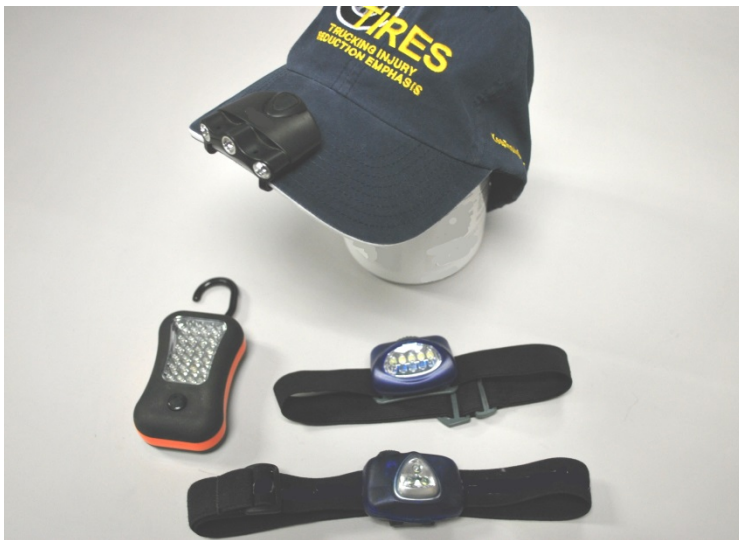
**Photo 6: The use of a headlamp or flashlight by a driver while walking or working outside their vehicle will provide illumination that will help them to be noticed by truck or other vehicle operators.**

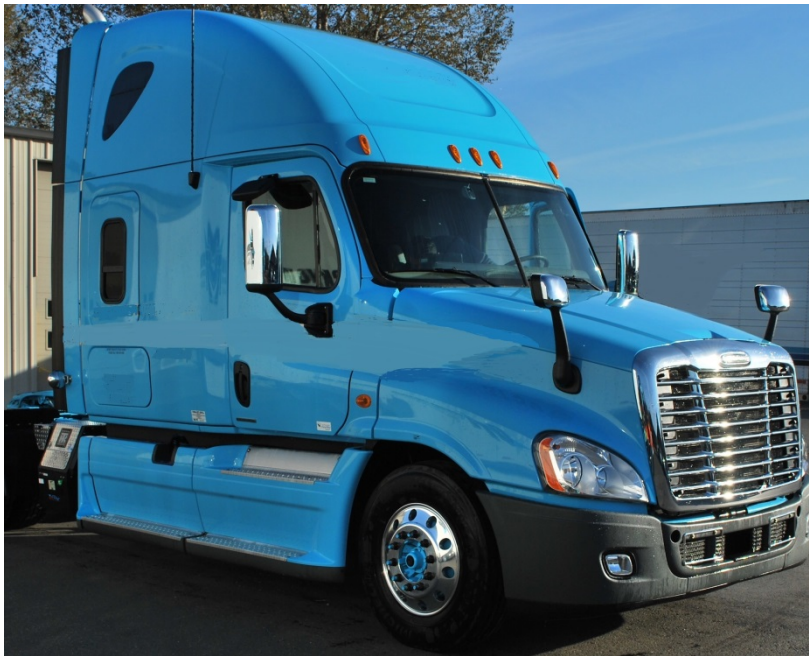
**Photo 6: Hood-mounted convex mirrors extend the driver’s field of view along the sides of the truck and trailer.**

**Recommendation #6: Install appropriate mirrors on all fleet trucks to ensure that drivers have superior visibility and that blind spots on the right side of the tractor-trailer are eliminated.**

Installing convex mirrors on the hood or fender of the truck will increase the driver’s field of view along the sides of the truck and trailer and help them to see objects and pedestrians.
