MIFACE Investigation Report #12MI008

Subject: Farm Laborer Died When Struck By Front End Loader Bucket

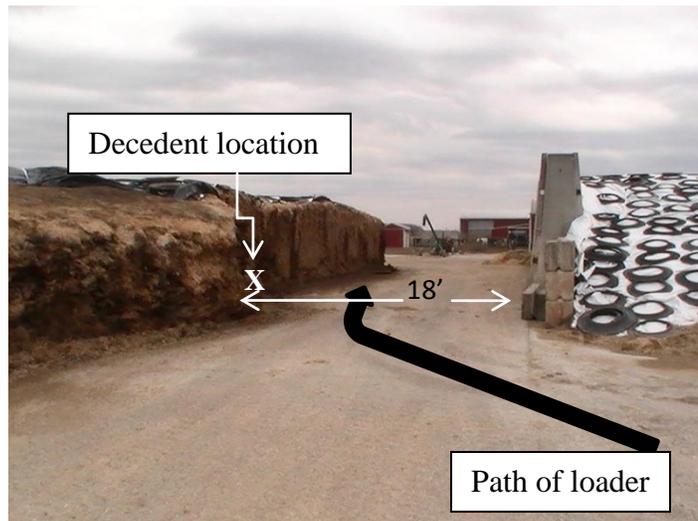
Figure 1. Incident area showing decedent's location and travel path of loader

working, the silage protruded approximately seven feet, which placed the decedent in the shadows. The front end loader operator was rounding the corner of the bunker silo on his way to obtain additional feed. It is hypothesized that the corner of the front end loader bucket struck the decedent. The impact knocked the decedent to the ground and he was run over by the front left loader tire (Figure 1). The decedent was alert and breathing when transported by helicopter to a nearby hospital. He died the following day from complications of the injuries sustained at the time of the incident.

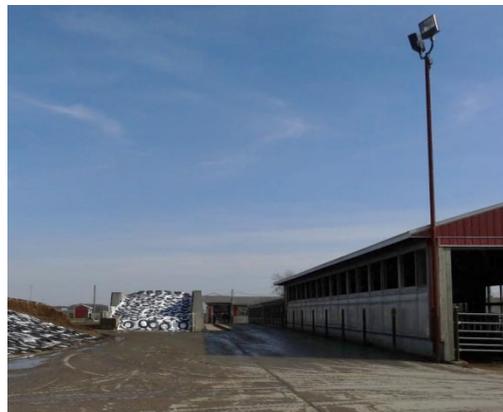
Figure 2. Location of high lumen sodium light.

- Reflective work vests are required for work during dark hours (before dawn and after dusk)
- Placed high lumen sodium yard lights to illuminate work area (Figure 2).
- Cut back silage pile to make a wider transport aisle for loader (Figure 3).
- Changed bunker wall configuration to minimize equipment turn radius (Figure 3).
- Moved feed mixing area nearer to the dairy operation.
- Change in feed work practice: One individual uses the loader to load feed and stays in the loader – another individual works by feed mixer to cut hay bale strings.
- Heightened safety awareness with added zero tolerance for risky work practices.
- Established the incident area as a restricted work area until daylight hours.

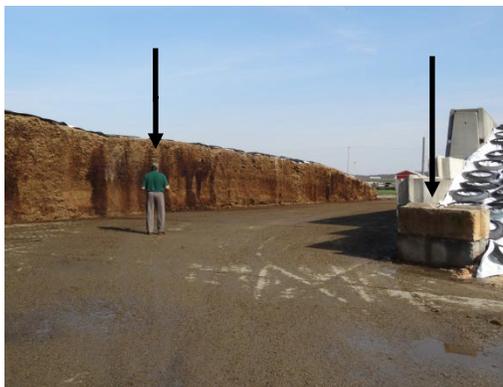
Figure 3. Bunker configuration change – note angle of cement compared to Figure 1 and approximate location of decedent.

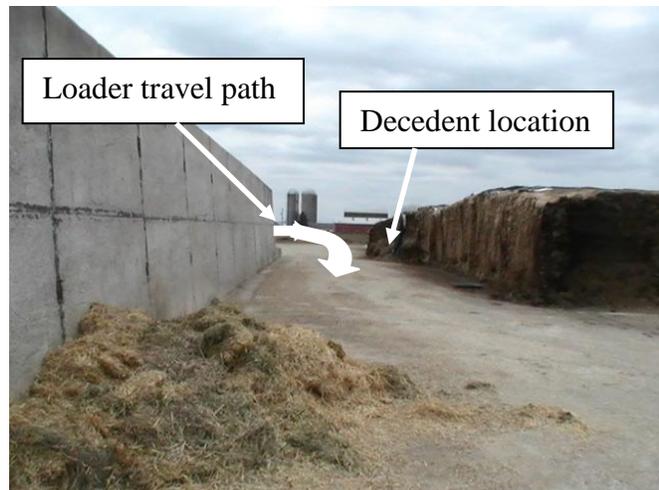
Figure 4. Incident area, standing on east end of bunker silo looking west.

With the front end loader facing south, the operator unloaded the contents of the bucket of the loader. The operator then backed up while turning the rear of the loader to the west so that the loader faced east. He then drove forward and began to round the corner of the bunker silo (Figure 4). He did not know that the decedent was working in the area

The front end loader operator did not see the decedent because of the dark and dusty conditions and because decedent was on the ground on foot in dark clothing. Both the police and the farm owner hypothesized that the decedent was struck by the loader bucket and then run over by the left front wheel of the loader while the operator was driving forward.

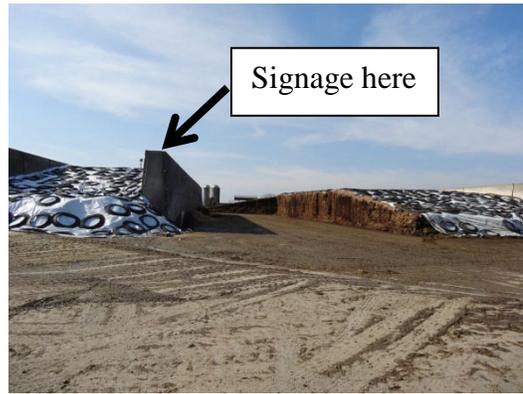
Figure 5. Possible signage location.

- Post a pictogram or a KEEP OUT/RESTRICTED WORK AREA sign in both Spanish and English sign on the bunker near the driveway entrance to alert workers.

The farm has established the area where the incident occurred as a restricted work area - restricting personnel access when it is dark. Although training had been performed, a sign/pictogram could be placed on the bunker walls (Figure 5) warning workers of the danger in the area and of the restricted nature of the area to serve as a visual reminder. Because the farm had workers who spoke Spanish, MIFACE recommends posting this area with a pictogram or sign in both English and Spanish as a reminder to workers.

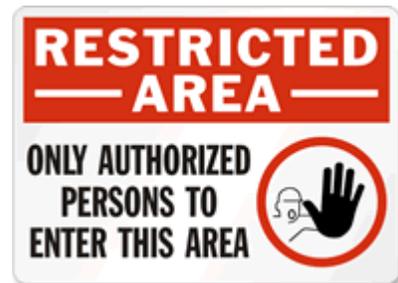
Illustration 1. Example of pictogram to alert workers.

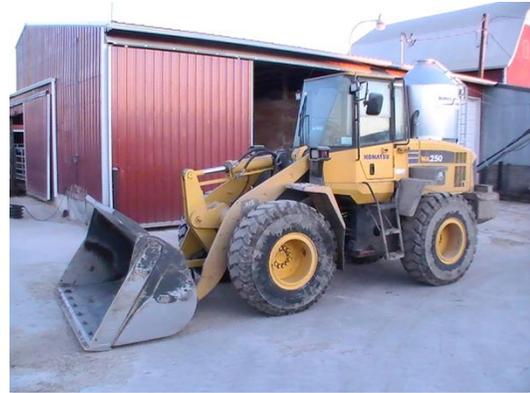
Figure 6. Front end loader involved in incident.

- Consider mounting auxiliary lighting (such as a light bar) on the front end loader and skid steer loaders for use during non-daylight hours.

A significant amount of work on a dairy farm is performed during non-daylight hours. Additional lighting on the loader (Figure 6) and the skid steer would increase the visibility of workers on foot as well as providing the machine operators better visibility for equipment operation.

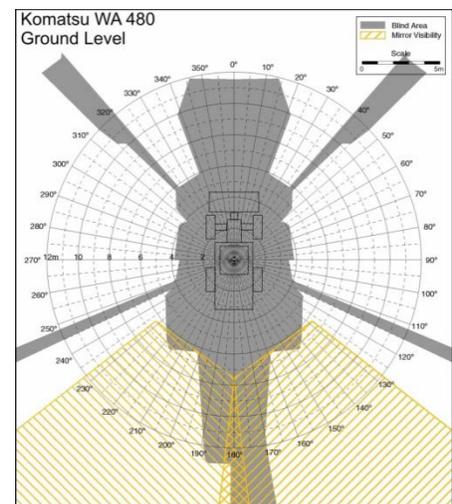
Although not the same model number, the NIOSH Workplace Safety and Health Topic, Highway Work Zone Safety, Construction Equipment Visibility provided a ground level blind area diagram for the Komatsu WA 480. Illustration 1 shows the ground level diagram identifying the machine operator blind spots for objects at a 3-foot height (approximately the height of a construction barrel). The areas in grey show the areas that the machine operator cannot see. With the decedent bending over, he would have been less than three feet high and it would have been extremely difficult for the operator to see him.

Illustration 1. NIOSH Construction Equipment Visibility Chart, Komatsu WA 480, ground level

- Train machine operators and workers on foot regarding the machine operator blind spots.

Employers should use the blind spot diagrams provided by NIOSH to train both the work on foot and the machine

operator to develop awareness about hazardous areas around construction vehicles and equipment due to limited visibility.
