Pedestrian Tow Truck Operator Struck and Killed by Drunk Driver While Rendering Assistance on Highway Roadside

CASE SUMMARY

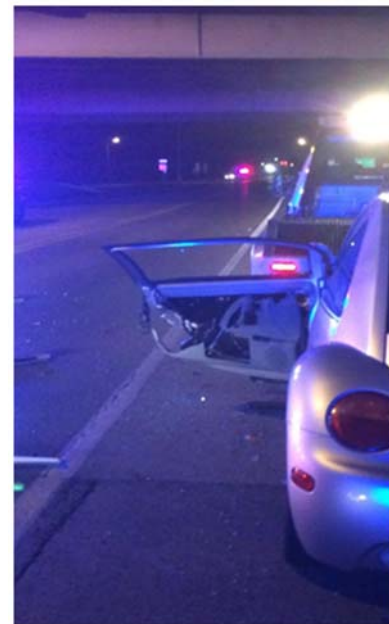
Figure 1. Tow truck and Volkswagen Beetle at the scene.

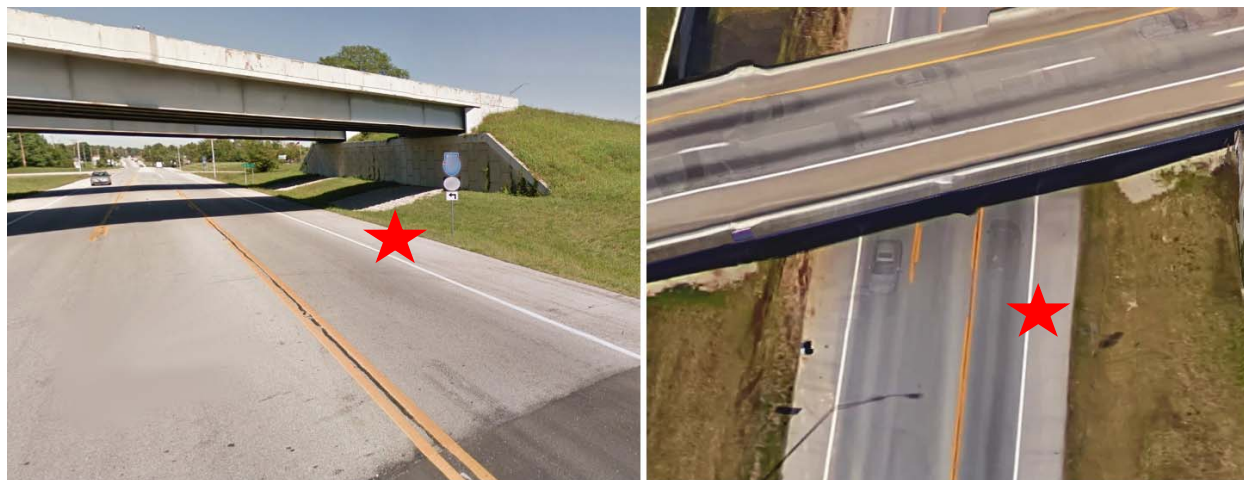
Figure 2. Ground and aerial view of the incident scene. The red star denotes approximately where the driver was standing upon being struck.

The incident scene was the eastbound lane of a two-lane state highway with a central turning lane dividing the two sides. Located just under a 4-lane highway overpass, the road was partially illuminated with streetlights. The roadway was straight, level and dry. The tow truck was parked 2-3 feet from the driving lane. The victim was on the right shoulder of the highway near the lift controls on the left-hand side of his truck. Directly behind the tow truck on the shoulder was a stalled Volkswagen Beetle in need of roadside assistance.

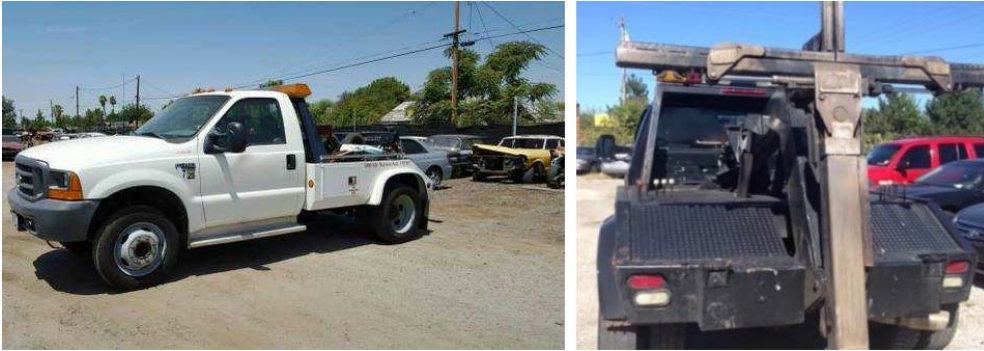
Figure 3. Stock images of a Ford F450 tow truck (this is not the exact unit involved in the incident).

The tow truck was a 1999 Ford F450 wheel lift tow truck (2 axle, 6 tires). The truck was equipped with dual winch controls on both sides of the truck for towing purposes. It is unknown if both winch controls were operational. The tow truck was equipped with a light bar with flashing LED warning lights and working lights.

Recommendation No. 1: When tow vehicles are equipped with dual winch controls, drivers should operate controls from the non-traffic facing side of the truck.

This particular tow truck was equipped with dual winch controls on both the right and left sides of the truck. By utilizing the passenger side of the tow truck, the tow truck driver would have been better protected from oncoming traffic. Some tow truck companies secure the disabled vehicle on the non-traffic side until they can get to a safe location to secure the other side.

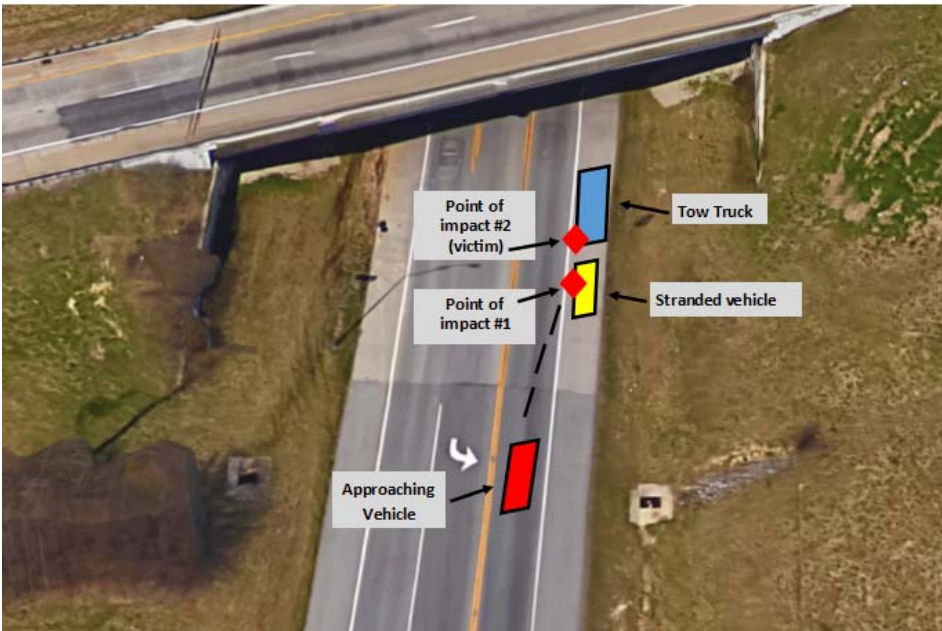
The driver trainee stood by the passenger side of the tow truck in a grassy area observing the tow truck driver. The tow truck driver operated the traffic-side winch controls of his tow truck, while the Volkswagen driver remained in his seat. As the tow truck driver adjusted the winch controls, a 2002 Toyota Corolla veered onto the right shoulder and struck the open driver's side door of the Volkswagen, then struck the victim and the driver's side mirror of the tow truck (see figure 4). The Toyota came to a brief rest on the eastbound shoulder in front of the tow truck, then fled the scene without rendering assistance to the victim.

Figure 4. Trajectory of the crash and locations of vehicles and victim.

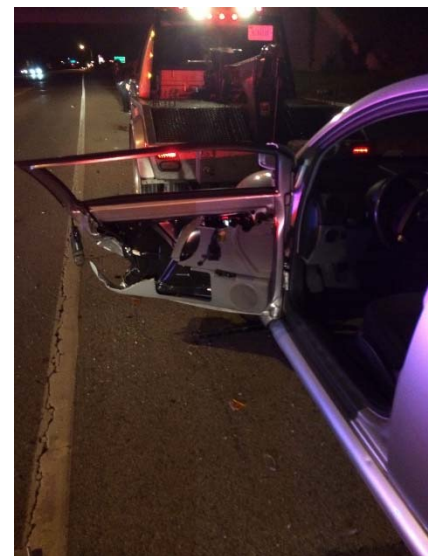
Figure 5. Volkswagen door following initial impact.
