OREGON FATALITY ASSESSMENT AND CONTROL EVALUATION

Fatality Investigation Report

OR 2015-02-1

Crane operator killed by falling steel beam

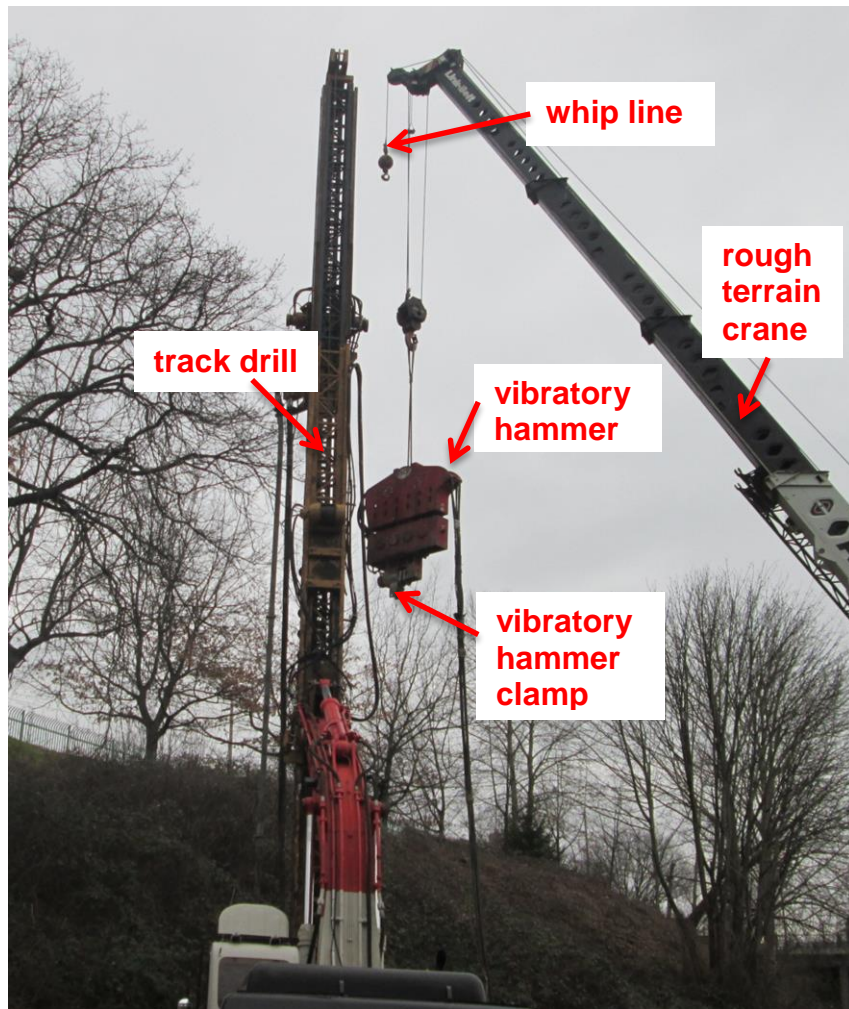
Figure 3. The equipment

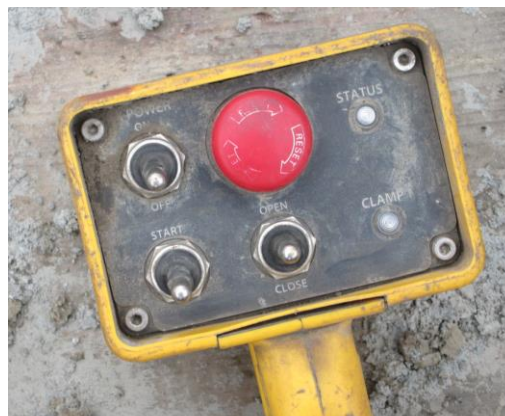
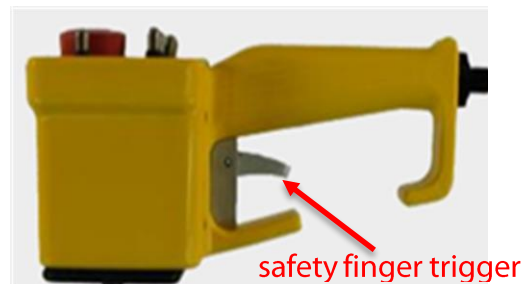
A hydraulic vibratory model MKT V-17/HP-325 hammer (MKT Manufacturing Inc., St. Louis, MO) was then attached to the crane rigging and swung into place over the pile. The vibratory hammer was built in 1979, and was powered by a diesel driven, hydraulic power unit with a 150-foot hydraulic hose bundle. It was originally operated through a control panel located on the power unit or remotely with a 50-foot electrical control pendant cable assembly. However, the employer had contracted a company to design and supply a wireless remote control (see Figure 4) to replace the pendant device. The design options for the remote control included an optional safety finger trigger that must be activated before any vibratory hammer action controls would function. However, this "safety trigger" (see Figure 5) option

was not selected for the wireless remote control unit that was ultimately used during the incident.

Figures 4 and 5. Vibratory hammer wireless remote control. Below is a drawing with the safety trigger option.

(2) The toggle switch on the wireless remote control (see Figure 4) may have been inadvertently activated by brushing against an object while hanging on the foreman’s belt releasing the clamp on the vibratory hammer. For this investigation the vibratory hammer manufacturer was contacted to determine whether remote controls for vibratory hammers were available. A picture of their remote control was provided (see Figure 6) and the safety features they described included recessed buttons and two buttons, PTO and clamp or vibro, must be pressed simultaneously to initiate action. This prevented inadvertent action when only one button is pressed. Whereas the remote control unit used in the incident had toggle switches extending beyond the case (See figures 4 and 5) and it did not include a safety trigger, a two switch safety feature, to prevent action of the vibratory hammer when the toggle switch was inadvertently pressed.

Recommendation # 2: Employers should consult the equipment manufacturer prior to modification or addition to equipment. The wireless remote control that replaced the original pendant control may have unexpectedly opened the clamp and released the pile.

- The replacement of the pendant control on the vibratory hammer for a wireless remote was a significant modification. The unexpected release of the pile by the vibratory hammer clamp may have been as a result of an inadvertent movement of the toggle switch or radio frequency interference. For critical and hazardous equipment, the manufacturer should be consulted before devices/equipment alterations or modifications occur. In a telephone conversation with the vibratory hammer manufacturer, they indicated that they were not contacted prior to the incident. In this case, the manufacturer would have offered their unit or recommended what safety features should be incorporated in a remote control.
