Volunteer Lieutenant Killed and Two Fire Fighters Injured Following Bowstring Roof Collapse at Theatre Fire – Wisconsin

Executive Summary

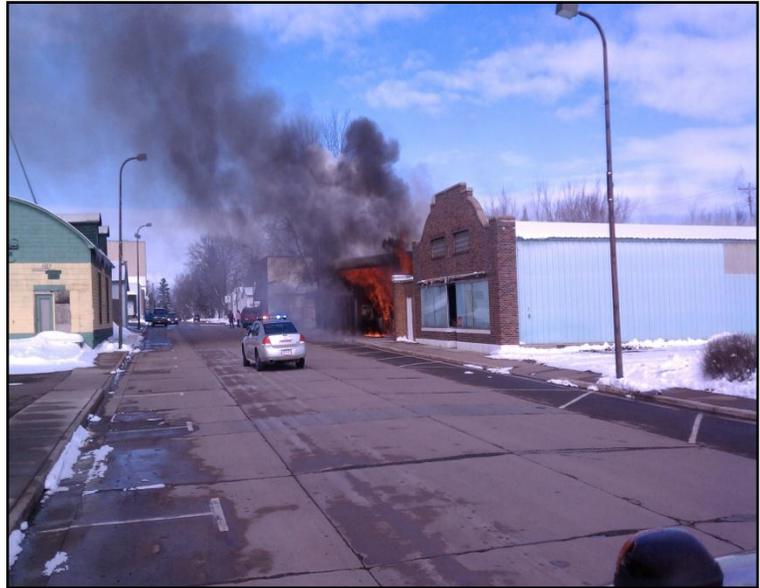
Incident scene when fire was first discovered.
(Photo courtesy of Julie Miklaszewicz.)

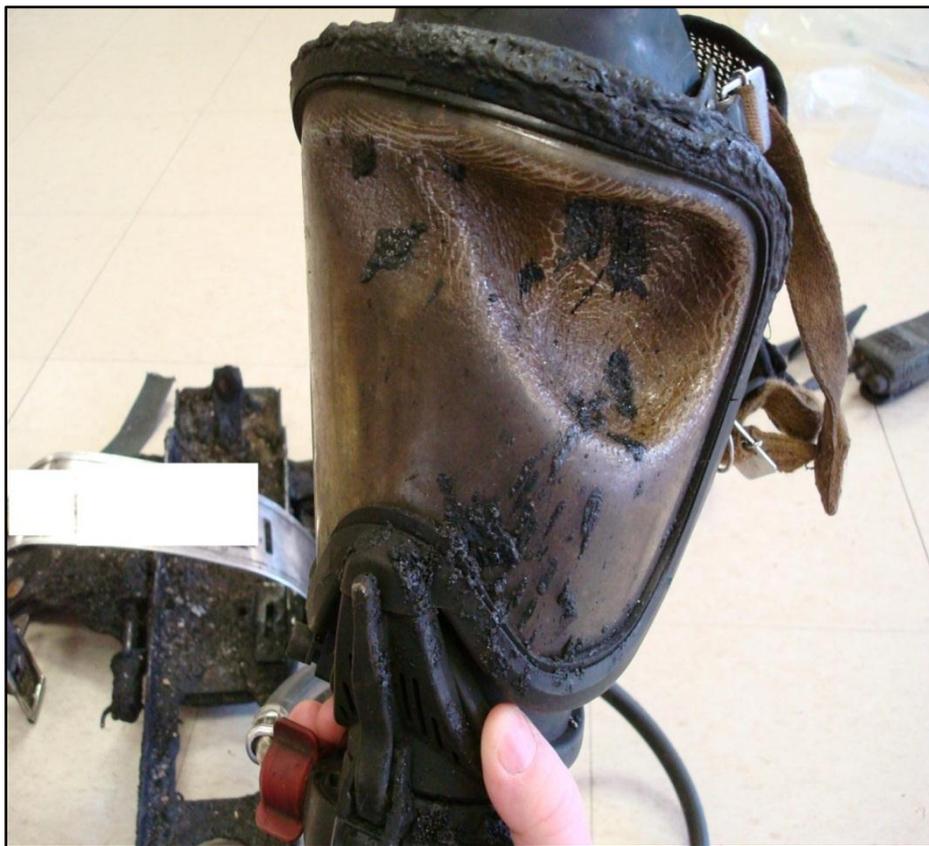
Photo 1. Victim's facepiece showing thermal degradation.
(NIOSH Photo.)

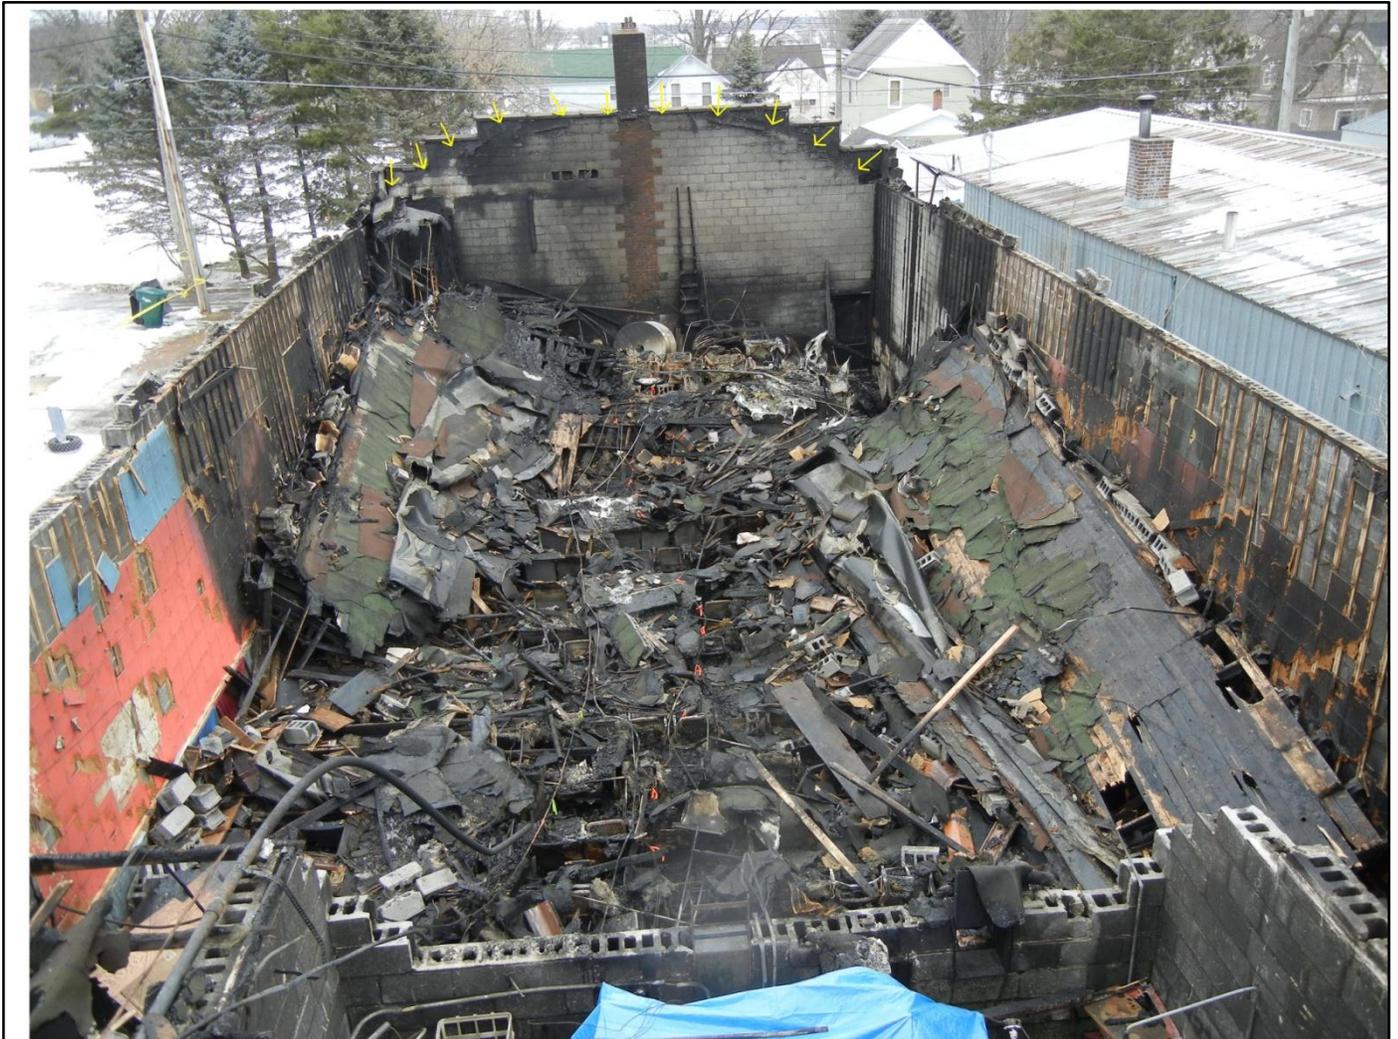
Photo 3. Photo taken from an aerial lift on the A-side of the structure showing the expansive area that the bowstring roof covered. Note the smoked dome outline, indicated by yellow arrows, on the far wall (C-side), indicating the location and span of the bowstring roof.
(Photo courtesy of state of WI.)

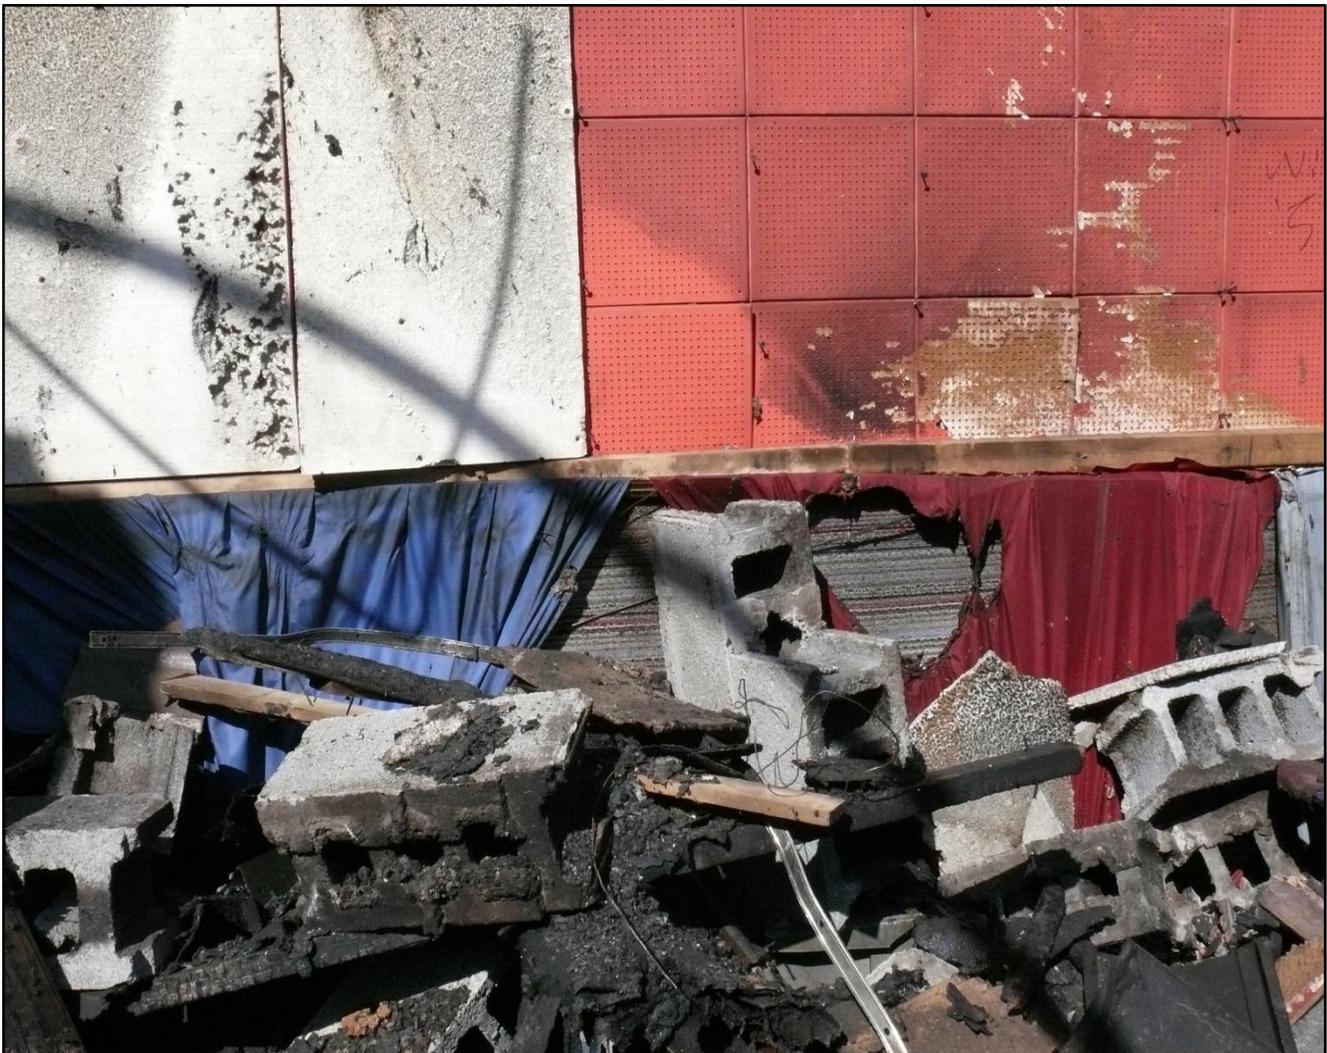
Photo 4. Interior auditorium walls, showing peg board, sound insulation, and wall curtains within the auditorium.

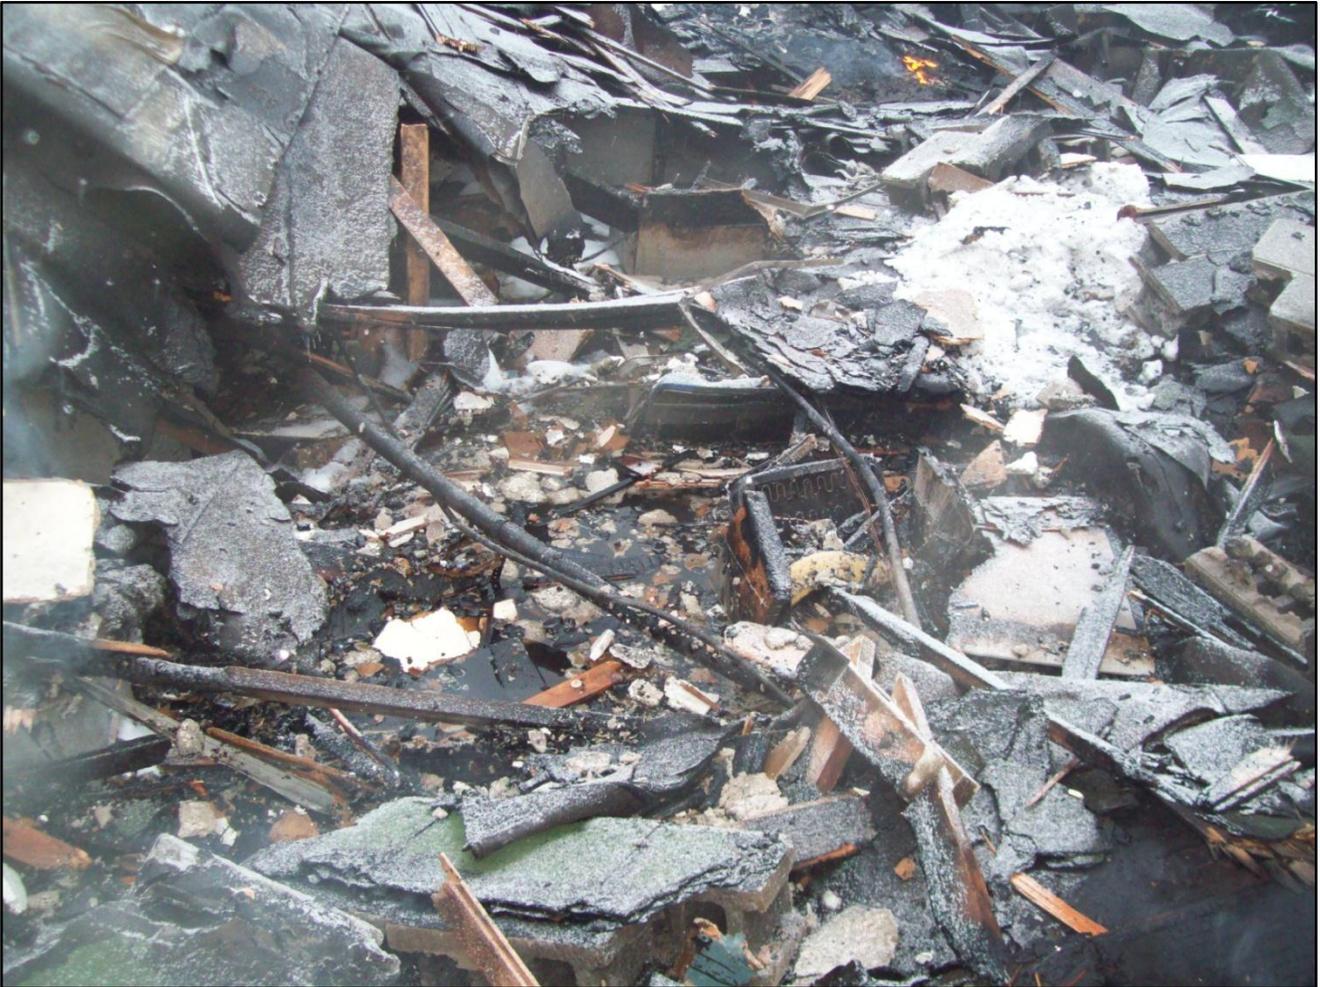
Photo 6. Victim discovered in this general area.
(Photo courtesy of 1st due department.)
