Apprentice Distiller Fatally Burned by Overpressurized Pot Still

Incident Number: 15KY019

Kentucky Fatality Assessment and Control Evaluation (FACE) Program
Incident Number: 15KY019
Release Date: December 15, 2015
Subject: Apprentice Distiller Fatally Burned by Overpressurized Pot Still

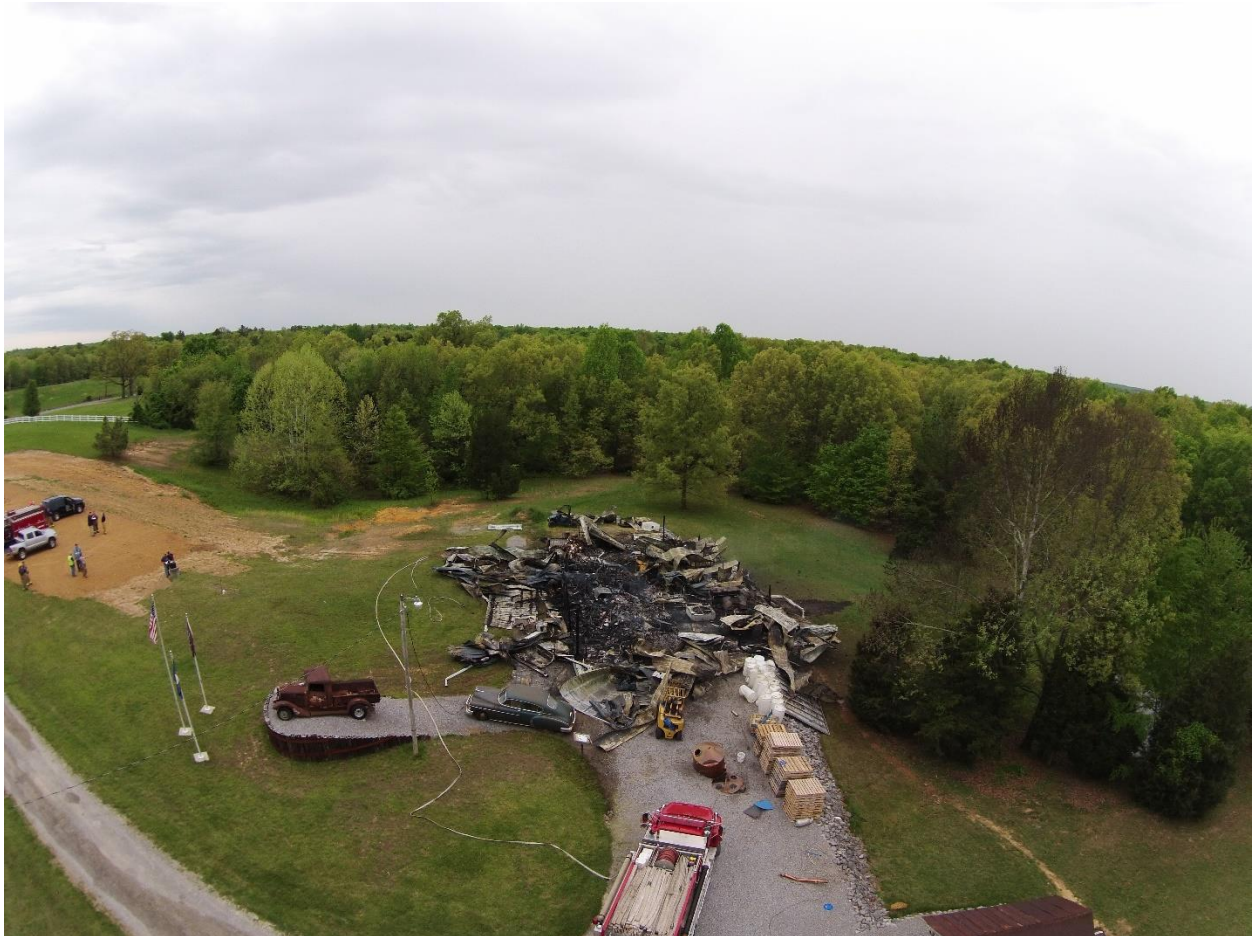
Photo courtesy of Marshall County Daily Newspaper

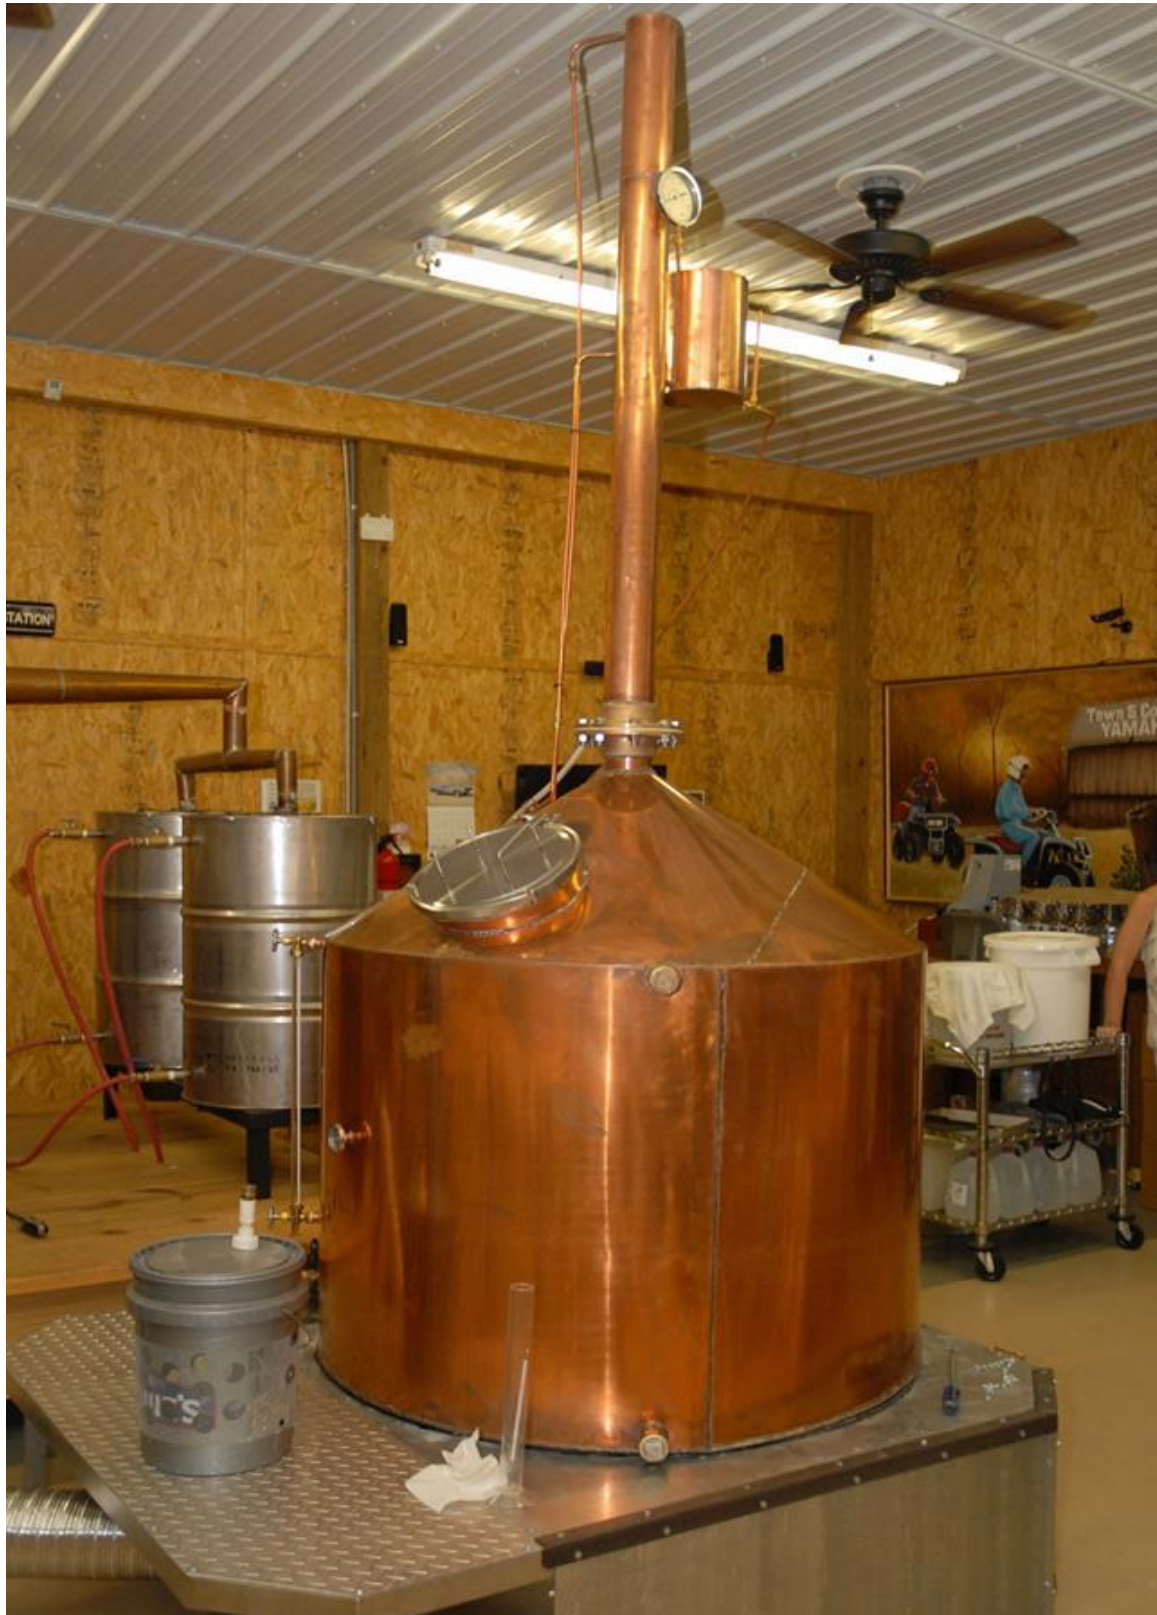
The equipment was a Revenoor 300 pot still with a reflux tower (see photo #1). This particular pot still was newly ordered in December 2011, and installed at the location in September 2012. According to the manufacturer's website, the pot still was designed with a solid copper temperature-controlled tower for added efficiency. The still had a heavy duty, treated steel cooker and a solid copper detachable column with silver soldered fittings. Each still is built with a safety valve which can be activated by less than one pound of pressure. The still has a water cooled condenser and 2 built in thermometers. The temperature operations are from 173 to 210 degrees Fahrenheit. The still was 12 ft 4 inches in height and came with a one-year warranty.

Photo #1: The actual still prior to incident. (Photo courtesy of the employer)

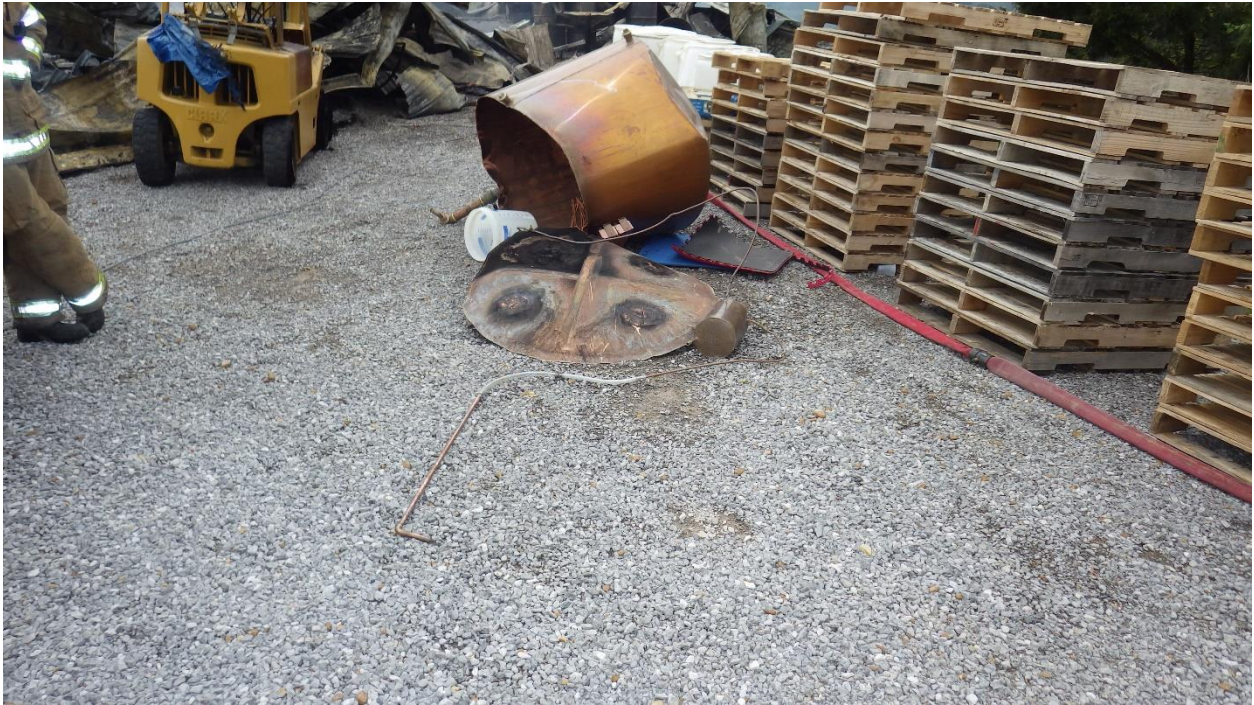
As they exited the building covered in hot mash, the second master distiller found the 300 gallon still and some of its components outside the building in the driveway, next to the distillery, and 90 feet from where the still had been mounted in the building.

Photo #2: The still in the driveway. (Photo courtesy of the State Fire Marshall)

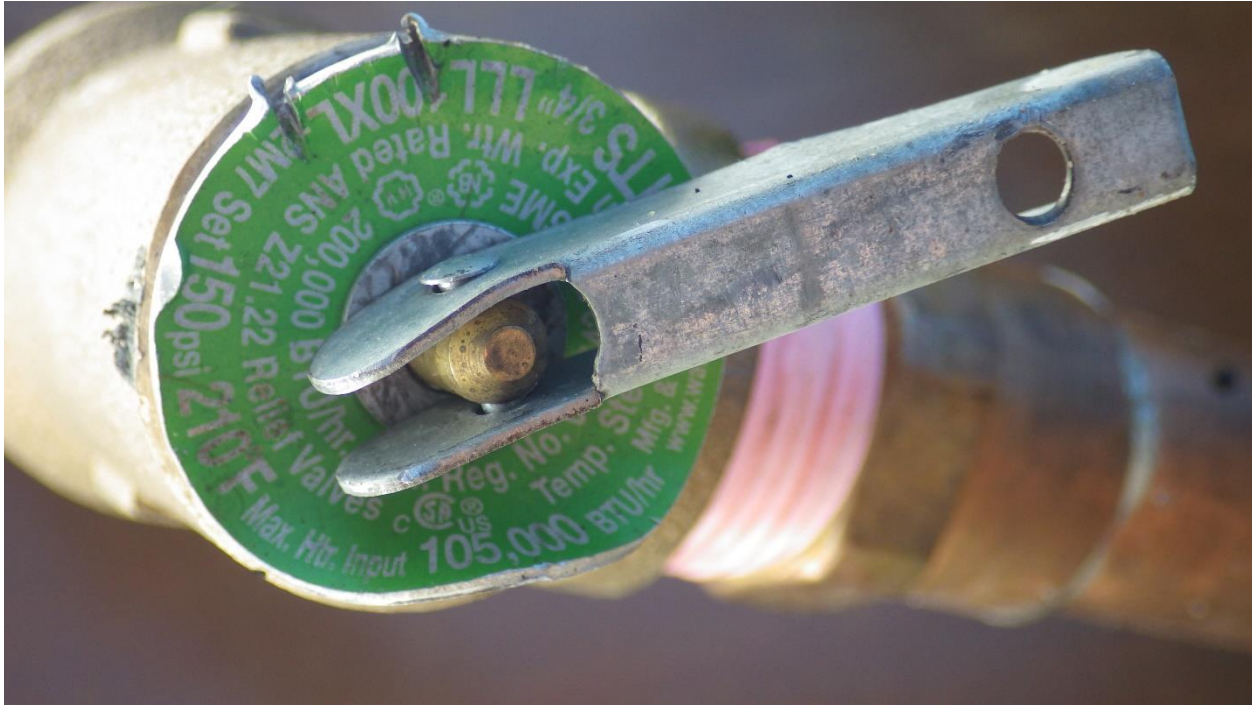
valve that operated on less than 1 psi of pressure.” However, the valve installed on the still was a Watts Model LLL100X1 with a 150 psi and 210 degrees Fahrenheit rating. The valve needed to have a lower psi rating as well as a lower degree rating to ensure the integrity of the still during over pressurization. Pressure could have built up in the still without the employees’ knowledge since they relied on the temperature and pressure relief valve to release pressure if necessary. An appropriate rated temperature and pressure relief valve may have prevented the event. It should also be noted the Watts Model LLL100X1 valve is listed for use only in water heaters.

The State Fire Marshal’s report stated that the setting on the pressure relief valve was different from the setting in the manufacturer specifications. The valve (see photo #3) should have been set to ~15 psi but was equipped with a 150 psi pressure relief valve. With a 150 psi valve, the still could become overpressurized, causing the still to rupture and mash to erupt (see photo #5). The manufacturer told the Fire Marshall that the pressure relief valve was a backup in case the output on the still became blocked.

Photo #3: The PSI of the temperature and pressure relief valve. (Photo courtesy of State Fire Marshall)

Recommendation No. 1: Batch distillation system manufacturers should ensure that an appropriate rated temperature and relief pressure valve be installed on manufactured pot stills.

The State Fire Marshall’s report ultimately recommended that “1) listed pressure relief valves should be installed in the vapor space of the pot and column with the discharge remotely piped to the exterior of the building; and 2) pressure gauges should be installed in the vapor space of the of the pot and the column.”

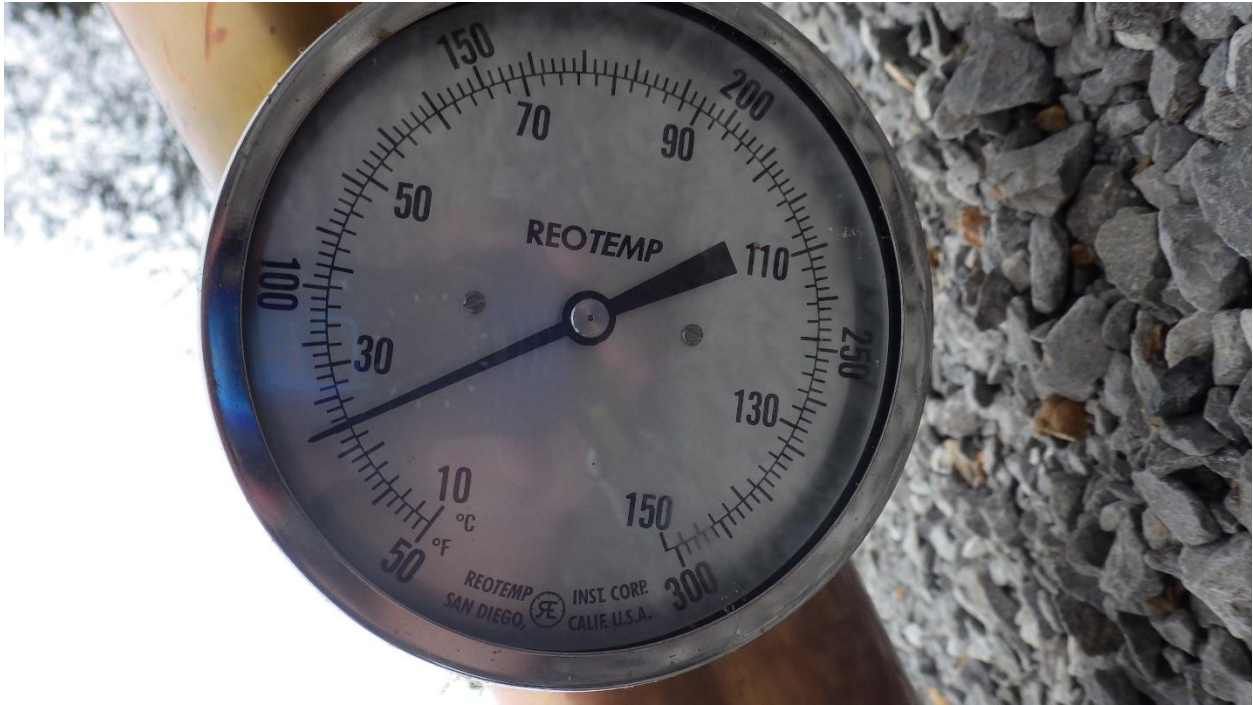
Photo #4: The temperature gauge on the column. (Photo courtesy of the State Fire Marshall)

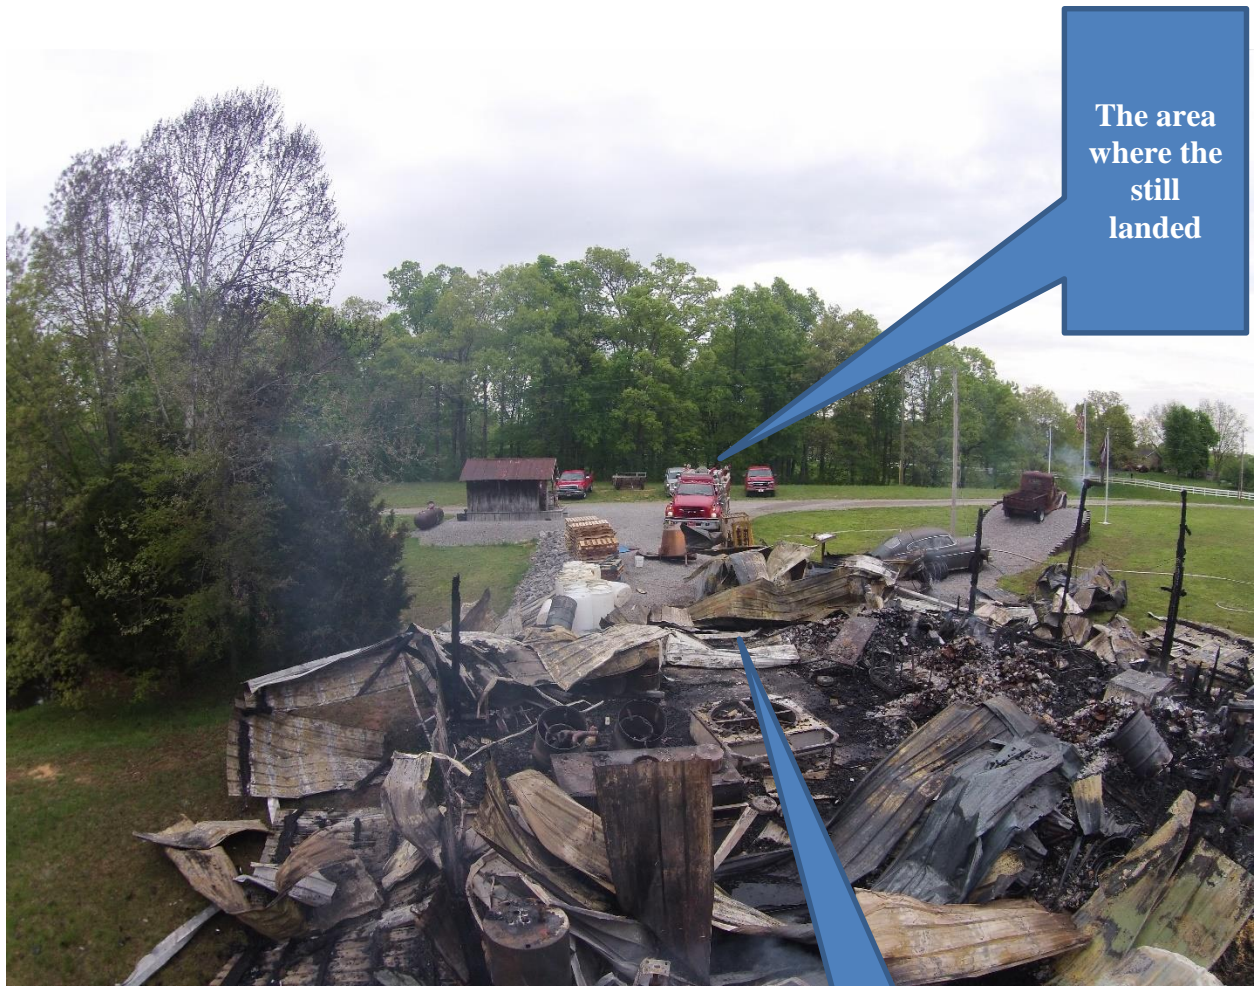
The area where the still landed

Area where the still was sitting prior to incident

Photo #5: Trajectory of the still. (Photo courtesy of the State Fire Marshall)
