Orchard Tractor Operator Dies when Run Over by Trailer-Mounted Water Tank Towed by Tractor

Investigation: # 08WA053
Release Date: November 18, 2013
SHARP Report: # 52-29-2013

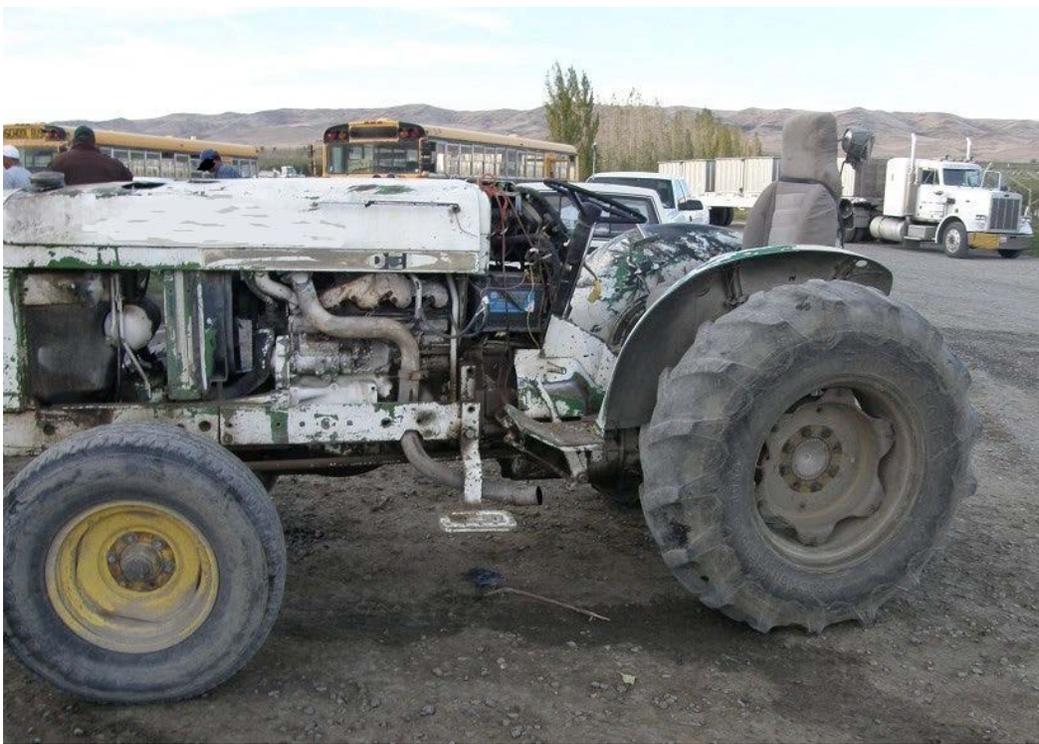
Photo 1: Tractor involved in the incident. It did not have either a rollover protective structure (ROPS) or a seat belt installed.

Discussion: The incident tractor did not have a ROPS and a seat belt installed. While in this incident the tractor did not roll over, an out of control tractor traveling downhill is at high risk of rolling over. In the event of a rollover, a ROPS along with a seat belt would provide a protective zone for the tractor operator.

Recommendation #4: Ensure that tractors are equipped with a rollover protective structure (ROPS) and a seat belt.

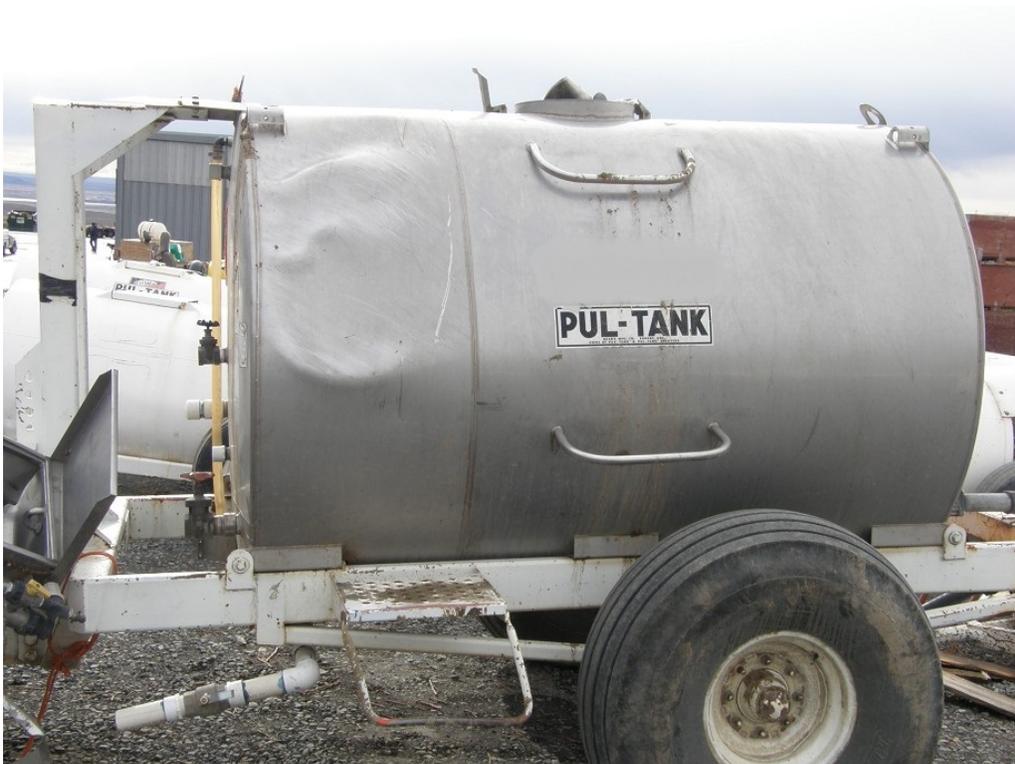
Photo 2: 1,000-gallon capacity trailer-mounted water tank that was being towed by the tractor.

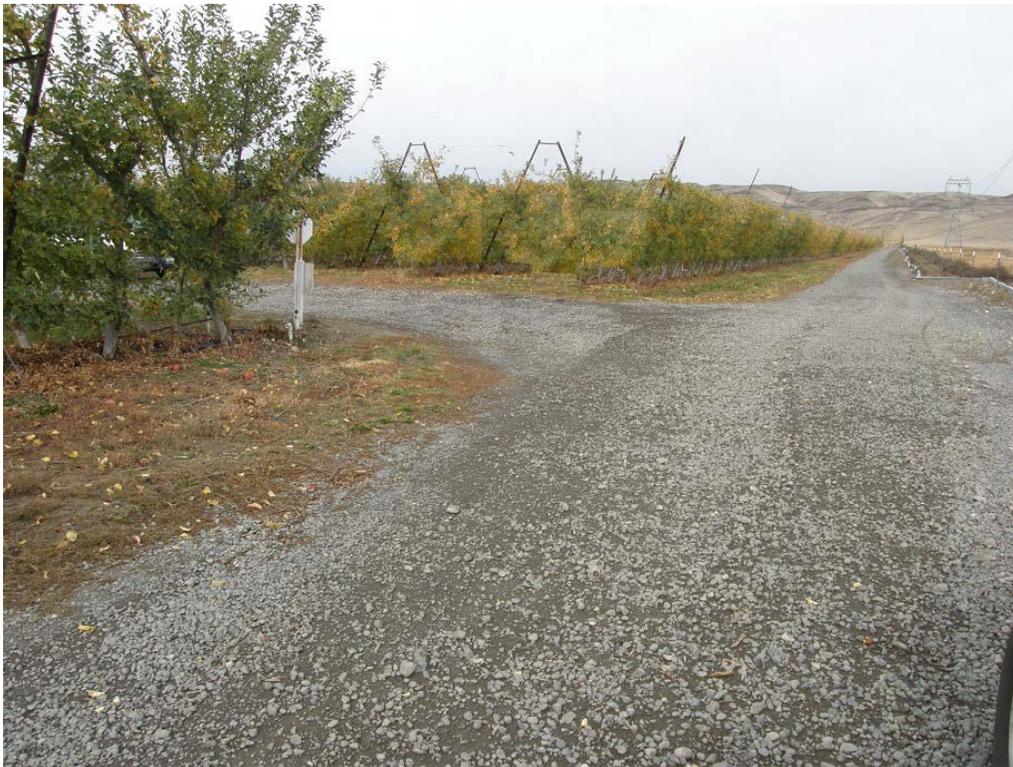
Photo 3: Compacted dirt and gravel road along which the victim drove the tractor with the attached water tank trailer prior to the incident. The victim drove along the road in the upper left of the photo and turned right and traveled downhill several hundred yards.

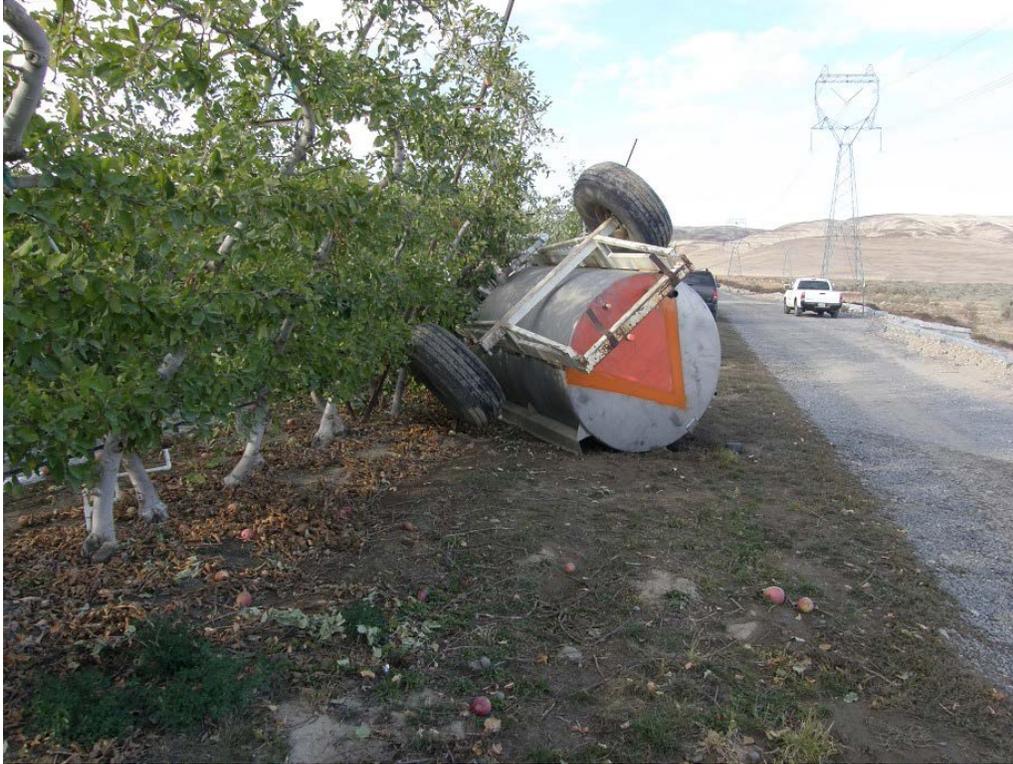
Photo 4: Incident scene with overturned water tank trailer looking uphill along dirt and gravel orchard road.

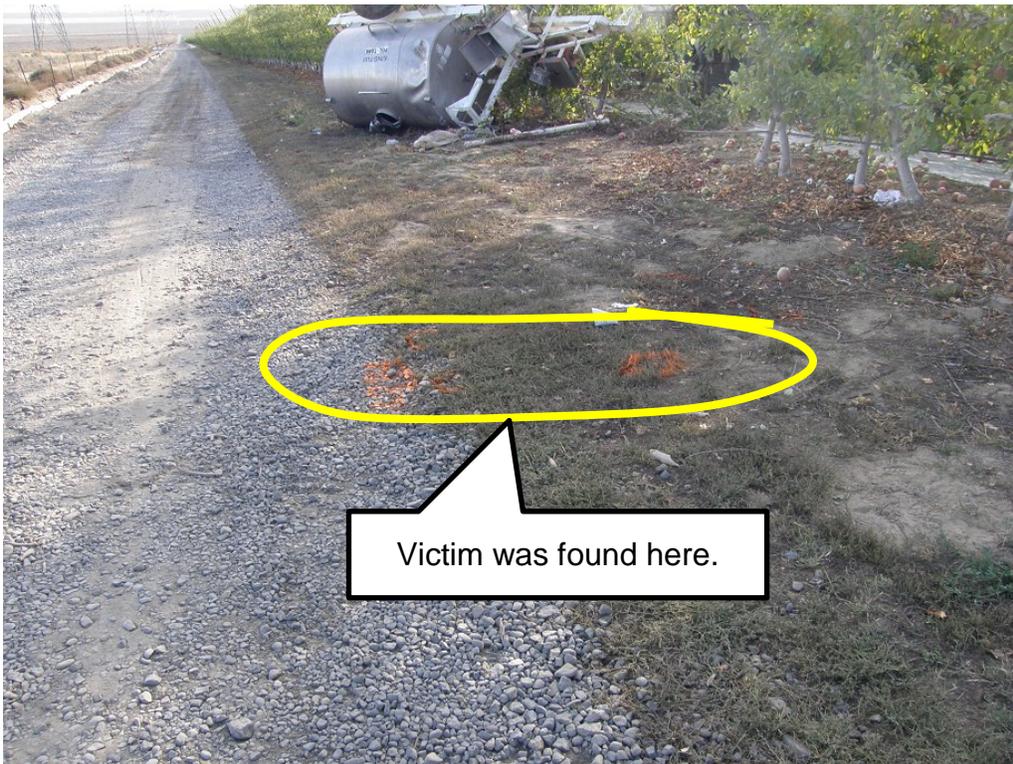
Photo 5: View looking downhill at the incident scene showing where the victim was found and the water tank trailer lying on its side.

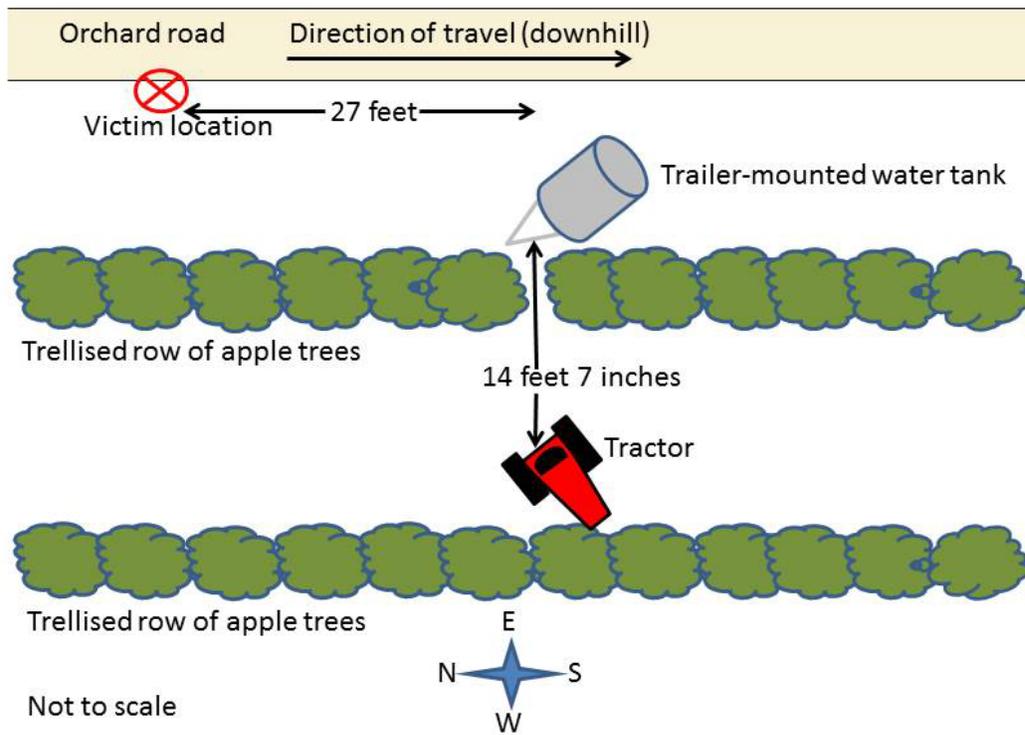
Figure 1: Approximate positions of victim, trailer-mounted water tank, and tractor at incident scene.

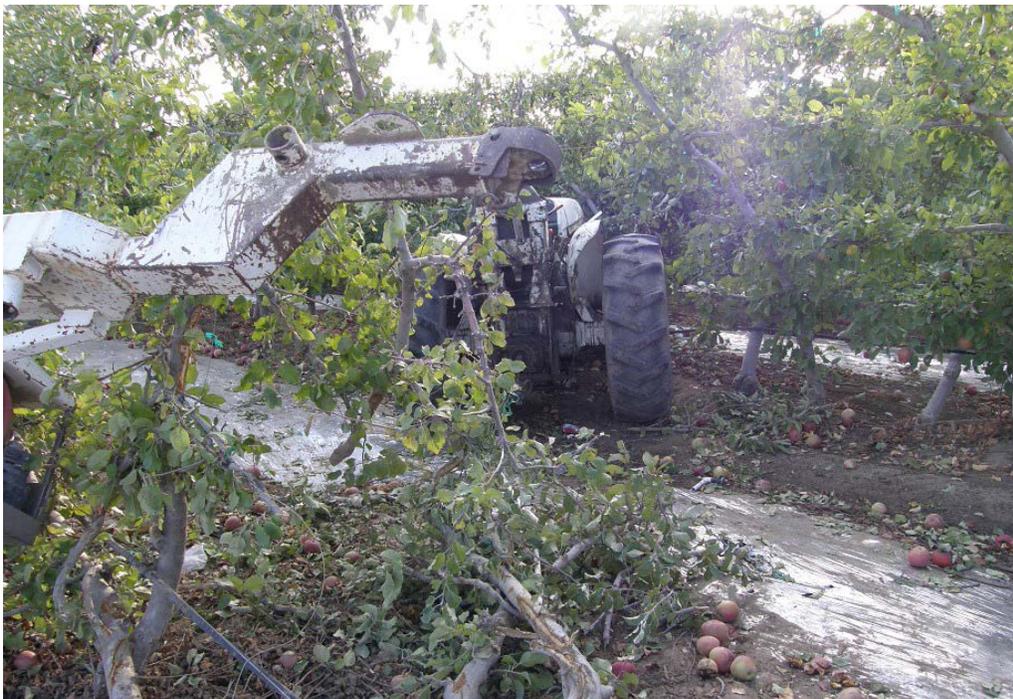
Photo 6: Water tank trailer tongue and coupler in foreground with tractor behind in orchard row at incident scene.

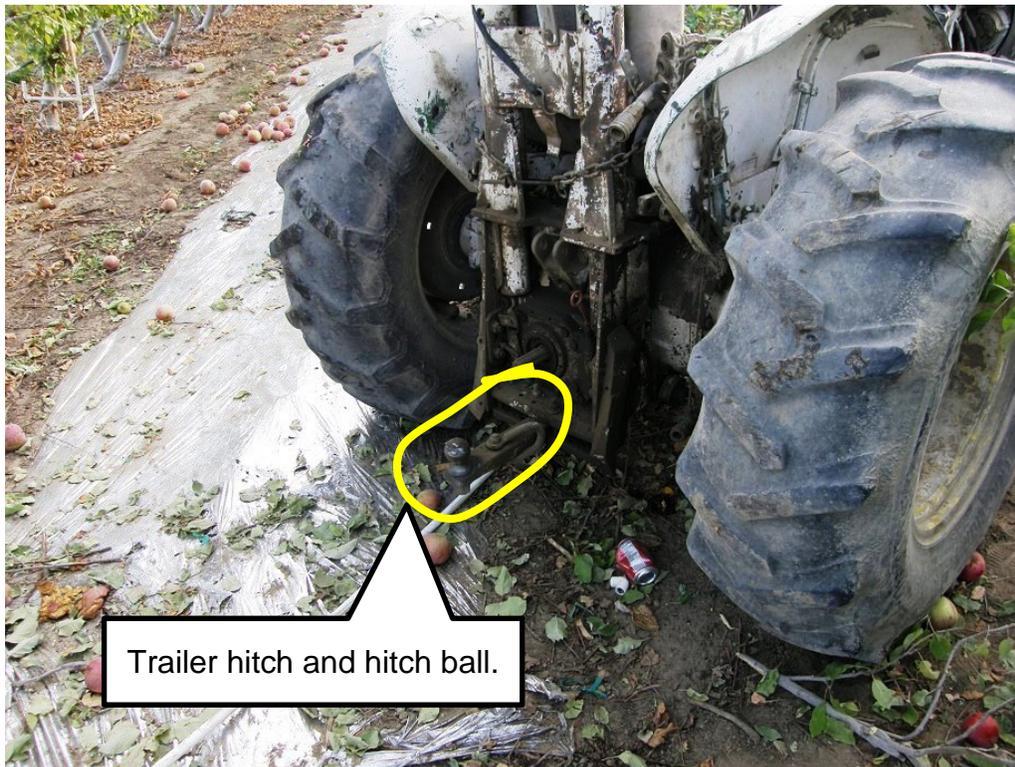
Photo 7: Rear of tractor showing trailer hitch and hitch ball at incident scene.

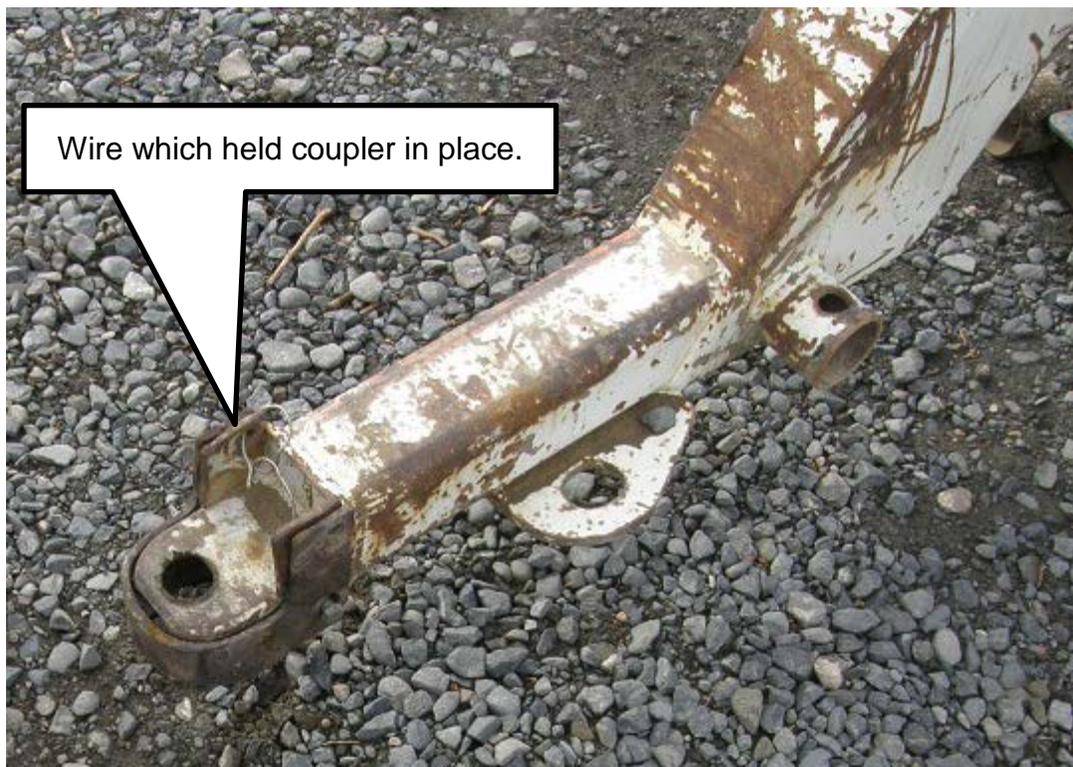
The coupler on the water tank trailer tongue was missing a locking safety bolt. This bolt secures the coupler ensuring that it does not come off of the ball located on the tractor's hitch. Instead there was a piece of metal wire where the bolt should have been. If the trailer coupler comes off the tractor ball, then the trailer becomes separated from the tractor. That is what happened to the water tank trailer when the metal wire failed, either prior to the victim coming off the tractor or after he was run over. It is unknown whether the precipitating event was the trailer separating from the tractor or whether the victim jumped or was jolted from his seat. The tractor and water tank trailer now separated continued on downhill.

In this incident, the trailer became separated from the tractor. A piece of wire was used to replace a missing locking bolt on the coupler. As the tractor sped downhill, the wire broke under dynamic force either before or after the victim jumped, fell or was knocked from the tractor. This allowed the coupler to come off the ball on the tractor's hitch and caused the trailer-mounted water tank to become detached from the tractor.

Photo 8: Coupler and water tank trailer tongue after the incident. A piece of wire was used to replace the missing locking bolt.

Recommendation #2: Maintain in a safe condition towing connections between tractors and all equipment including trailers, implements, and other attachments, and remove from service if in need of repair.

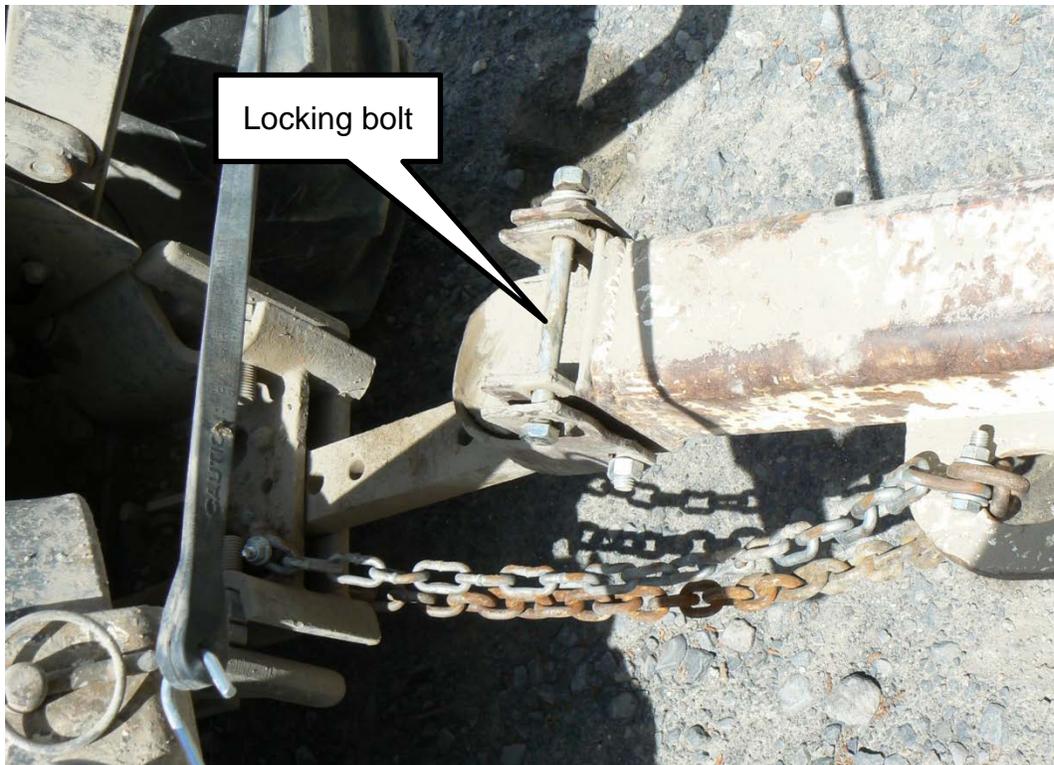
Photo 9: Coupler properly attached to trailer hitch and ball using a locking bolt.

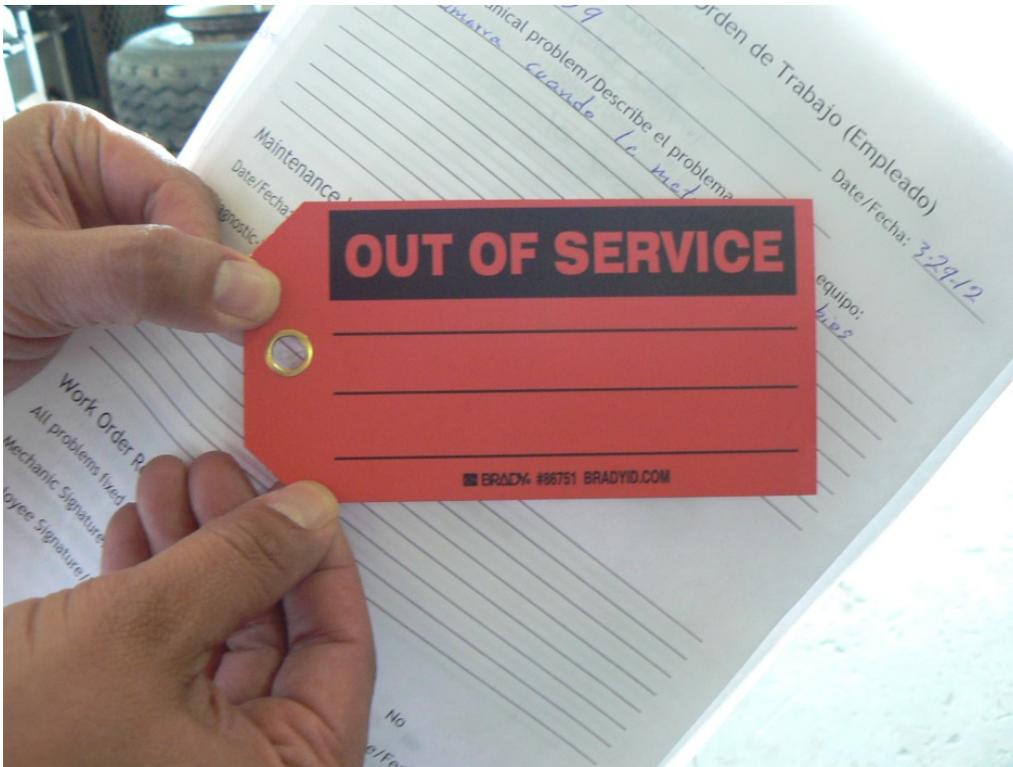
Photo 10: Post-incident the employer created an “out-of-service” tag and maintenance form that employees are required to use for equipment in need of servicing.

At the time of the incident, the employer did not have a policy of removing defective equipment from service. After the incident, the employer created and enforces a policy that if equipment is in any way not working properly an employee should not use it, put an “out-of-service” tag on the equipment, and fill out a maintenance form describing what is in need of repair so that a mechanic can fix it.
