Massachusetts FACE • Occupational Fatality Report

Mechanic Repairing a Multi Terrain Loader Pinned between the Loader's Lift Arm and Frame – Massachusetts

Investigation: # 09-MA-044-01

Release Date: July 11, 2011

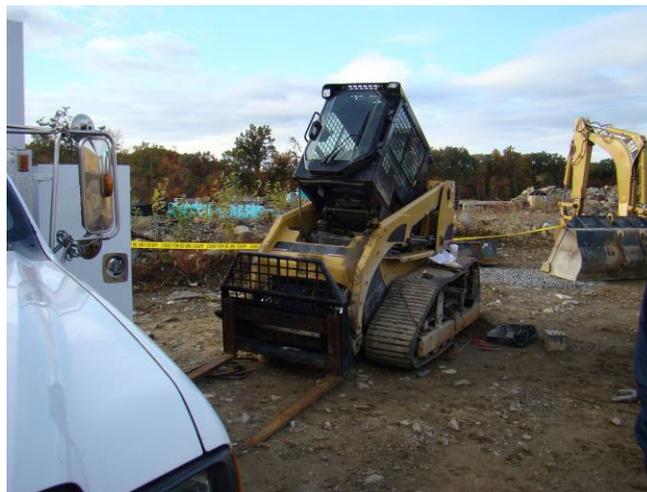
The machine that was being repaired at the time of the incident was a multi terrain loader (loader). The machine is similar to a skid-steer loader, with one of the main differences being that multi terrain loaders have rubber tracks instead of tires (Figure #1). The loader was manufactured in 2005 and was purchased by the company in 2006 from an equipment rental company. The loader's dimensions are 115 inches long (with no attachments), 82 inches high and 75 inches wide. The loader's lift height is 93 inches. The employer reported that the loader had not had any major problems or needed any major repairs since being purchased.

Figure 1 – Loader involved in the incident

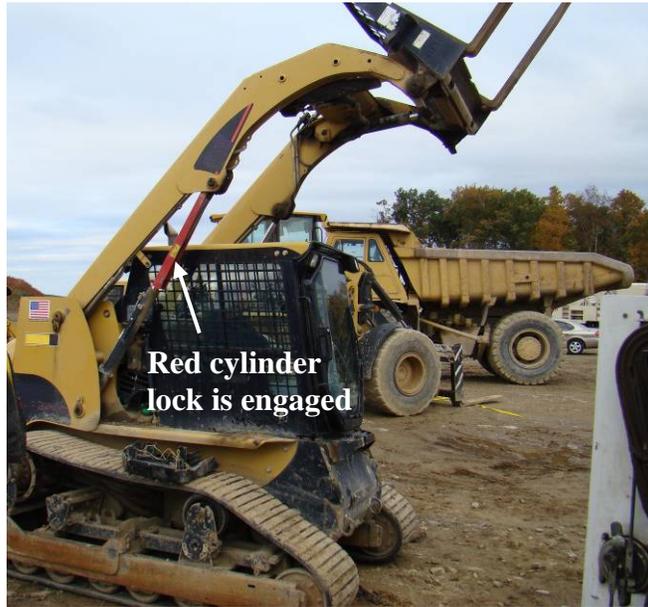
The loader has a lift arm that wraps around the front of the machine. The lift arm has two hydraulic cylinders located on either side of the loader. The hydraulic cylinder located on the right side of the loader is equipped with a cylinder lock. When engaged, the cylinder lock will prevent the raised lift arm from being able to be lowered, both intentionally and unintentionally. To engage the cylinder lock, first the lift arm must be lowered and the cylinder lock storage pin removed from the cylinder lock brace by either the operator exiting the cab or by someone outside of the cab. The lift arm is then raised until the brace engages by dropping onto the cylinder (Figure #2). A lock pin is inserted through the lift arm brace and a cotter pin installed to keep the lock pin and brace in position on the cylinder. Again, this task can only be performed by a person who is outside of the loader's cab. To lower a lift arm that is locked in the raised position, the above procedure is performed in reverse.

In this case, at the time of the incident, the loader's lift arm was in the raised position and the cylinder lock was not engaged. The loader was running and the lap bar restraint was in the down position even though no worker was seated in the operator's seat. Also, it was discovered after the incident when the loader was inspected that the operator's seat interlock was not functioning. All of these factors combined with the victim working underneath the raised lift arm contributed to the event that led to the fatal injury sustained by the victim.

Figure 2 – Loader with lift arm raised and cylinder lock engaged

Recommendation #2: Employers should ensure that the lift arm cylinder lock is engaged prior to raising the multi terrain loader's lift arm for maintenance tasks.

Discussion: During normal operation of a multi terrain loader, operators should never exit or place any part of their body outside of the cab without lowering the lift arm to the ground first.¹ In this case, the incident occurred not during normal operation of the loader, but during a maintenance task where the victim needed the loader's lift arm in the raised position. Prior to the entering the loader's cab to raise the lift arm maintenance tasks, the lift arm cylinder lock should have been engaged. Engaging the lift arm cylinder lock first and then raising the lift arm will prevent any movement of the lift arm during the maintenance task and will allow safe access to the cab with the lift arm in the raised position.¹ In addition, the process of engaging the lift arm cylinder lock should be incorporated into the loader's lockout/tagout procedures (Recommendation #4).

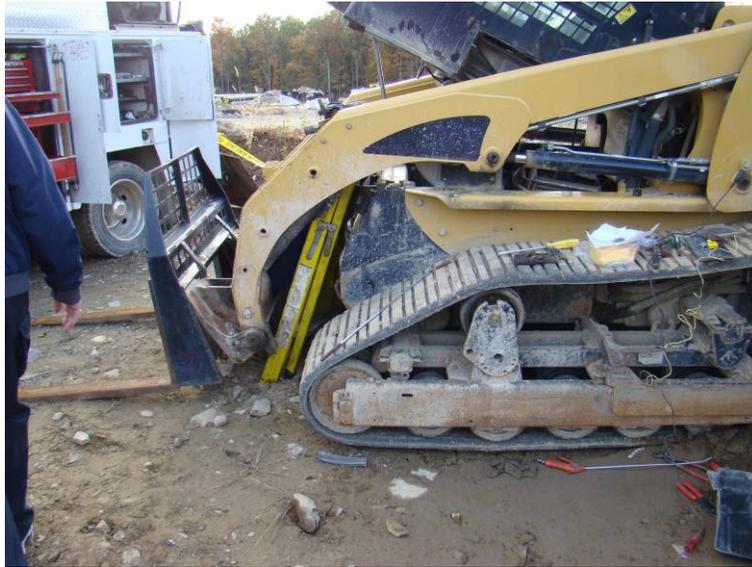
The loader has an access panel located on the machine's left side that provides access to the heating unit. At the time of the incident, the access panel and the heating unit were removed from the loader and the heating unit was disassembled. The loader's lift arm, with a fork attachment connected to it, was in the raised position and the cylinder lock was not engaged. The loader's cab was also partially raised for better access to the heater and other components. The victim had placed a four foot stepladder against the loader's cab, underneath the raised lift arm (Figure #3). It appears that the victim was standing on the stepladder when the incident occurred.

Discussion: In this case, although un-witnessed, evidence suggests that the victim might have positioned the step ladder against the front of the loader to reach up into the cab area to start the loader's engine. Once the engine was started, it appears that the victim might have unintentionally engaged the lever that controls the raising and lowering of the loader's lift arm, causing the lift arm to lower and crush the victim against the ladder and the loader frame/cab. Ensuring that employees only start and engage a loader's controls while seated in the operator's seat, can prevent the unintentional engaging of the loader's controls leading to crushing injuries by the loader's lift arm.

Figure 3 – Loader with step ladder visible

Recommendation #3: Employers should ensure employees only start or access the controls of a multi terrain loader when seated in the loader's cab.
