MIFACE INVESTIGATION REPORT #09MI075

SUBJECT: Semi-Truck Driver Died When Struck by Precast Concrete Panel That Fell From Semi Trailer

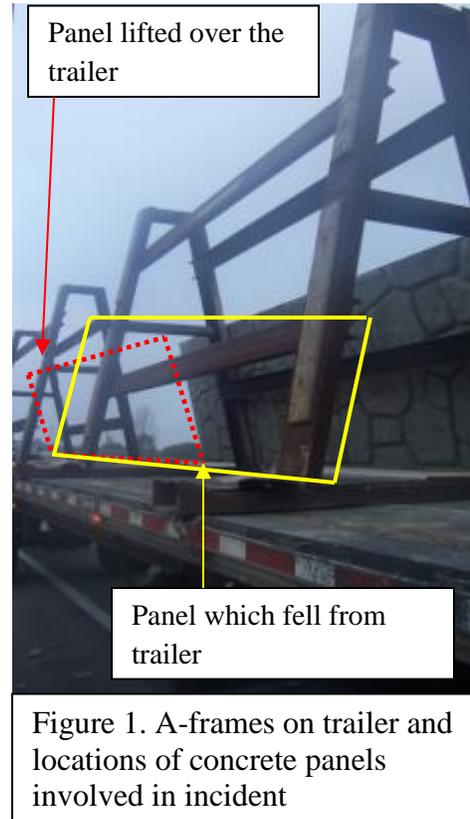
In fall 2009, a male semi-truck driver in his 60s died when he was struck by a 3,770-pound precast concrete panel that fell from a semi-truck trailer. The semi-trailer had two A-frames carrying precast concrete panels. One A-frame was located toward the rear of the trailer and one to the front of the trailer. The sides of the A-frame, against which the panels rested, were faced outward on both sides of the trailer. After arriving at the site, the decedent removed the load securement straps from all of the concrete panels. The unsecured precast concrete panel that struck the decedent was located on the A-frame toward the front of the trailer facing the passenger side. A crane operator was lifting a precast panel from an A-frame located at the rear of the trailer facing the driver's side. A single looped tag line approximately 45 feet in length was in use. The following sequence of events is postulated: As the precast panel from the rear of the trailer was lifted up and over toward the truck cab, the looped tag line caught the edge of the unsecured panel at the front passenger side A-frame. The decedent was standing near the passenger door and noticed the looped tag line catch on the corner of the incident panel. As he was approaching to move the tag line away from the panel, the tag line ran out of slack, tightened, and exerted enough force to cause the panel to fall from the A-frame, strike his right shoulder and head, and then pin him to the ground (See Figure 1). After the panel fell, the crane operator lowered the precast panel he was lifting. Coworkers unhooked this panel and then hooked the crane to the panel pinning the decedent. The panel was lifted from the decedent and emergency response was called. The decedent was transported to a local hospital and declared dead.

The rigger indicated he felt the trailer shake and looked over and saw the concrete block lying on top of the decedent. The crane operator indicated he heard a loud "bang" and saw that the panel had fallen from the trailer. The incomplete wood upon the A-frame (See Figure 1) allowed the unsecured panel to pivot in its transported position; scuff marks were present on the lower portion of the A-frame. After the panel fell, the crane operator lowered the precast panel he was lifting to the ground. Contractor A employees unhooked this panel and then hooked the crane to

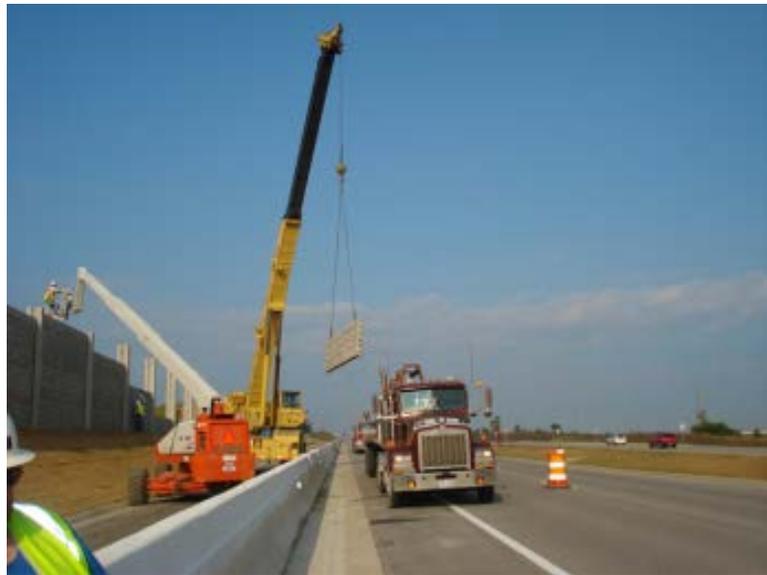
Figure 2. Overview of construction site including example of position of decedent's truck and location of additional company trucks

A man lift was positioned east of the crane on the south side of the concrete barrier with its platform positioned at the sound barrier wall (Figure 2).

company trucks were in line to his west (Figure 2). He removed all the load securement straps from the concrete sound panels. While the panels were being unloaded the decedent stood next to the concrete roadway barrier near the passenger door.

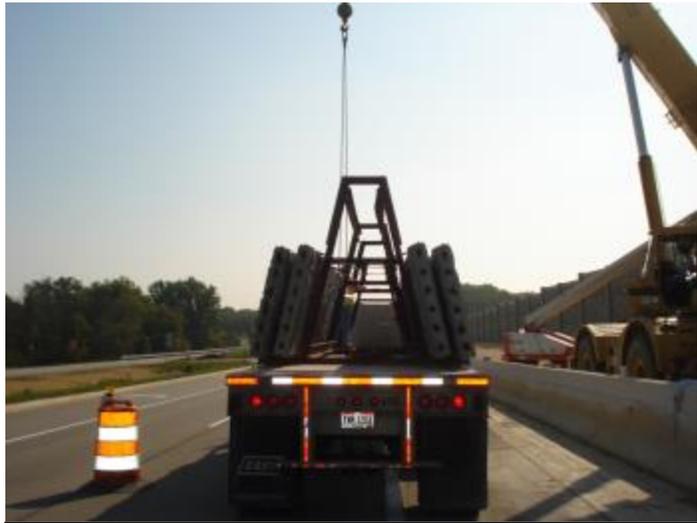
Figure 3. Example of concrete sound panel orientation on A-frames on trailer

The semi-trailer was equipped with two A-frames that carried the precast concrete sound panels (Figure 3). One A-frame was located toward the rear of the trailer and one to the front of the trailer. The A-frames were appropriately secured to the trailer bed. The sides of the A-frames, against which the panels rested, were facing outward; the driver (northern direction) and passenger side (southern direction) of the trailer. The foot of the A-frame supporting the panel involved in the incident was narrower than the bottom of the slab. Additionally, the wood attached to the A-frame stopped short of the bottom of the steel.

The keyway on the bottom of the barrier panel that fell caused the bearing surface to become smaller. The A-frames were measured at 12 degrees south to north. The concrete sound panels were located approximately 65 inches above the roadway. An example of panel securement for transportation is shown in Figure 4.

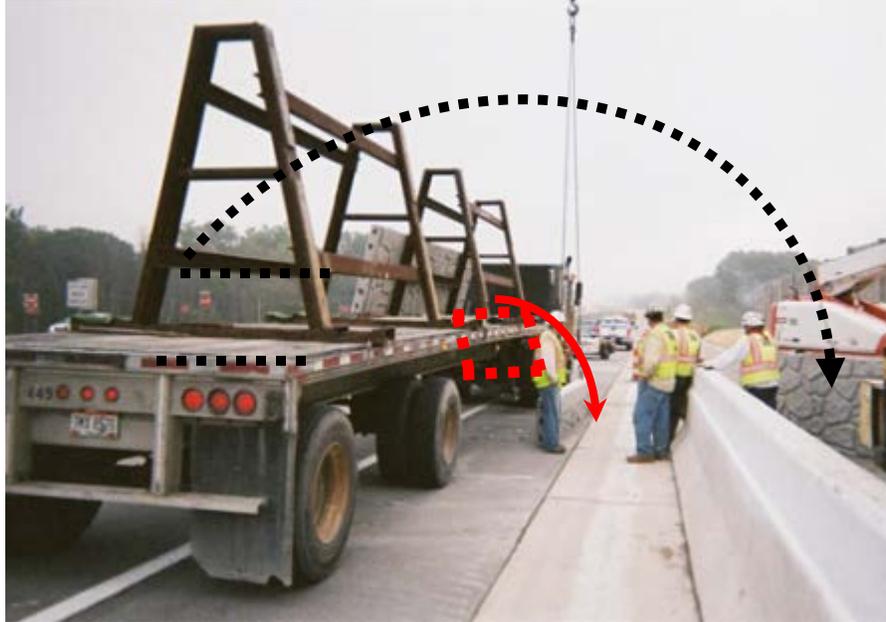
Figure 5. Path of panel being unloaded and position of panel that fell from truck striking decedent

The unsecured 2-foot high by 19-foot long by 16-inch wide precast concrete panel weighing approximately 3,500 pounds that struck the decedent was located on the A-frame toward the front of the trailer facing the passenger side. The incident occurred when the crane operator lifted a 4-foot, 7,000-pound precast panel that was resting against the A-frame located on the driver's side at the rear of the trailer (See Figure 5).

away from the panel. While he was approaching, the tag line ran out of slack, tightened, and exerted enough force to cause the panel to fall from the A-frame and strike his right shoulder and head, and pin him to the ground.
