# MIFACE Investigation Report #10MI021

## Subject: Farmer Grading Field Pinned Under Overturned Tractor

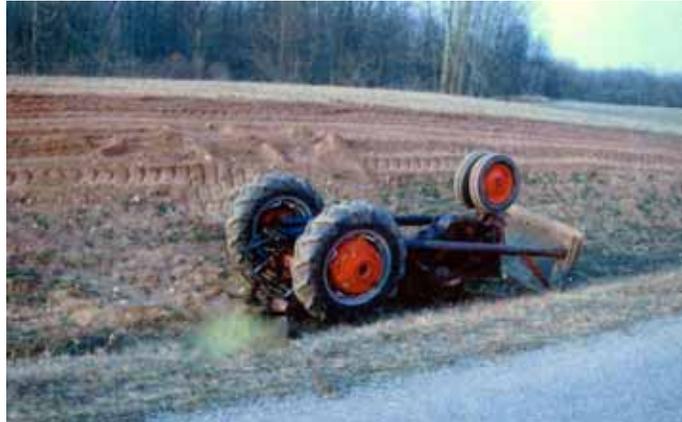
Figure 1. Incident scene.

Evidence suggests that the decedent encountered difficulty maintaining directional control of the tractor and push blade as he made a pass along the sloped edge of the field. While he was attempting to regain control, the tractor became unstable and overturned into the ditch. The decedent was unable to jump off or free himself before the tractor came to rest on top of him. When the neighbor drove the same road back to her home 15 minutes later, she

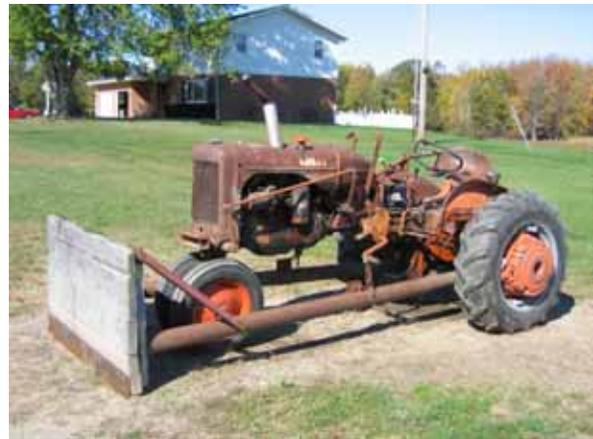
The decedent was operating a 1940s Allis Chalmers, tricycle tractor equipped with a home-made push blade attachment. The 5-foot long by 2 feet 8 inch high wooden blade had a 5-inch metal piece at its base. The blade was connected via a piece of channel iron on each end of the blade to 4-inch diameter metal pipes. On each pipe was a bracket that was attached to a chain, which was attached to a gear mechanism that raised and lowered the pipe and blade. The piping was welded to a metal bar attached to the back of the tractor. (See Figures 2 - 4). The decedent had attached two metal weights to the rear of the tractor (Figure 5). The two weights may have acted as counterweights to balance the additional weight the blade placed on the front of the tractor, or to balance the weight of the hoist mechanism for easier lifting of the blade. The attachment location of these weights was unknown. These weights became detached during the overturn.

Figure 2. Incident tractor showing home-made push blade attachment

- Select an appropriate machine for the task. In this incident, a rollover protective structure (ROPS) fitted unit should be the preferred unit, but a newer tractor with a 3-point hitch rear mounted blade or a track-type dozer with a front blade would have been better suited to move the soil.

Older tractors have limited ability to attach implements, other than what they were originally designed and intended to be used for. The decedent's tractor did not have a 3-point hitch, so a rear-mounted blade was not possible. Using a front mounted blade on a tricycle tractor to push soil contains risk and may be a misuse of the manufacturer's intended use of this tractor. Additionally, the use of farm built implements on agricultural tractors could contain unknown risks to the user due to engineering and other factors. The home-made push plow involved adding a great deal of weight to the front and sides of the tractor, which could have affected the stability of the tractor significantly.

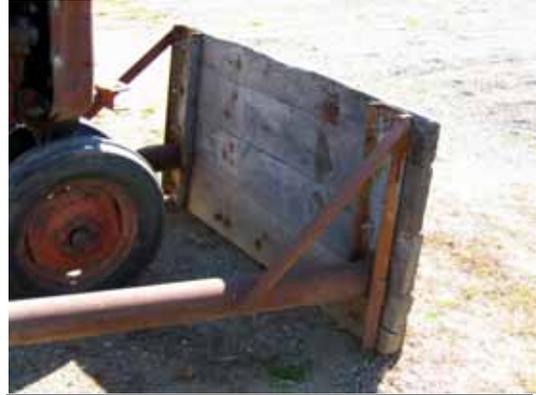
Figure 3. Close view of incident tractor showing home-made push blade attachment

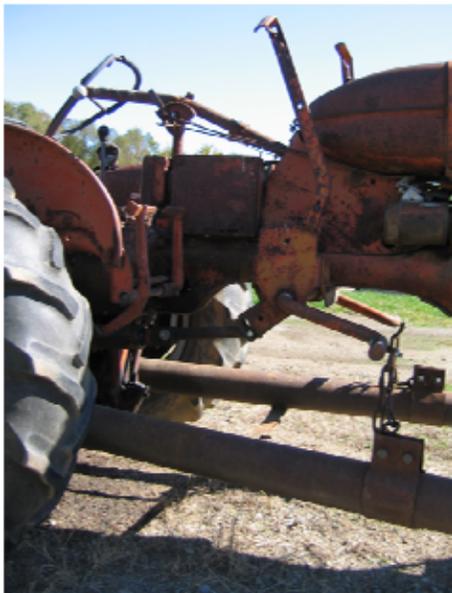
Figure 4. Attachment and hoist mechanism for raising and lowering blade

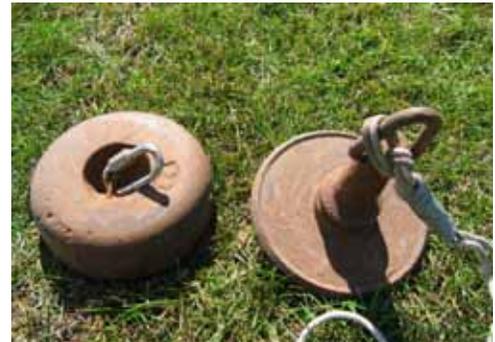
Figure 5. Weights attached to rear of tractor
