FROM: Iowa FACE Case no.: 2011 IA 035 Report date: 10 October 2012

SUBJECT: Convenience store cook died from smoke inhalation

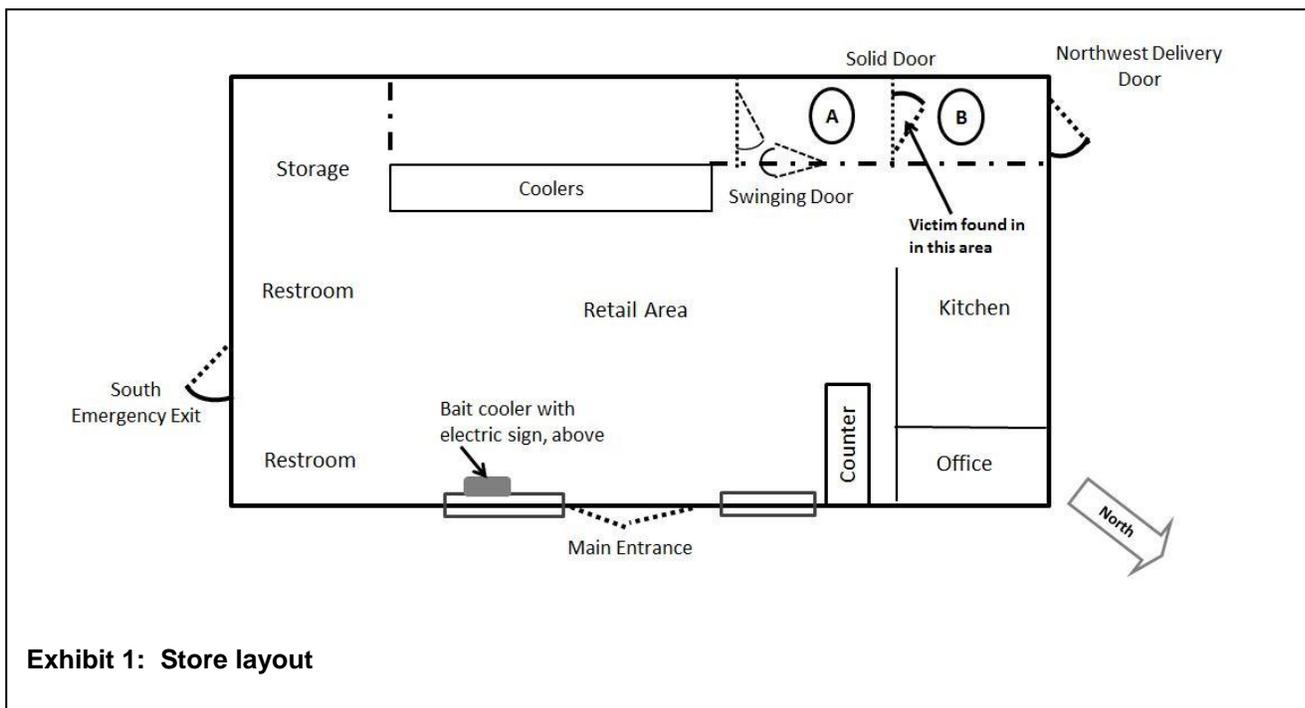
To the west of the kitchen area were the two storage rooms through which the worker would have to travel to escape through the northwest delivery door. The first room ("A" in Exhibit 1) contained a washer, dryer, hot water tank and extra soda from the store. To travel to the delivery door, one must pass through this room and through a heavy wooden door into a second storage area ("B" in Exhibit 1). This door was an outward-swinging push door (*i.e.*, swung toward the northwest exit) from room A to B, with a levered door handle, and hinges on the right of the door as exiting. This second room (B) contained a floor sink, buckets, electrical panel, the fire suppression system for the kitchen's grill, and boxes of soda for the fountain dispenser. Employees reported that the door between these two rooms was usually shut.

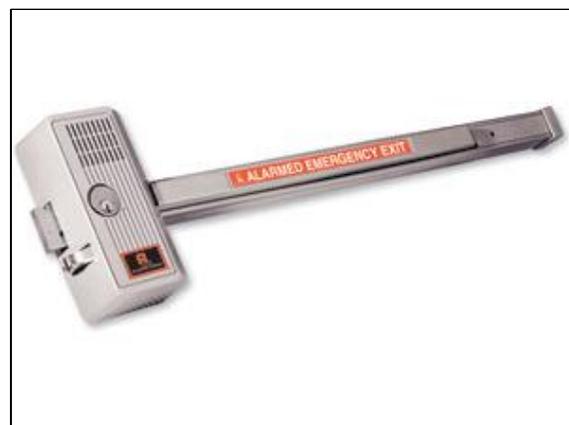
The employee remained on her cell phone with the 911 dispatcher, and when she was by the northwest delivery door, she indicated that it would not open. Exhibit 2 illustrates the type of panic bar installed on the door in question, although the door in this case did not contain the "Alarmed Emergency Exit" label on the panic bar itself. The installed panic bar had a keyed system to allow disabling the alarm system to facilitate moving product into the store during operating hours without activating an alarm. Once in storage room B, the decedent remained on the phone with the dispatcher until 4:04 am, when communications were lost.

Exhibit 2: Example of a panic bar ("crash bar") similar to the bar mounted on northwest delivery door

Although the northwest delivery door was not a designated fire exit, routine review and testing of the opening mechanism may have improved this worker's ability to escape. At this time, it is unknown whether the panic door mechanism had malfunctioned or whether the worker did not depress the panic bar on the northwest delivery door. Routine testing of the delivery door latch mechanism would have identified problems with the mechanism prior to the morning of the fire.

Substituting the interior-keyed deadbolt with panic bar hardware that locks to prevent entry from the outside, but allows exit from within would have allowed the worker to exit the door upon first detection of fire without having to find and insert her key. The employee could have potentially exited the store within seconds of detecting the fire. Alternatively, leaving the key in the lock until the store is opened may have assisted the escape of this worker, when visibility near the front door was limited by smoke that prevented her from approaching the door after locating her keys. The panic bar, however, is the preferred mechanism for fast escape.
