## **Massachusetts FACE • Occupational Fatality Report**

### **Truck Driver Dies while Rotating Tires Mounted on Demountable Multi-piece Rim Wheels - Massachusetts**

**Investigation: # 11-MA-044-01**

**Release Date: March 1, 2013**

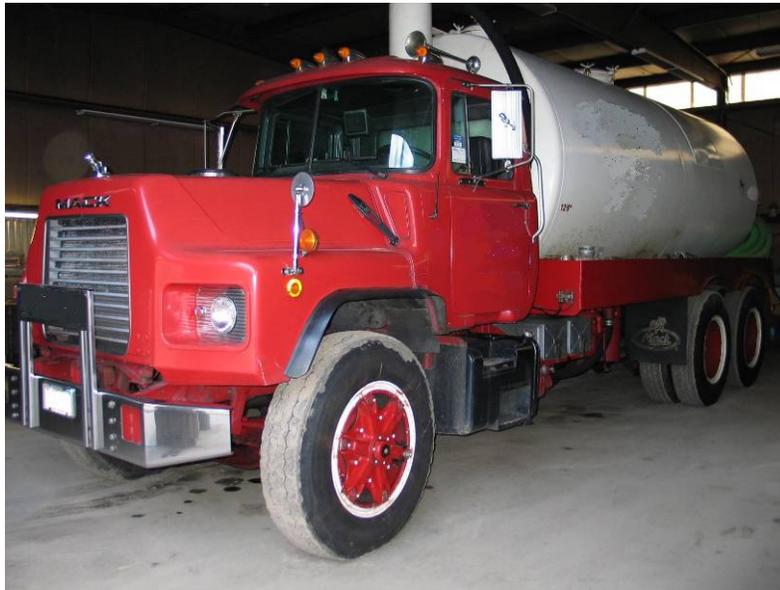
The truck involved in the incident is a 10-wheel septic system pump truck. Both the truck chassis and tank were manufactured in 2001 (Figure #1). The truck has a diesel engine and rear tandem axle dual wheels with demountable rims and tubeless 1100 R24 tires. The tires were reported to be approximately one year old at the time of the incident. The truck's rear wheels are three-piece demountable rims. The three pieces are a rim base, a split locking ring, and a continuous side ring. The rim parts are designed so the locking ring fits into a gutter on the base rim, locking the continuous side ring in place on the rim when the tire is inflated. These demountable rims also have a cast spoke hub, a component of the axle, to which the demountable rim is clamped. In this case, the spoke hub consisted of six spokes (six bolt pattern) and six clamps to hold the rim in place on the spokes. Since the spoke hub is attached to the truck's axle when the rims are removed from the truck, the spoke hub section remains attached to the truck (Figure #2).

**Figure 1 – Truck involved in the incident**

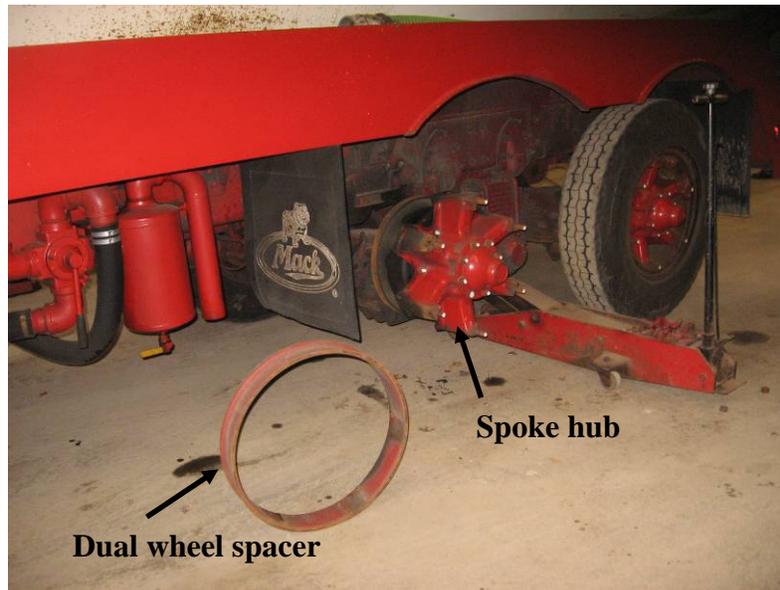
To begin the task, the victim backed the truck into one of the company's garage bays. The garage door was left open and the truck was positioned so the truck's cab remained outdoors. It appears that prior to starting the task of rotating the tires started, all of the truck's tires were fully inflated on their rims. A hydraulic floor jack was positioned under the left rear axle to raise the truck's left rear tires off the ground. Once the left rear tires were lifted off the ground, the victim removed both the outer and inner wheels on the forward rear axle.

**Figure 2 – Truck involved in the incident with three of the four driver’s side rear wheels removed**

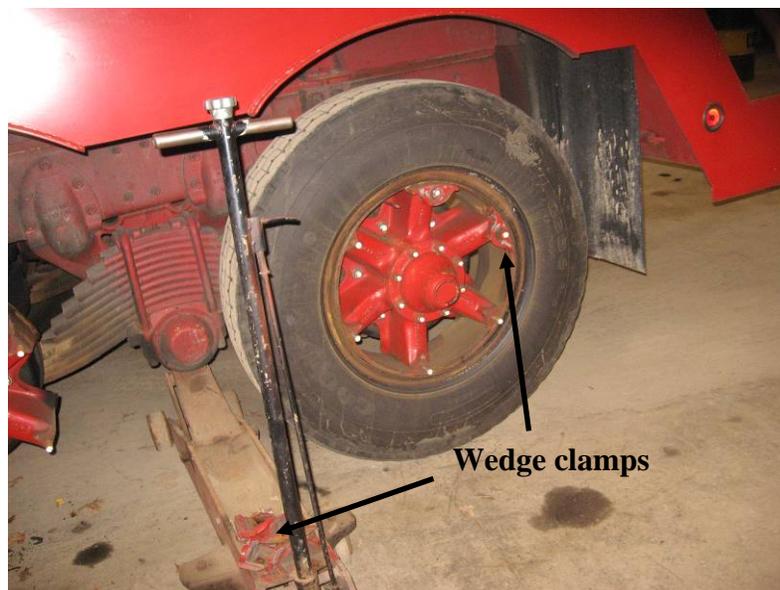
When placing tires mounted on demountable rims onto a truck, the rim is positioned onto the spoke hub and then the wedge clamps are used to hold the rim in place on the spokes. The wedge clamps prevent the rim from spinning on the spokes and are positioned onto the studs. Lug nuts fasten the wedge clamps onto the spoke's studs and secure the wheel in place (Figure #3). For dual wheel setups, the outer tire and rim mounts onto the same spoke hub as the inner rim, and the rims are separated by a spacer.

Since the victim was working alone and the incident was un-witnessed it is difficult to know exactly what happened and what the victim was doing when the incident occurred. It appears that the victim had just removed the outer rear wheel on the rear most axle by loosening and removing most of the six lug nuts and wedges (Figure #2). The victim then moved this wheel away from his immediate work area. Evidence suggests that the victim was standing in front of the inner left rear wheel and was starting to remove the wheel from the axle when its rim suddenly released. It would appear that when the rim released, this caused the victim to be blown back. Both the split locking ring and continuous side ring and at least one of the wedges were propelled out from the wheel with great force. The victim was struck in the forehead by one of the wedges.

**Discussion:** In this case it appears that most of the lug nuts may have been completely removed prior to ensuring that all of the rim's wedge clamps were loose. This possibly contributed to the incident. Demountable rim wheel wedge clamps are likely to be under pressure when in place. When the lug nuts have been completely removed from the studs and the pressure releases, the wedges can be forcefully release through the air.

**Figure 3 – Demountable rim wheel with wedge clamp**

To prevent the wedges from releasing into the air, first loosen all of the lug nuts leaving them threaded on the wheel studs a few turns; do not totally remove the lug nuts from the studs. Next use a hammer to loosen the wedges by tapping on them. When the wedges become loose they may move away from the rim with a “pop”. Leaving the lug nuts threaded multiple turns on the wheel studs will stop the movement of the wedges and prevent their release into the air. Once all of the wedges are loose, the lug nuts and wedges can be totally removed from the wheel’s studs.

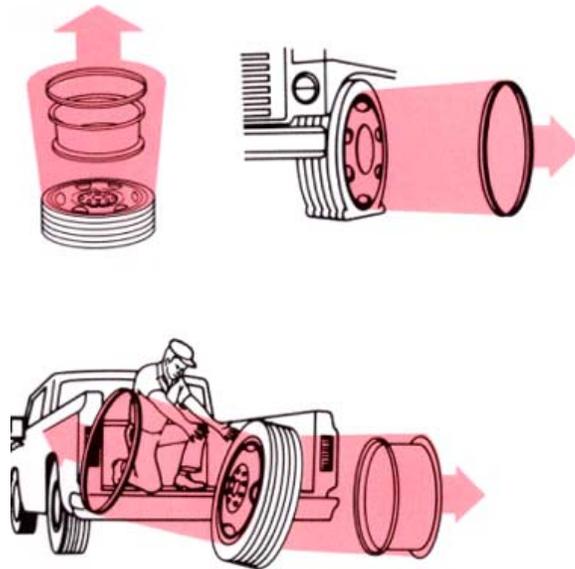
**Discussion:** When multi-piece rim wheels are inflated, they are under great air pressure. It is this air pressure that holds the multiple components of the multi-piece rim wheel together. When there is an uncontrolled release of the air pressure from the tire, this causes the rim wheel components to separate. When the rim wheel components separate, they are usually dislodged causing them to be thrown at extreme speeds and violent force (Figure # 4).

**Discussion:** OSHA's definition of trajectory is any potential path or route that a rim wheel component may travel during an explosive separation, or the sudden release of the pressurized air (Figure #4). When a rim wheel with an inflated tire is mounted on a vehicle, the hazard of being struck by a wheel component during an explosive separation or sudden release when working on the wheel exists. Therefore, to minimize this hazard it is extremely important for employees to always stay outside of the trajectory by never positioning themselves in front of or over inflated tires.

**Figure 4 - Trajectory of multi-piece rim parts in different scenarios.**

In this incident, the wheels that were being rotated reportedly appeared to be in good condition with no noticeable damage. Therefore, this case underscores the importance of always deflating multi-piece rim wheels, releasing the air pressure in a controlled fashion, prior to maintenance or removal from a vehicle. Deflating multi-piece rim wheel tires can be accomplished by removing the wheel's core valve.
