Scrap Processor Struck by Wrench and Dies after Makeshift Torque System Fails

Incident Number: 14KY036

Kentucky Fatality Assessment and Control Evaluation (FACE) Program

Release Date: March 5, 2015

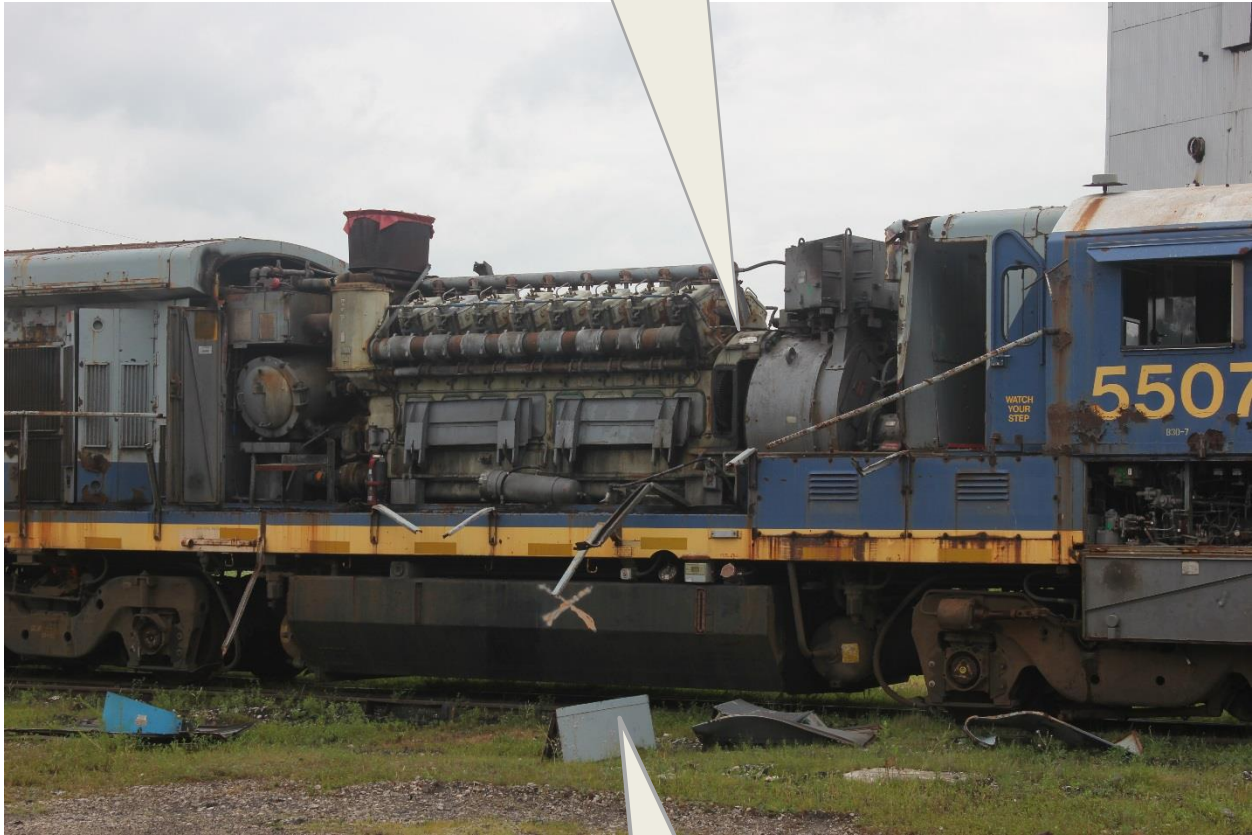
Location of the flywheel

The guardrail had been removed prior to work being performed, and the employees were not using fall protection while working six feet above the ground. Had the railing and fall protection been in place, it could have prevented the victim falling onto scrap metal pieces that were on the ground, possibly reducing his injuries.

Locomotive where the victim was working.

Victim fell onto
scrap metal

Recommendation No 3: Employers should require guarding or ensure that fall protection is utilized when employees are working four feet or more above ground.³

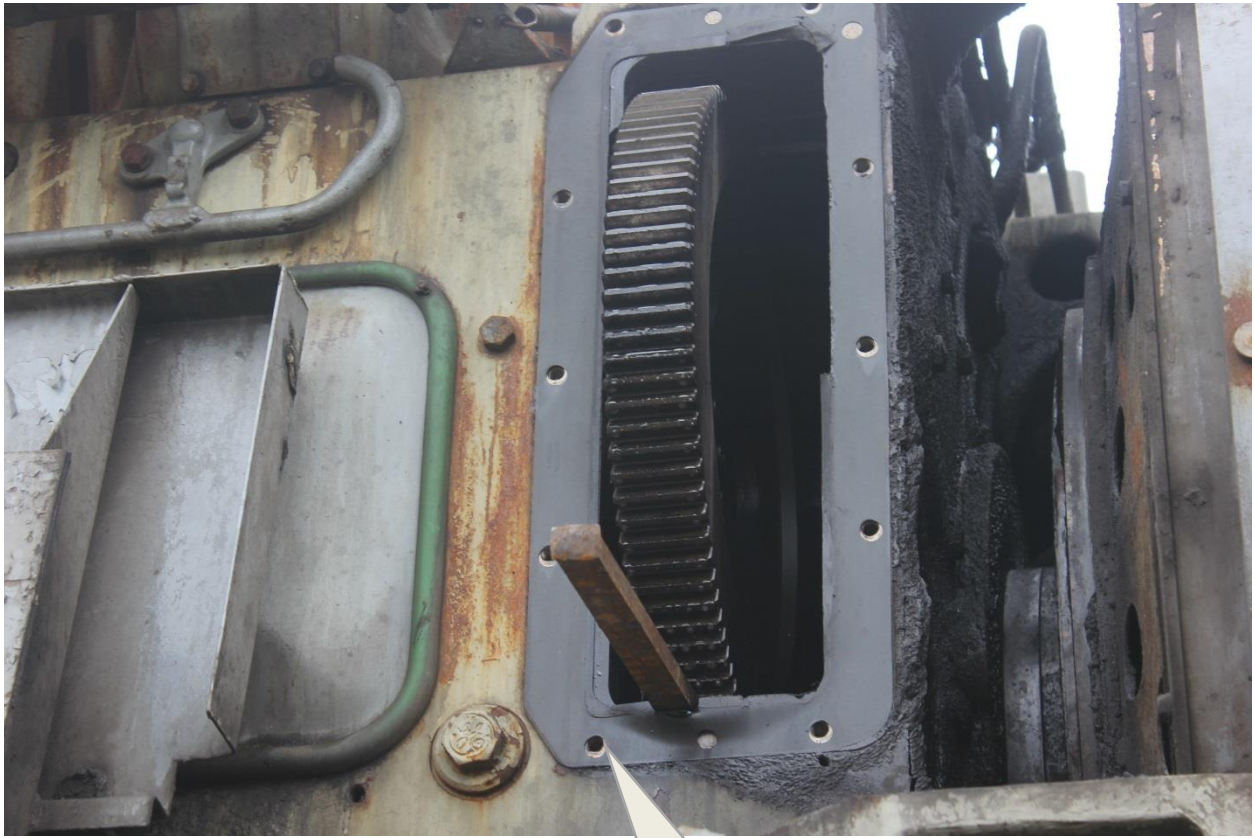
Area of bolt removal

The scrap processor placed the wrench on the bolt and signaled the excavator operator to apply tension. While tension was applied, the victim grabbed the sling and leaned over to observe the bolt. The wrench slipped off the bolt, shot out and struck the victim on the right side of his head causing him to fall 6 feet to the ground, striking several pieces of scrap metal. Emergency

The area where the bolts were being removed.

Recommendation No. 1: Employers should ensure employees use appropriate tools for the required job.¹

When the employer required bolts to be salvaged, a hydraulic wrench should have been provided.

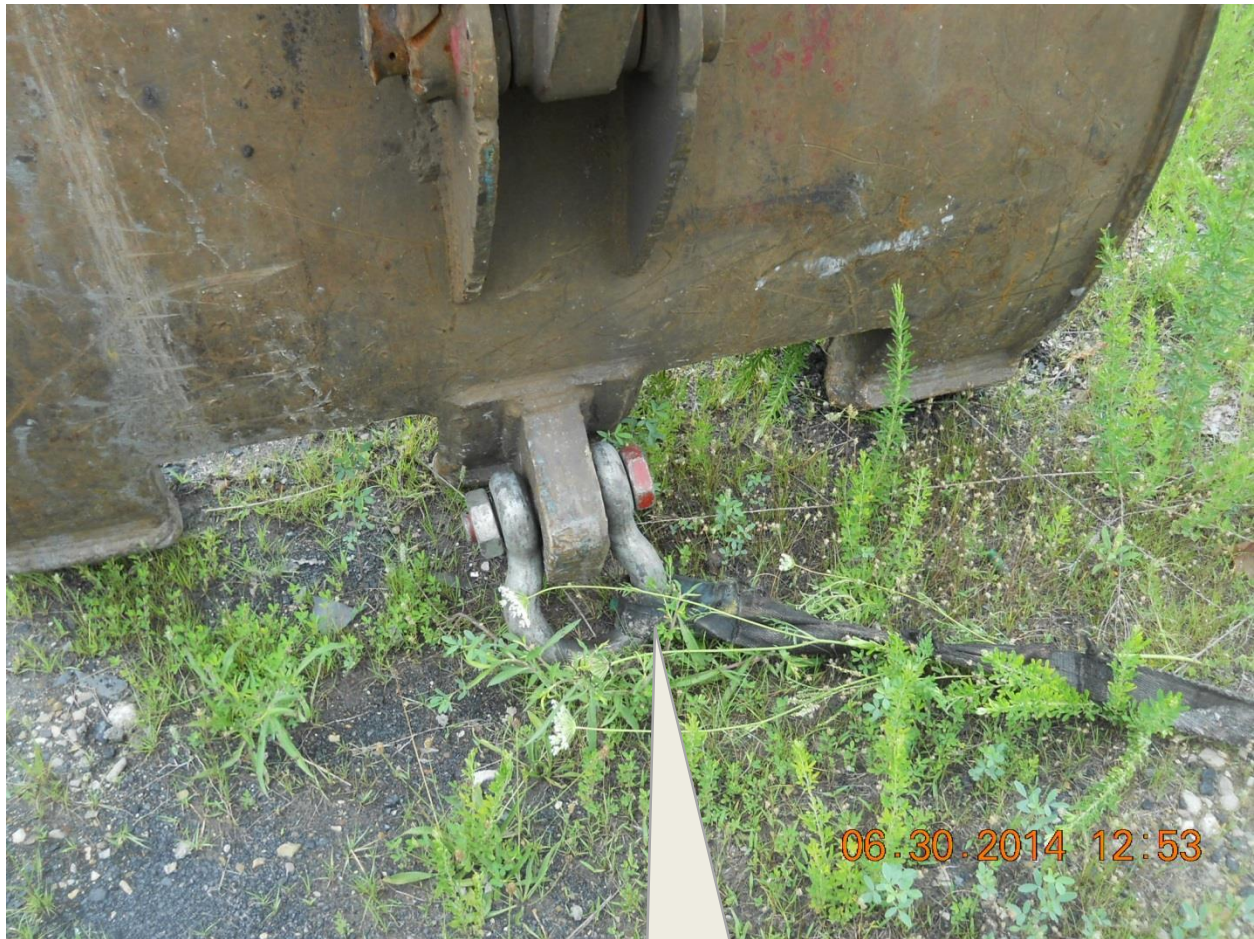
Where the
sling was
attached to the
excavator
