Production Supervisor Falls 19.5 feet through a Metal Roof and Dies

Incident Number: 14KY048

Kentucky Fatality Assessment and Control Evaluation (FACE) Program
Incident Number: 14KY048
Release Date: August 24, 2015
Subject: Production Supervisor Falls 19.5 Feet through a Metal Roof and Dies

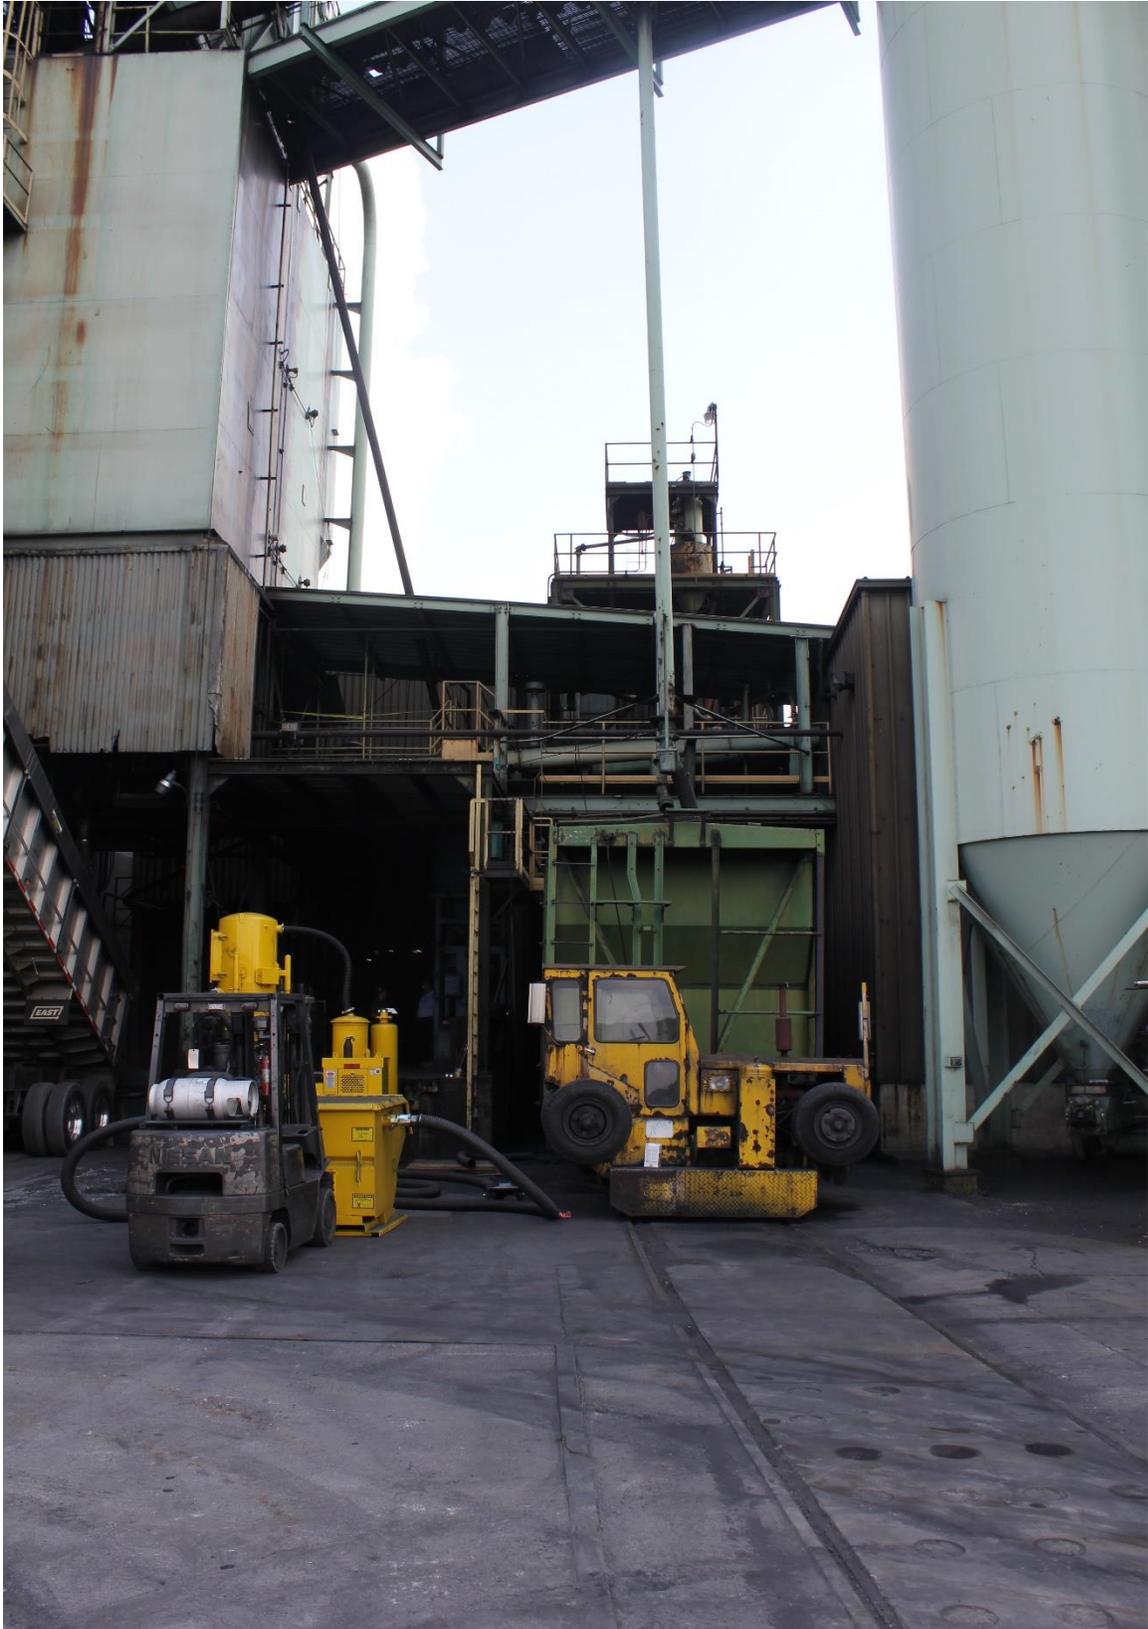
Photo 2: Incident scene

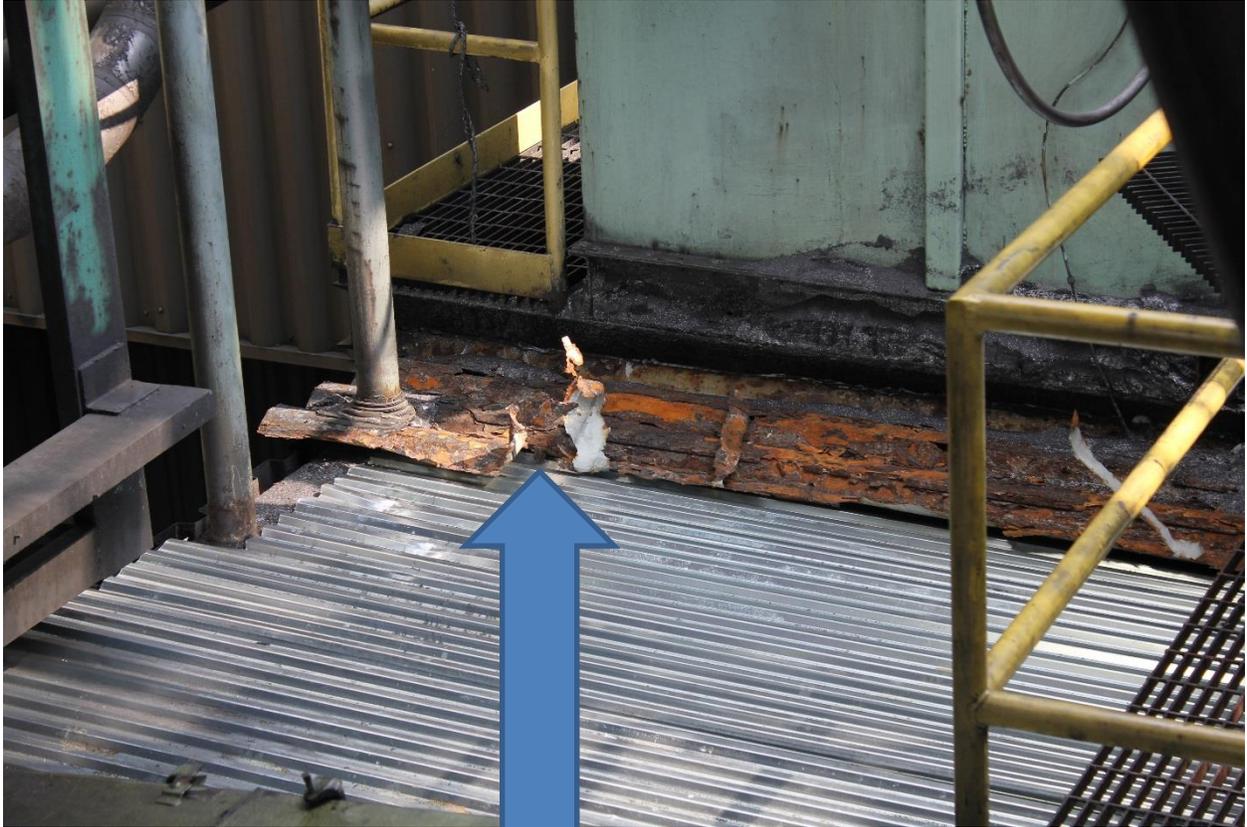
The scene was a metal roof covering a loading dock with a hardened earth surface. The roof area was flat and had a catwalk that ran over for access to the top of the roof. The edge of the roof area did not have any railings present and was 19 feet 6 inches above the ground. The area was slightly more than 13 feet wide. The metal roof had visible signs of rust and deterioration (see photo 3). Plywood was used to cover holes in the metal.

for him and found him lying on the ground. The supervisor had stepped onto a rotten area of the metal roof and had fallen through the roof 19 feet 6 inches to the hard dirt surface below.

The metal roof was in poor condition as evidenced by the plywood sections covering holes and that there had been at least two other employees who stepped through the roof but had not fallen. The roof was not in suitable condition to support human body weight. Routine assessment of the structural integrity of the roof and regular maintenance of the roof would have prevented this fatality.

Photo 3: rusting roof

Recommendation No. 1 Employer worksites should be regularly assessed for structural integrity.

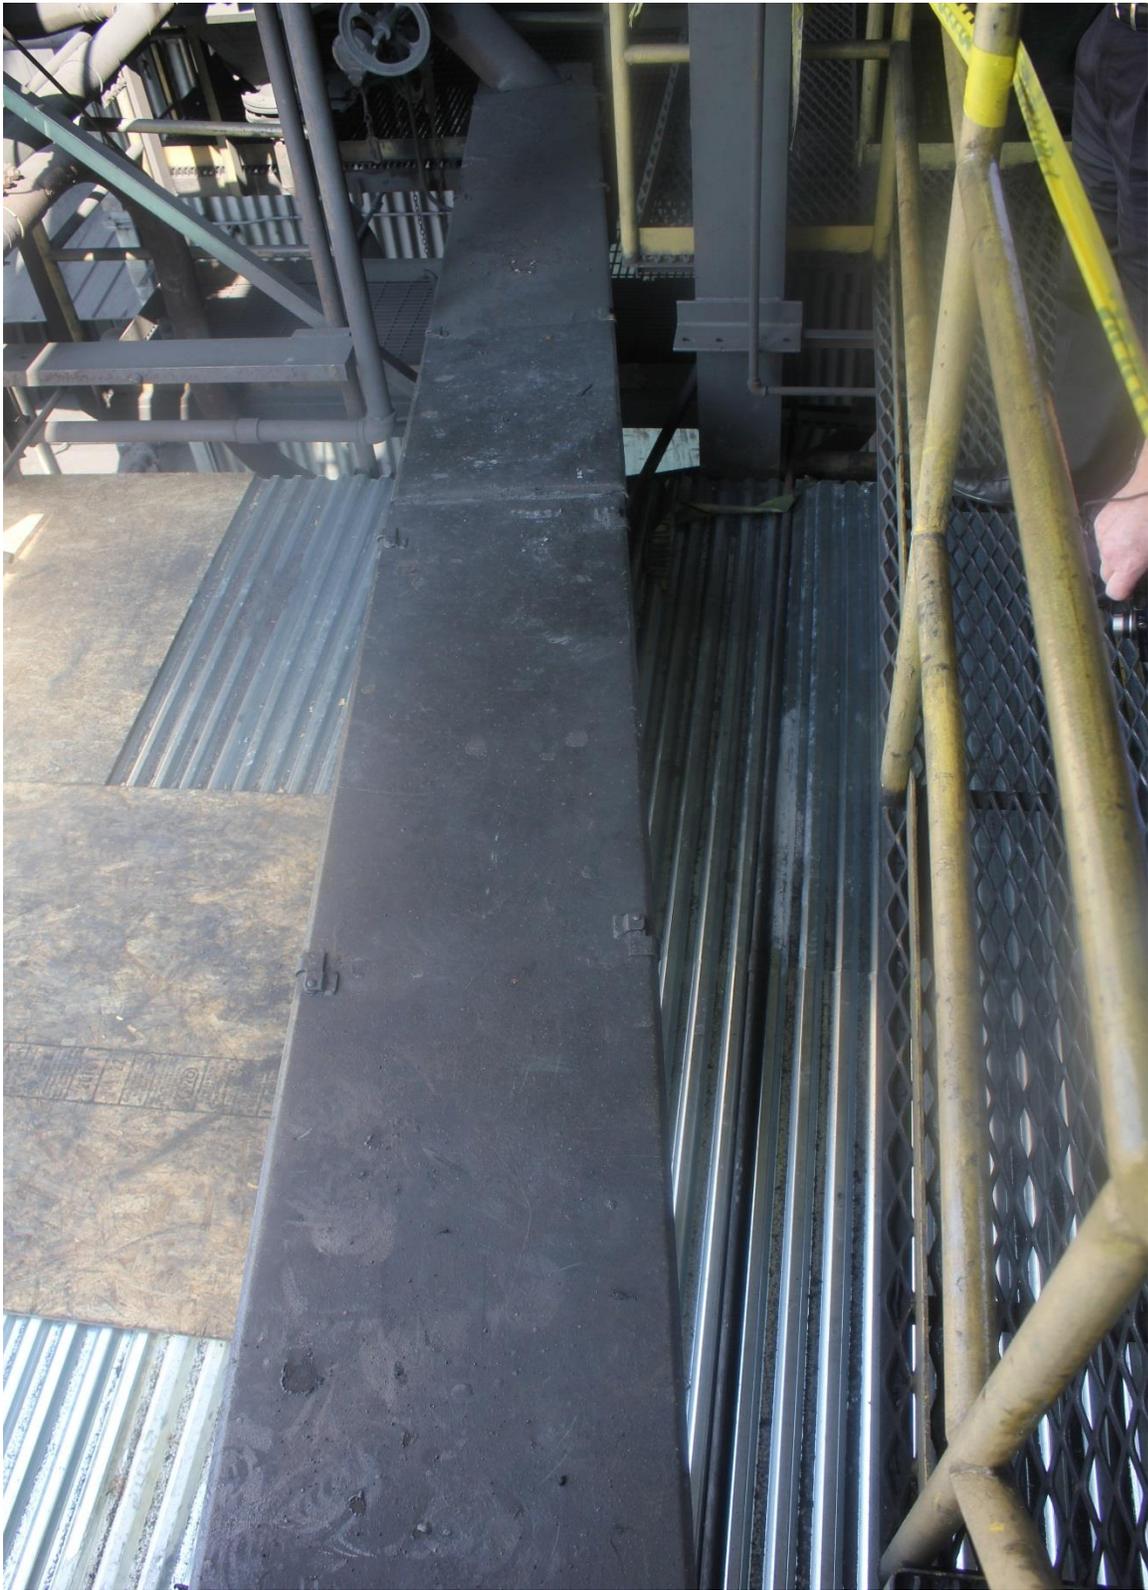
Photo 4: catwalk used
