National Personal Protective Technology Laboratory

Status Investigation Report of Three
Self-Contained Breathing Apparatus
Submitted by the
Pennsylvania State Fire Academy
Lewistown, Pennsylvania

NIOSH Task No. 14292

May 1, 2007

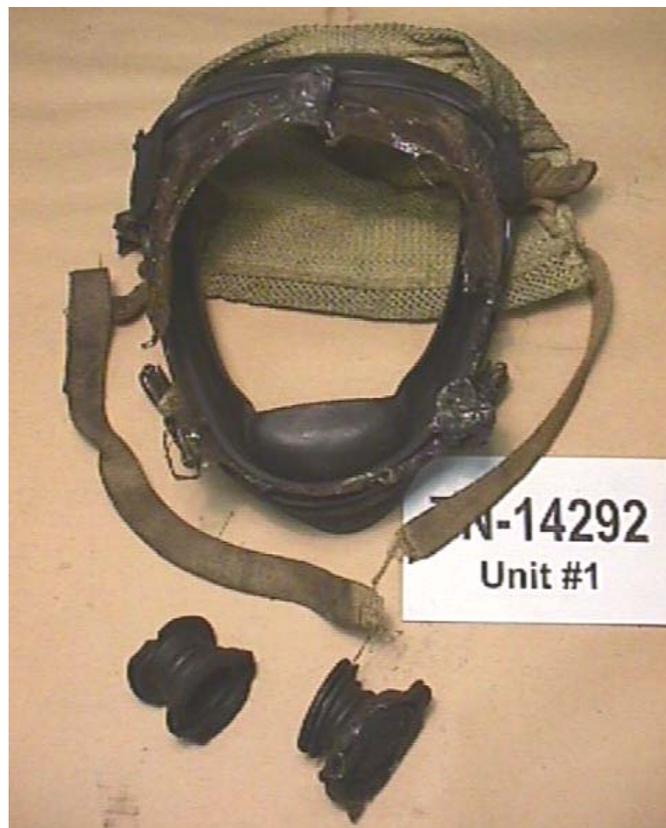
Figure 4 – Unit #1 Facepiece

The facepiece is a Scott AV-2000 facepiece assembly which consists of a black rubber facepiece seal, lens, lens frame, and yellow mesh head harness. It has suffered serious damage as a result of heat exposure, and the portion which was not covered by a protective hood has failed catastrophically.

The central portion of the lens is missing and the edges of the remainder are melted outwards, indicating extremely severe exposure to heat. Bubbles have formed throughout the remaining portion of the lens, and it is blackened in places. The black lens frame is mostly undamaged, although the portion in the chin area is slightly melted. It is likely that this area of the frame was not covered by a protective hood. The frame still securely holds the facepiece seal to the lens.

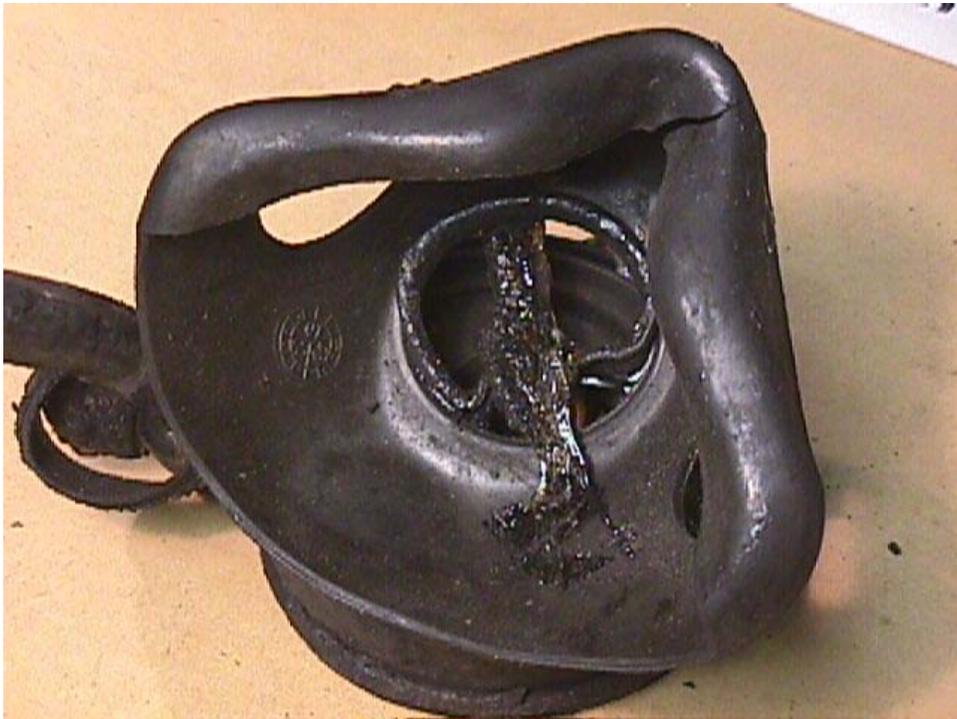
Figure 8 – Unit #1 Nosecup

ring, although this has melted and distorted from exposure to heat. Strings of the melted lens material itself adhere to the nose cup. The nose cup material is pliable and does not appear to be degraded. There is a tear in the seal at the bridge of the nose. Both inhalation valves are shriveled and distorted and no longer function properly. A date code molded into the nose cup interior indicates that it was molded in the **second quarter of 2001**.

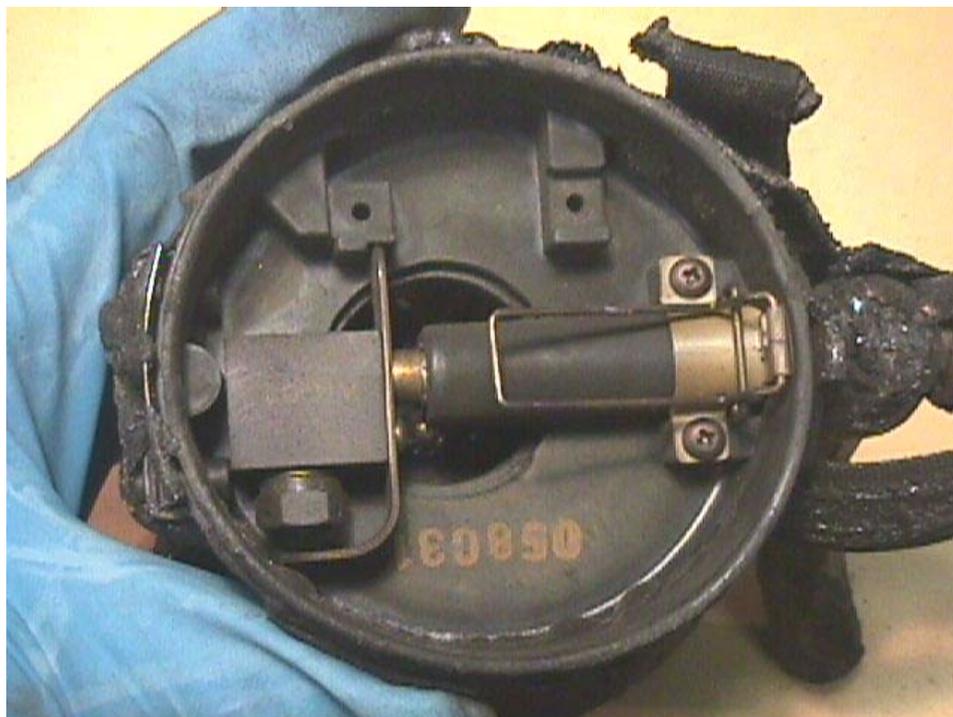
Figure 14 – Unit #1 Regulator Body

The facepiece-mounted air pressure regulator assembly has been heavily damaged by heat. It is fused to the portion of the facepiece to which it is normally removably attached. The outer regulator cover is melted and flattened, and the donning mechanism lever is absent. Heat has also extremely damaged the inner cover. The walls of the regulator are blistered and distorted, especially at the bottom. The metal demand lever still operates smoothly. The number “**058031**” is marked on the interior of the regulator housing.

Because of melting and distortion of the purge valve operator, the current position of the valve cannot be determined and it cannot be operated. The facepiece latching mechanism is likewise melted and inoperable. The regulator diaphragm is no longer installed in the regulator and the silicone diaphragm is torn and appears slightly charred. The exhalation valve mechanism built into the diaphragm no longer functions and the plastic components have suffered great heat damage.

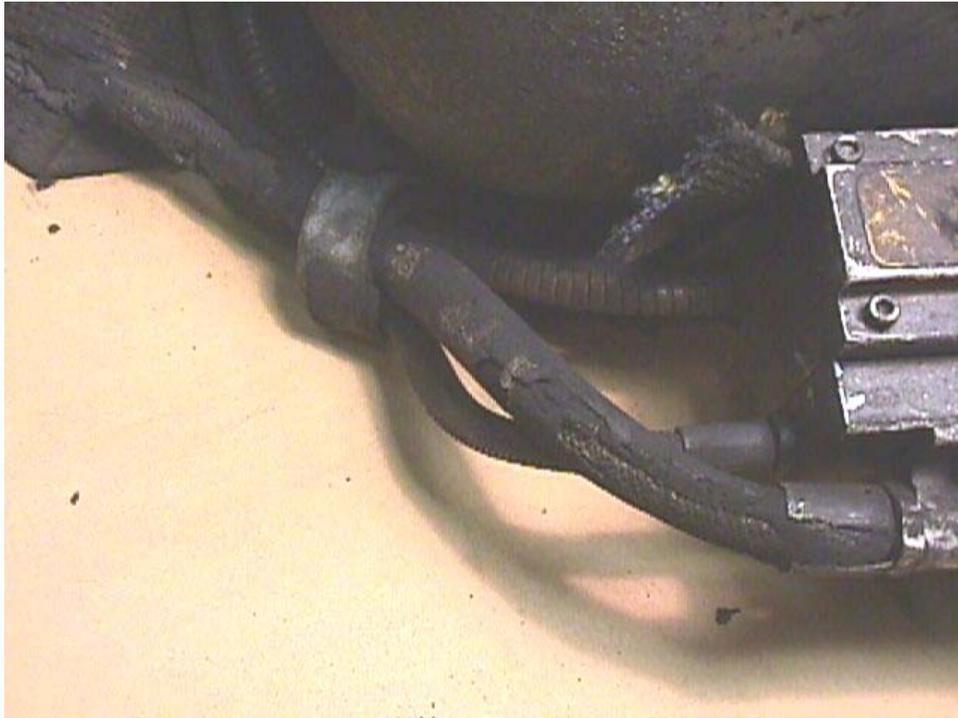
Figure 19 – Unit #1 Low Pressure Hose

Most of the low-pressure hose which runs from the air pressure regulator to the pressure reducer is absent. A few inches of hose are attached to the regulator, and approximately 1½ inches of hose extend beyond the backframe assembly. The rubber hose jacket is charred and has burned away in places, exposing the inner reinforcing layers. The crimp ferrule at the end which is attached to the pressure reducer has split.

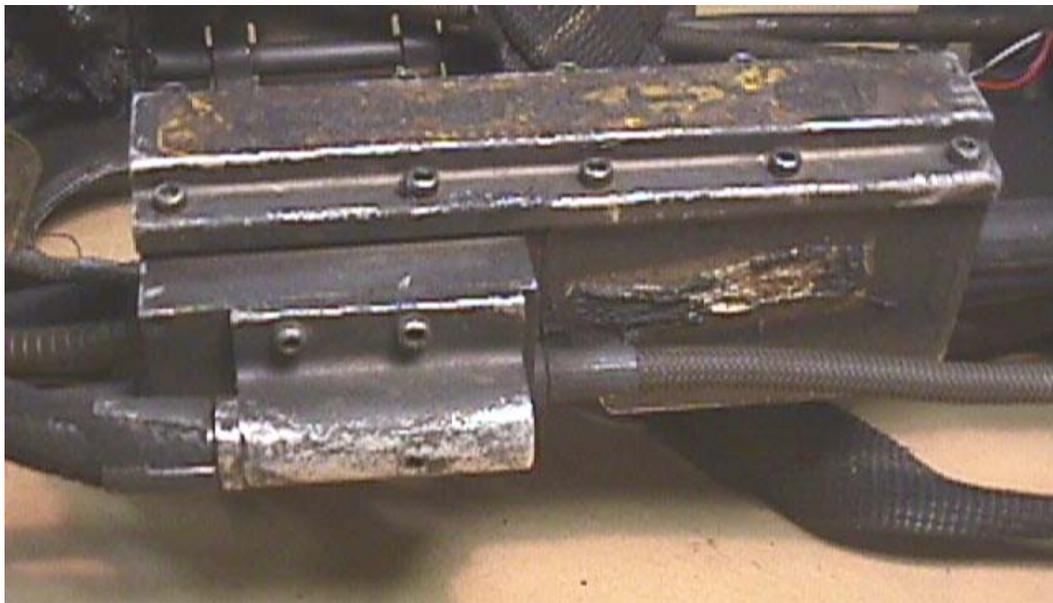
Figure 20 – Unit #1 Pressure Reducer

The metal housing of the air pressure reducer is blackened by soot, but shows no obvious signs of damage. Labels on the rear and side of the housing have been burned beyond recognition, but a label adhered to the front of the reducer reads “MID ATLANTIC FIRE AND AIR” and indicates the unit was serviced in **September 2005**. The ten screws securing the reducer cover plate all appear to be tightened. The reducer is securely attached to the backframe.

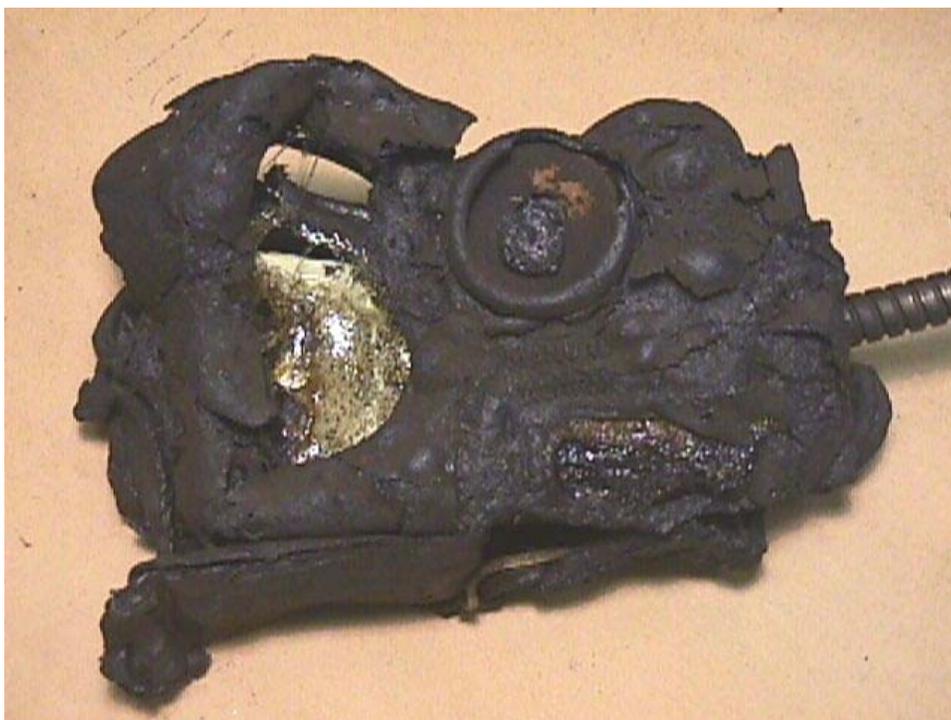
Figure 21 – Unit #1 Remote Pressure Gauge/PASS Console

A Personal Alert Safety System (PASS) device was incorporated into the pneumatics of Unit #1. Like other components of the SCBA, it has suffered severe thermal damage and is not functional.

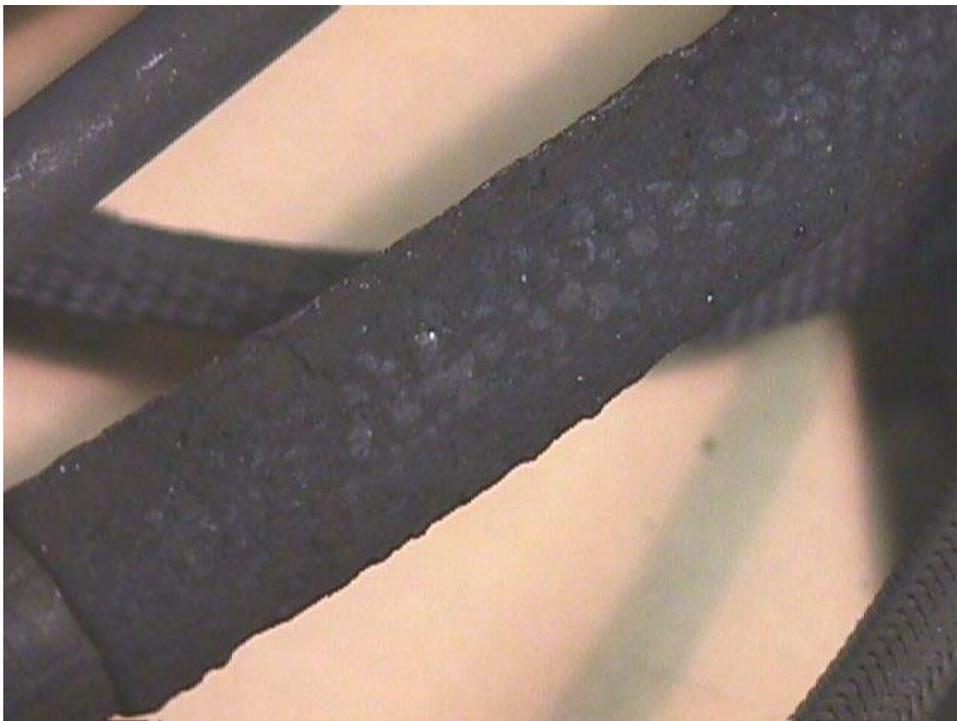
Figure 24 – Unit #1 High Pressure Hose

The high pressure hose which leads from the compressed air cylinder to the air pressure reducer has a black rubber jacket. There is cracking and charring of the jacket on the back side, however the front side maintains a normal appearance. The hose assembly turns freely at the reducer.

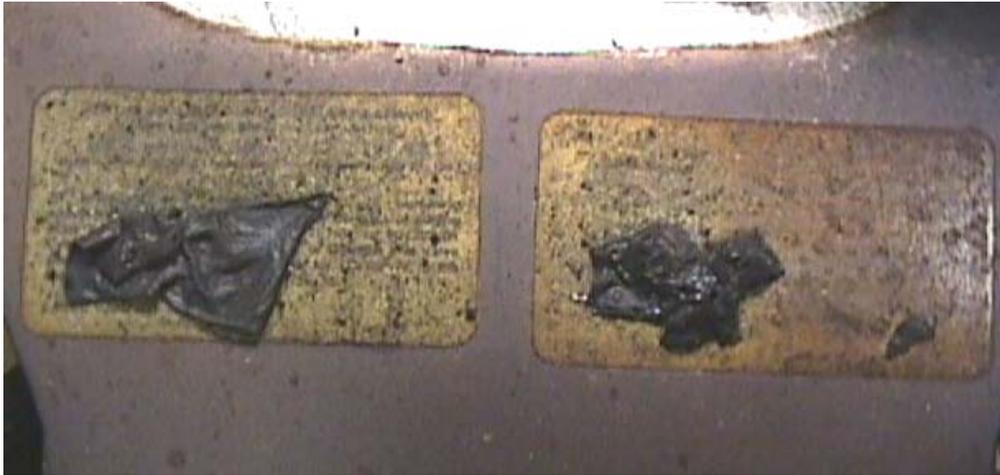
Figure 27 – Unit #1 NIOSH Approval Labels on Back Side of Backframe

which is normally present around the center hole in the backframe is no longer attached and is partially burned. Two NIOSH approval labels are affixed to the back side of the backframe; while their plastic coating layer has shriveled and charred, they remain mostly legible and bear the approval numbers **TC-13F-96** and **TC-13F-212**. Two additional NIOSH labels are present on the front of the backframe, and heat and mechanical damage have obscured the approval numbers of both.

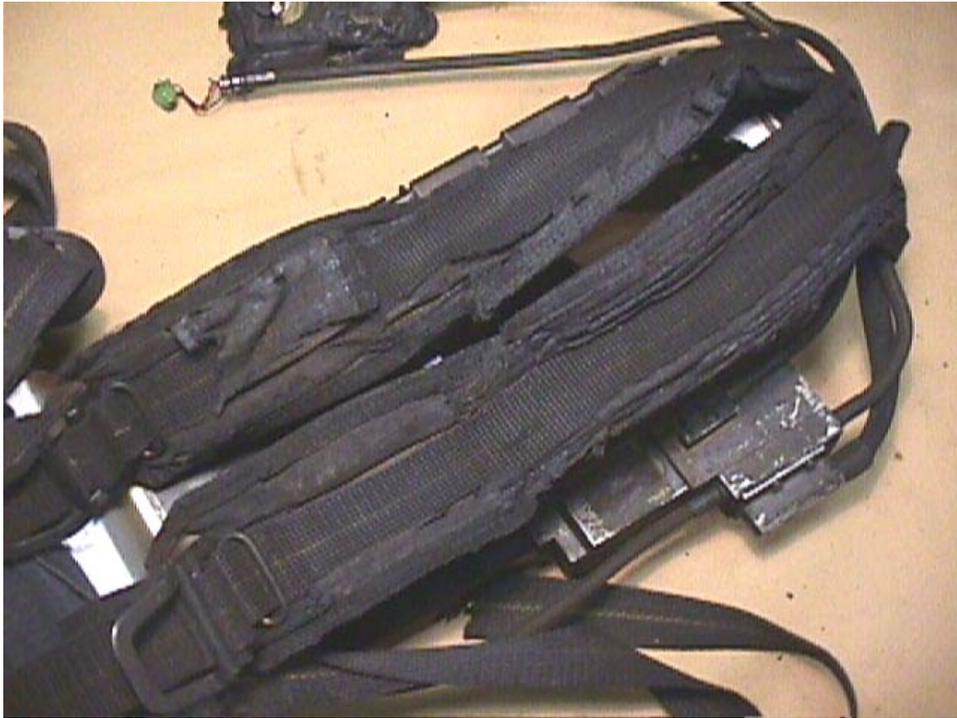
Figure 29 – Unit #1 Shoulder Straps

Both shoulder straps are securely fastened to the backframe at the top. The webbing is blackened, and the fabric components of each are severely charred and damaged. Both length adjustment straps are cut; it appears likely that this was done during rescue operations as the cut edges are not singed. Otherwise, the webbing remains intact and is securely fastened at the bottom to the backframe. Both adjustment buckles operate properly.

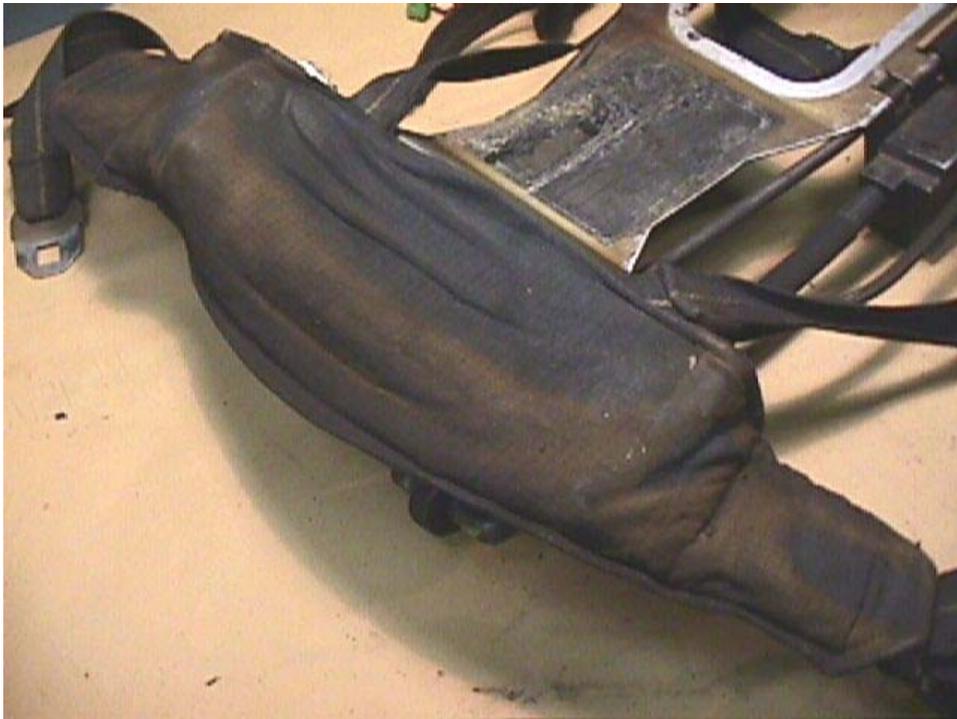
Figure 30 – Unit #1 Waistbelt

The waistbelt fabric is discolored on the side which contacts the wearer, and charred on the opposite side. The webbing portions of the waistbelt are blackened and appear to have been weakened by heat exposure although they remain intact. Attached to the left adjustment strap are a regulator storage point and the female half of the seat belt buckle. The edges of the storage point are melted. The male half of the buckle is attached to the right adjustment strap and the buckle couples and releases easily. Both length adjustment buckles operate smoothly.

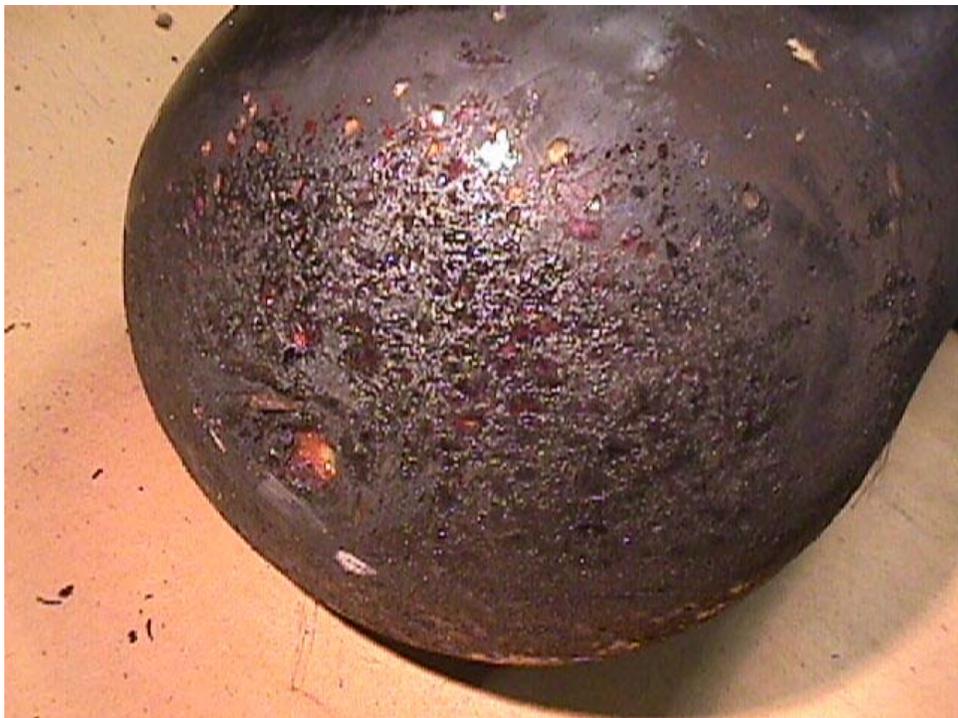
Figure 38 – Heat Damage to Unit #1 Cylinder

The cylinder is a fully-wound composite type. Almost the entire exterior surface of the cylinder is blackened. There is evidence of heat damage to the outer epoxy layer on the dome end opposite the valve, although heat has not caused the underlying fiber reinforcement to become exposed. There are, however, a number of scratches on the back sidewall of the cylinder; discussion indicates that this likely occurred during rescue operations. There are no labels visible on the cylinder exterior, although the serial number “**90153**” is stamped into the neck.

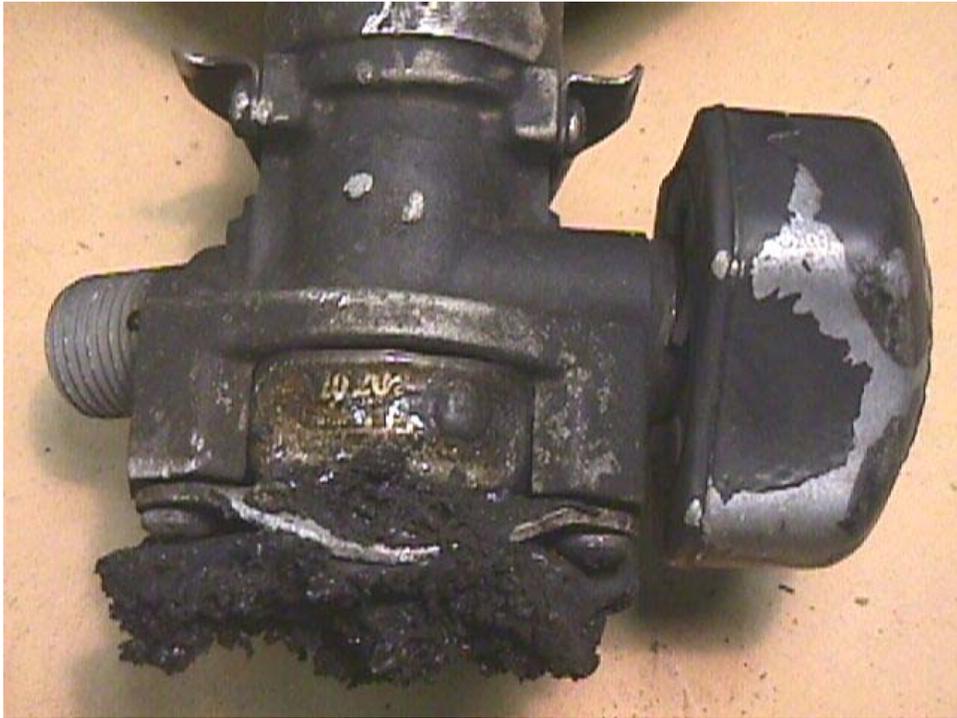
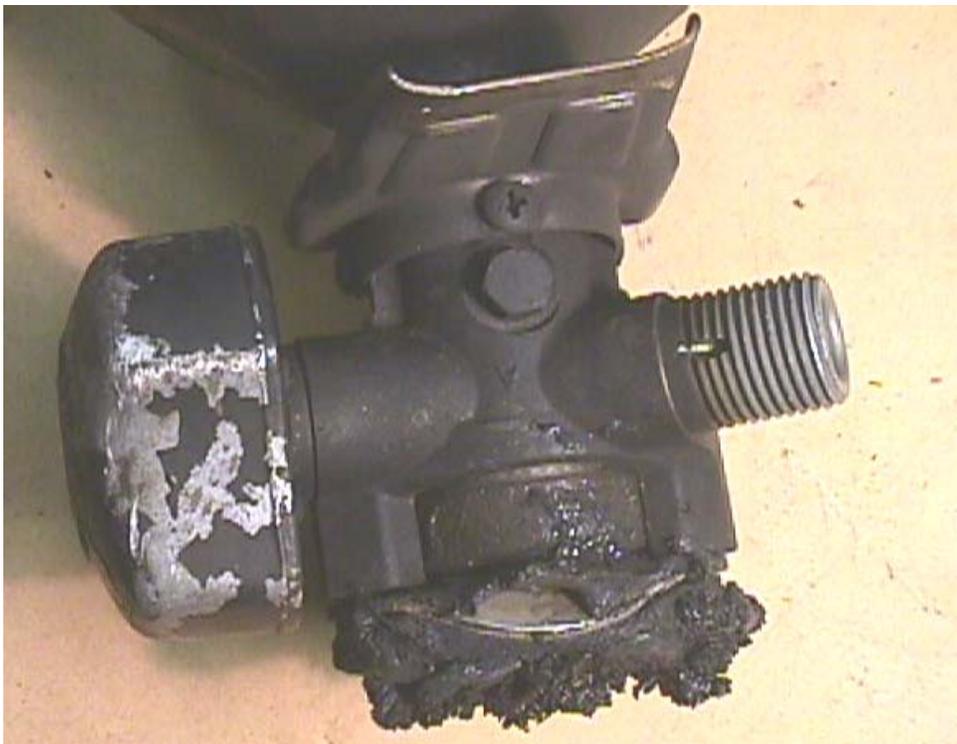
The cylinder valve outlet threads appear undamaged. The locking-type valve handwheel was found to be fully closed and it operates properly. The valve body is blackened with soot. There is no visibility through the gauge lens on the front side; on the back side it can be seen that the gauge has a range of 4500 psi, but the gauge pointer is not visible. Upon opening the valve, the cylinder was found to be empty. The rubber end bumper is severely charred. The cylinder mounting bracket is intact and securely fastened to the valve with three screws. A burst disc assembly is installed in the valve.

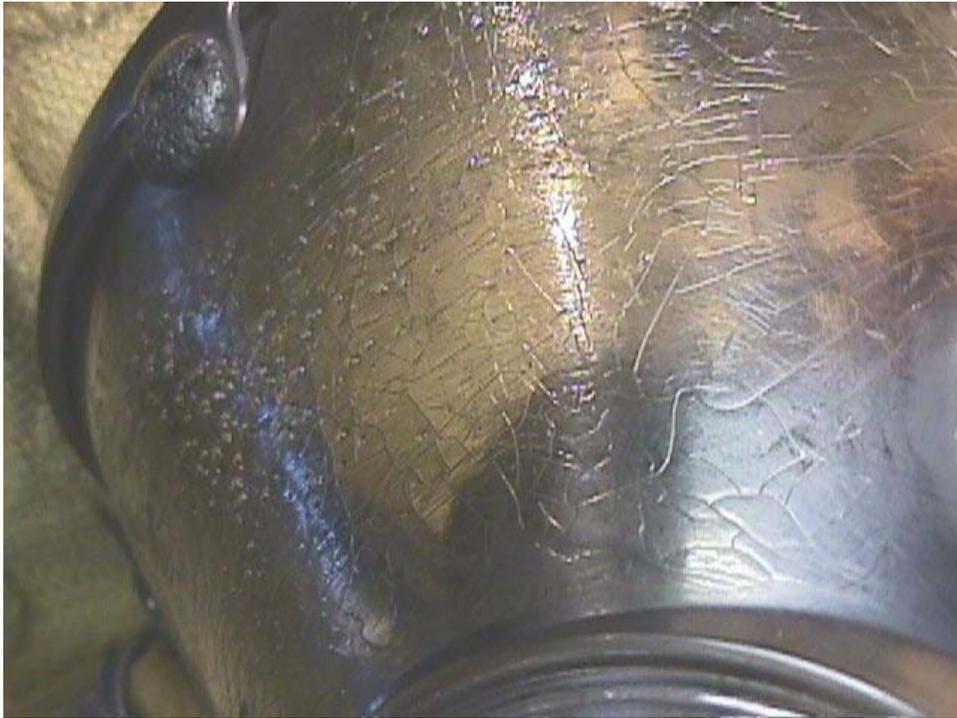
If the Unit #2 and #3 facepieces are typical of those in use at the fire academy, the damage to the coatings of the lenses is an indicator that thermal conditions beyond the equipment's designed range are reached in training scenarios there. In particular, the distortion of the Unit #2 facepiece lens shows that it has reached temperatures beyond the glass transition point.

Figure 45 – Crazeing of Unit #2 Lens Coating

If Units #2 and #3 are to be placed back in service, they should be repaired, inspected, and tested by a qualified service technician. The facepieces of both units should be repaired or replaced, and the bell alarm of Unit #2 adjusted to within the proper activation range.

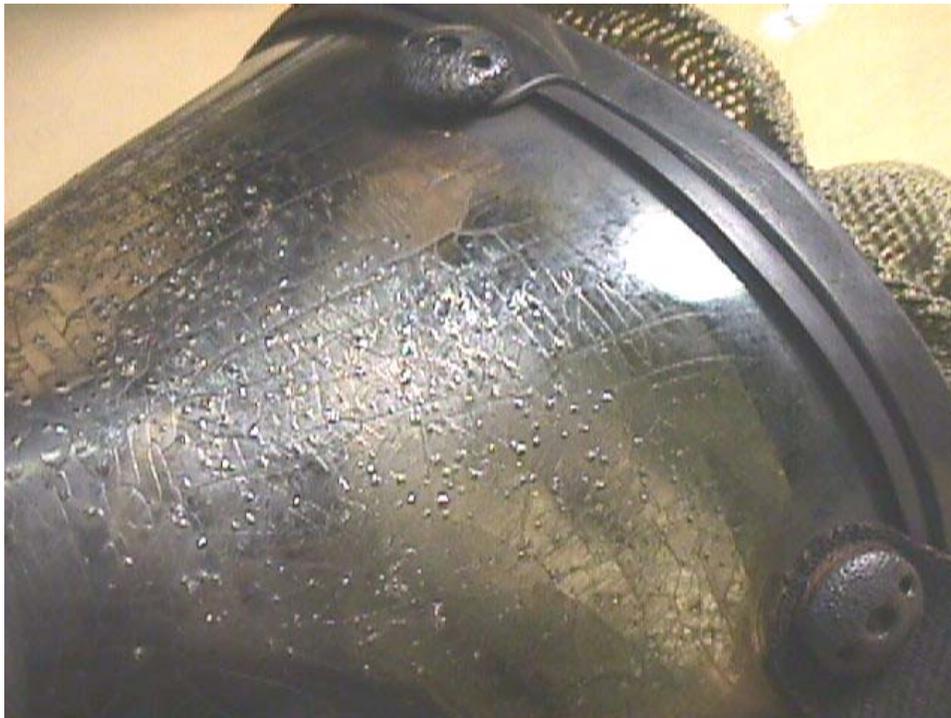
Figure 49 – Craziing of Unit #3 Lens Coating

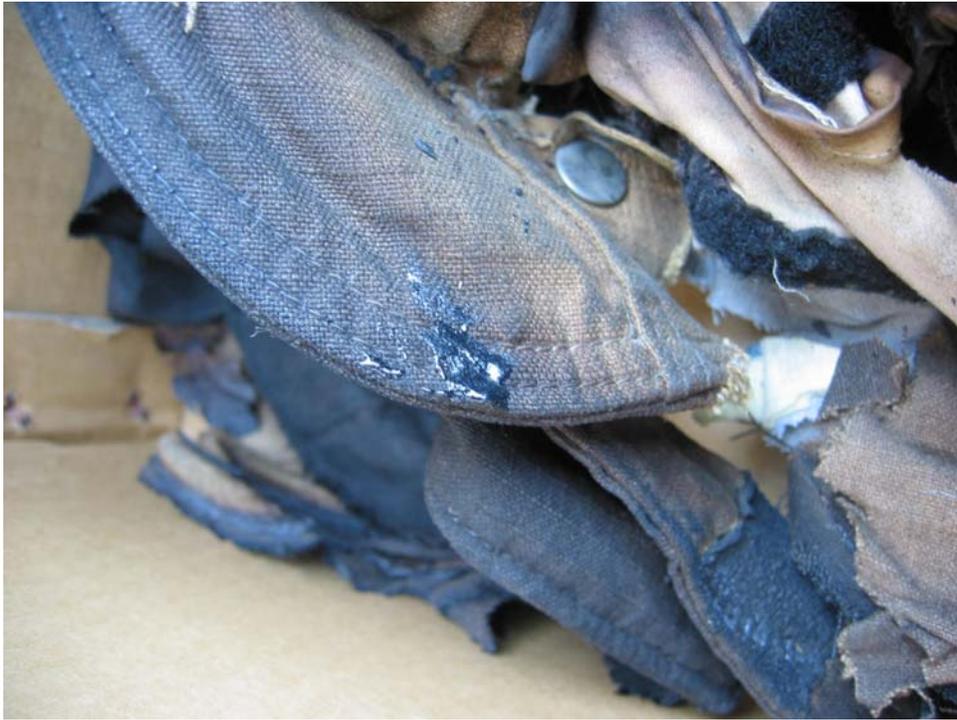
Figure 61 – Plastic Adhered to Collar of Turnout Coat

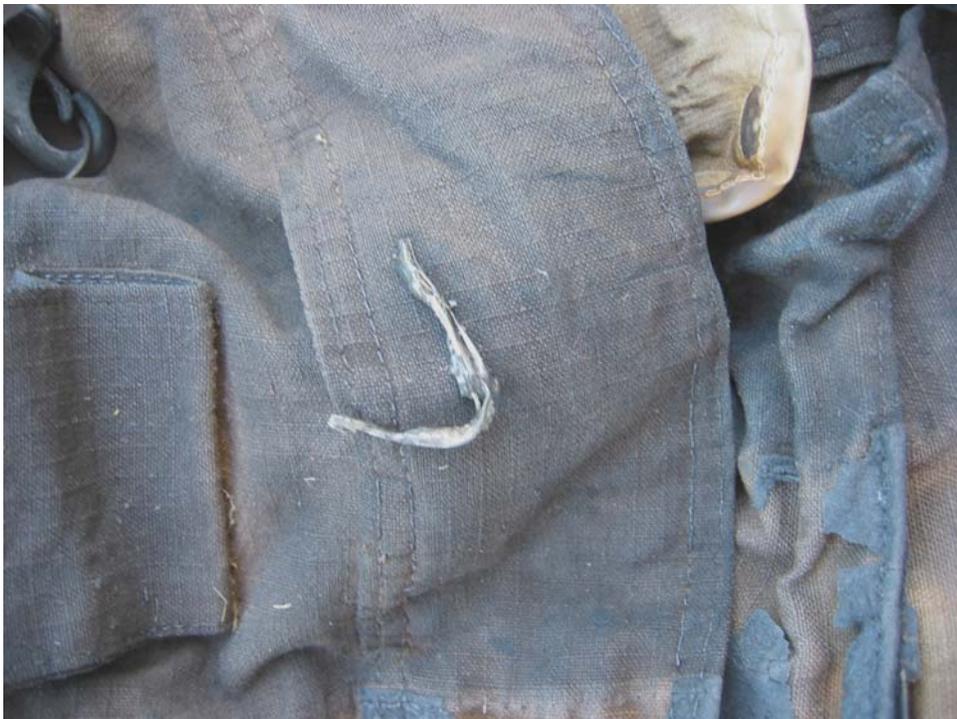
Figure 67 – Plastic Adhered to Front of Turnout Coat

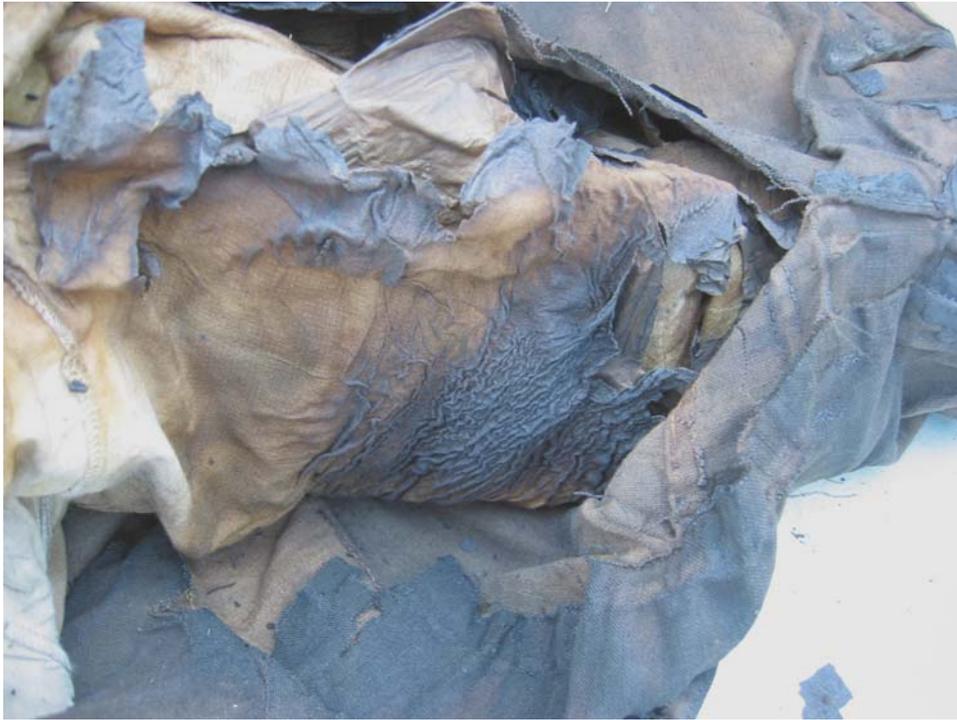
Figure 69 – Damage to Moisture Barrier of Turnout Coat
