Volunteer Fire Fighter Dies and Junior Fire Fighter Is Injured After Tanker Rollover During Water Shuttle Training Exercise - Kentucky

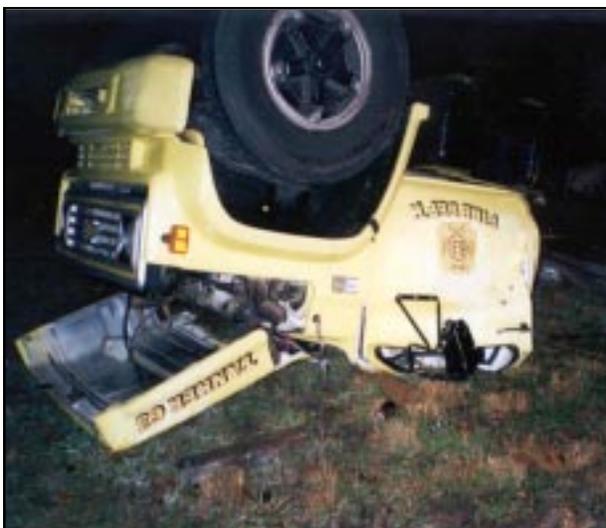
Cab area of tanker

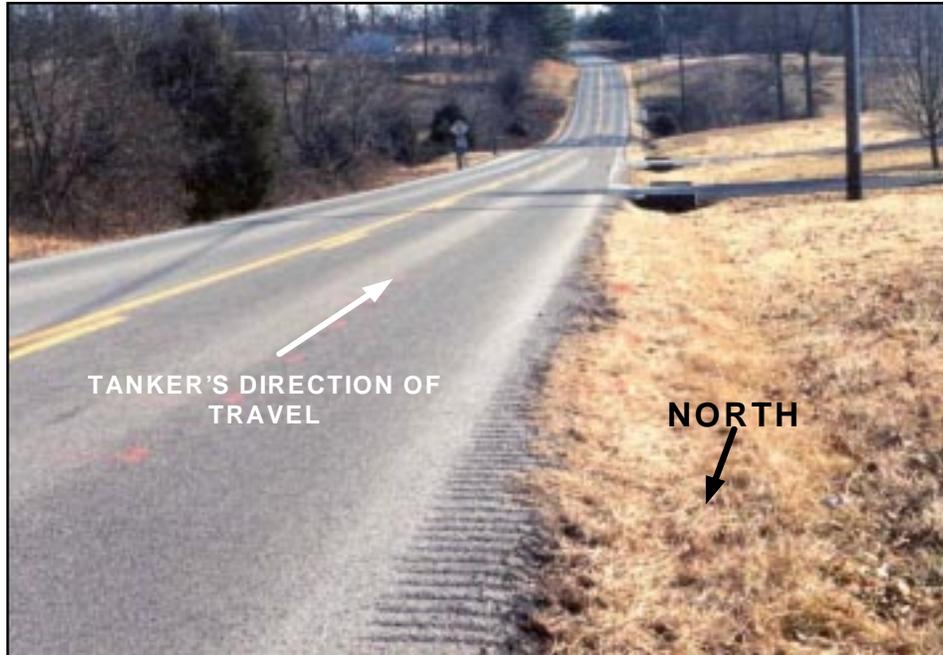
Discussion: Fire departments should ensure drivers of fire service vehicles are familiar with the potential hazards/conditions that exist on the roadways (e.g., insufficient shoulder) on which they may be traveling. In this incident, the speed of the tanker truck when it left the roadway was estimated to be under the posted 55 mph speed limit; however, for unknown reasons the tanker truck drifted off the roadway. Potential motor vehicle hazards that existed on the route of the incident included (1) no shoulders on the roadway in the area of the incident, (2) heavy fog in the area of the incident, (3) sloping embankments on the east and westbound lanes and, (4) soft and broken asphalt along the pavement edge.

Photo 1. Eastbound view of the road where the tanker veered off

Recommendation #1: Fire departments should ensure all drivers of fire department vehicles are responsible for the safe and prudent operation of the vehicles under all conditions.^{1,2}

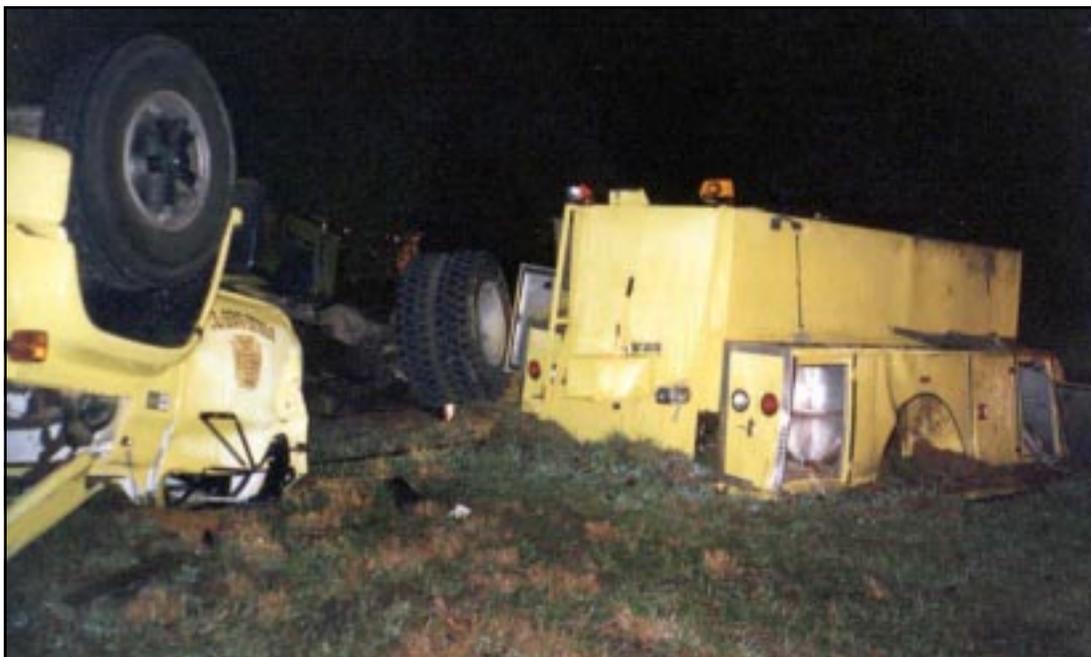
Photo 2. Incident scene

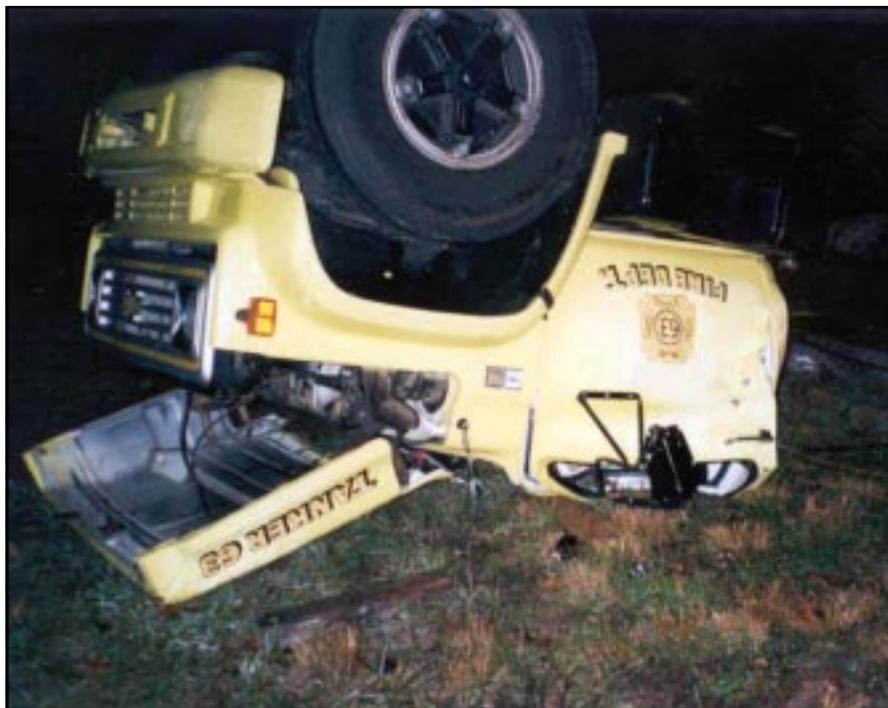
Photo 3. Cab area of tanker

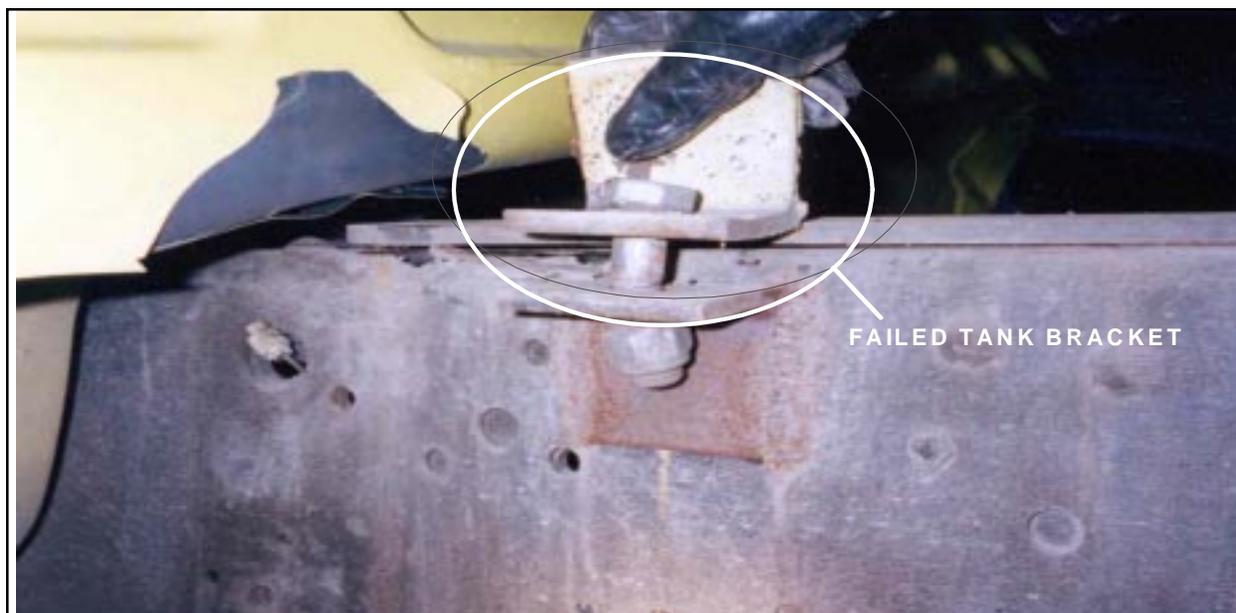
1. The driver's side front connection failed along the vertical fillet welds between the tank bracket and tank frame (see Photos 4 & 5). Examination of the mount location on the tank frame and photographs taken after the incident indicate that the fillet welds lacked penetration into the parent metal, with failure occurring along the interface between the bracket parent metal and the weld.

Photo 4. Driver's side front tank mount; tank bracket failed along fillet weld to tank frame

Recommendation #3: Fire Departments and apparatus constructors should ensure that second unit body mounting systems are of substantial design and construction.

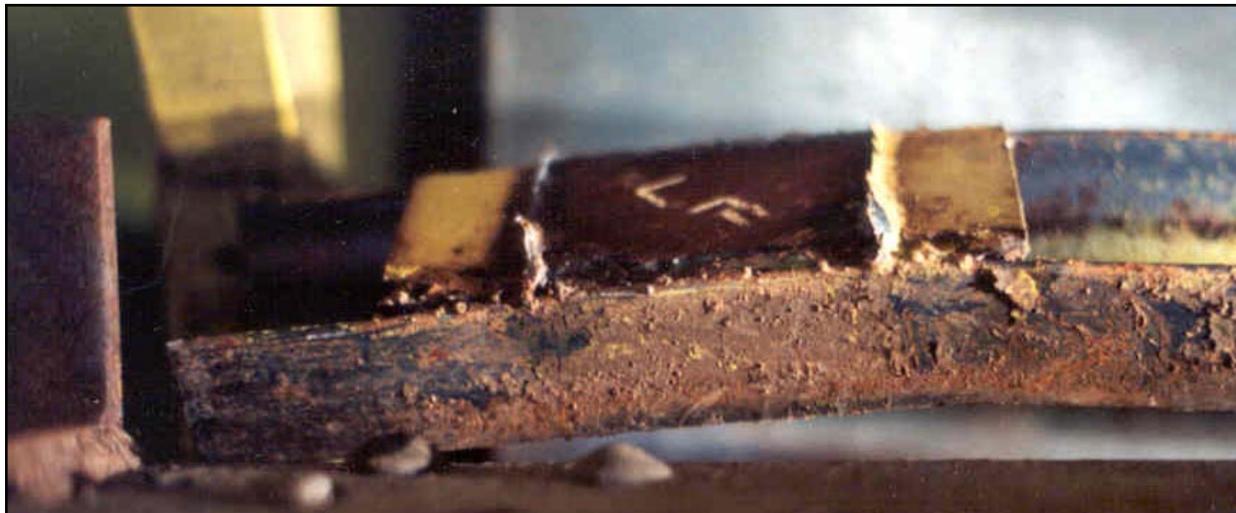
Photo 5. Tank frame at bracket location; weld material remains on tank frame

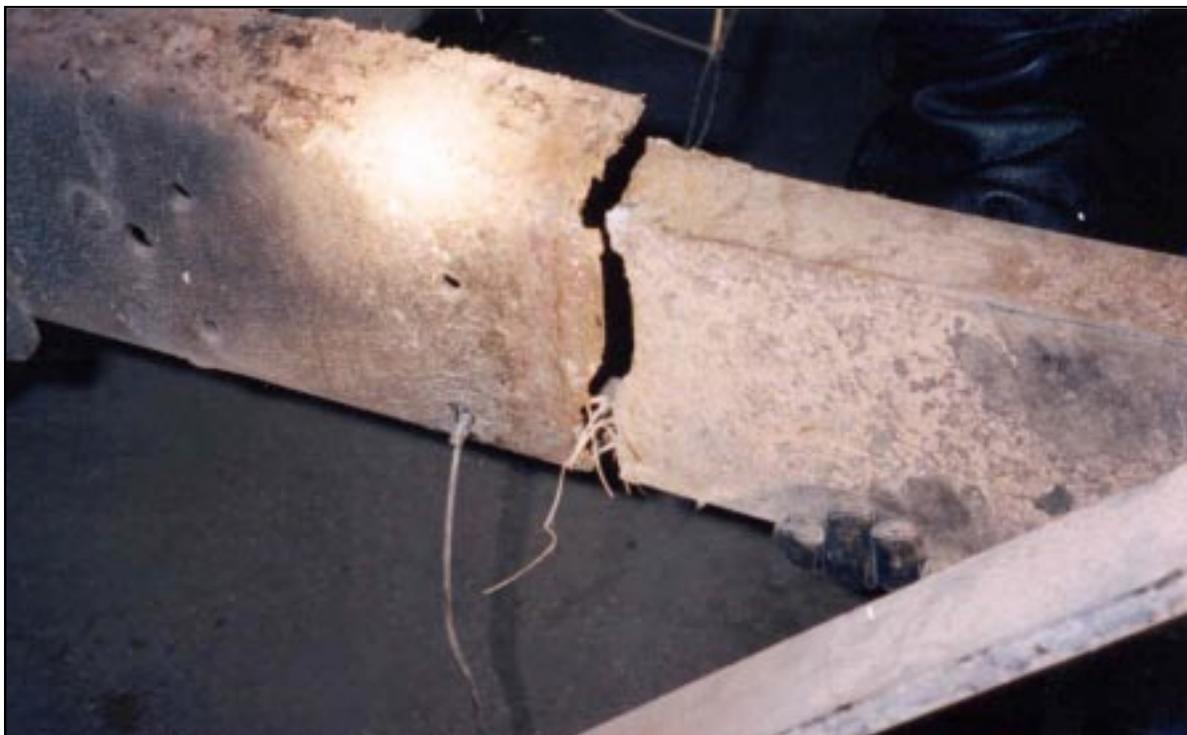
2. The welded joint between the driver's side chassis extension and the frame rail failed at the weld/parent metal interface. Examination of photographs (see Photos 6 & 7) indicate that the weld was not continuous along the seam and lacked penetration into the parent metal. Depending upon the material used in manufacture of the chassis, some truck manufacturers recommend the use of overlays bolted and welded to the frame rails for splice reinforcement, or prohibit the use of welding during frame modifications.

Photo 6. Driver's side frame rail extension

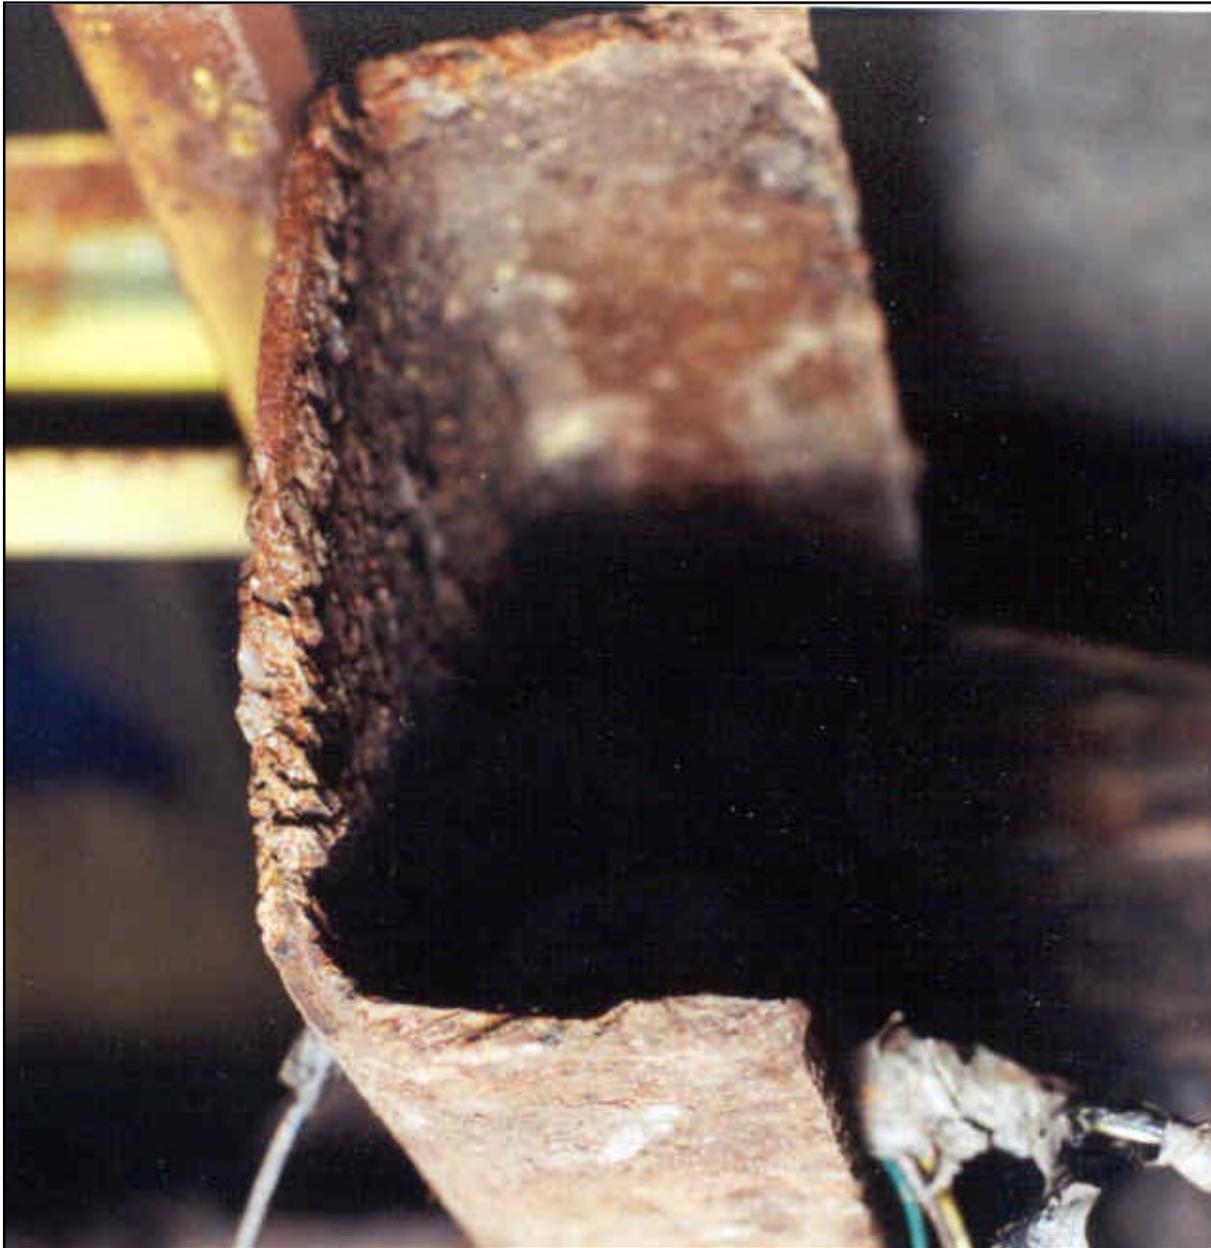
Photo 7. Driver's side frame rail extension

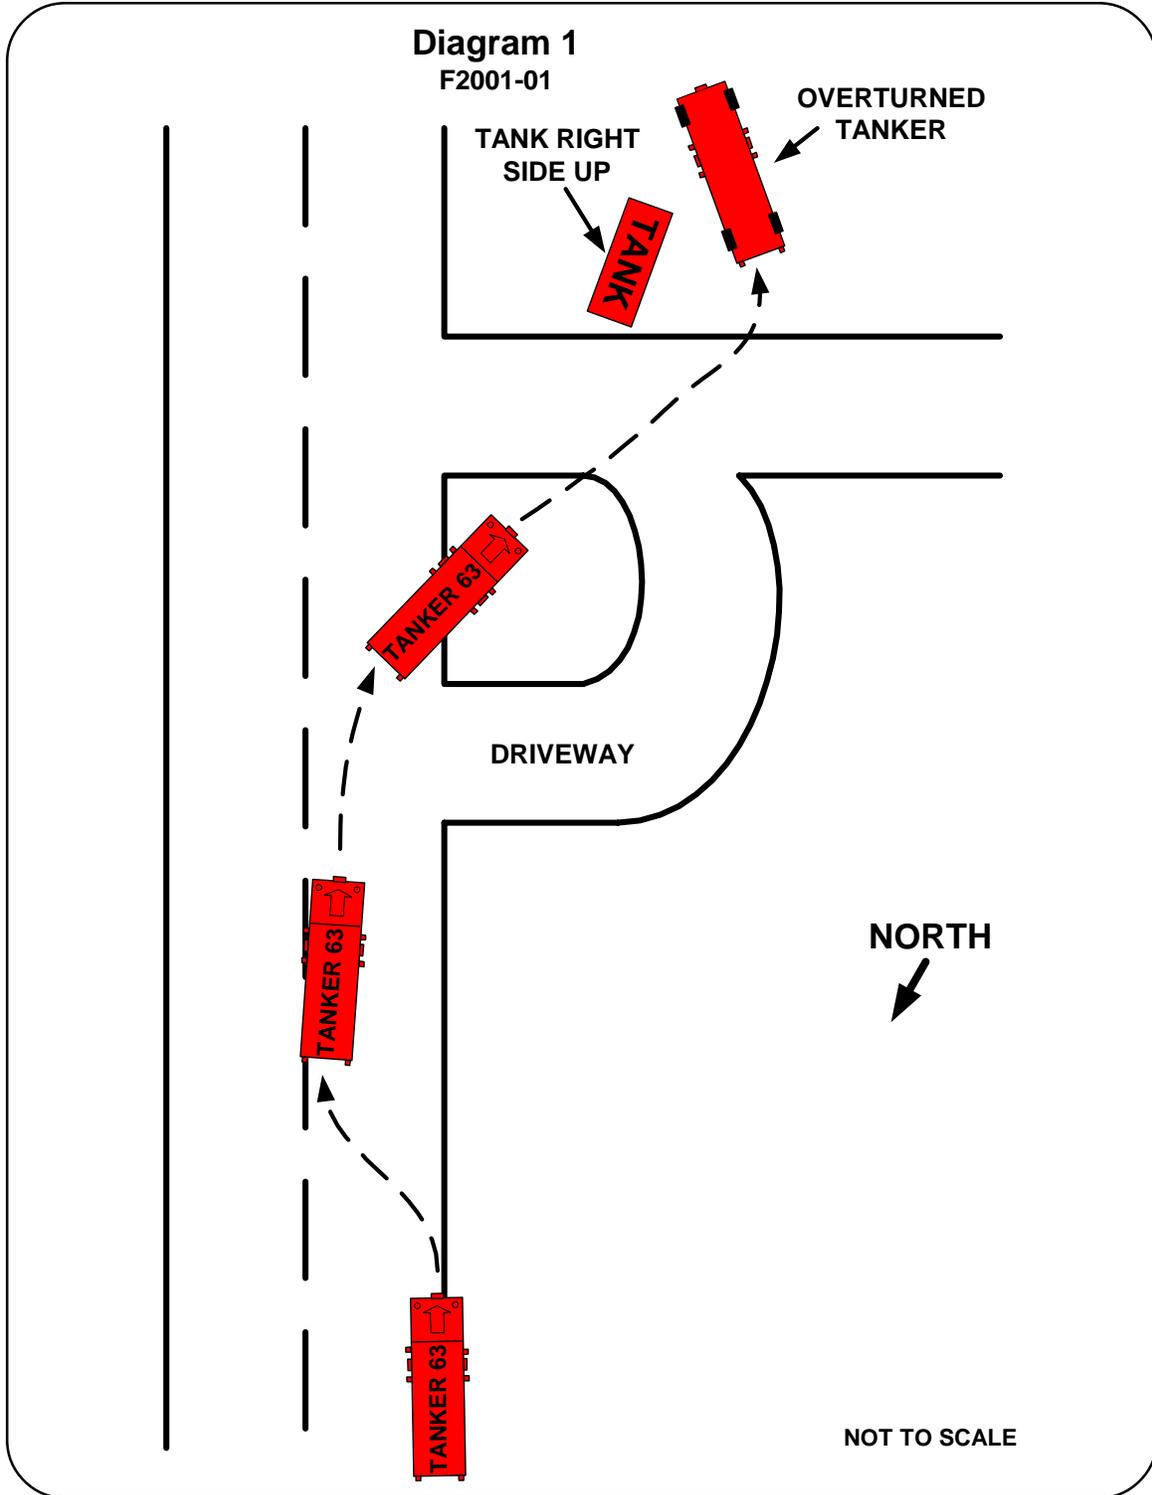
Diagram of incident

the tanker veered off the eastbound (right) lane and traveled down a slight embankment and through a ditch line (see Diagram). According to the County Sheriff investigators, at some point during the incident, the water tank began to separate from the chassis, and it is believed that as the truck entered the ditch line the tank became airborne, struck the east edge of the driveway, and began a flat rotation of 180 degrees. The driver side front tire was turned to the right and dug into the west edge of the driveway, causing the truck to pitch forward and become airborne. The junior fire fighter was ejected, and it is believed that he exited the truck through the windshield as the truck crossed the driveway. *Note: The junior fire fighter was wearing a turnout coat, jeans and work boots. The tanker was equipped with a shoulder and lap seat belt safety restraint system for the driver and passenger positions. The highway patrol's report indicated that the victim and junior fire fighter were not wearing their seat belt safety restraint systems at the time of the incident.* The truck remained airborne until coming to rest upside down facing east while the tank came to rest in an upright position facing west. Both the tank and truck came to rest in the yard east of the driveway. Tanker 61 arrived at the fill site when Engine 62, with a fire fighter driving, was leaving en route to the fire station. After traveling approximately 1 mile from the fill site, Engine 62 came upon the incident scene (see Photo 2). The fire fighter from Tanker 62 radioed the Chief and reported that Tanker 63 had gone off the road and overturned. At 2008 hours, the Chief radioed to Central Dispatch to report the incident and request assistance while he responded from the fill site in Tanker 61 with a Captain driving. Central dispatched an ambulance to respond at 2008 hours. The fire fighter from Engine 62 observed the junior fire fighter lying face down approximately 15 feet from the cab of Tanker 63,
