## Career Fire Fighter Dies From Injuries Sustained In Fall From Apparatus - Massachusetts

## Fatality Assessment and Control Evaluation Investigative Report #F2004-19

### *Career Fire Fighter Dies From Injuries Sustained In Fall From Apparatus - Massachusetts*

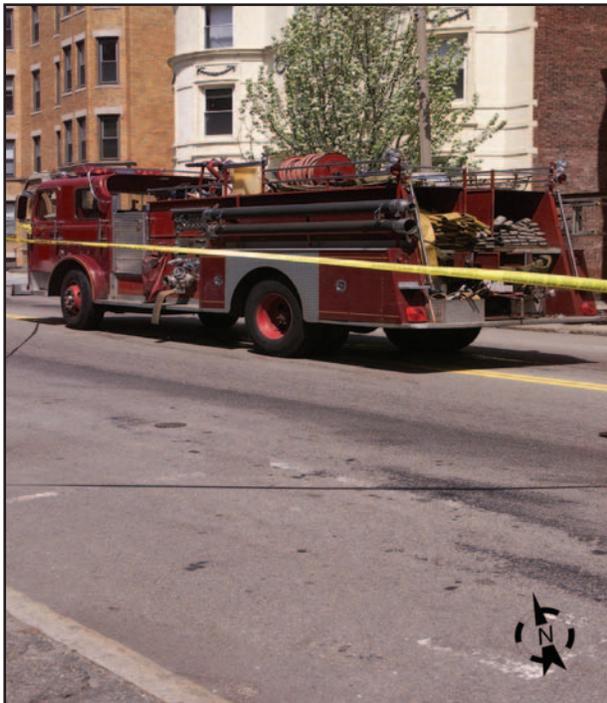
*Incident scene*

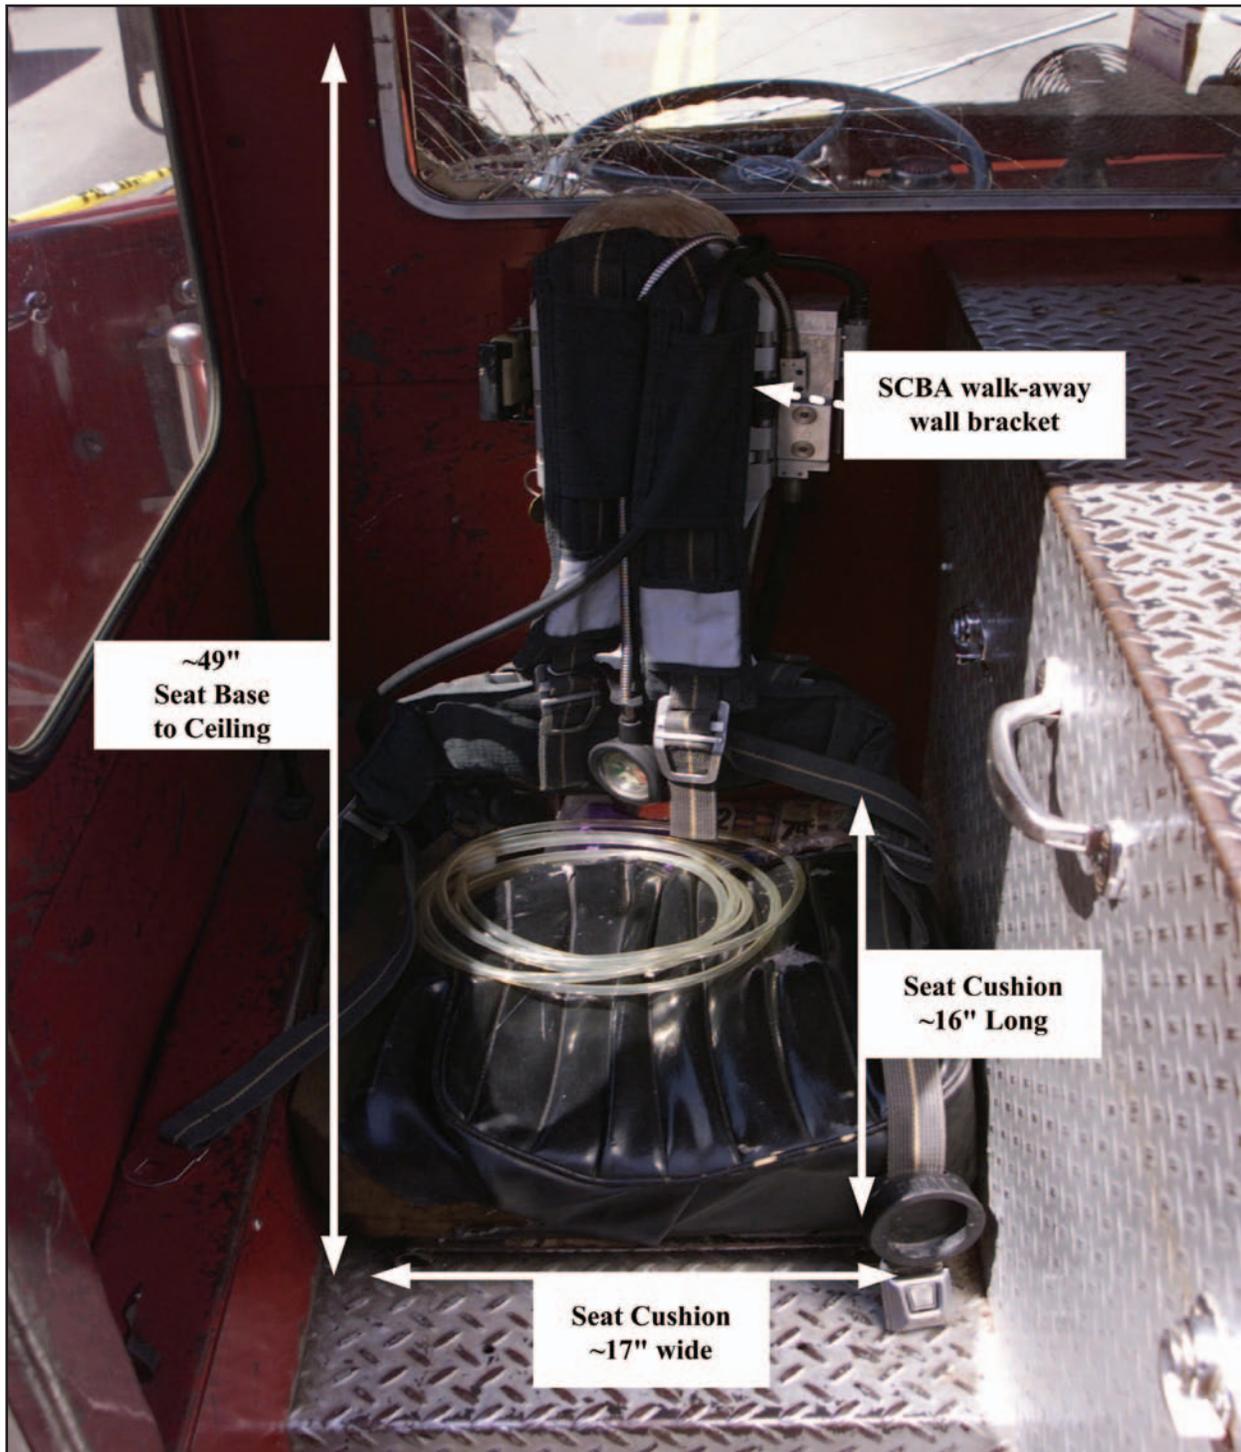
*Photo 1. Victim's seating position*

Equipment The victim was riding in a 1976 cab-forward engine that was being used as a reserve unit while the assigned engine was in the shop for maintenance. The fire department purchased the engine new in 1976 and had safety bars installed in the open jump seat area. In 2001, the safety bars were replaced with half-style doors that were equipped with a slam-lock system. The door locking system included an inside vertical and thumb-rotary locking/unlocking feature. The seatbelt was a lap-only type. A self-contained breathing apparatus (SCBA) walk-away wall bracket<sup>a</sup> was installed behind the victim's seat (Photo 1).

During the police investigation immediately following the incident, the victim’s seat belt was found wedged under the seat cushion, indicating that the belt was not being worn.

Maintenance checks should include an inspection of all seat belts and safety restraints to ensure they are securely mounted and operate freely. Webbing must not be cut or frayed and buckles must open and close properly. The location of the seat belts or safety restraints should confirm that they are positioned to be worn. A check of the apparatus following the incident found the victim’s seat belt lodged beneath the bottom seat cushion.<sup>1,5</sup>

***Recommendation #2: Fire departments should ensure that routine apparatus maintenance includes documented inspections of all seating areas.***

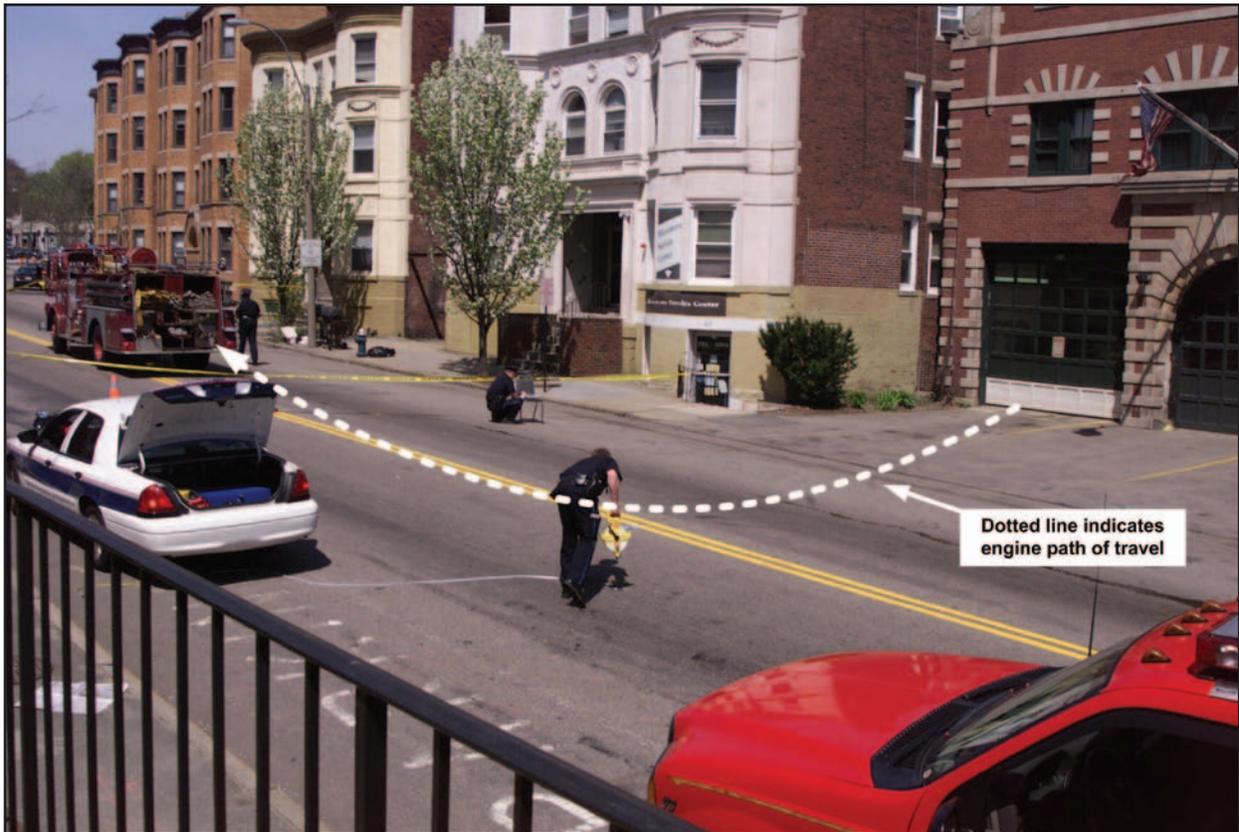
*Photo 2. Engine path of travel*

Weather / Road Conditions The incident occurred on a city street that runs directly in front of the fire station (Photo 2). The road surface is made of asphalt and is well traveled. There were no defects to the road surface that would hinder the performance of the roadway or interfere with the operation of the engine.

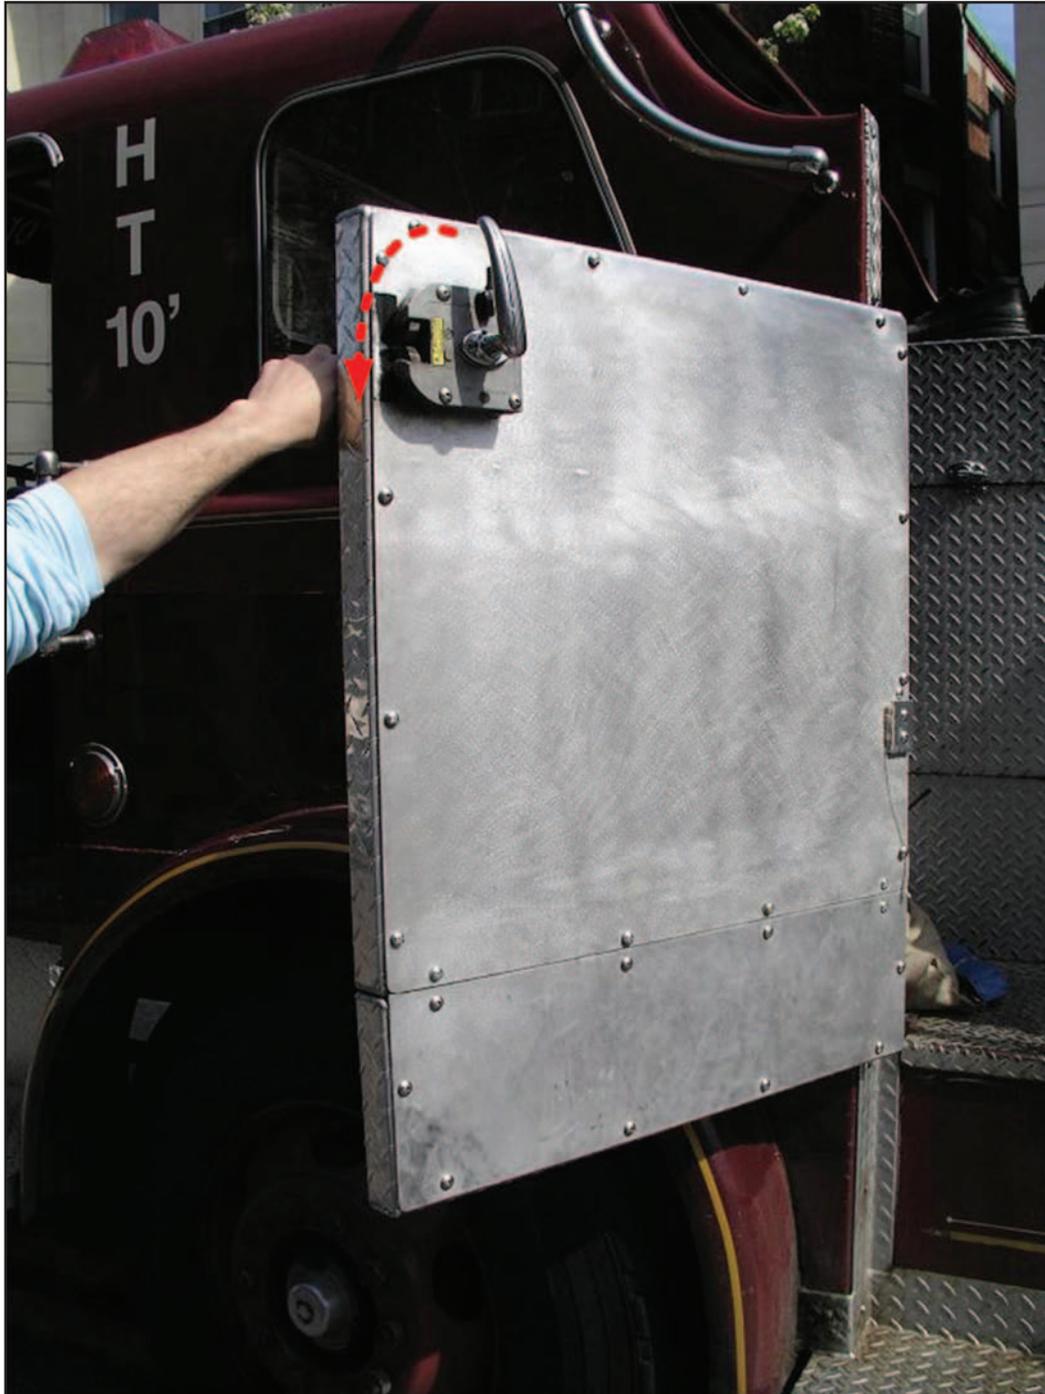
*Photo 3. Depiction of door handle operation*

The engine involved in this incident was a 1976 cab-forward model and was used as a spare during maintenance operations of assigned apparatus. At the time of the incident, the engine had been retrofitted with a half-door that was equipped with a slam-lock system. The door locking mechanism included an inside vertical and thumb-rotary locking/unlocking feature. Police determined that the door locking mechanisms were operational at the time of their investigation. When police officers closed and locked the door, the handle would not move under normal pressure and the door would not open. This indicated that the lock may not have been engaged at the time of the incident.

When at rest, the interior handle on the driver side jump seat door faces upward in a vertical position (Photo 3). Immediately following the incident, a police officer attempted to open the locked door by turning the handle and pushing his body forcefully against the door several times. These actions did not cause the door to open. The door could be opened only when it was unlocked and the handle was moved in a counterclockwise direction. These actions indicate that the door was not locked at the time of the incident.

**Recommendation #4:** *Fire departments should ensure that all interior crew and driving compartment door handles are designed and installed to protect against inadvertent opening.*

A recessed door handle, or one that is positioned to require intentional effort or deliberate motion to activate, would provide an extra safety measure that may prevent inadvertent opening.
