## ***Volunteer Fire Fighter Dies in Tanker Rollover Crash – Texas***

### **SUMMARY**

Fatality Assessment and Control Evaluation  
Investigation Report # F2006-06

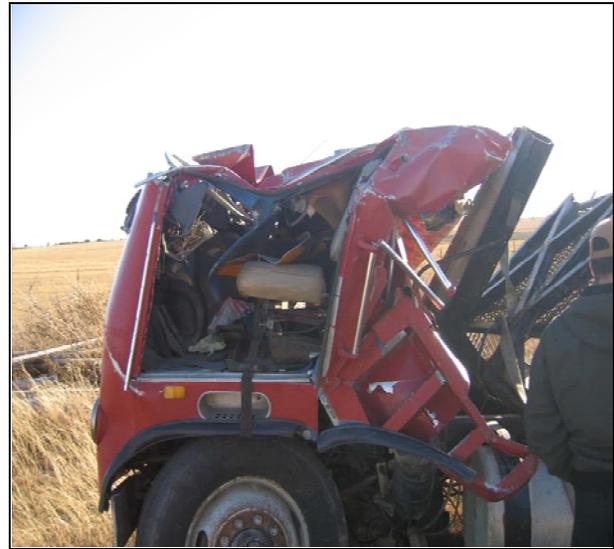
On November 22, 2005, a 28-year-old male volunteer fire fighter (the victim) died while responding to a mutual-aid call for a major grass fire. The victim was driving the department's tractor trailer (tanker) on a two-lane state highway. The tanker went off the road, overturned, and came to rest in a field. The victim was ejected and found lying unresponsive on the roadway. He was pronounced dead at the scene by the Justice of the Peace.

- ***ensure that water tankers are operated within safe weight restrictions that comply with the specific vehicle characteristics***
- ***ensure that all fire apparatus meet the requirements of NFPA 1901 Standard for Automotive Fire Apparatus***
- ***ensure that drivers of fire department vehicles receive training at least twice a year on each vehicle that they may be called upon to operate***
- ***develop and enforce standard operating procedures (SOPs) that require mandatory use of seat belts in all vehicles***

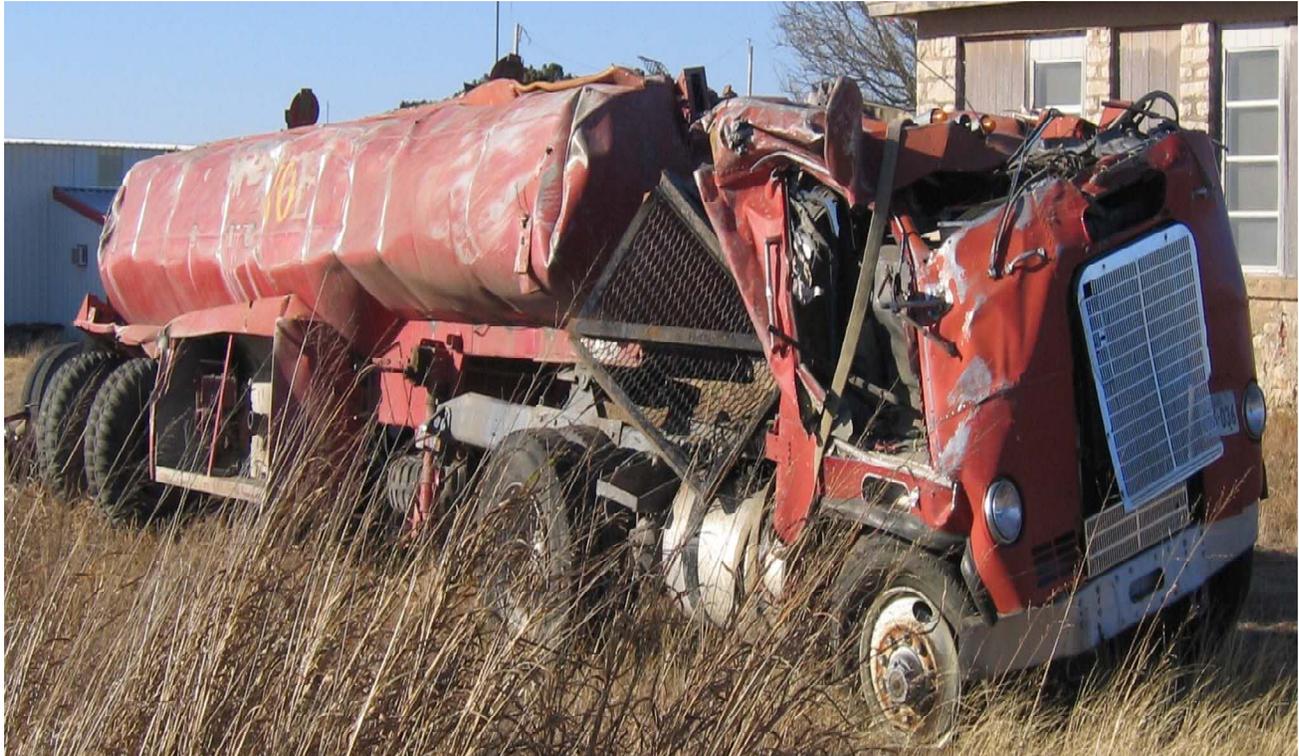
**Photo 1**  
**F2006-06 TX**  
**Apparatus Involved in Incident**

The vehicle involved in this incident was a tractor trailer tanker (Photo 1). The tractor was a 1979 cab-over-engine model. The military surplus trailer (tanker) was built in 1968 and had originally been used by the military to transport fuel.

The tractor had a gross vehicle weight rating (GVWR) of 15,500 pounds and was equipped with an air brake system. The tractor was equipped with seat belts but both the driver and passenger seat belt anchors were broken according to the state police report. According to witness statements, a line splice had been installed on the rear brakes of the tractor drive axle a week before the incident occurred. The rear axle was separated from the frame during the incident.

The military surplus trailer (tanker) had a GVWR of 35,250 lbs. It was equipped with an air-over-hydraulic brake system. According to witness statements, the air canister on the trailer was replaced approximately one month before the incident. The surplus military fuel trailer (tanker) contained two 2,500 gallon compartments that were divided by a longitudinal bulkhead. To facilitate water discharge and movement, the department cut holes in the bulkhead. The tanker was owned by the U.S. Department of Agriculture, Forest Service and had been acquired by the department through the Texas Forest Service Federal Excess Personal Property (FEPP) program.<sup>2</sup>

The 5,000 gallon capacity tank involved in this incident contained two 2,500 gallon compartments that were divided by a longitudinal bulkhead. The fire department cut holes in the bulkhead to facilitate water discharge and movement, but there was no evidence of a baffle system that would assist in controlling side-to-side water surges.

***Recommendation #1: Fire departments should ensure that water tankers are operated within safe weight restrictions that comply with the specific vehicle characteristics.***

***Recommendation #2: Fire departments should ensure that all fire apparatus meet the requirements of NFPA 1901 Standard for Automotive Fire Apparatus.***

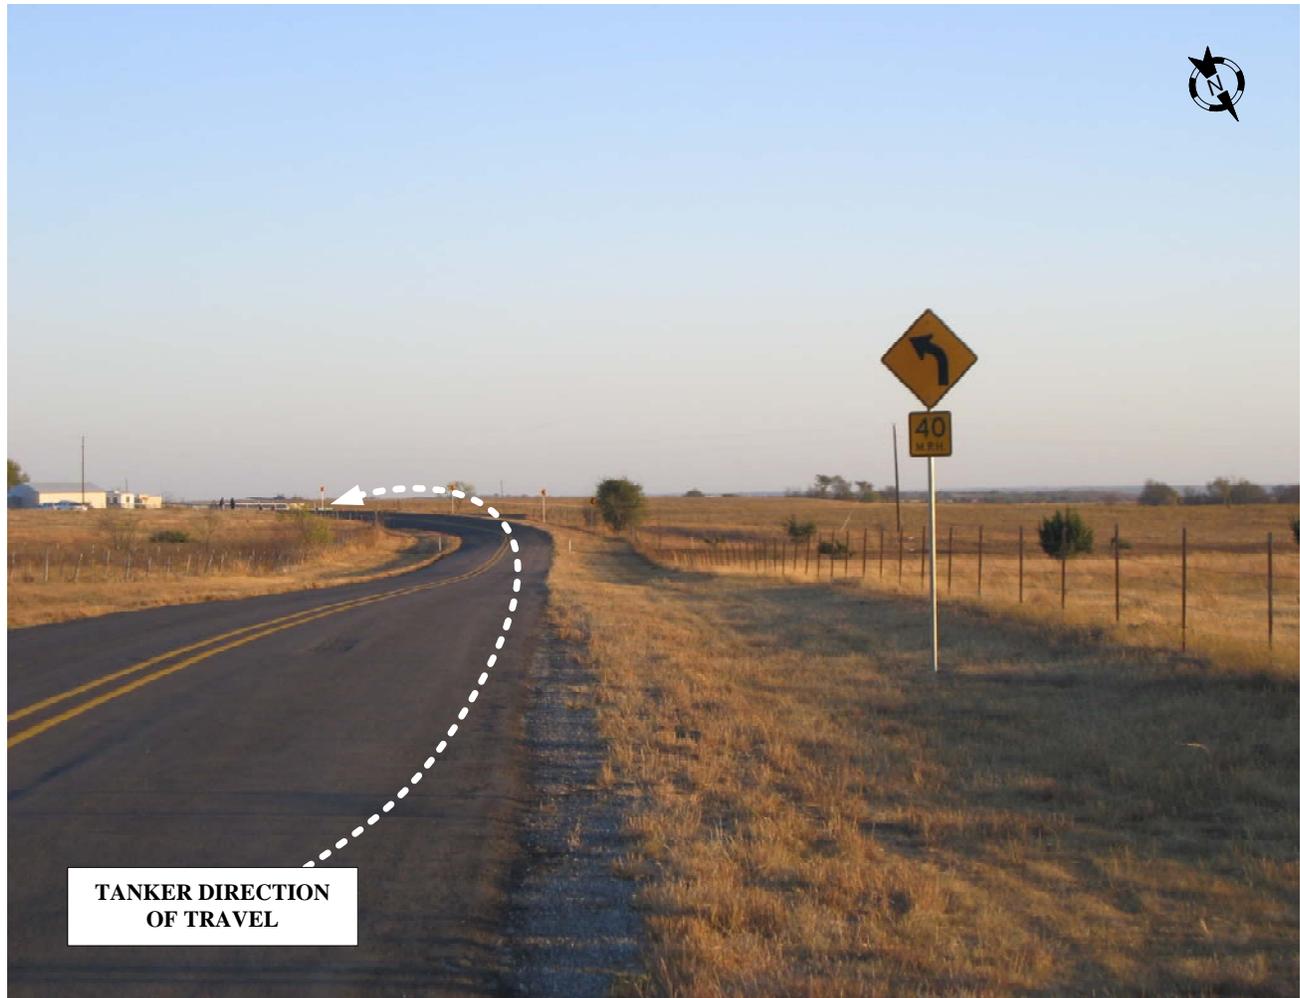
**Photo 2**  
**F2006-06 TX**  
**Roadway Approaching Bend Where Incident Occurred**

The incident occurred on a clear day with no precipitation present in the area. The road surface was comprised of asphalt pavement. There was a grassy shoulder that extended into a fairly steep ditch in the area where the apparatus left the roadway and there were no guard/guide rails. The speed limit was 55 miles-per-hour (mph) with a caution speed of 40 mph posted approximately one fourth mile prior to the curve where the incident occurred.

The route to the fire was a two-lane state road with a posted speed limit of 55 mph. The roadway had several moderately sharp turns which the victim had negotiated successfully prior to the crash. The road was straight with a slight grade that descended into a sharp turn to the left where the incident occurred (Photo 2). Although there were no witnesses to the crash, it is believed that as the victim approached the curve, for reasons unknown, he ran off of the road and while attempting to steer the tanker back onto the roadway lost control of the vehicle. The tractor trailer tanker rolled to a stop in a field approximately 30 feet from the edge of the roadway (Photo 3). The tractor rolled one time

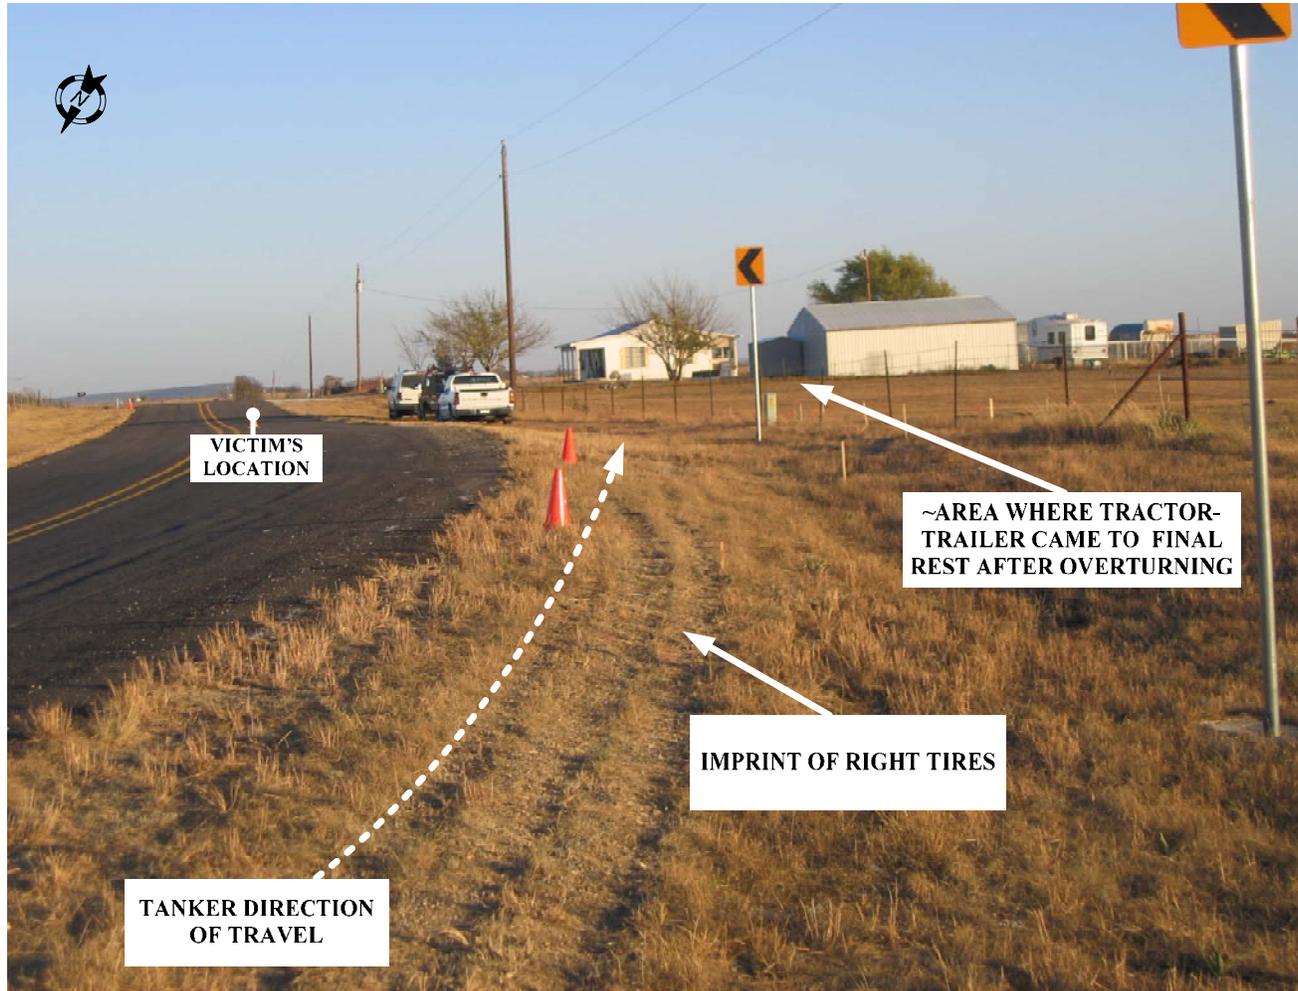
**Photo 3**  
**F2006-06 TX**  
**Location Where Incident Occurred**

landing on its wheels and the trailer came to rest on the driver's side. Several tire/axle assemblies were separated from the tractor trailer by the force of the rollover.
