## **Career Lieutenant Dies in Residential Structure Fire - Colorado**

## Fatality Assessment and Control Evaluation Investigation Report # F2006-19

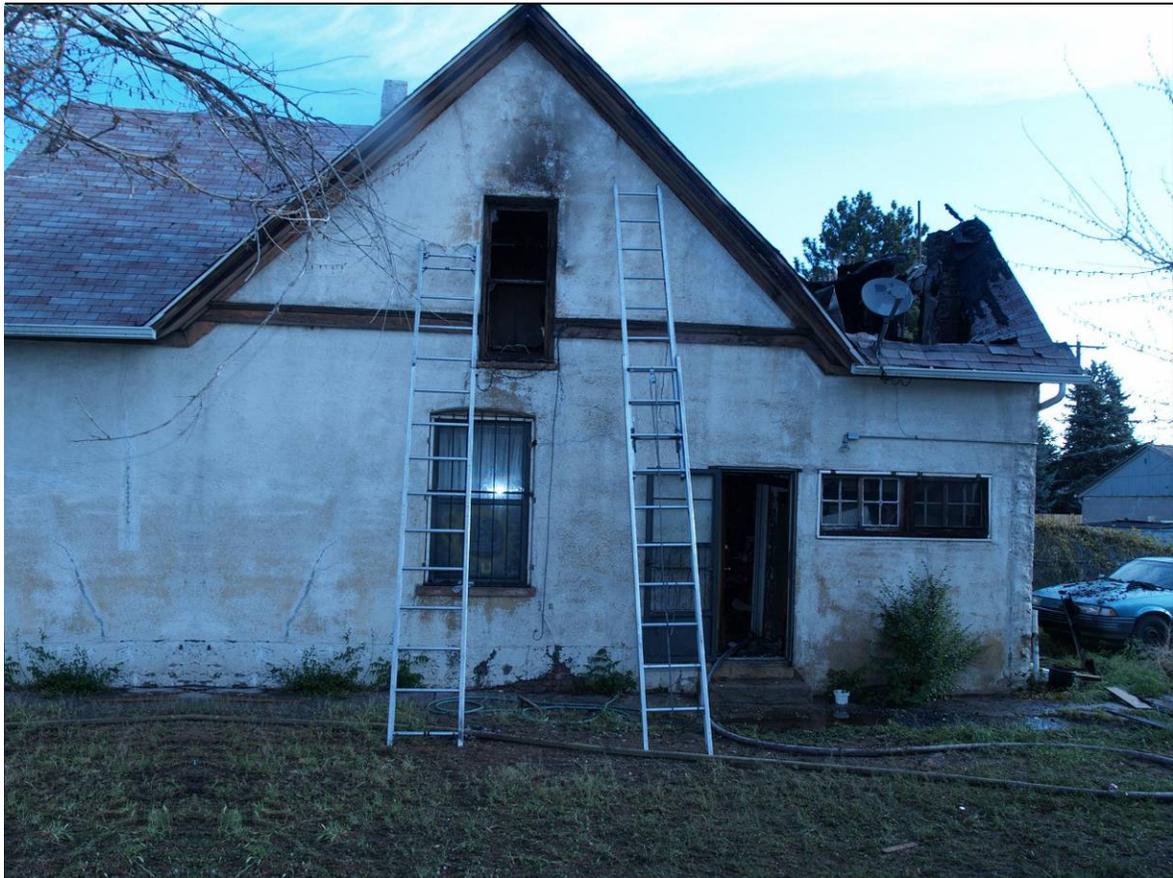
The building was a two-story, non-sprinklered residential structure that was constructed of wood framing with an exterior stucco finish. The roof consisted of wood rafters with asphalt shingles over wood boards (see [Photo1](#)). Also, this photo shows the D-side door the victim entered. The window

above is in the room the victim was found and the burnt away roof was over the bedroom where the fire originated.

Photo 1. D-side of the structure where the victim entered. The second floor window is the room where the victim was found.
