Death in the line of duty...

A summary of a NIOSH fire fighter fatality investigation

Career Fire Fighter Dies in Wind Driven Residential Structure Fire – Virginia

Fatality Assessment and Control Evaluation Investigation Report # F2007-12

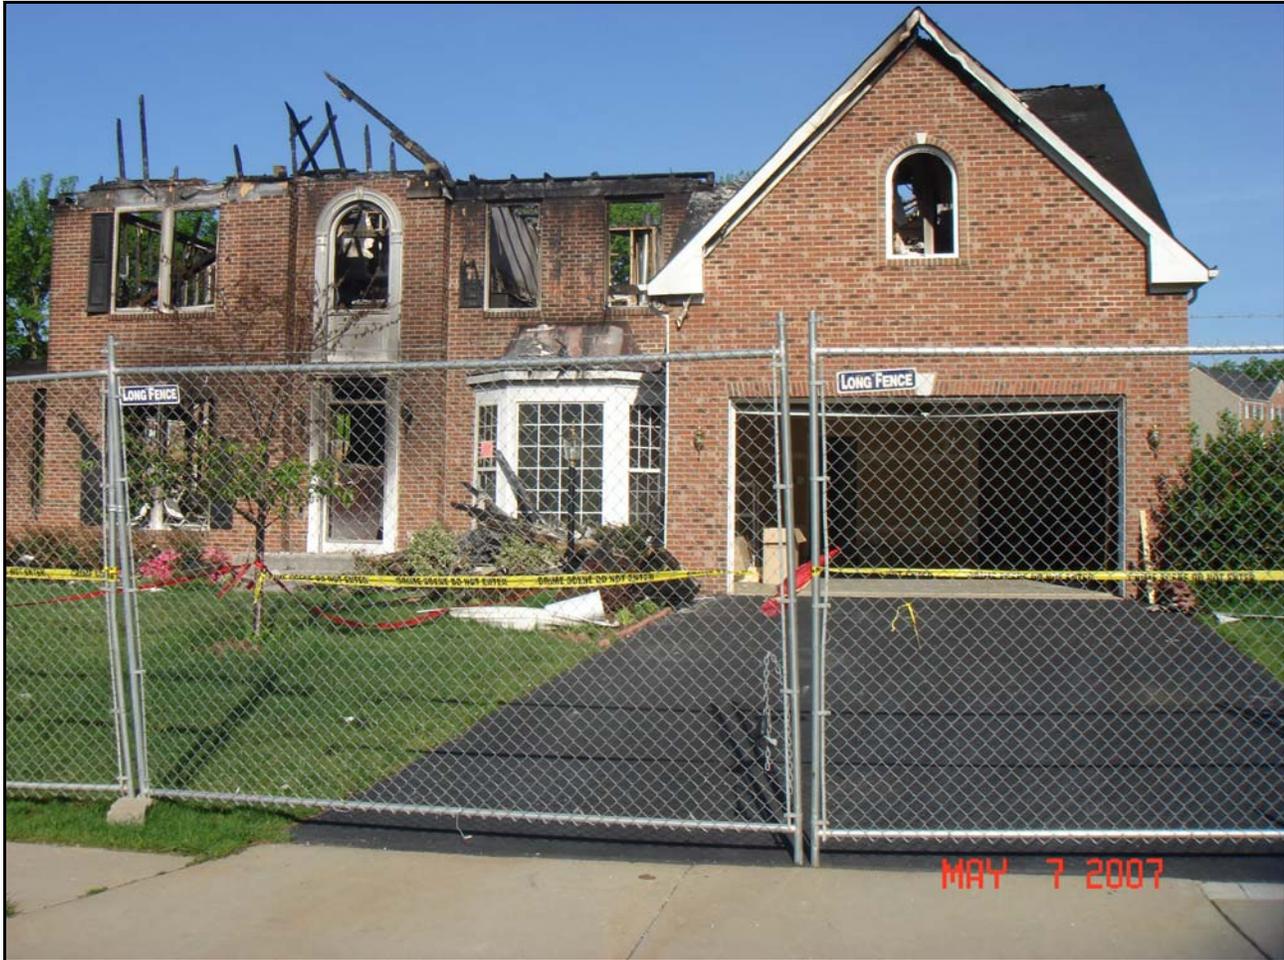
The building was an approximately 6000 square foot, two-story plus finished walkout basement, non-sprinklered residential structure that was constructed of wood framing with vinyl siding and a brick veneer front on the exterior. The residence had a large 700 square foot wood deck that ran three quarters the length of the rear of the structure on the first floor (C-side). The roof consisted of wood rafters with fiberglass shingles over oriented strand board sheathing (see Photo1).

Photo 1: A-side of the structure where the victim entered. The victim was found in the second floor master bedroom above the bay window.

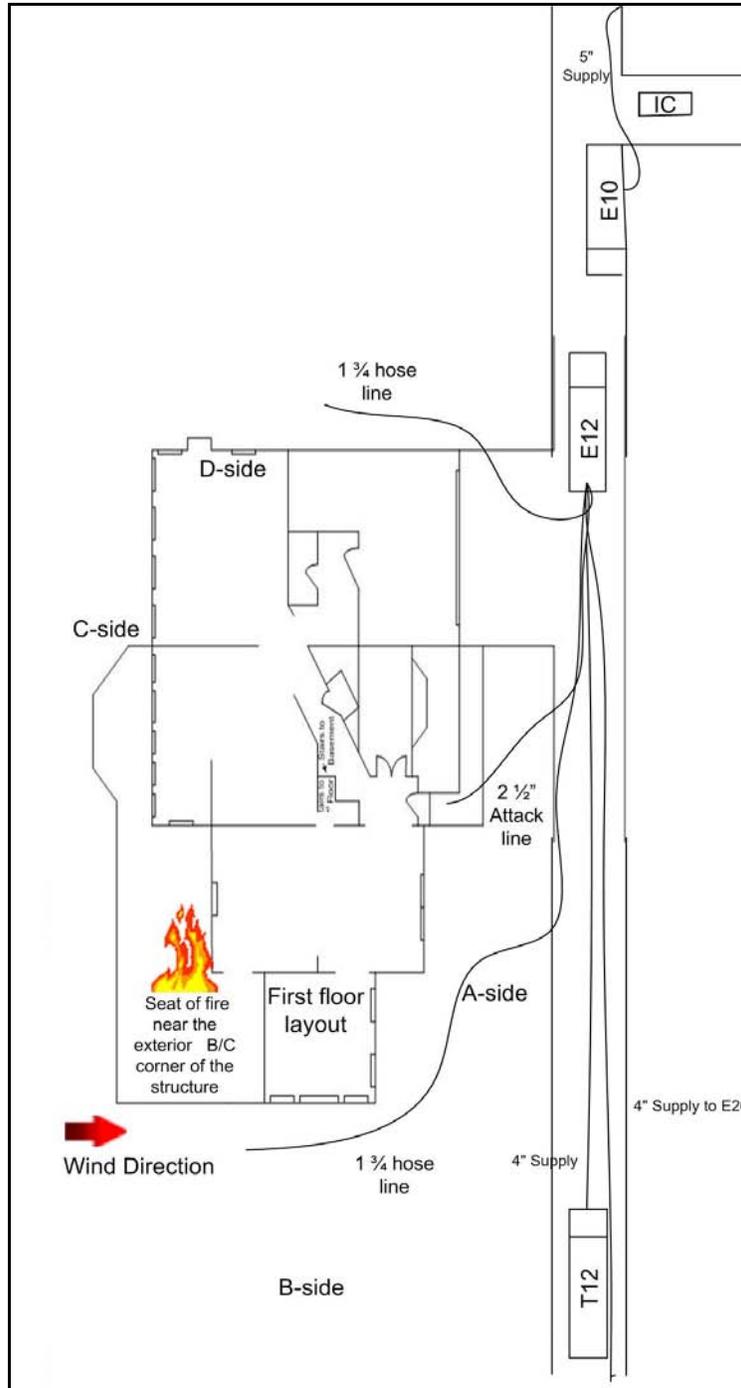
A charged 2 ½" hoseline was stretched to the front door from E12 by the E12 crew. LT#2 and the victim donned their SCBA while waiting to enter the structure. The victim tried the door, which was unlocked, so the victim and LT#2 walked into the foyer. E10 arrived on scene and was instructed by LT#1 to pull 300 feet of 1 ¾" hose from E12 in case it would be needed in the rear. At 0611 hours, with a light haze of smoke visible on the first floor, the T12 crew walked up the stairs to check the bedrooms. The E12 crew was delayed at the door with the attack line due to poor water pressure. LT#1 straightened out several kinks in the hose prior to entering the structure. At the top of the stairs, LT#2 and the victim encountered smoke banked down 3 feet from the second floor ceiling and went to the D-side of the residence towards the master bedroom. At 0611 hours, a Battalion Chief arrived on scene and assumed incident command. E20 arrived on scene and was instructed by the IC to pull 200 feet of 1 ¾" hose from E12 and cover the D-side exposures. (see Diagram#1)

Diagram #1: Apparatus and hoseline location at time of incident

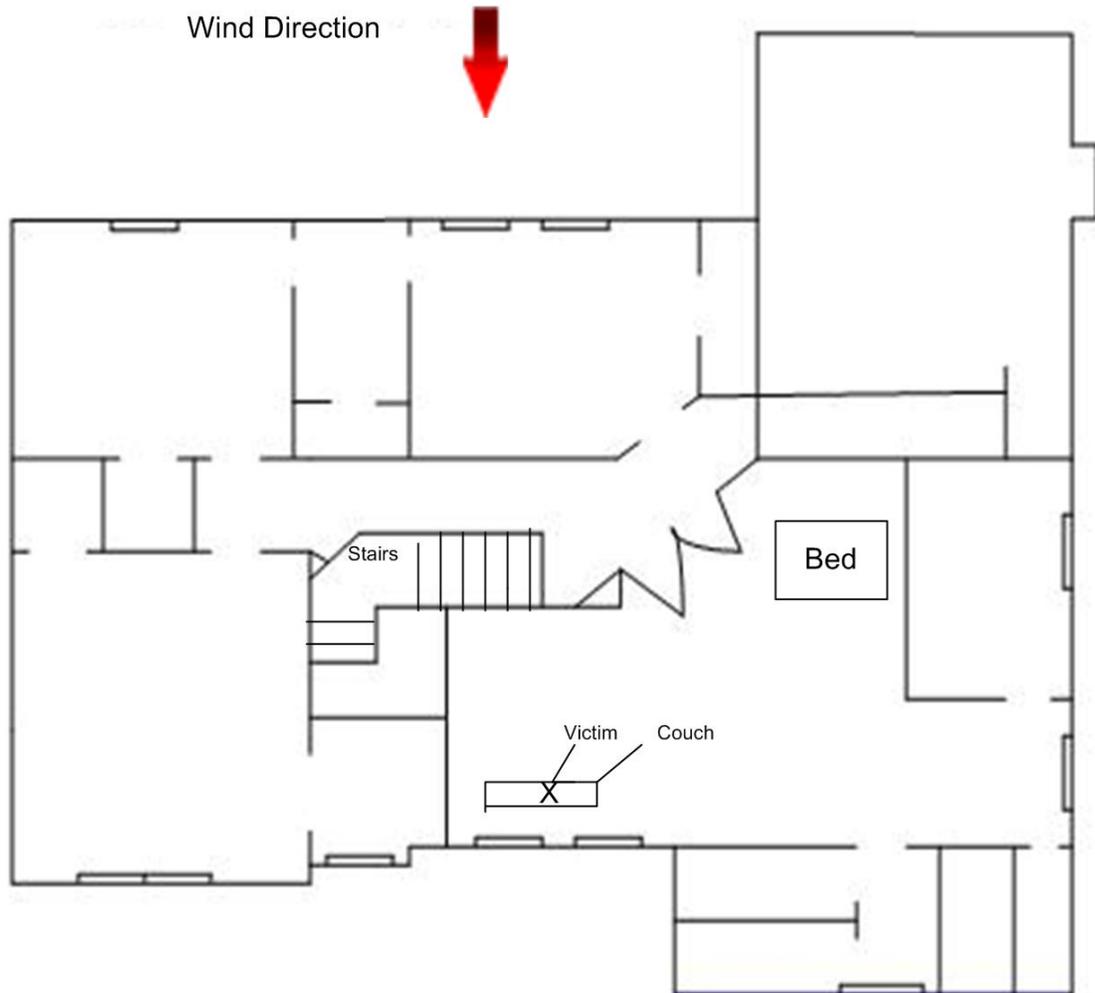
At 0631 hours, additional crews attempted to re-enter and search for the victim, but they were unable to reach the second floor due to intense heat and fire conditions. At 0634 hours, command requested dispatch of a third alarm. At 0643 hours, crews with TICs in hand were able to reach the second floor, but due to structural collapse and high-heat conditions, access to second floor areas was limited. *(Note: The victim's PASS was never heard by fire fighters on the fire ground. Due to extreme heat damage, post incident testing was not possible.)* At 0657 hours, the victim was found in the master bedroom partially on a couch underneath the bedroom A-side windows. (see Diagram #2)

Diagram #2. Location of victim on second floor in master bedroom of fire structure

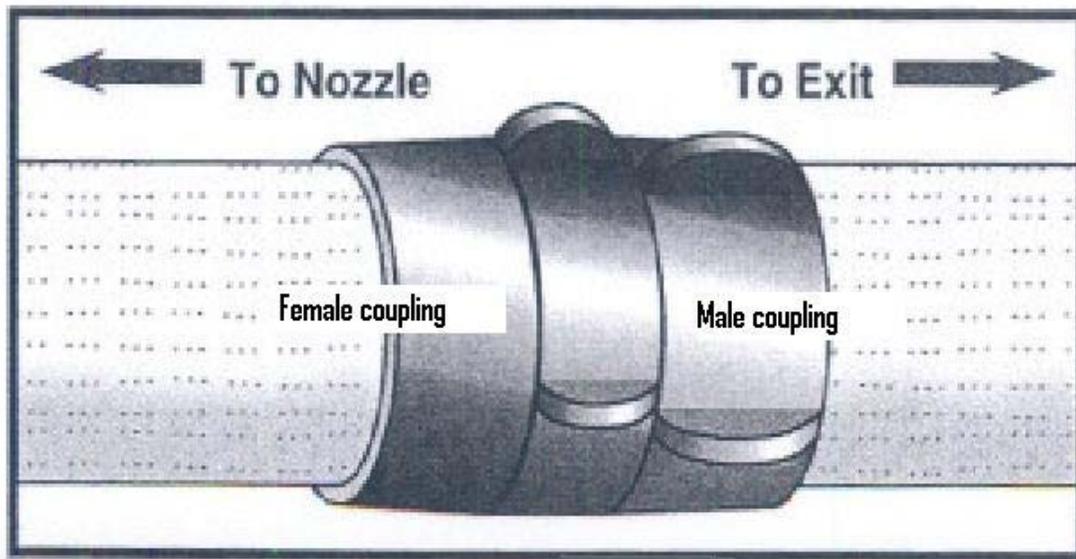
Diagram #3. Hose couplings will indicate the direction toward the exit. Adapted from IFSTA Essentials of Fire Fighting, 4th Edition.

conditions while wearing gloves, the hose entangled, and with various obstructions present. This procedure should be incorporated into SOPs, trained upon, and enforced on the fireground.
