Volunteer Fire Fighter Dies When Struck By a Bus While Working Along an Interstate Highway – Illinois

Fatality Assessment and Control Evaluation Investigation Report # F2007-26

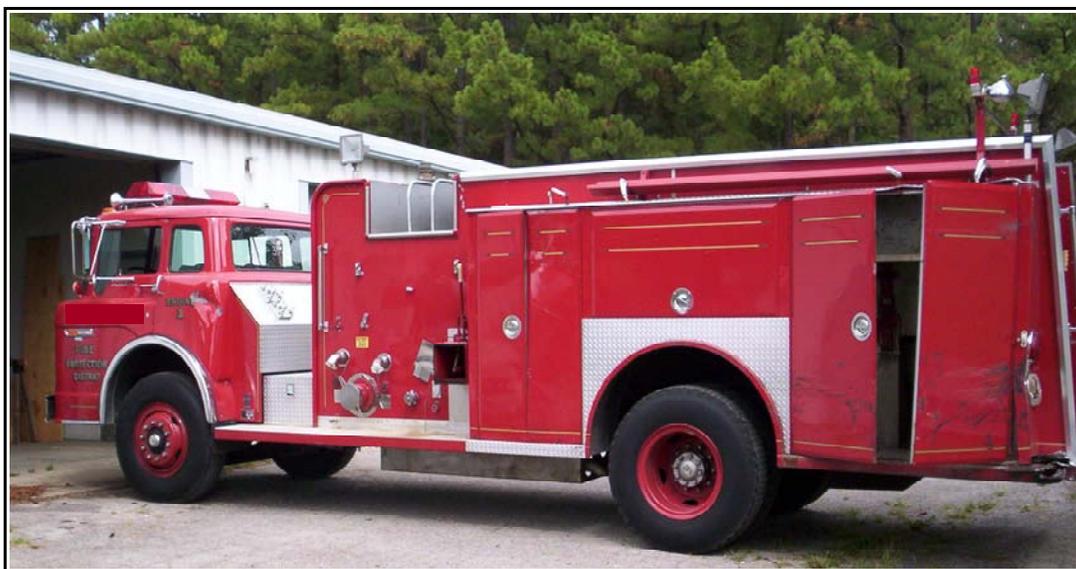
Apparatus involved in the incident
NIOSH photo

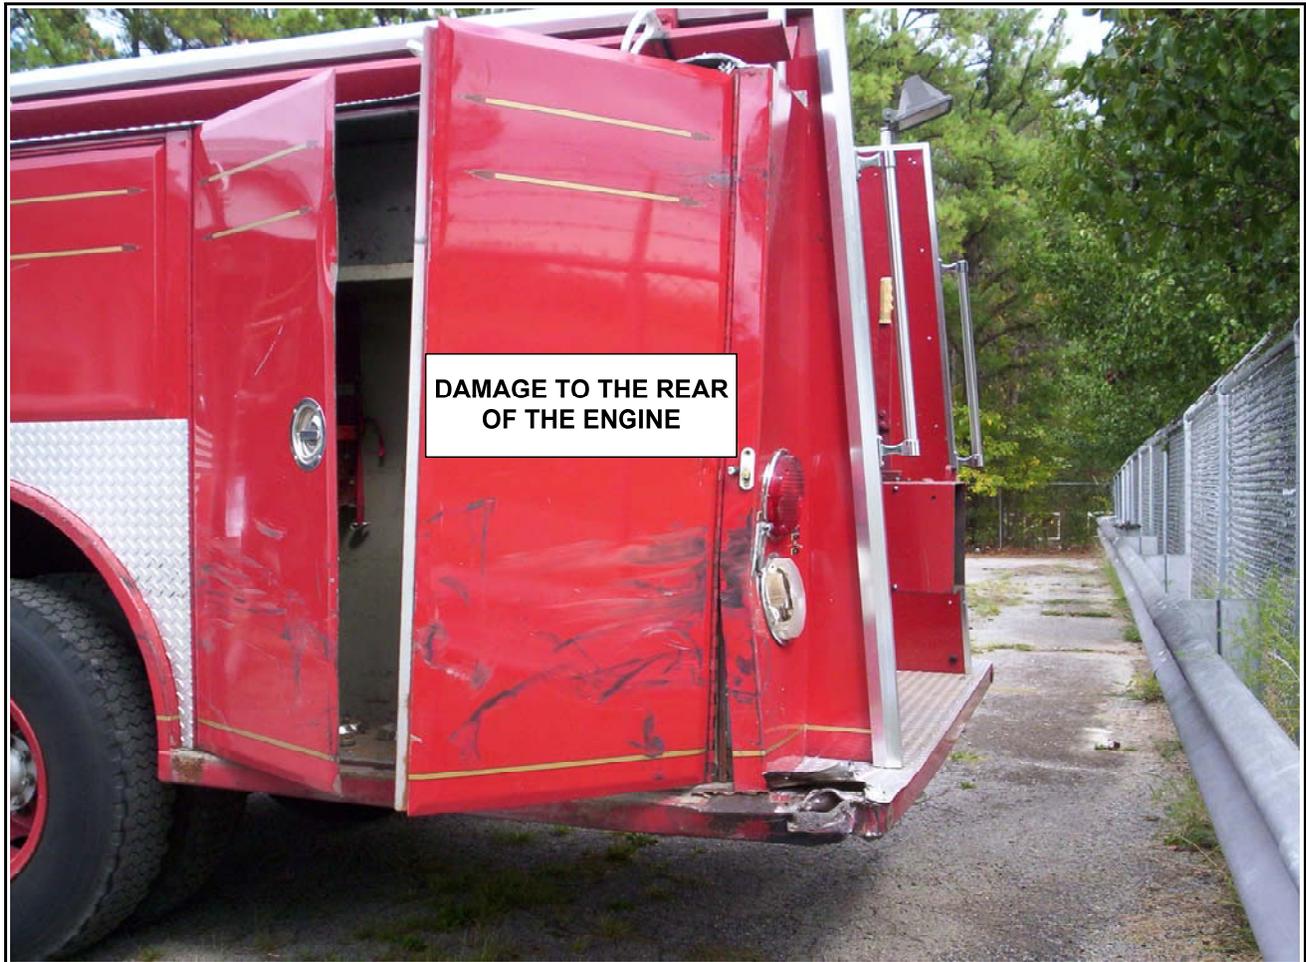
The fire apparatus that was struck by the bus was a 1989 engine. Following the incident there was contact damage on the driver's side rear panel, step and side door (**Photo 1**). The bus was a 1998 tri-axle commercial passenger motorcoach that was equipped with an automatic transmission. The interior seating area included two passenger seats on either side of a center aisle from behind the driver to the rear of the bus. Following the incident, contact damage was visible on the side front bumper, headlight, grill, windshield, rear fender molding, and the second axle tire and rim (**Photo 2**).

**Photo 1. View of the area where the bus struck the engine.
(NIOSH photo)**

As is the case with many volunteer fire departments, this department has an aging fleet. The apparatus involved in this incident was a 1989 engine that did not have retro-reflective markings. However the rescue unit that was parked to the rear of the apparatus was equipped with a lighted directional arrow that was in operation at the time of the incident (**Diagram 1**). NFPA 1901 applies to newly manufactured apparatus and is not retroactive. In many cases it can be cost effective and easy to retrofit existing vehicles to improve fire fighter emergency work zone safety. Fire departments should consider putting reflective tape on apparatus to mark doors, fixed sections that are not blocked by doors or ladder racks, and also down low around the bottom of the apparatus. A video detailing guidance for retrofitting apparatus with the newly recommended safety lighting and markings can be found by accessing the Emergency Responder Safety Institute website, <http://www.respondersafety.com/MarkedAndSeen.aspx>.⁷

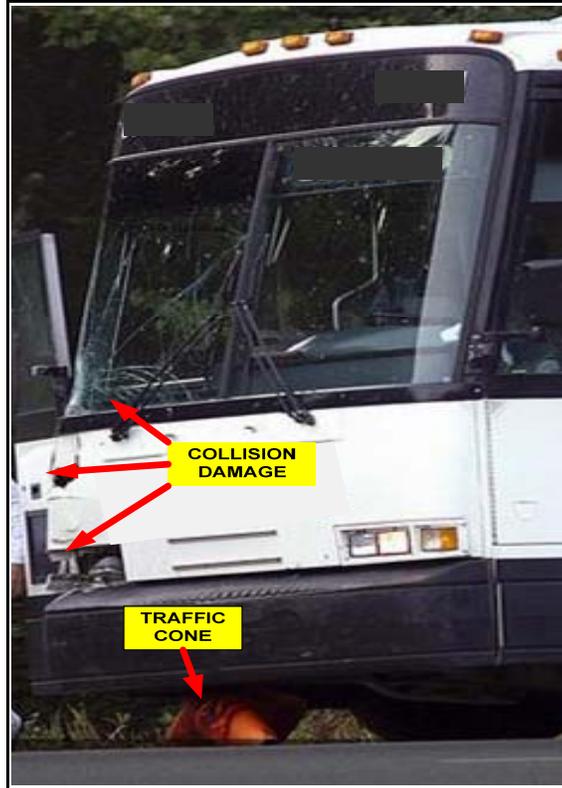
In this incident, the department had placed six 28 inch orange emergency cones around the scene to provide a taper to redirect traffic. Several of these cones were struck by the bus, and one was found wedged under the front of the bus when it came to a stop approximately one-half mile from the initial impact. It is possible that additional flares or reflective signage further upstream may have alerted an attentive driver in time to avoid striking an emergency responder under similar circumstances. However, the fact that the bus driver ignored all of the warning lights and cones that the department had utilized provides evidence that, for whatever reason, he was not responding to visual stimuli.

Photo 2. View of the front of the bus that struck the victim showing collision damage and the traffic cone that had been run over and dragged by the bus.
(Photo courtesy of the fire department)

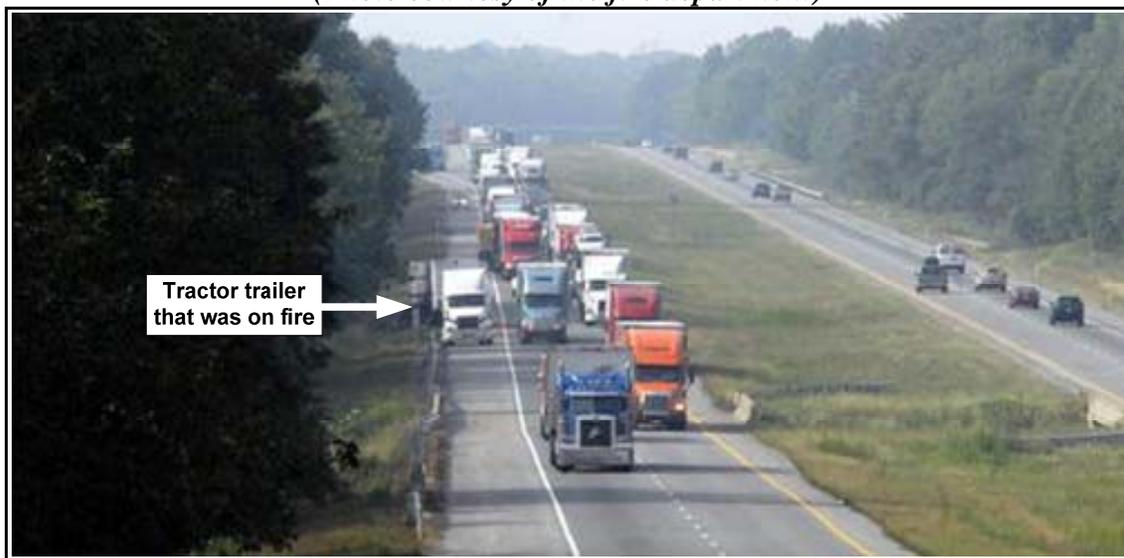
Photo 3. View, facing southbound, showing the highway at the location of the incident.
(Photo courtesy of The Southern Illinoian)

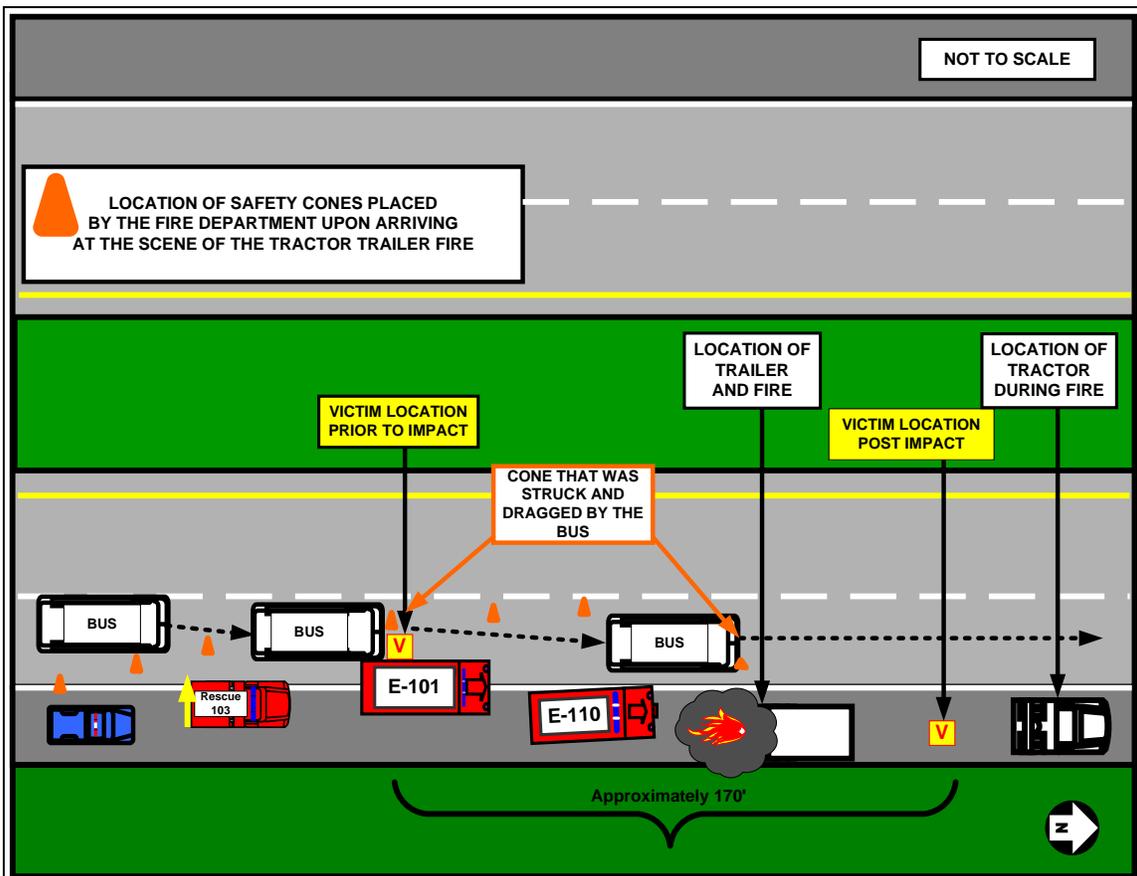
Four fire department vehicles reported on the scene at approximately the same time. All vehicles were equipped with emergency lighting that remained in operation from arrival to departure following the incident. The fire department units on the scene were (**Diagram 1**):

- Unit #103, a rescue truck, with a fire fighter and a safety officer parked on the highway shoulder. Unit #103 was equipped with a lighted directional arrow board that was in operation at the time of the incident.

- Engine #101 with two fire fighters and the victim parked just ahead of 103 straddling the fog line and about 6 feet into the driving lane.
- Engine #110 with three fire fighters parked on the fog line ahead of #101.
- The chief's SUV was parked behind Unit #103 and the POV was behind the SUV.
- **0414 Hours**
The victim was struck and killed by the bus as he was placing hose into the storage compartment near the front of Engine 101.

Diagram 1. Overview of incident scene showing vehicle placement and victim location.
