Volunteer Fire Fighter Dies after Ten-Foot Fall From Engine – Ohio

SUMMARY

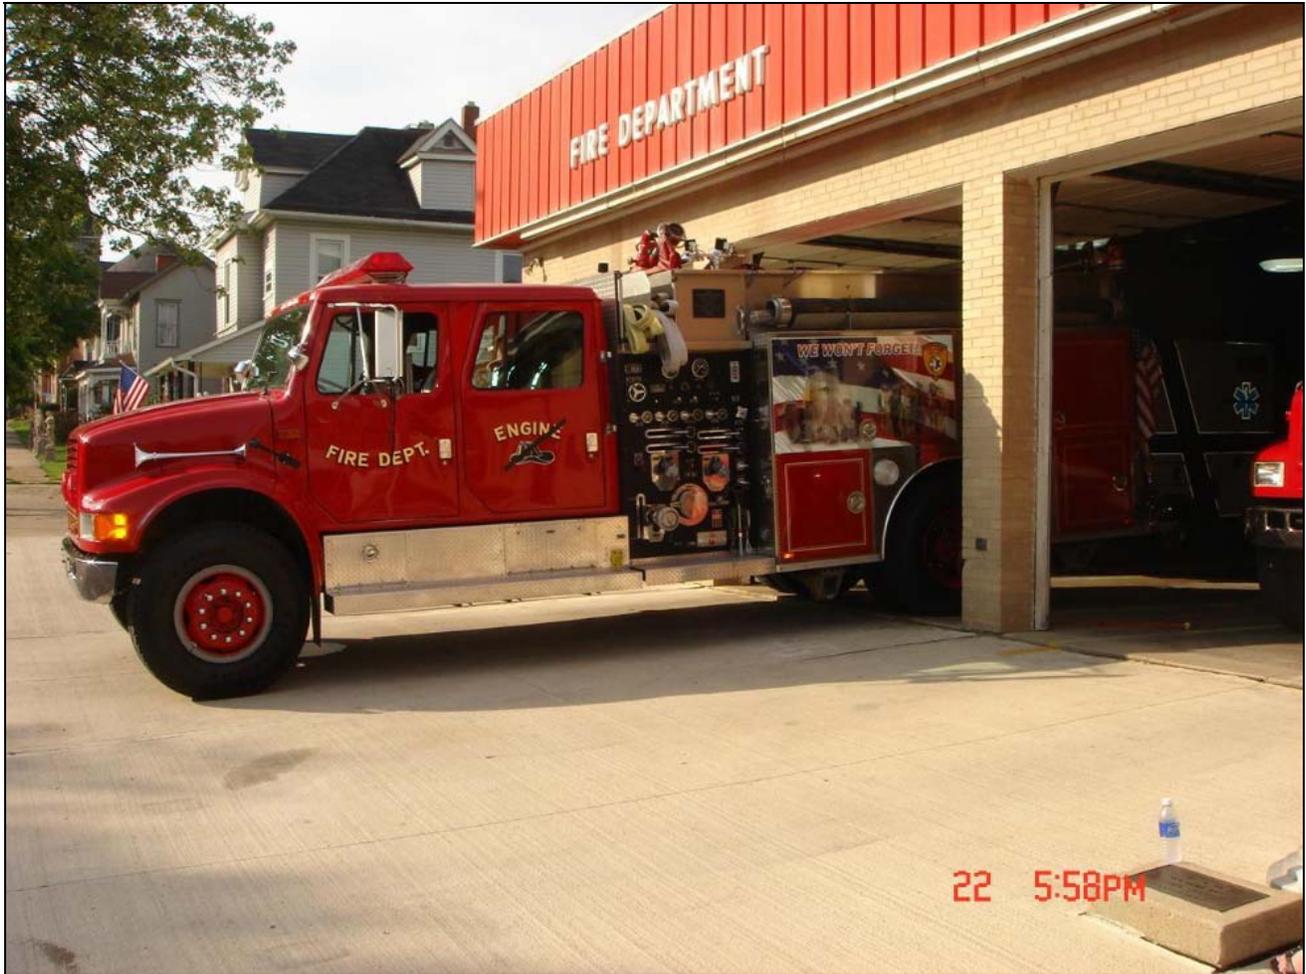
The victim parked the engine and positioned it with its rear section in the bay area, while the front section was on the concrete apron in front of the station (Photo 1). According to fire fighters who were at the station during this time, the victim was reloading hose onto the engine's hose bed prior to the incident. The victim and one of the junior fire fighters unloaded approximately 250 feet of hose that had been used at the structure fire. Following the hose unloading, a second fire fighter along with the second junior fire fighter handed approximately 200 feet of dry hose up to two fire fighters that had climbed up on the engine and into the hose bed.

Photo 1. Approximate Position of the Engine During the Incident.
(NIOSH photo)

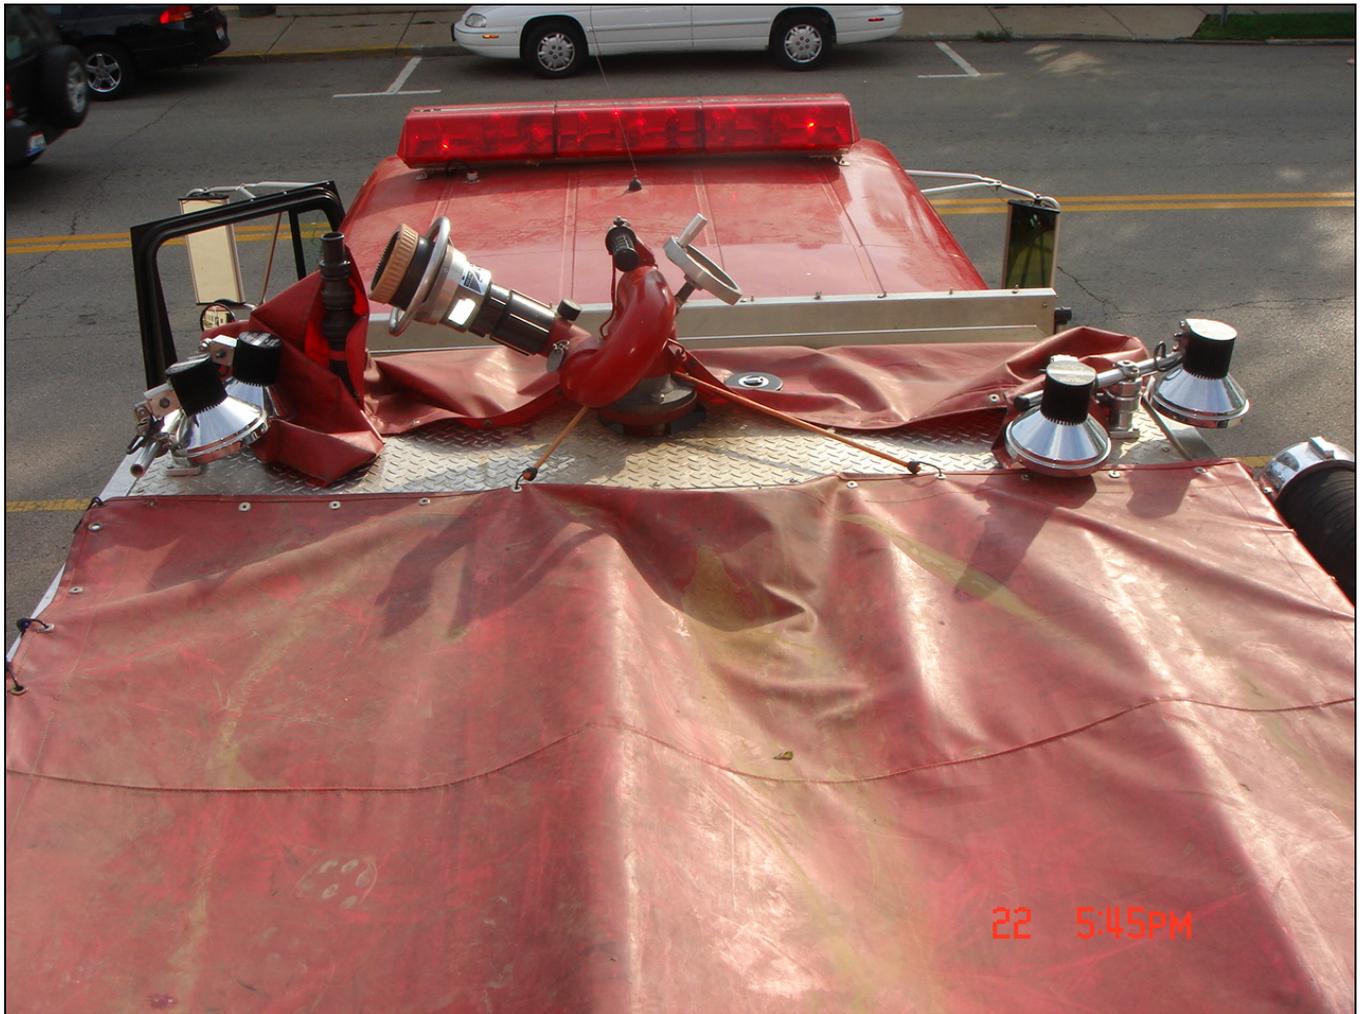
Following the reloading of hose, the first junior firefighter descended from the back of the engine, while the victim remained on top of the engine to load the fire nozzle that was attached to the end of the hose. The victim then began to cover the bed with a vinyl hose bed cover. He attached the cover with a bungee cord to the water deck gun at the front of the hose bed because most of the grommet-snaps on the front of the cover no longer worked (Photo 2). He then attached the right side of the cover with the original grommet-snaps on the cover (Photo 3). After securing the back of the cover, the victim descended from the hose bed at the back of the engine.

Photo 2. Aerial View of the Front Section of the Vinyl Hose Bed Cover.
(NIOSH photo)

Recommendation #3: Fire departments should ensure that hose bed covers on fire apparatus are maintained in good physical condition or are replaced when needed.

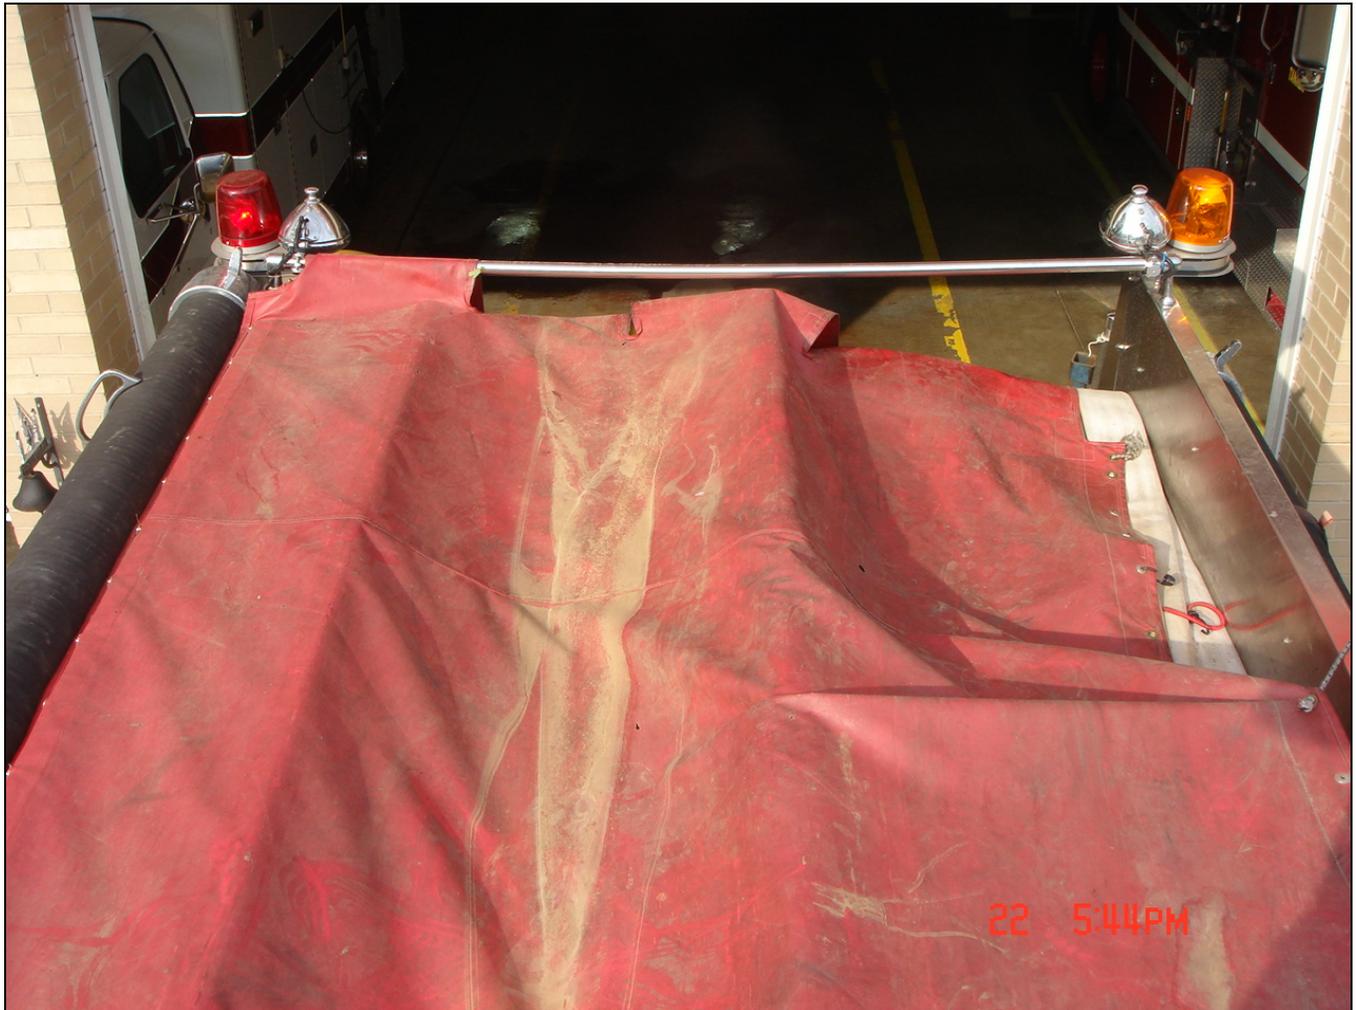
Photo 3. Aerial View of the Engine Vinyl Hose Bed Cover.
(NIOSH photo)

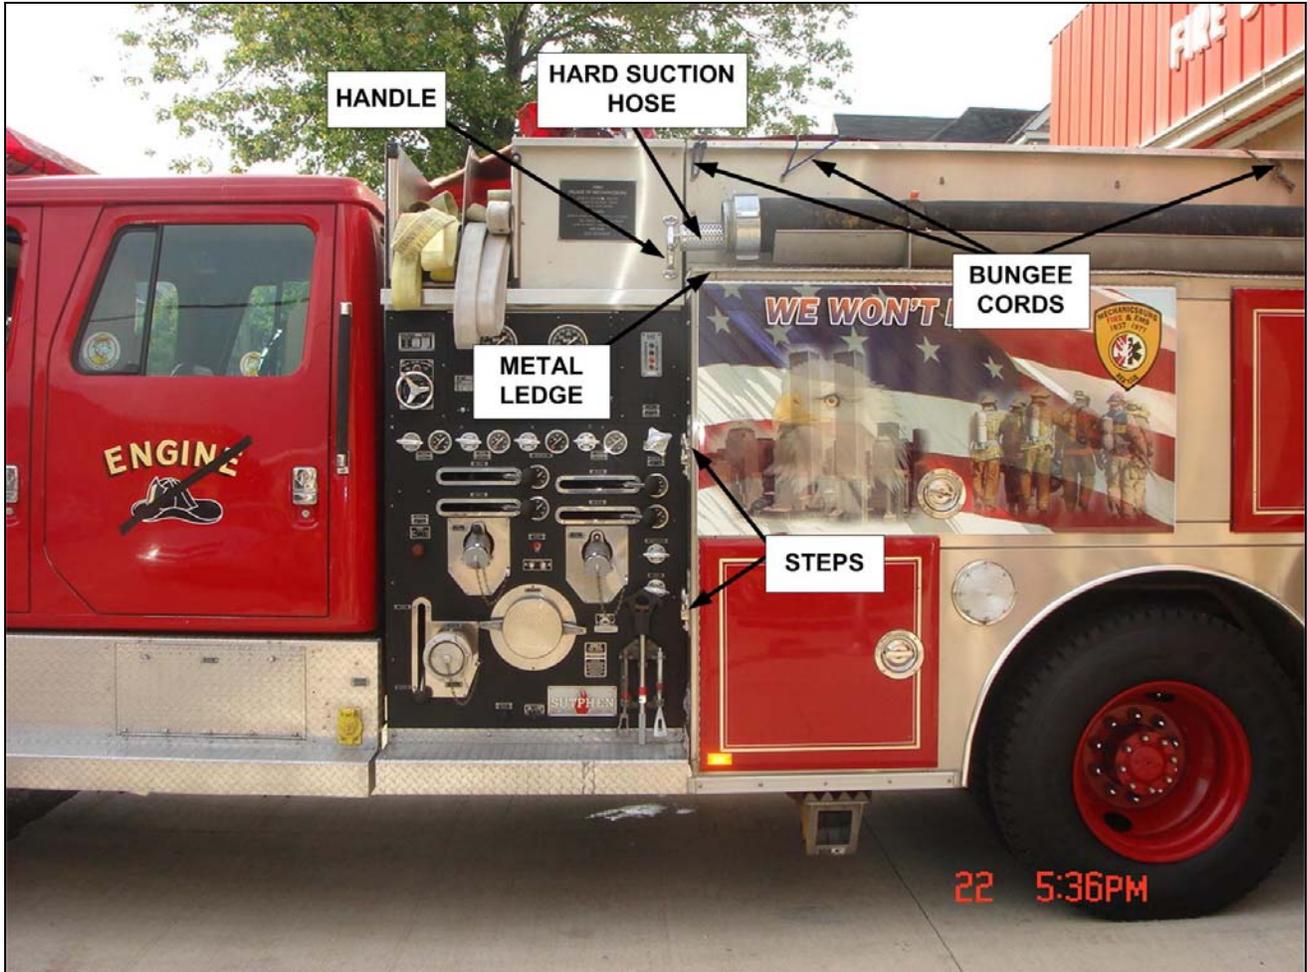
The victim walked around to the driver's side of the engine to a point that was even with the front of the hose bed. He ascended the side of the engine near the pump panel by gripping a handle and climbing up on two extended foot steps (Photo 4). He was positioned with his left foot on the top step and his right knee on a metal ledge next to the hose bed where the hard suction hose is mounted.

Photo 4. Side of the Engine Where the Victim Ascended and the Incident Occurred.
(NIOSH photo)

Recommendation #2: Fire departments should consider requiring the use of a ladder when servicing items that are out of reach from ground level on the fire apparatus.

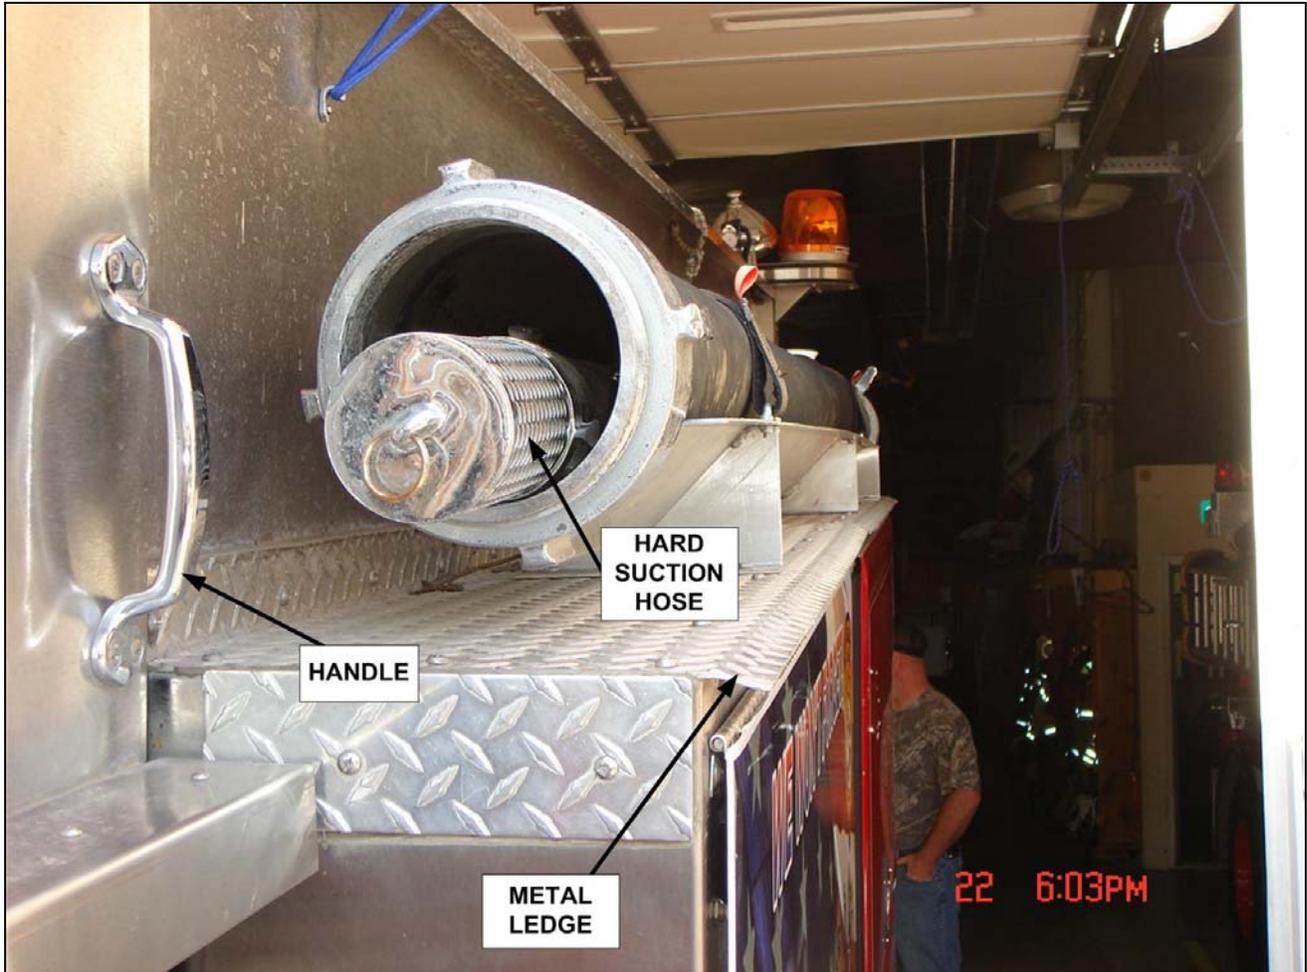
It should be noted, that the victim only had approximately 3 inches of available space on the metal ledge for his knee, due to the strainer hose and mounting hardware. The victim began to draw the vinyl cover over the hose bed's front left side (Photo 5). The left side of the cover required the use of bungee cords because the grommet-snaps no longer worked on this side. While the victim was attempting to adjust the cover over the hose bed, a fire fighter in the area saw the victim lose his balance and fall backwards from the engine. Attempting to arrest his fall, the victim reached for the front corner of the vinyl cover, however, it was unable to support his weight and it tore. The victim continued falling approximately ten feet and landed on the concrete apron at approximately 2107 hours. The victim landed on his head and lay supine on the concrete ground.

**Photo 5. Handle and Metal Ledge with the Hard Suction Hose
Where the Victim's Right Knee was Positioned.
(NIOSH photo)**
