A Summary of a NIOSH fire fighter fatality investigation

November 3, 2008

A Volunteer Mutual Aid Captain and Fire Fighter Die in a Remodeled Residential Structure Fire - Texas

Fatality Assessment and Control Evaluation Investigation Report # F2007-29

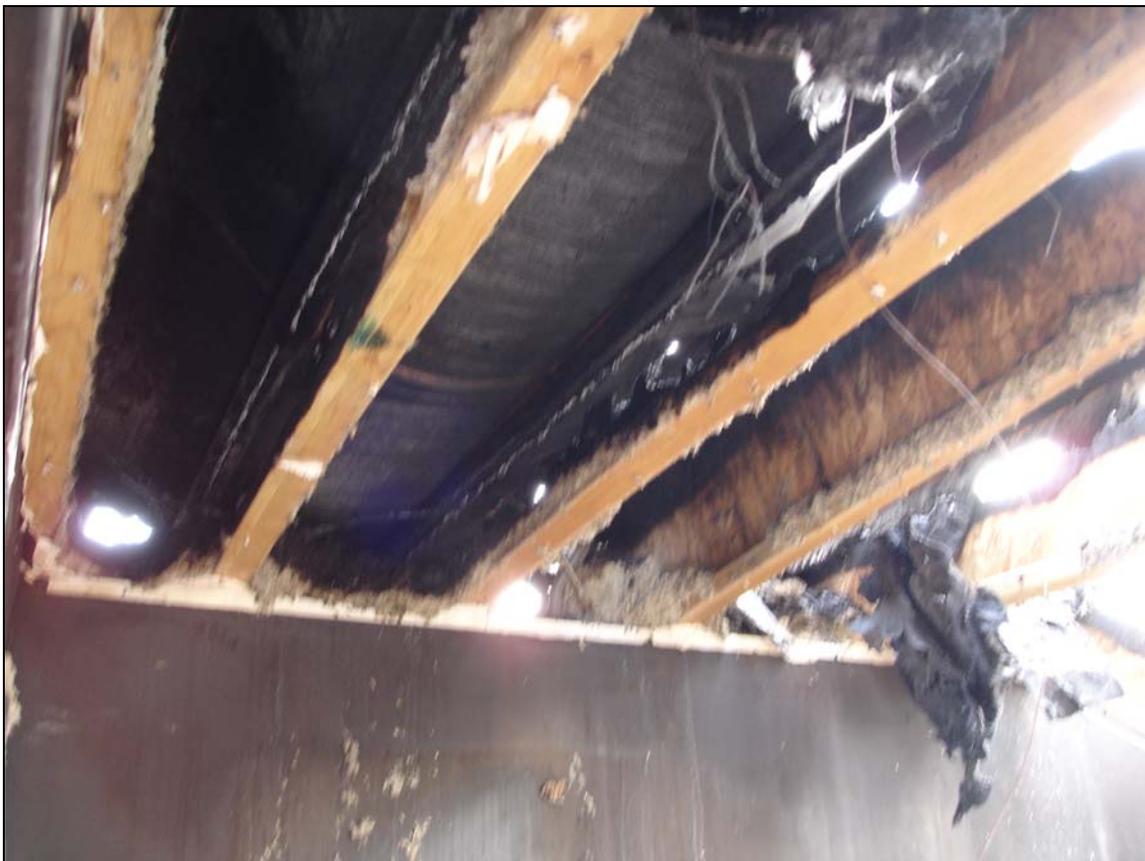
The 2,700 square foot building was a single story, non-sprinklered residential house that was constructed of wood framing with exterior wood sheathing. The roof consisted of wood rafters with plywood sheathing and conventional asphalt shingles. The structure had been remodeled with several additions over the years (See Diagram #1). The right side addition had been added using engineered joists covered with plywood as an attic floor with a stick built roof which was tied into the existing roof of the main structure (this section is where venting was performed with little effect due to the attic flooring). See photos #1 and #2.

Photo #1: Shows right side addition's ceiling joists made of engineered joists covered with plywood. Vertical roof ventilation was done on the roof rafters above this ceiling.

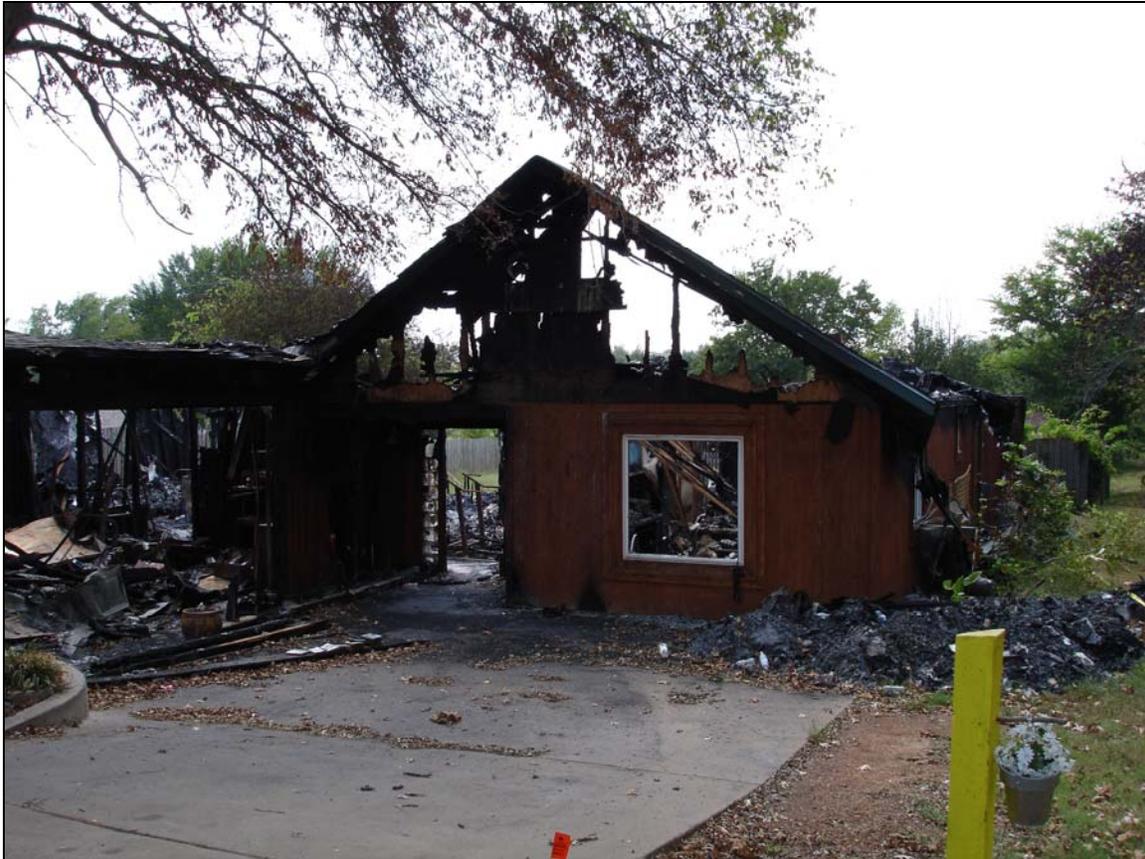
Photo #2: Front and right side view (A/D corner) of the fire structure showing roof pitch of right side addition. Roof ventilation was conducted above the front window about 10 feet back from the edge of the roof.

In this incident, ventilation was being performed while the interior attack crew was already inside working. When the ventilation was completed, minimal smoke was pushed out of the vented hole but dark smoke pushed out of the front door, in spite of the fact that a PPV fan was set up at the front door. *Note: The dark smoke pushing out the door indicated that the conditions were worsening and the vertical ventilation was not impacting the fire.*

Recommendation #4: Fire departments should ensure that proper ventilation is coordinated with interior attack

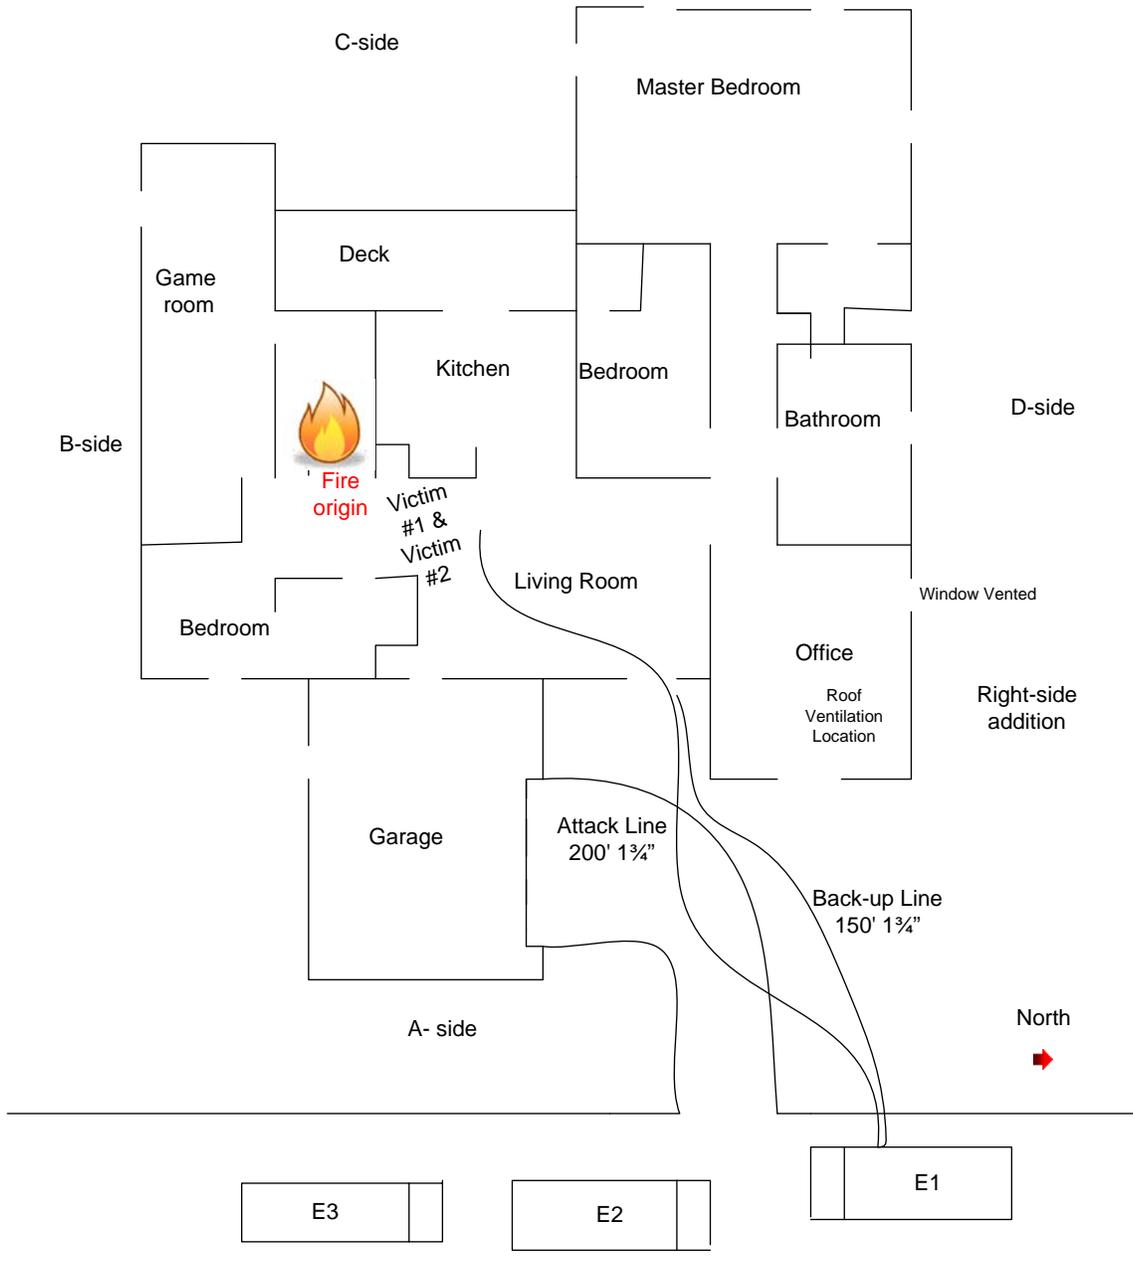
Diagram #1 – Shows location of victims and hose lay at time of incident.
