# Death in the line of duty...

A summary of a NIOSH fire fighter fatality investigation

November 9, 2009

## **Two Career Fire Fighters Die While Making Initial Attack on a Restaurant Fire –Massachusetts**

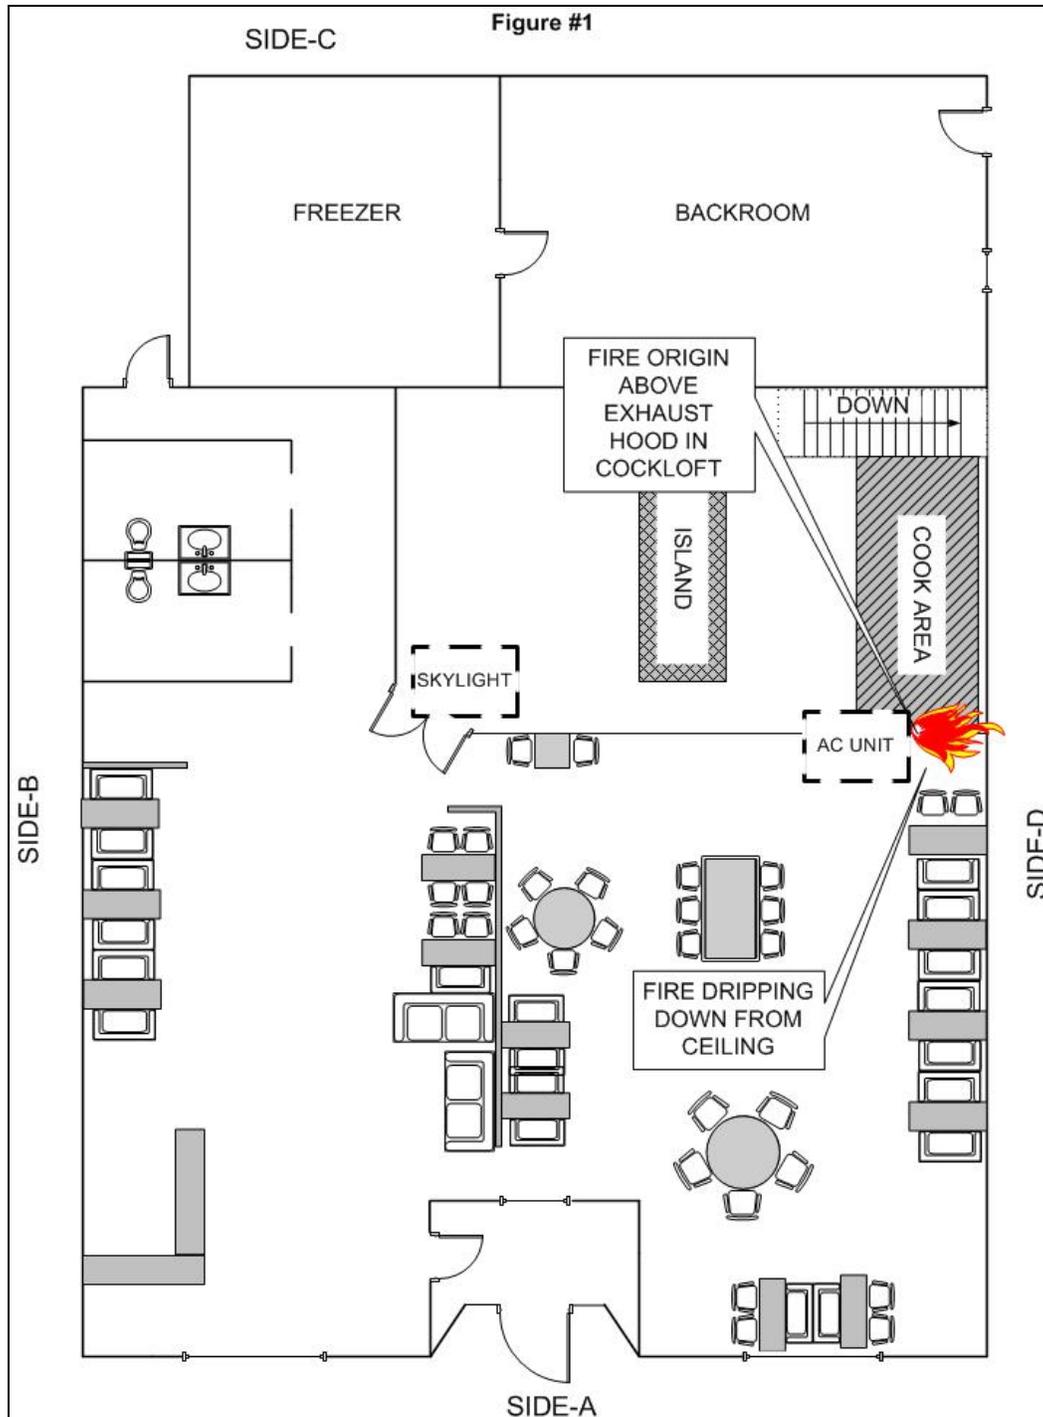
The roof was sloped towards the back and had a 3 ft parapet wall on the front. It consisted of built-up rubber roofing with backer board over the original tar and gravel roof. There was a 3-ton heating, venting, and air conditioning unit (HVAC) on the roof, that weighed approximately 400 pounds. There was also a skylight that measured 3 ft 8 in x 3 ft 5 in. Both were located over the kitchen area (Figure 1).

**Figure 1. Layout of restaurant and fire origin.**

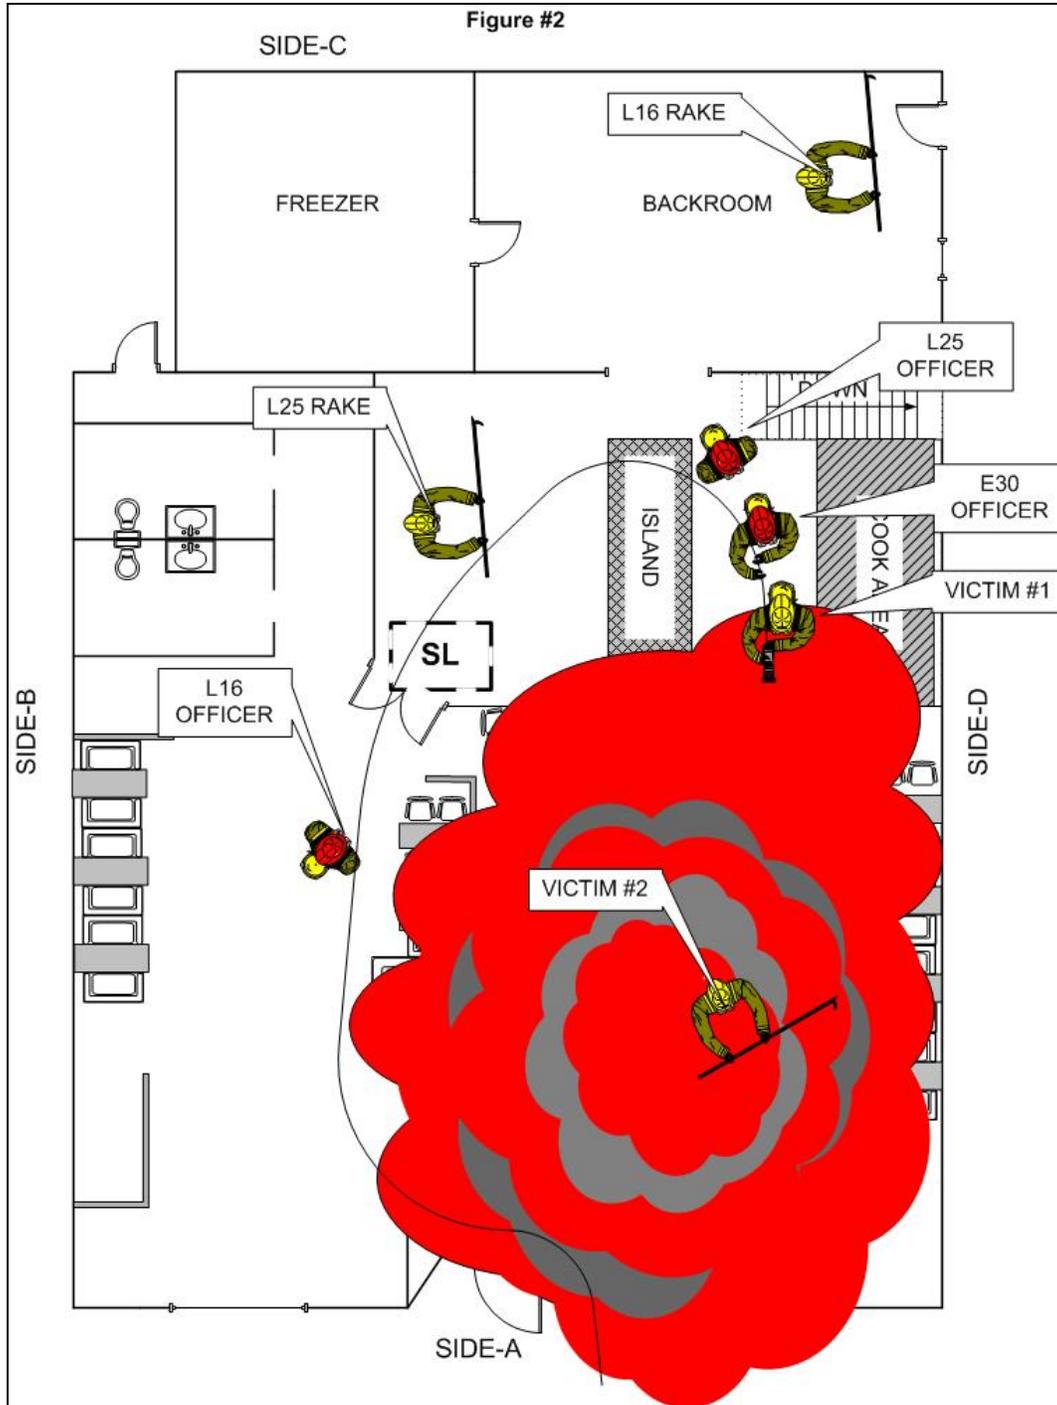
At approximately 2112 hours, the L25 officer told the L25 rakeman to stay with the handline as he went to look for an exit in the rear of the structure. The E30 officer and Victim #1 started to hear popping from the ceiling as it was coming down upon them. The smoke and heat conditions intensified forcing them to the floor. The L16 officer moved from the C-side of the dining room over to E30’s handline due to the deteriorating conditions. The smoke conditions were now banking to the floor and the heat forced the L16 officer to his knees. At approximately 2113 hours, as he awaited for the additional handline, he heard a loud crack and within a minute heard a loud rush. He described it as sounding like a “freight train” as a rapid fire event took place blowing down the ceiling tiles and a fireball blew out of the front of the structure (Photo 5, Photo 6). He described that the dining room turned orange. He felt hot water falling on him from the E30 handline in the kitchen (Figure 2).

**Figure 2. Position of members at the ignition of the rapid fire event.**

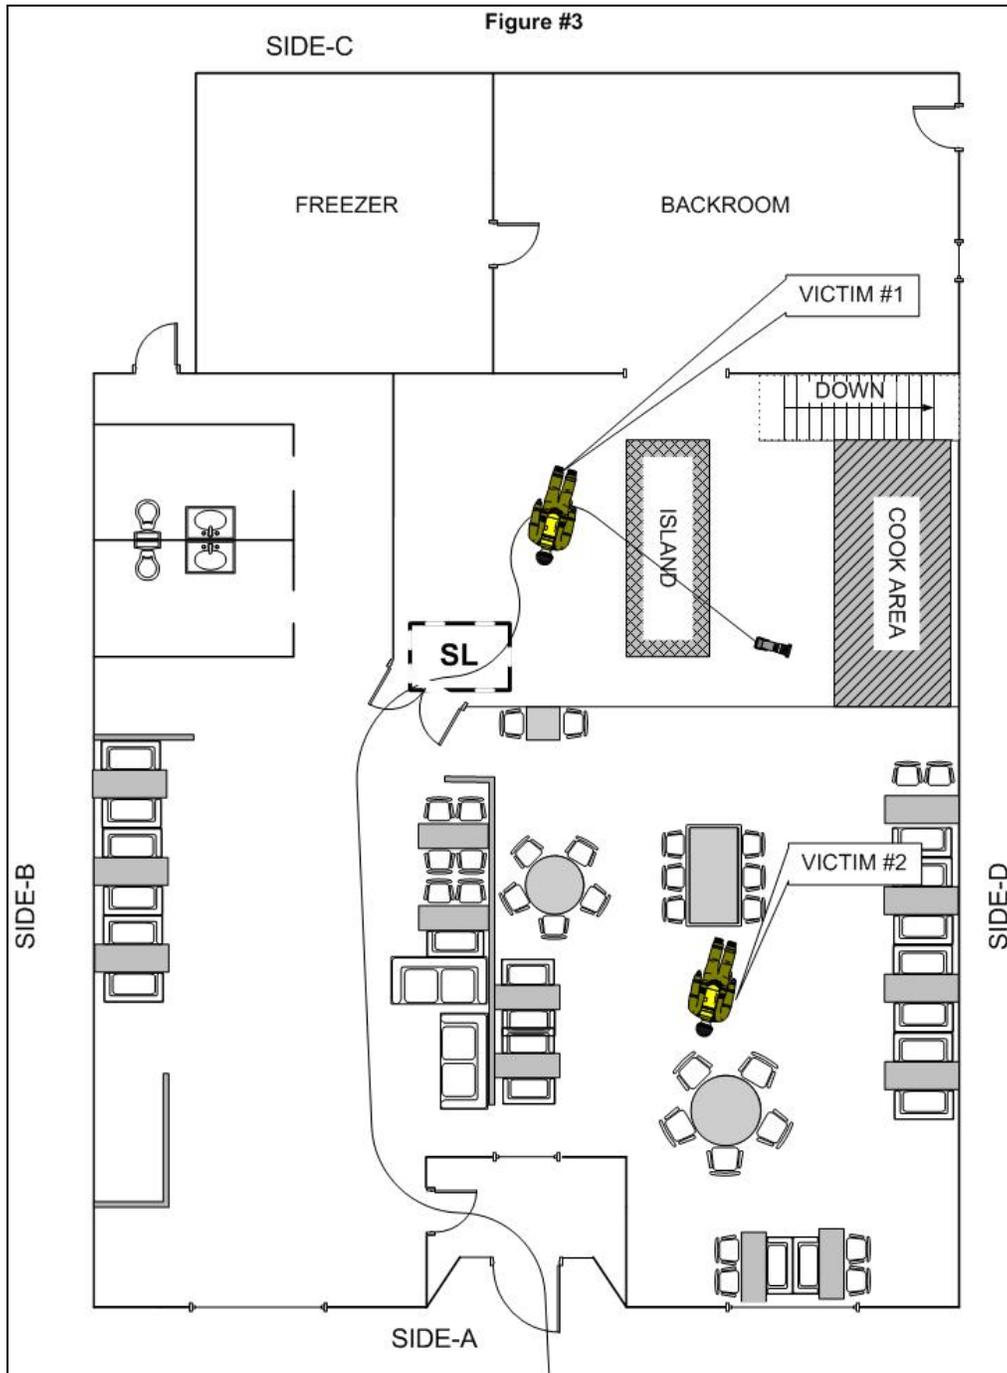
**Figure 3. Location of victims.**

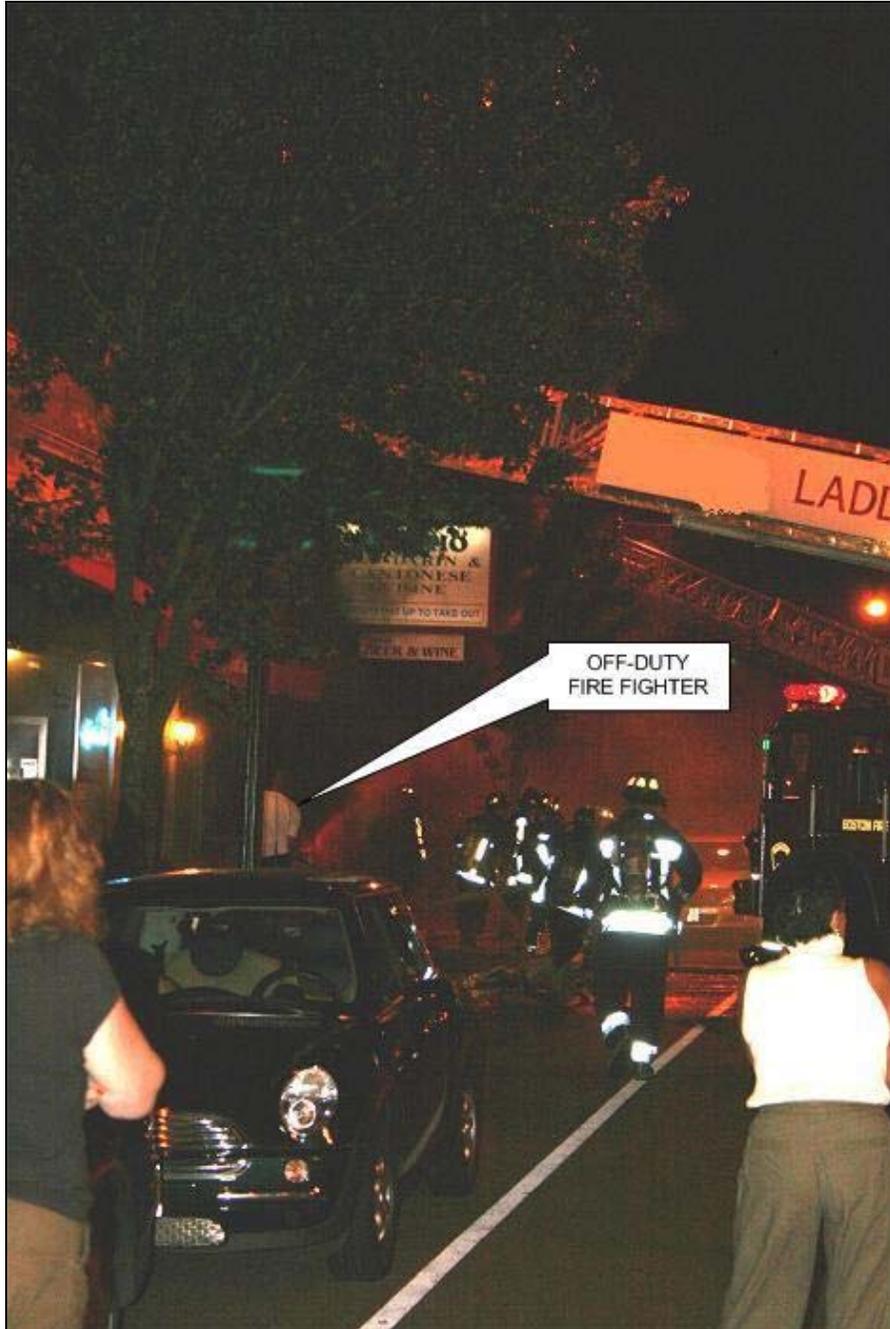
In this incident, vertical ventilation was never completed. The initial attack team and the initial IC were inside the structure fighting fire in the cockloft area that was open in the kitchen. The fire conditions worsened in the dining room area as thick black smoke began to bank down to the floor. Horizontal ventilation was performed on the front windows, which flanked the point of egress for the crews working inside. This provided oxygen to the fire and lead to a rapid fire event.

**Photo 3. Off-duty fire fighter in white T-shirt conducting initial vent at 2112:56 hours.**  
*(Photo courtesy of fire department.)*

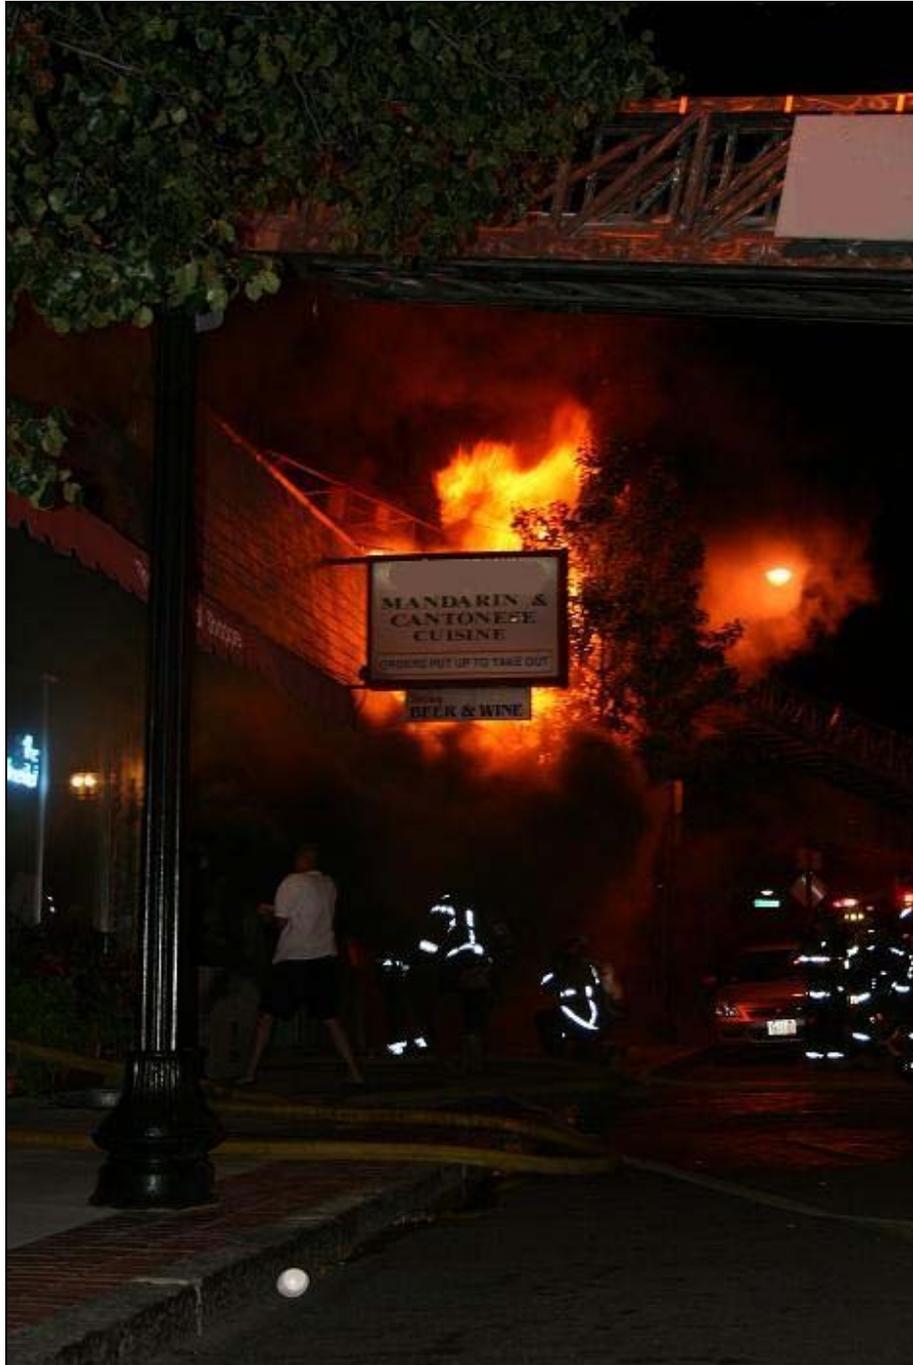
**Photo 4. Conditions after venting at 2113:14 hours.**  
*(Photo courtesy of fire department.)*

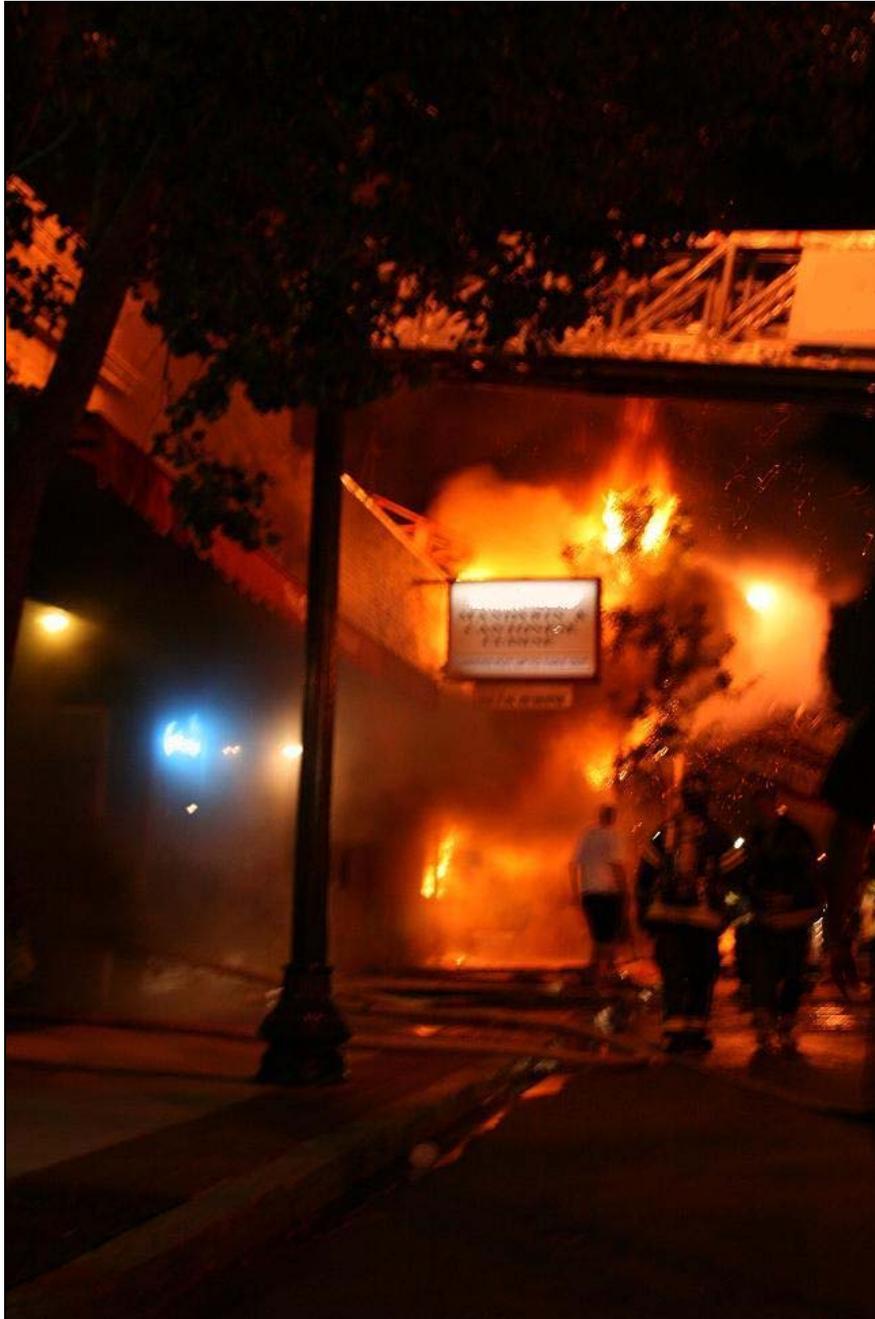
**Photo 5. Conditions after venting at 2113:36 hours.**  
*(Photo courtesy of fire department.)*

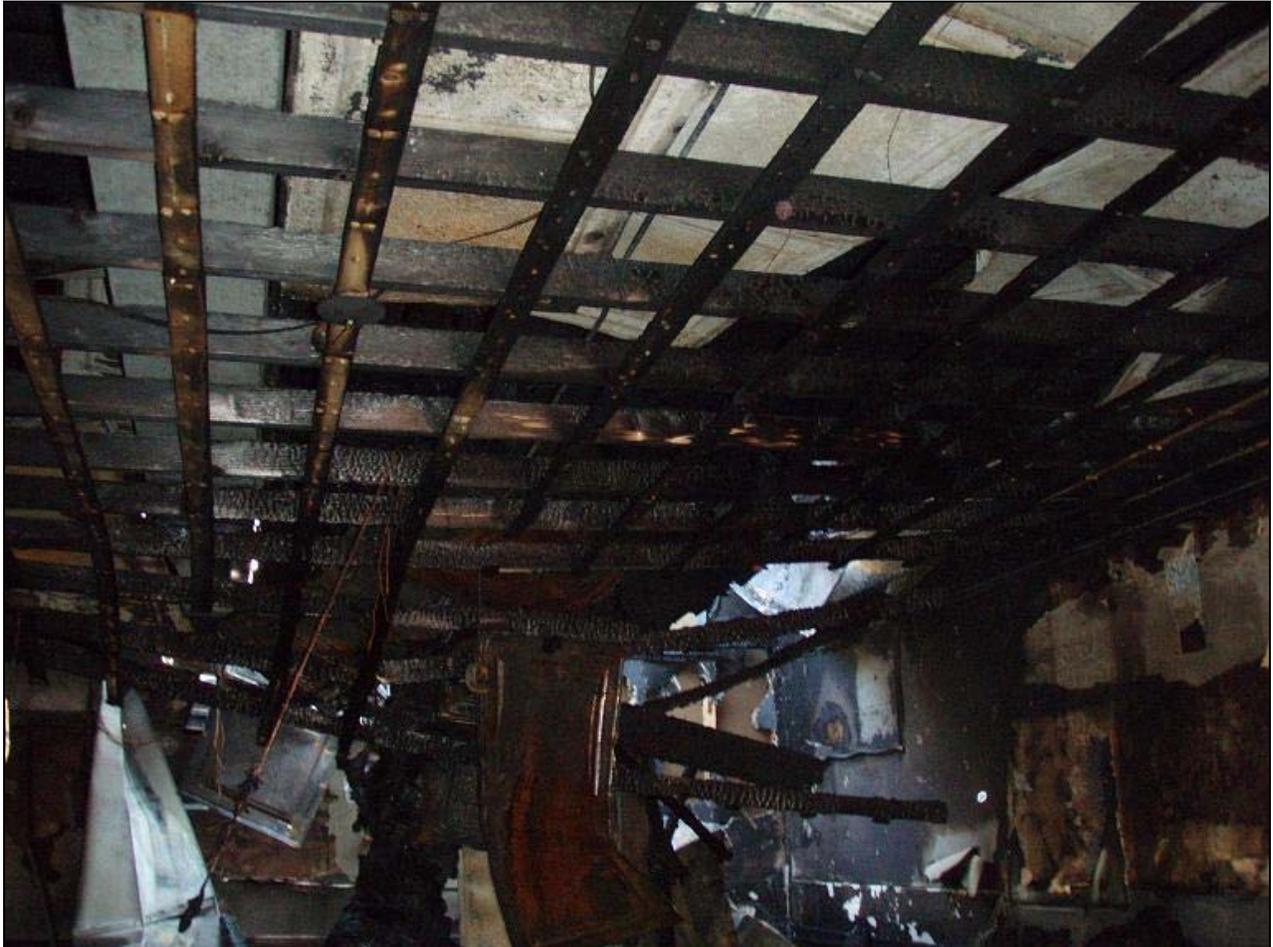
**Photo 6. View looking towards kitchen and D-Side wall from dining room at exposed furring strips where the ceiling tiles were attached prior to the rapid fire event.**  
*(Photo courtesy of fire department.)*

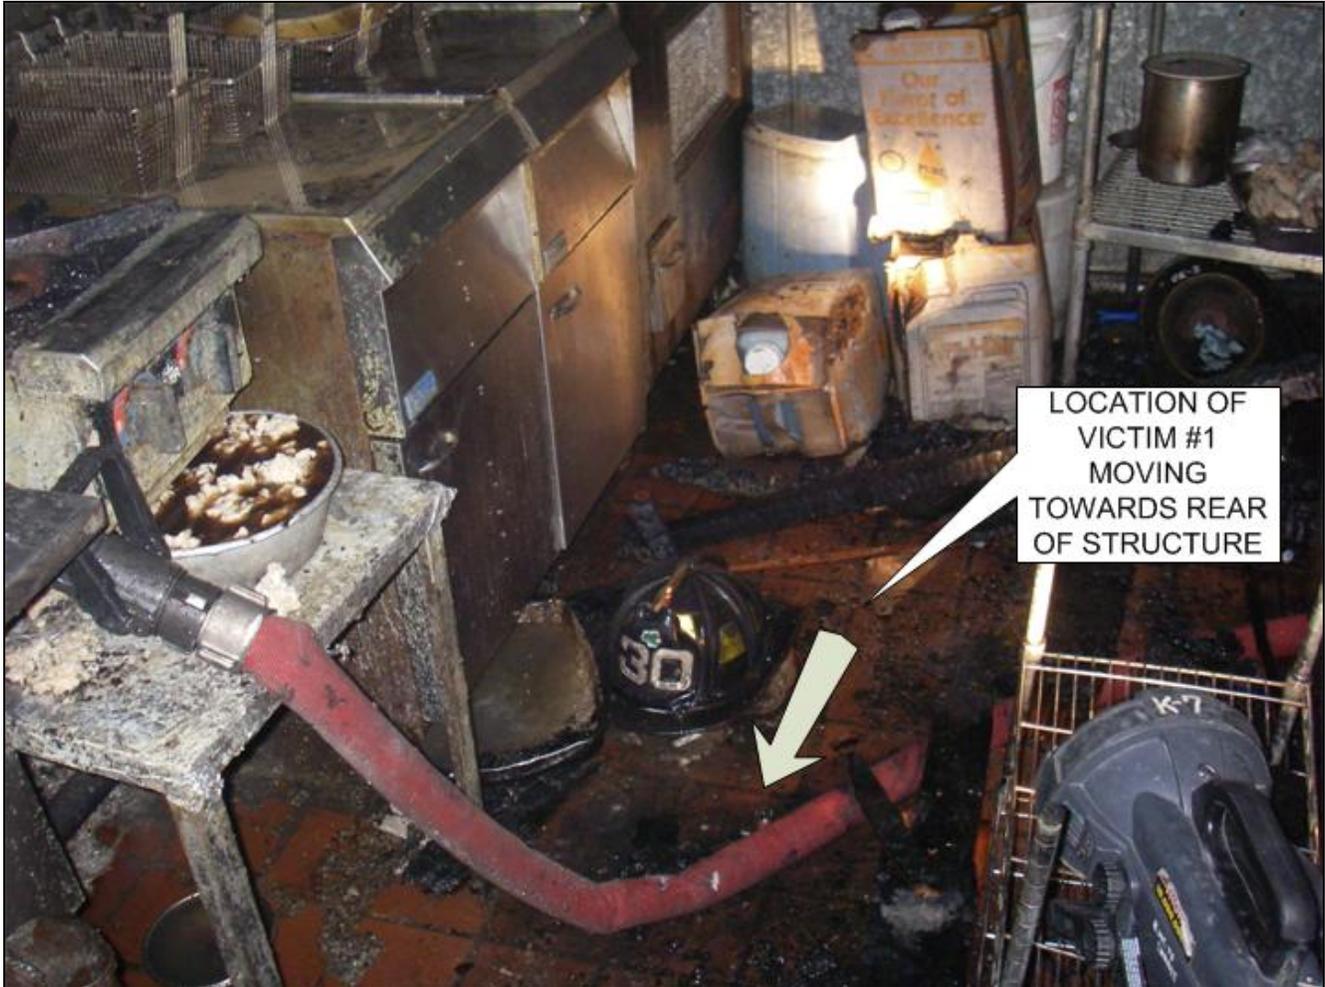
**Photo 7. Location of Victim #1 in kitchen.**  
*(Photo courtesy of fire department.)*

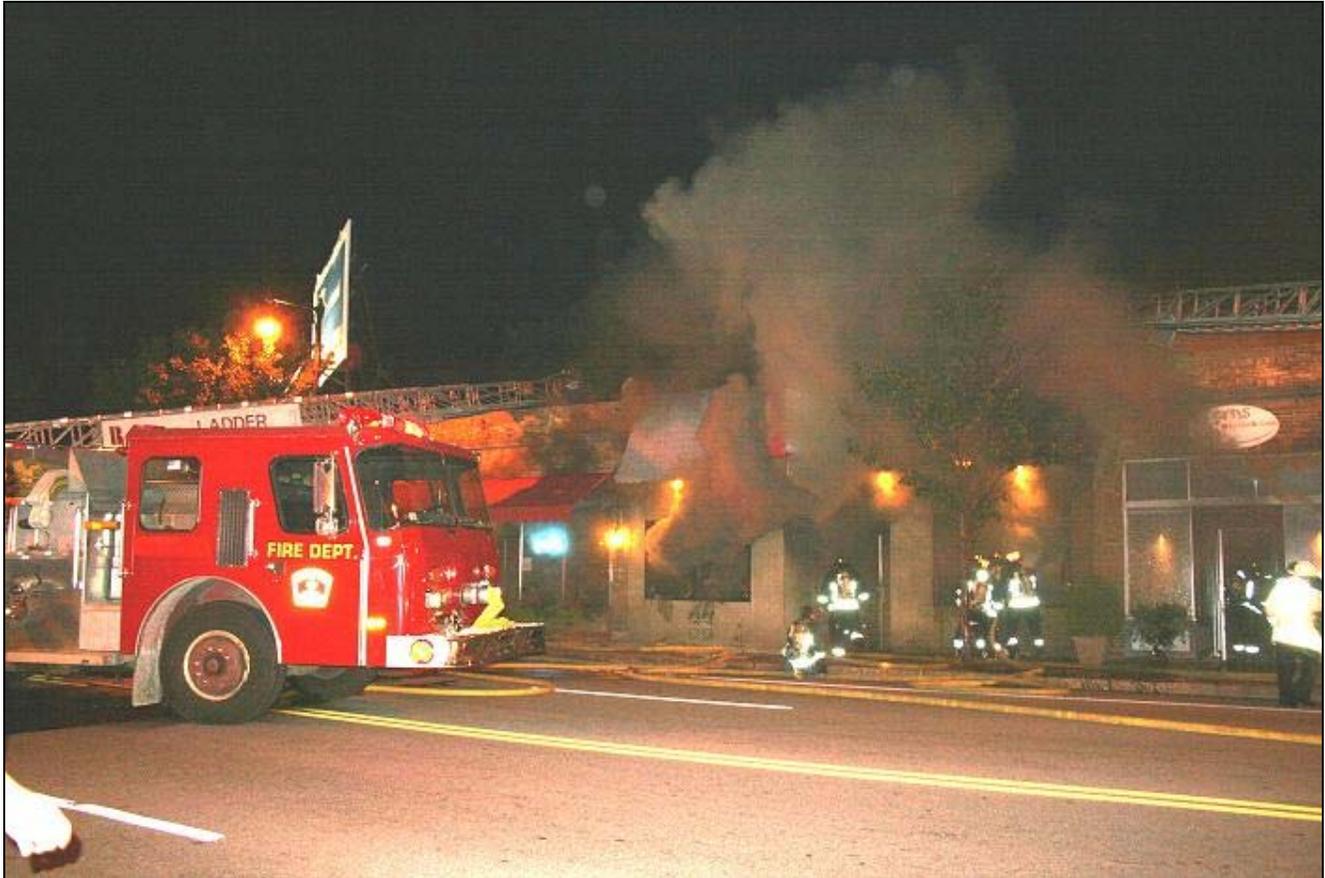
**Photo 8. Conditions after venting at 2114:40 hours.**  
*(Photo courtesy of fire department.)*

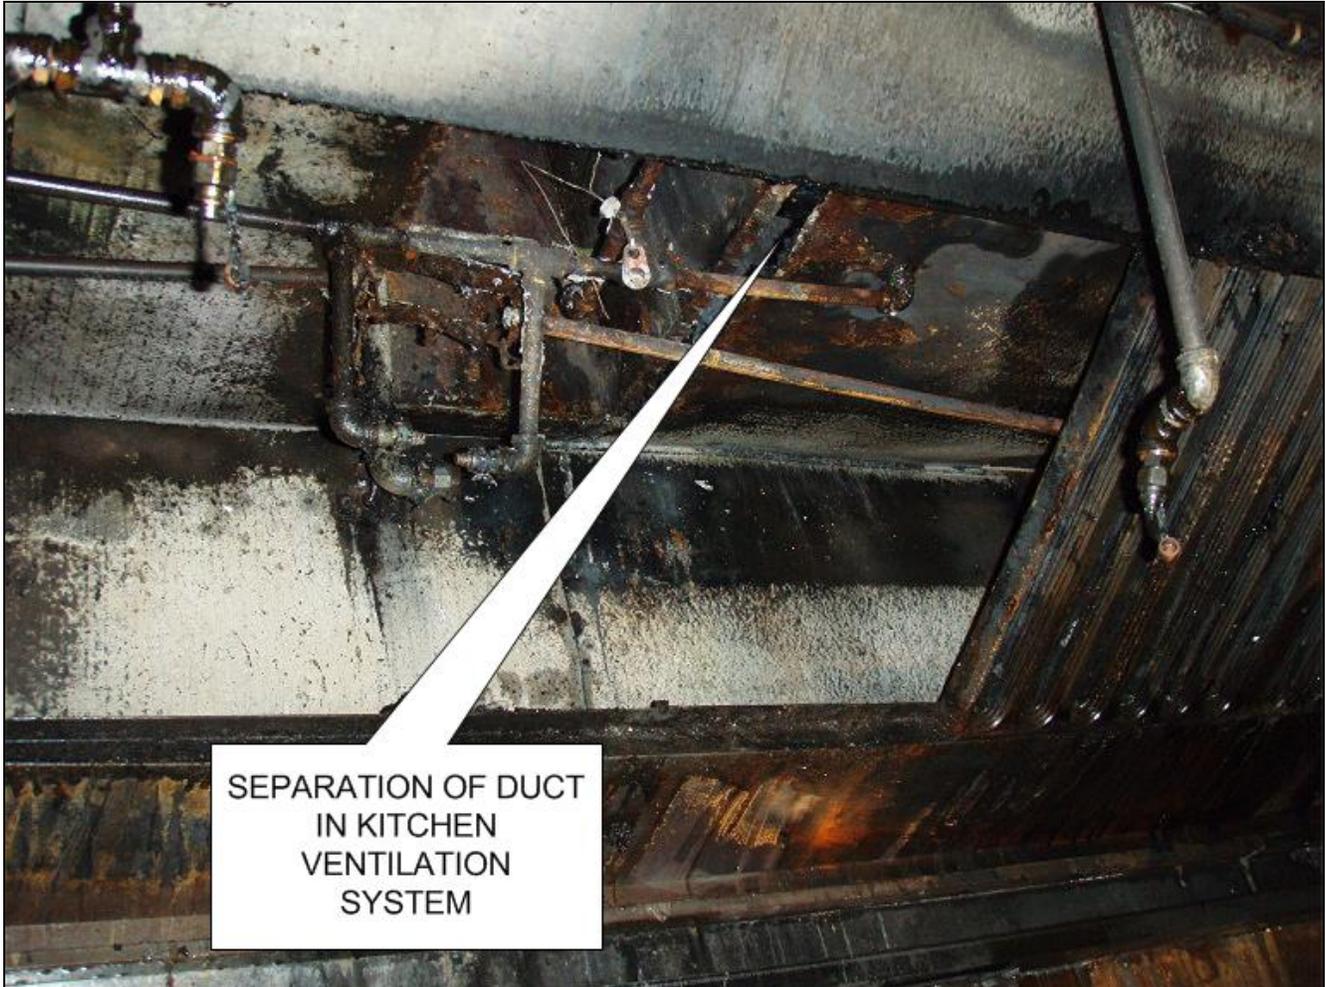
After the fatal fire, the exhaust system had been inspected by the fire department, the business owner, a fire protection equipment company, and a contracted engineering firm. The system consisted of galvanized sheet metal ranging from 26-gauge to 22-gauge thickness that is typically found in residential heating and cooling applications. It was connected with sheet metal screws and dovetail joints used in heating and cooling operations.

Discussion: The NFPA *Fire Protection Handbook* states “throughout history there have been building regulations for preventing fire and restricting its spread. Over the years these regulations have evolved into the codes and standards developed by committees concerned with fire protection. The requirements contained in building codes are generally based upon the known properties of materials, the hazards presented by various occupancies, and the lessons learned from previous experiences, such as fire and natural disasters.”<sup>35</sup> The restaurant where the incident occurred was constructed and in operation prior to the city adopting the requirements of NFPA 96, *Standard for Ventilation Control and Fire Protection of Commercial Cooking Operations*<sup>36</sup> into their building codes. After the fire, it was determined that there were multiple violations regarding the installation, materials, and maintenance used in the kitchen exhaust system. Some of the materials and installation discrepancies include: improper ductwork materials, improper/inadequate ductwork connections, penetration in ductwork, inadequate clearance to combustibles, lack of access for cleaning and inspecting, and the absence of ductwork enclosures. Ductwork should be 16 or 18-gauge stainless steel to withstand the intensity of a fire and provide for corrosive protection.<sup>36, 37</sup> The seams should be liquid tight and the duct work should have the proper clearance to combustibles or be enclosed. It should also have access points for adequate cleaning and inspecting. The ductwork in this incident was galvanized sheet metal typically used for residential heating/cooling applications. The ductwork was connected with sheet metal screws and dovetail joints associated with that type of application. It had corroded and provided a large opening for the grease from the cooking operations to exit into the cockloft area (Photo 9).

SEPARATION OF DUCT  
IN KITCHEN  
VENTILATION  
SYSTEM

**Photo 9. View behind filter of kitchen ventilation hood.**  
*(Photo courtesy of fire department.)*

***Recommendation #19: Code setting organizations and municipalities should require all commercial cooking operations to have periodic inspections of their kitchen exhaust systems and require all kitchen exhaust system installers to be certified to nationally recognized standards.***

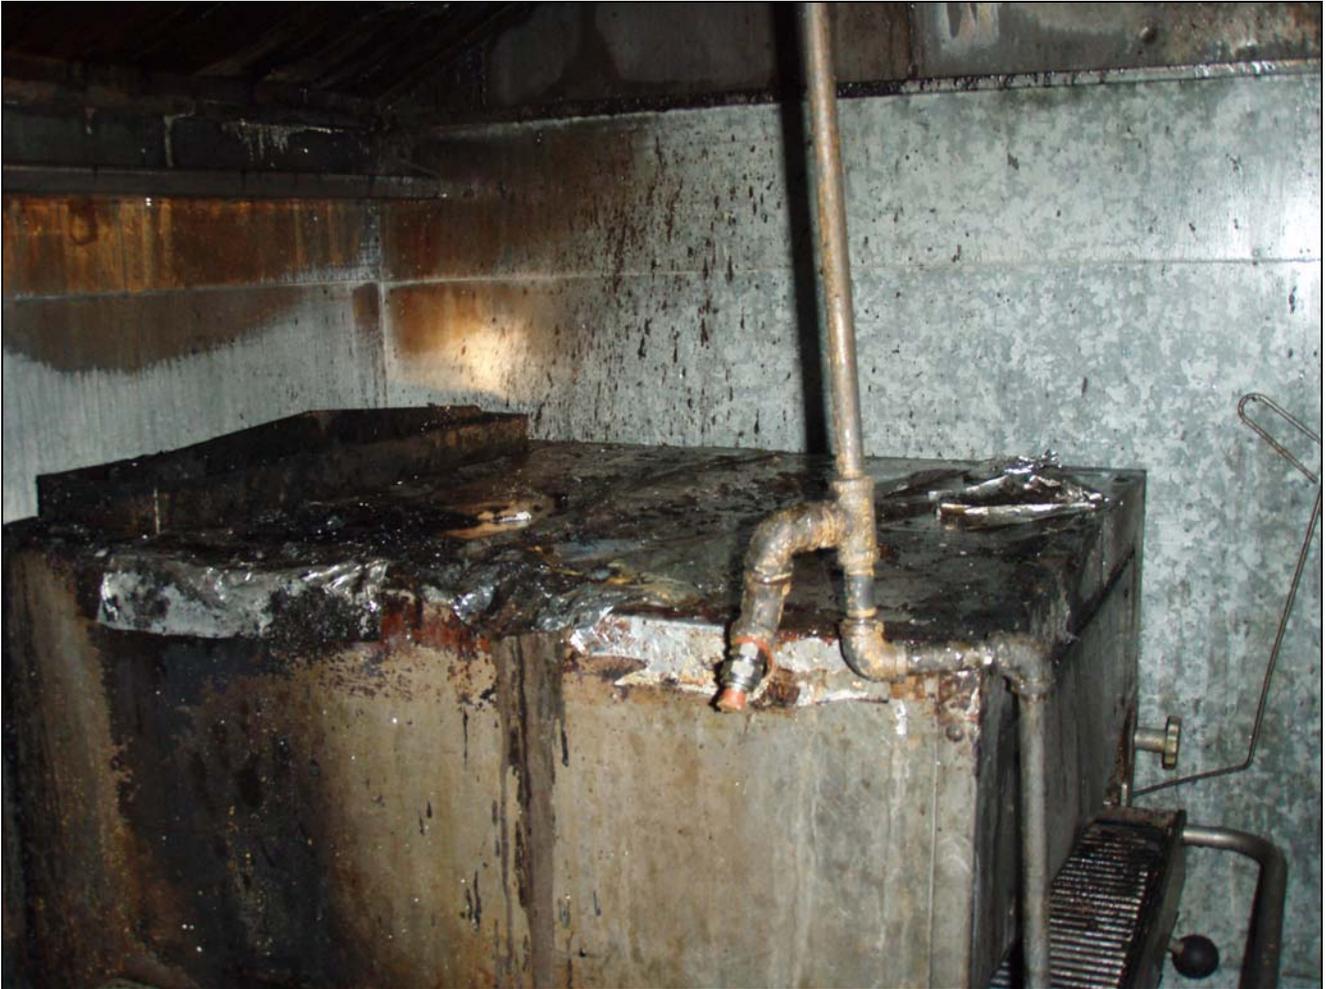
**Photo 10. Foil placed on top of broiler to catch grease that dripped from ceiling.**  
*Photo courtesy of fire department.*
