Two Career Fire Fighters Die Following a Seven-Alarm Fire in a High-Rise Building Undergoing Simultaneous Deconstruction and Asbestos Abatement—New York

SUMMARY

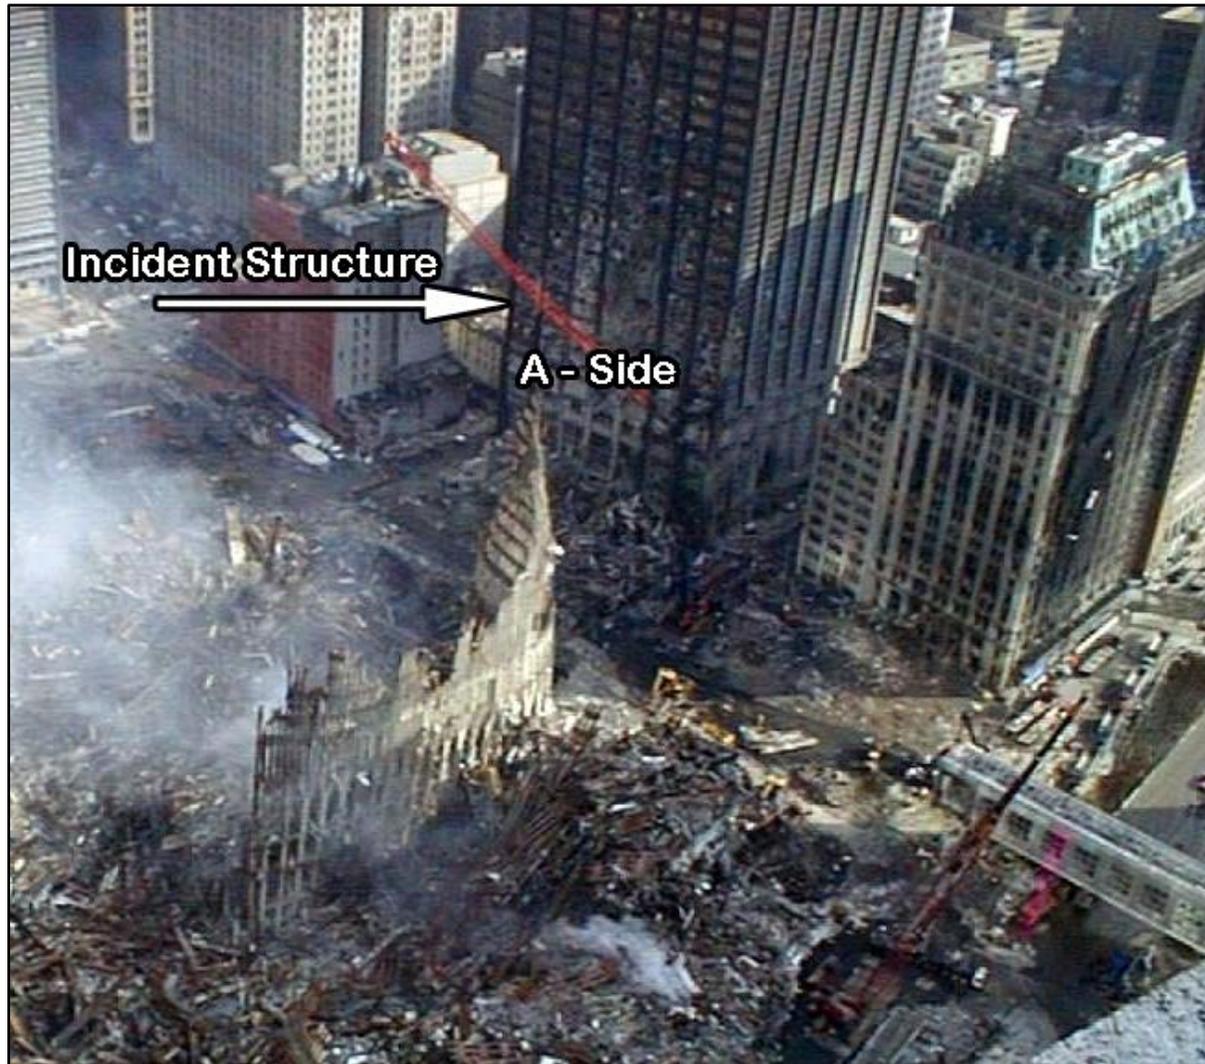
The structure was heavily damaged on September 11, 2001, when a multistory gash was torn into the north façade (A-side) by the collapse of surrounding buildings (see Photo 2). The structure remained abandoned and open to the elements allowing it to become contaminated with mold. Other contaminants (toxins such as asbestos, dioxin, lead, silica, polyaromatic hydrocarbons) and human remains were also present in the building.

Photo 2. View of the damage sustained to A-side of the incident structure following September 11, 2001.
(Photo courtesy of NOAA.)

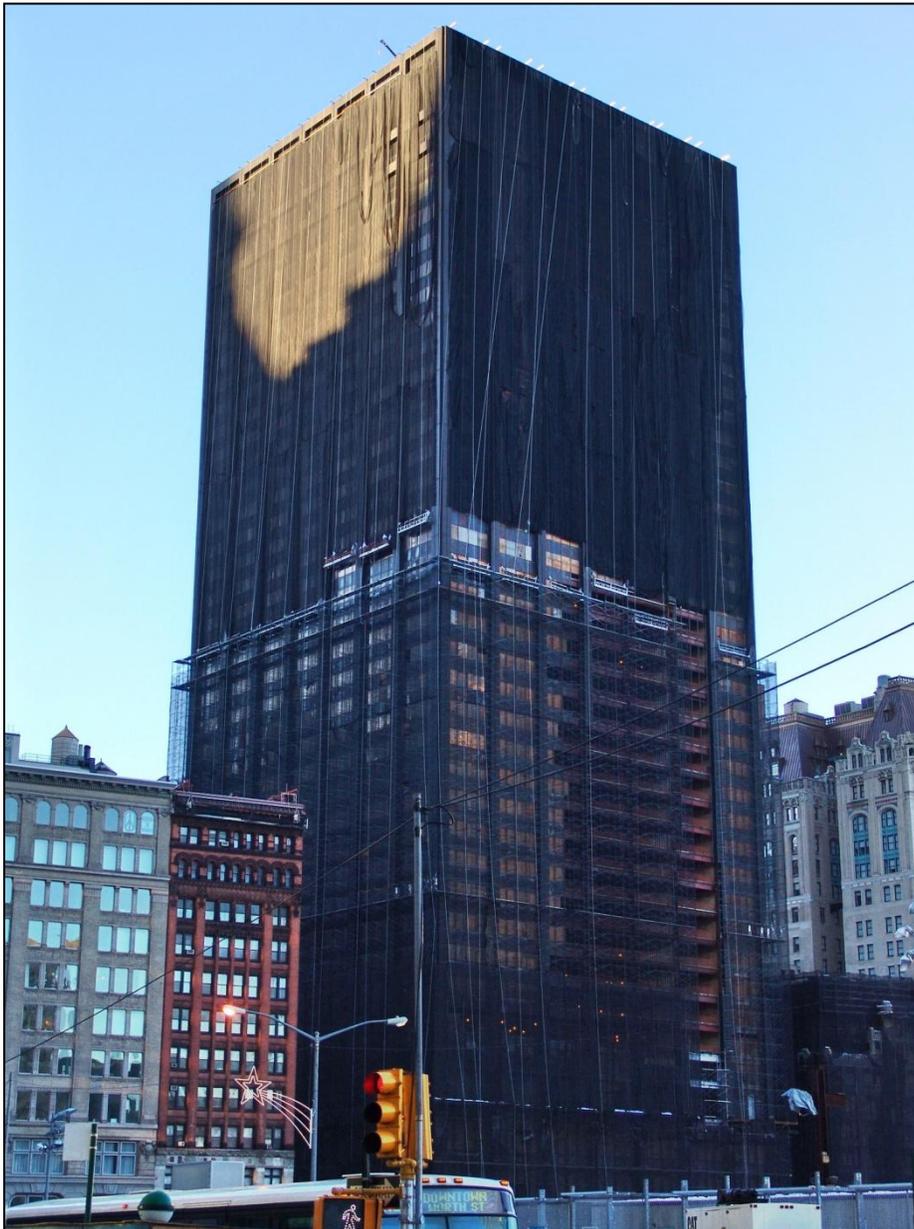
Photo 3. Incident structure beginning deconstruction in December 2006.
(Photo courtesy of fire department.)

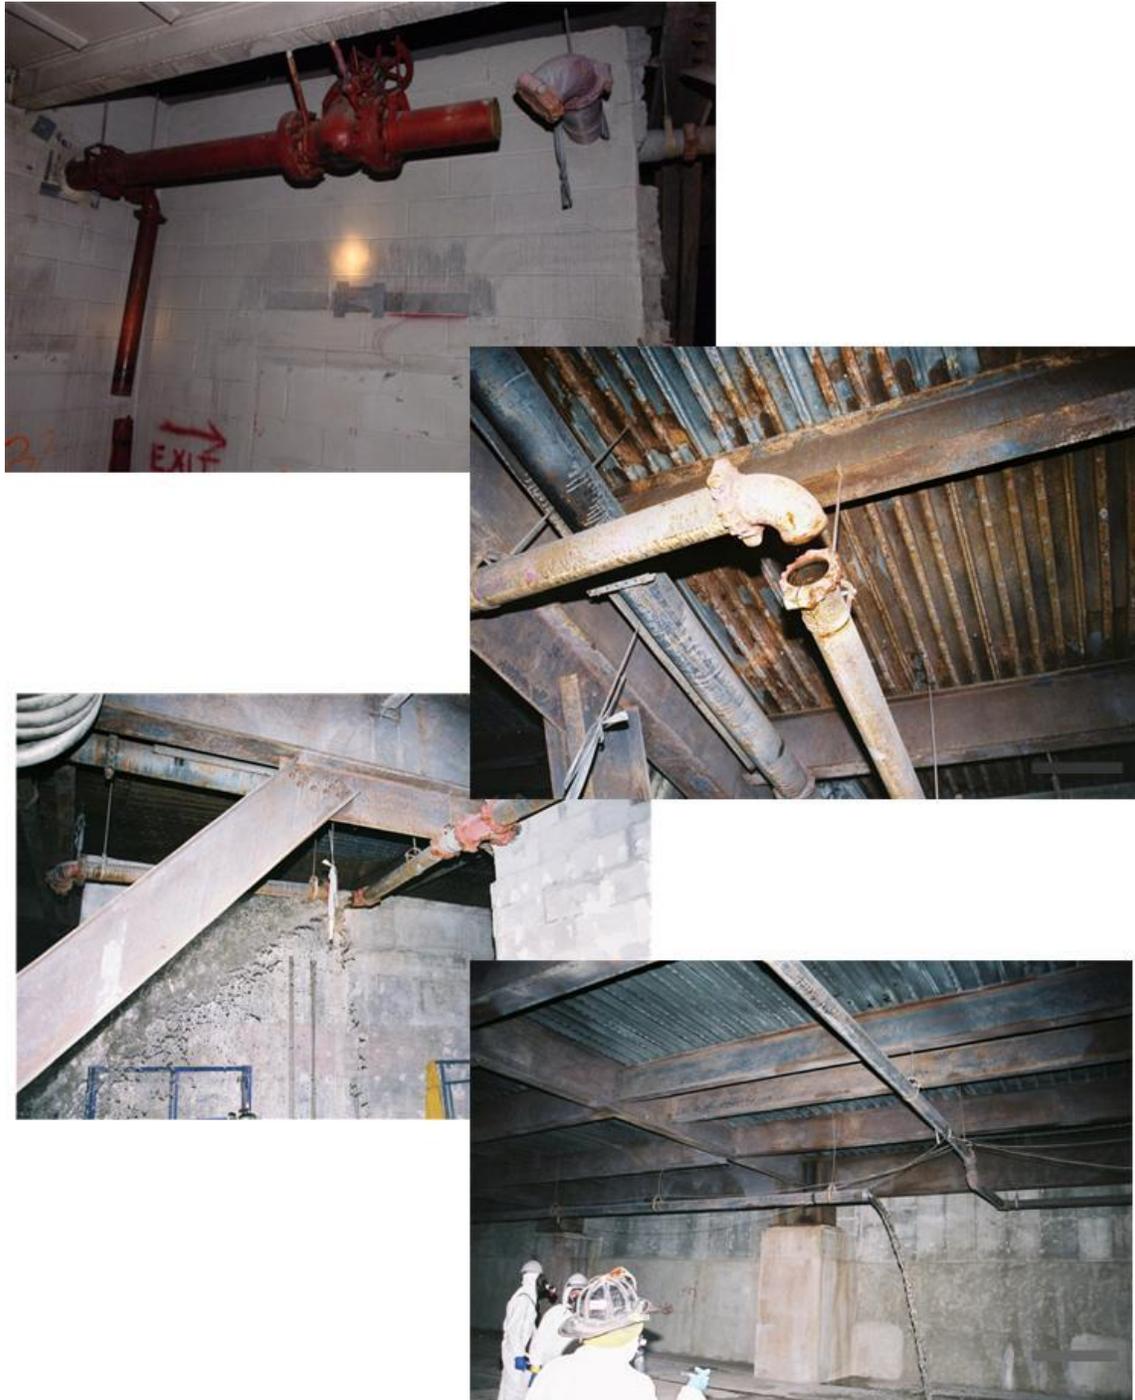
The Class III standpipe system was originally constructed with a fire department connection (FDC) on each side of the building. There were 6-inch standpipe risers in each stairwell extending from sublevel B to the top floor. Sections of standpipe in sublevel A had portions of the supply pipe missing; this prevented supplying any water to the system from any FDC. The standpipe FDC connection on the A-side was severely damaged and had been previously removed. Fire fighters connected to the B-, C-, and D-side FDCs on the day of the fire, and water flowed out the missing sections of pipe into sublevel A (see Photo 4). The standpipe riser in the A-stairwell was intact but the hose outlets used for fire fighting were either removed or capped. The standpipe riser in the B-stairwell was disabled. Building construction personnel had modified the system for construction use to only supply water from garden-type hoses on certain floors. The standpipe system was supplied by a manual 750-gallon-per-minute (gpm) fire pump and an automatic 500-gpm fire pump, both of which were out of service on the day of the fire.

Photo 4. Standpipe system was inoperable due to missing sections of pipe.
(Photos courtesy of fire department.)

Recommendation #2: Fire departments should be prepared to use alternative water supplies when a building's standpipe system is compromised or inoperable.

Section 10.8.2 “Safeguarding Construction and Alteration Operations: Fire Protection During Demolition, System Operation” states, “Where a building is equipped with sprinklers, the sprinkler protection shall be retained in service as long as the condition requiring the use of sprinklers exists.”³¹ The incident structure was originally equipped with sprinklers, but, subsequent to the demolition, the sprinkler system was partially removed and made inoperable.

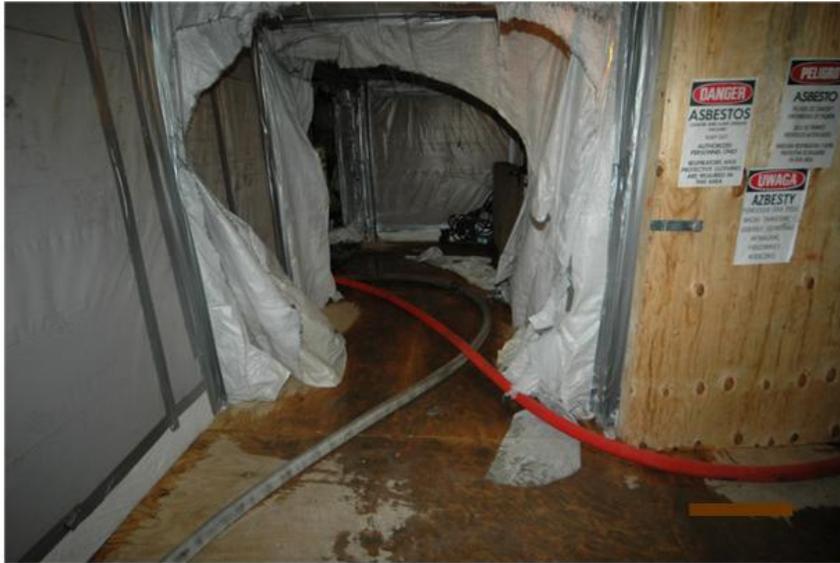
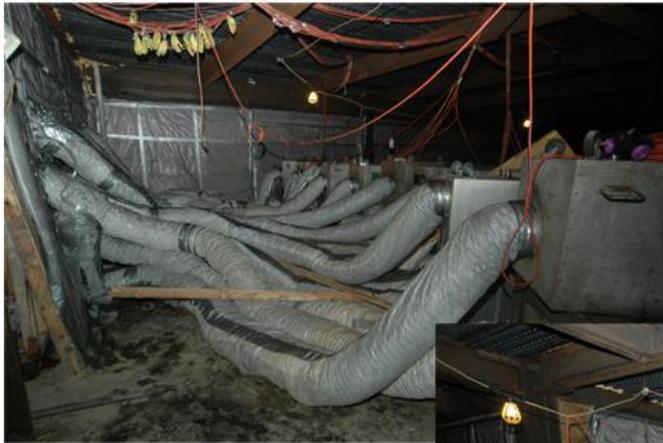
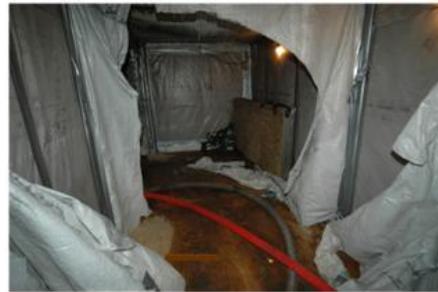
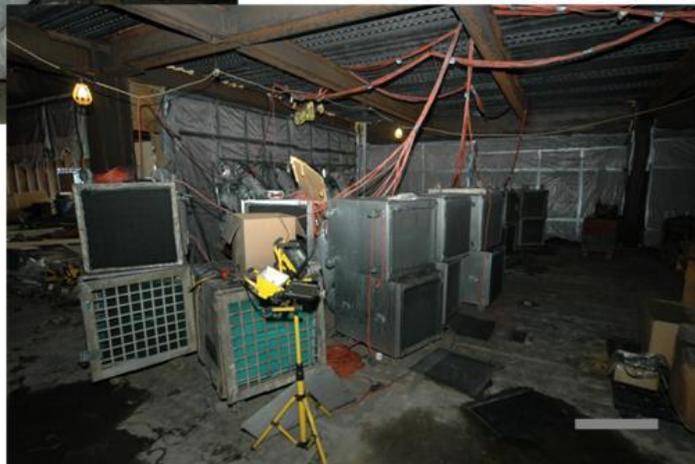
Photo 5. Plastic sheeting, ductwork and fans used for asbestos abatement.
(Photos courtesy of fire department.)

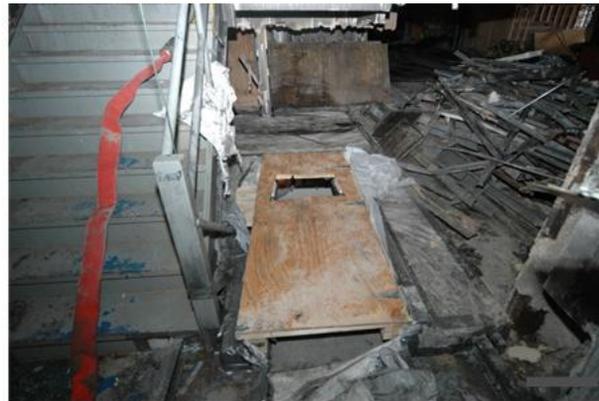
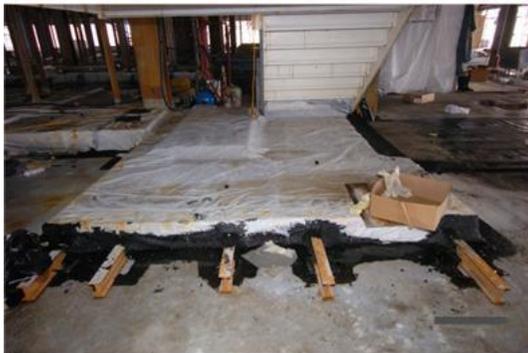
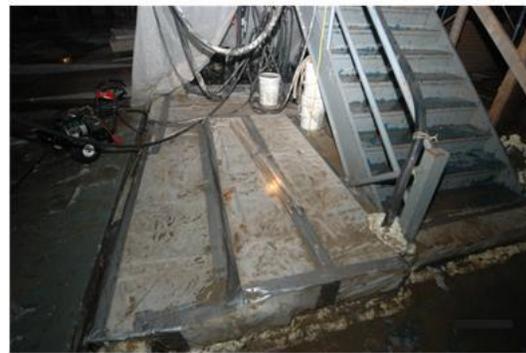
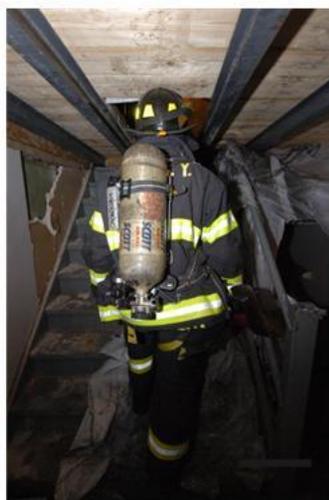
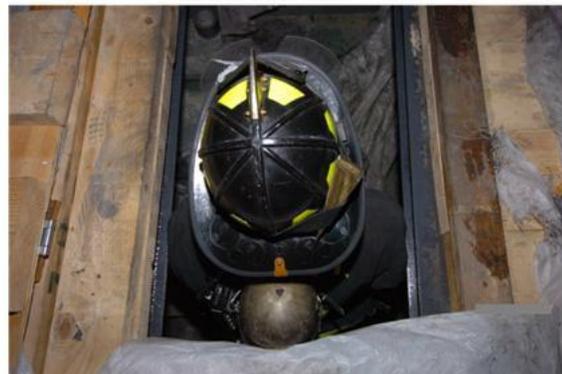
The Rescue 1 officer led the way to the 17th floor. The Ladder 10 officer dropped his TIC in the stairwell and could not locate it in the heavy smoke. At 1607 hours, the Rescue 1 officer reported to command that he could not see any flame but could hear fire crackling on the 17th floor A-stairwell landing. Battalion Chief 2 acknowledged and said to keep back since there was no water supply. At 1607 hours, command assigned units to check on the standpipe. Command ordered Ladder 15 to go below the 15th floor and check the standpipe riser. At 1611 hours, Battalion Chief 2 ordered Rescue 1 to the 14th floor since there was now fire on the 15th floor and no water. Rescue 1 and Ladder 10 both began to back down the A-stairwell. This was a very slow process since the hatches were small and only one fire fighter could pass at a time (see Photo 6). Fire fighters on the 16th floor were also backing down the B-stairwell.

Photo 6. Stairwell hatches.
(Photos courtesy of fire department.)

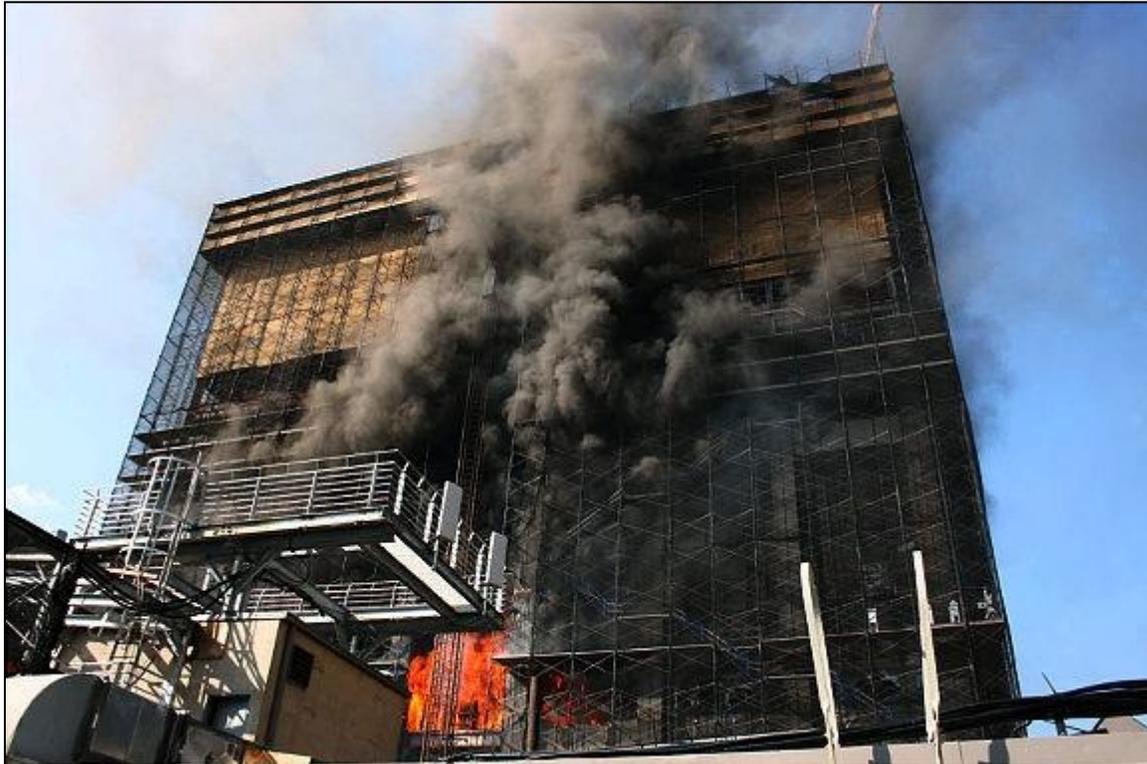
Photo 7. Fire conditions on C-side.
(Photo courtesy of fire department.)

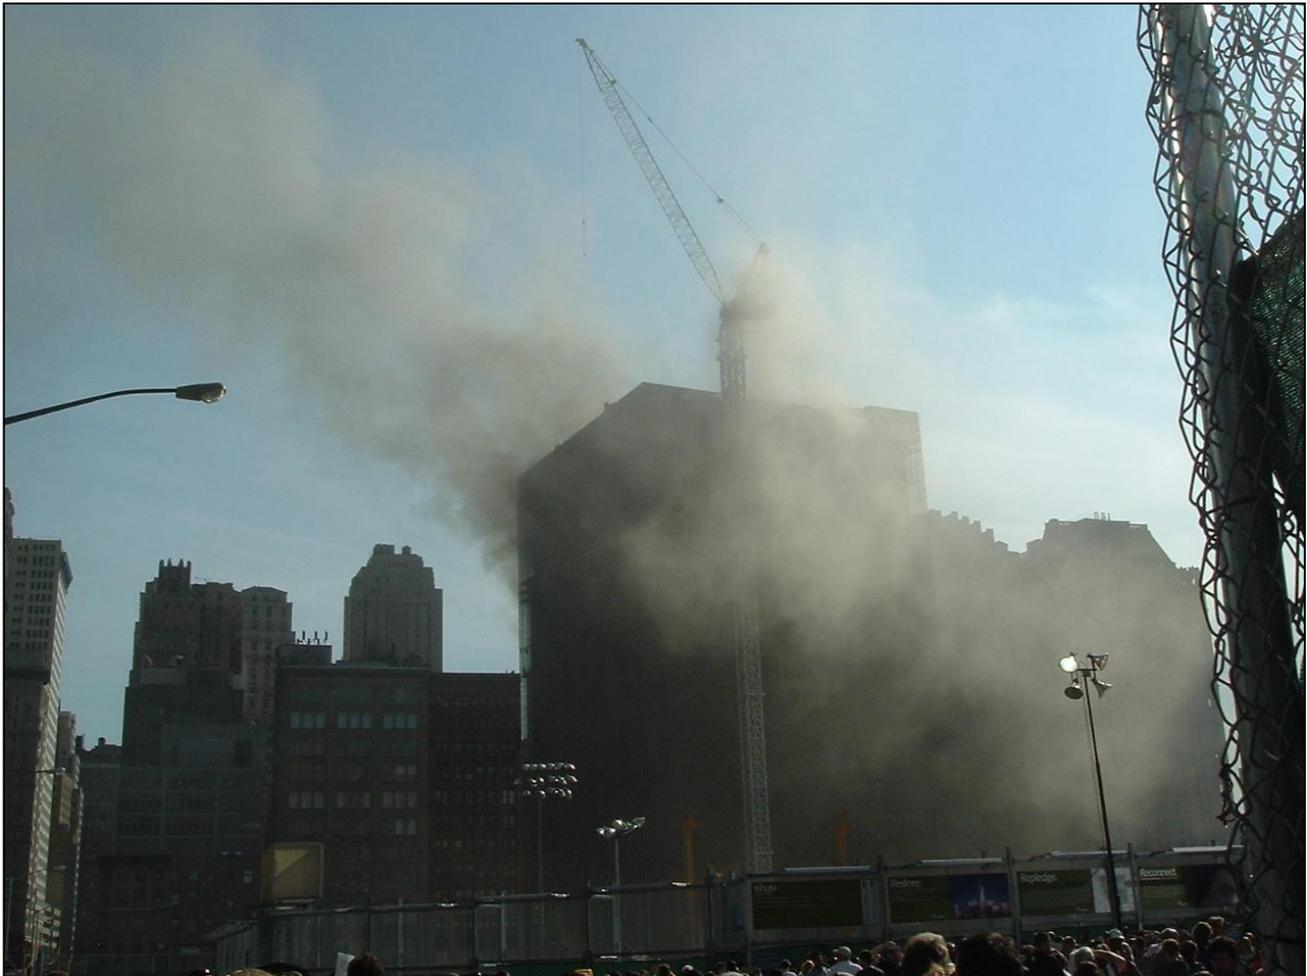
Photo 8. Fire conditions at 1658 hours.
(Photo courtesy of fire department.)
