Volunteer Fire Fighter and Trapped Resident Die and a Volunteer Lieutenant is Injured following a Duplex Fire - Pennsylvania

SUMMARY

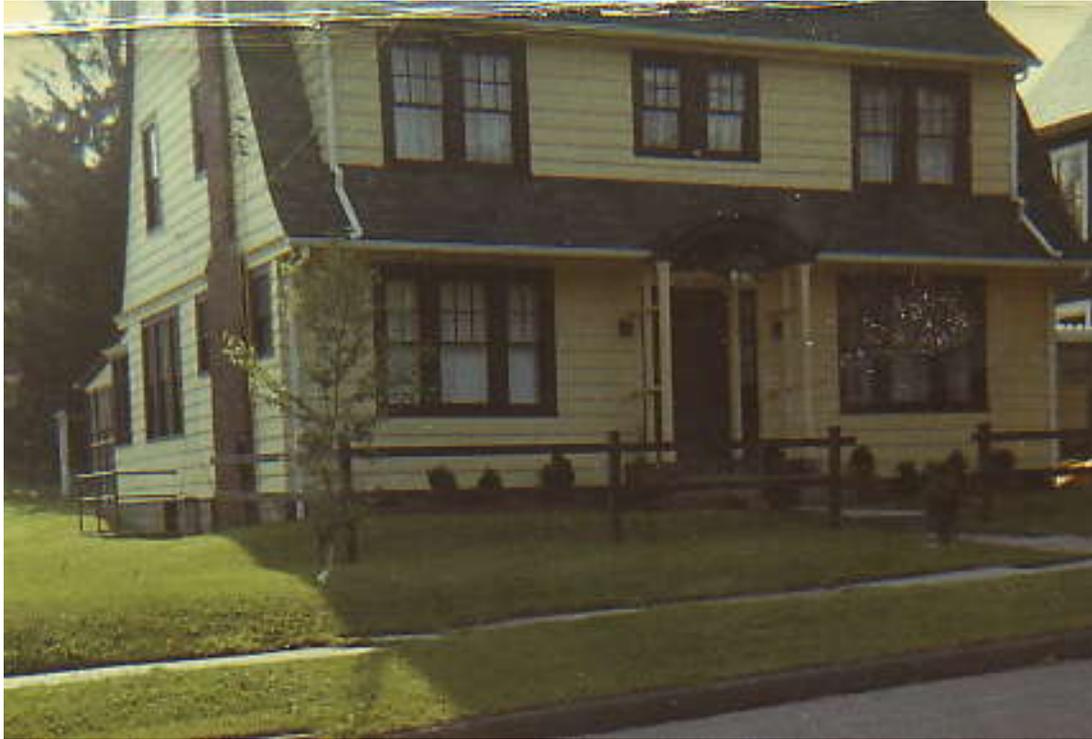
The incident structure was a two-story duplex originally built in the 1930s (see Photo 1 and Diagram 1). Each floor of the structure had approximately 1,088 square feet of furnished living area, with a 1,088 square foot unfinished basement. The structure was balloon-frame constructed and each unit of the duplex was a mirror image of the other. Each first floor had a living room, dining room and kitchen. There were two 40 square foot decks, one for each unit, at the rear of the structure and the units shared a common front entry. The second floors had two bedrooms and a bathroom. Interior construction was plaster over wood lath with carpeting over hardwood floors. The right unit had wood paneling throughout the first floor. Exterior construction was wood clapboards over wooden framing. The building owner had previously lived in the structure as a single family residence and had installed adjoining doors on the second floor and attic level in the 1960s. The building was not insulated and did not contain a rated fire wall between the units. The roof consisted of asphalt shingles and the house sat on a 75 x 75 foot level lot.

Photo 1. Structure prior to incident.
(Photo courtesy of Fire Marshal)

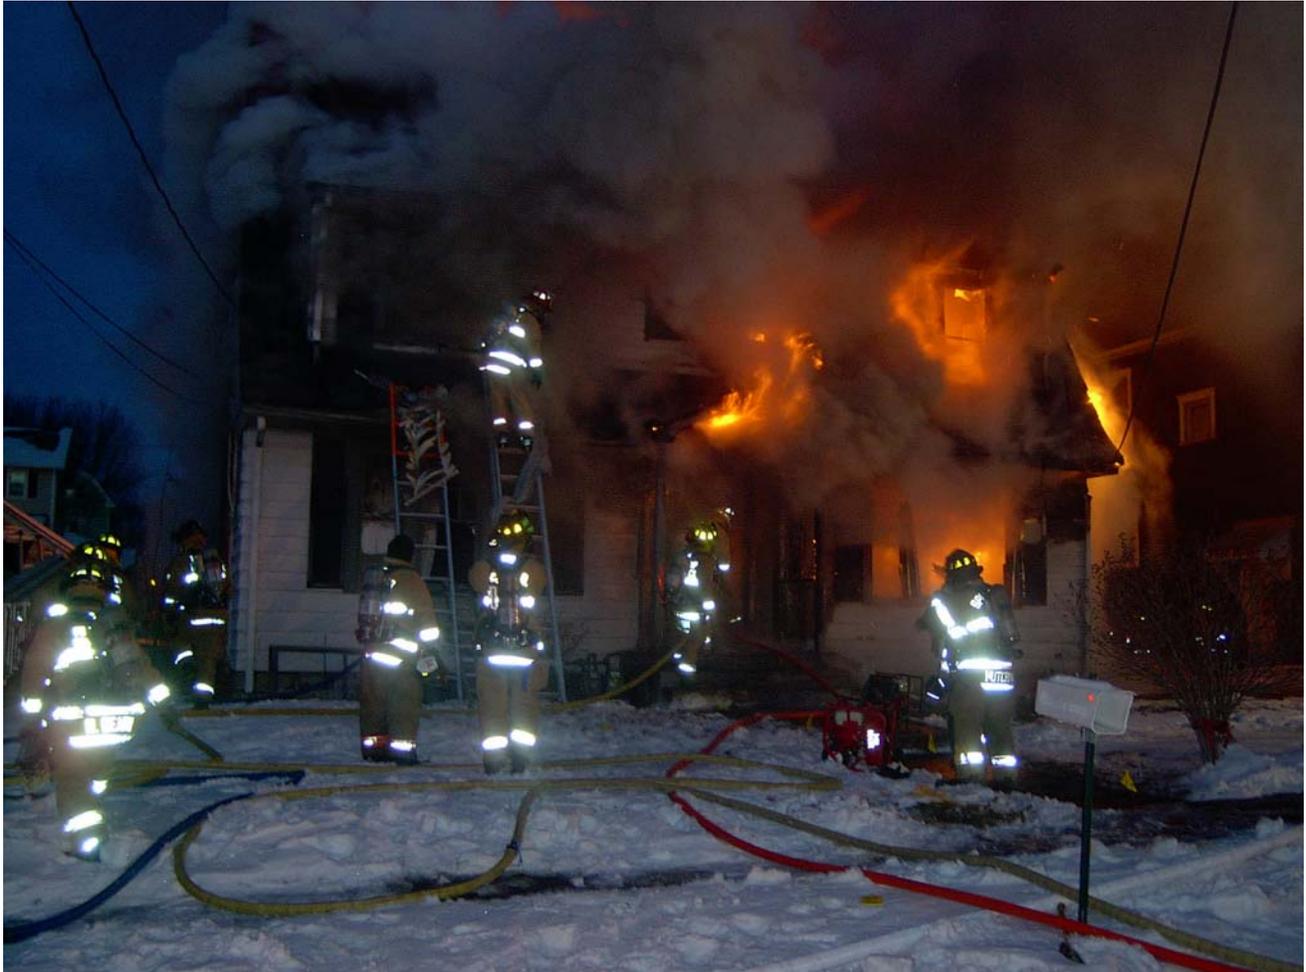
Photo 2. Incident scene.
(Photo courtesy of the fire department)

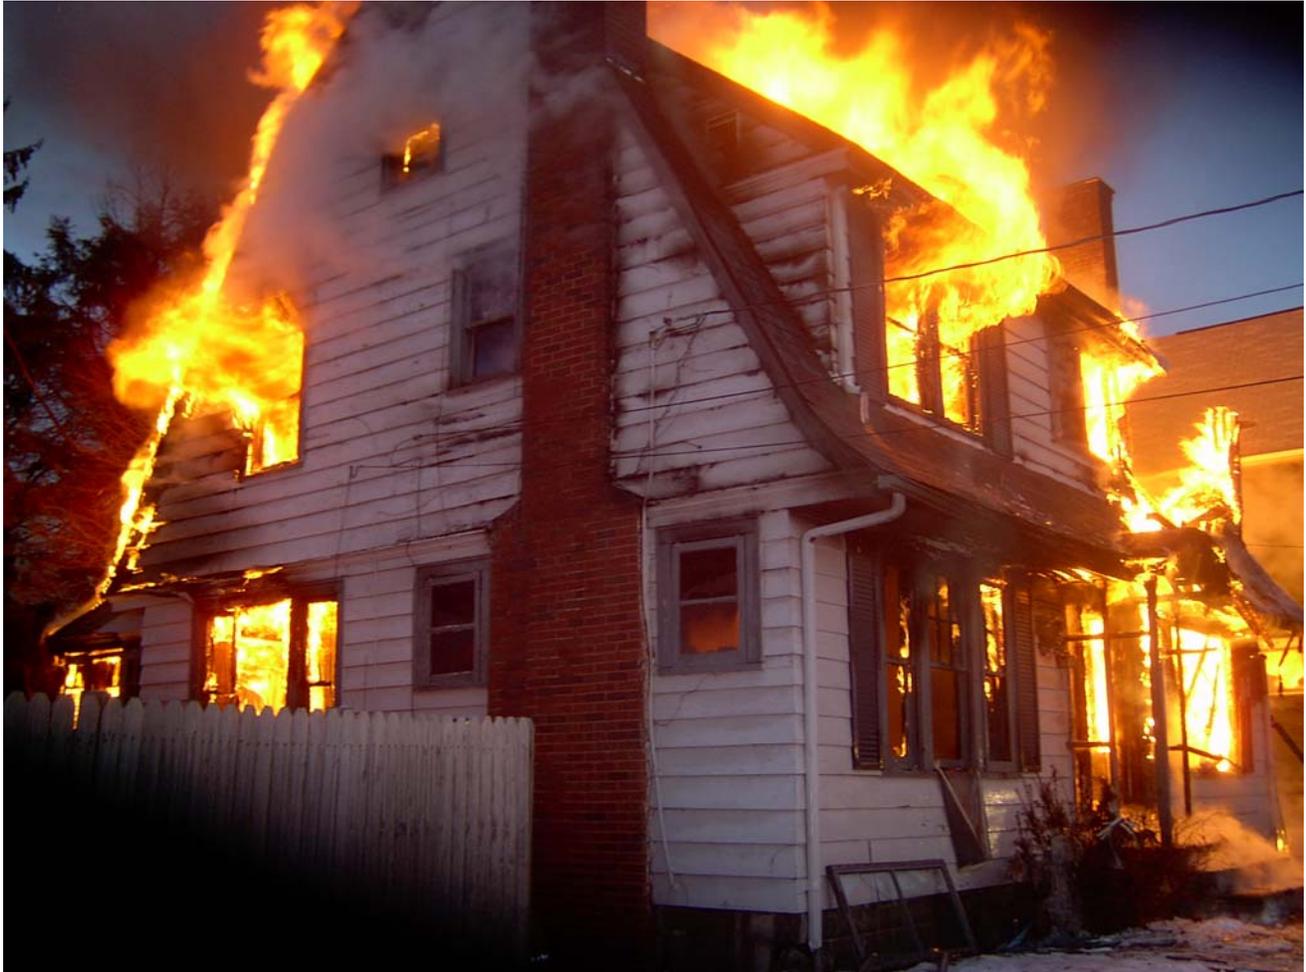
The IC changed his fire attack approach to defensive immediately following the evacuation horn (see Photo 3). Fire fighters concentrated on protecting exposures and suppressing a vehicle fire caused by the collapse of the "D" side wall. A water shuttle was set-up to supply water for their defensive attack.

Photo 3. Deteriorating fire conditions after evacuation.
(Photo courtesy of the fire department)

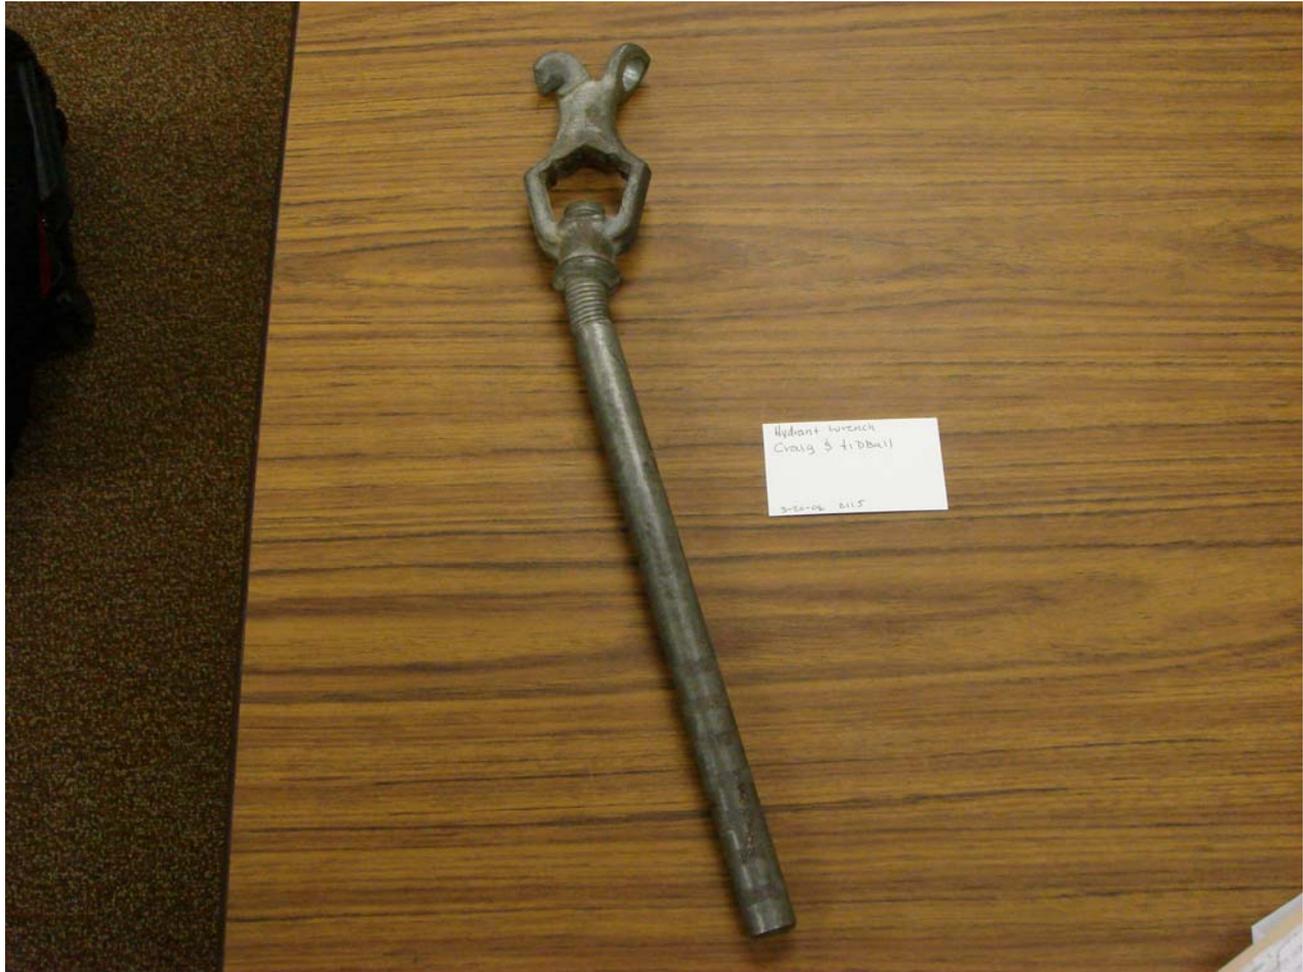
The weather at the time of the incident was partly cloudy with a temperature of 6°F and calm winds. The cold weather was a factor in this incident with two frozen hydrants in the vicinity of the structure.

large diameter hoses (LDH) for a hydrant water supply line. Fire fighters were unable to open two of the hydrants in the vicinity of the incident structure. Fire fighters bent their hydrant wrench on one of the frozen hydrants (see Photo 4). These hydrants were checked and lubed twice a year by public works officials and opened freely several hours after the fire incident. Temperatures that morning were around 6°F, with several inches of snow on the ground. Fireground operations were mainly run from apparatus tank water; this caused fluctuations in water pressure and sometimes no water at all. The hydrants installed in this neighborhood were dry-barrel hydrants. Dry-barrel hydrants are routinely installed in geographical areas that are exposed to freezing conditions. Dry-barrel hydrants are still opened the same as wet-barrel hydrants, except that the main valve is located underground below the frost line. Once the dry-barrel hydrant is closed, the water in the barrel will drain out underground through drain holes.² These drain holes remain open until the hydrant is opened again, allowing flow of water. It is believed that either the drain holes got clogged, not allowing water to drain out from a prior use, or that ground water from excessive rainfall found its way into the barrel via the opened drain holes and froze, rendering the hydrants inoperable. In preparation for potential issues, fire departments should develop standard operating procedures (SOPs) for temporary water sources to be dispatched like tankers, water shuttles, or portable drop tanks.

Photo 4. Bent hydrant wrench.
(NIOSH photo)

Recommendation #1: Fire departments should be prepared to use alternative water supplies during cold temperatures in areas where hydrants are prone to freezing.

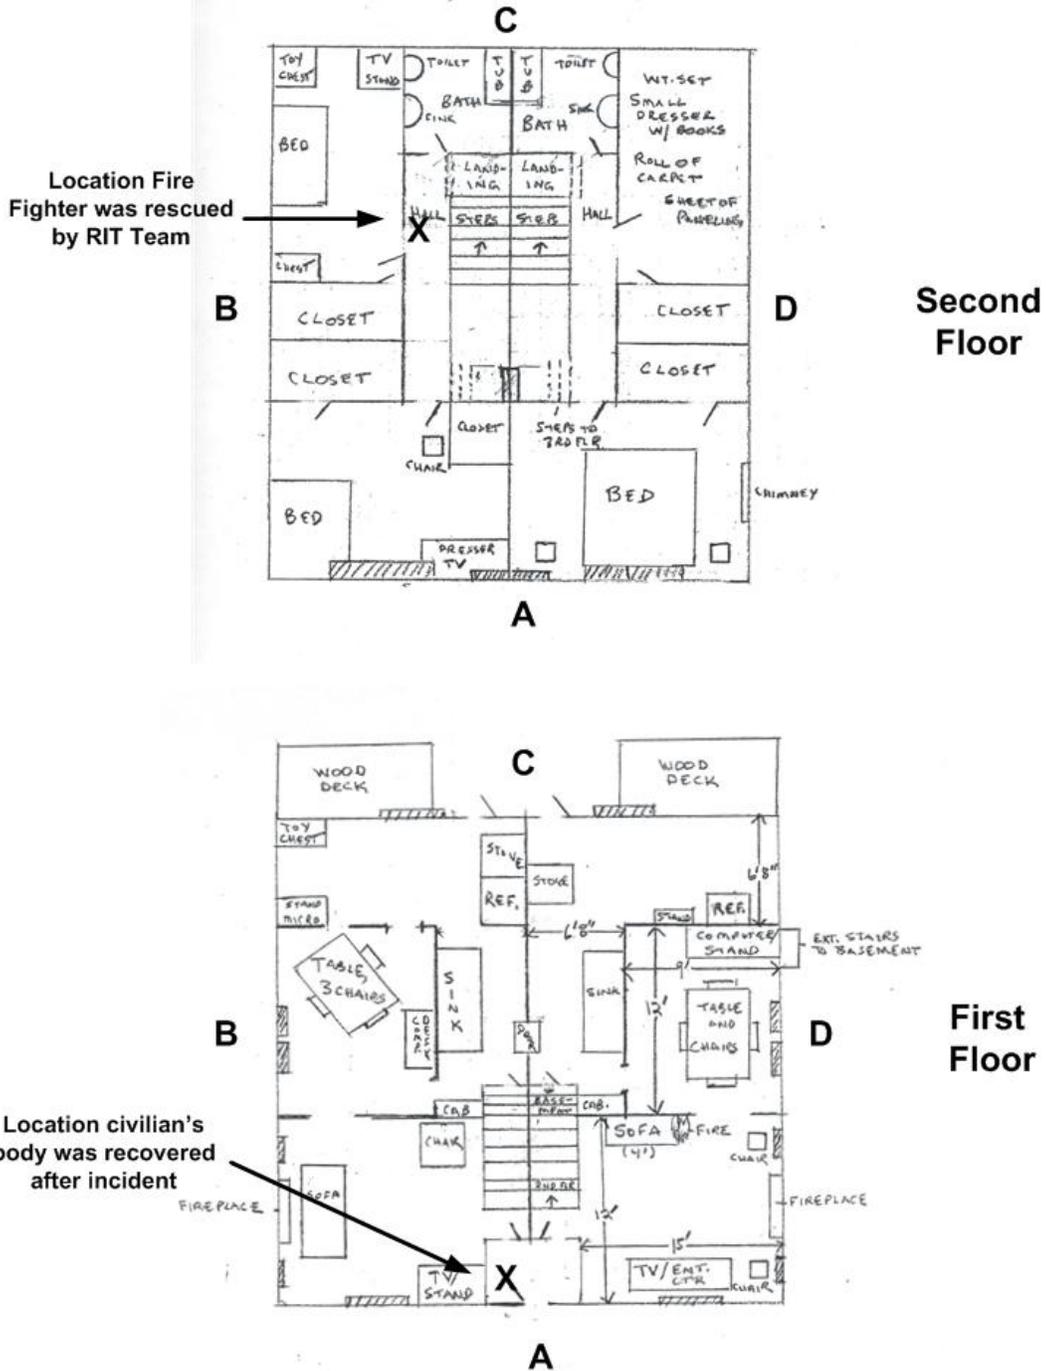
Diagram 1. Layout of the Duplex First and Second Floors (Courtesy of Fire Marshal)

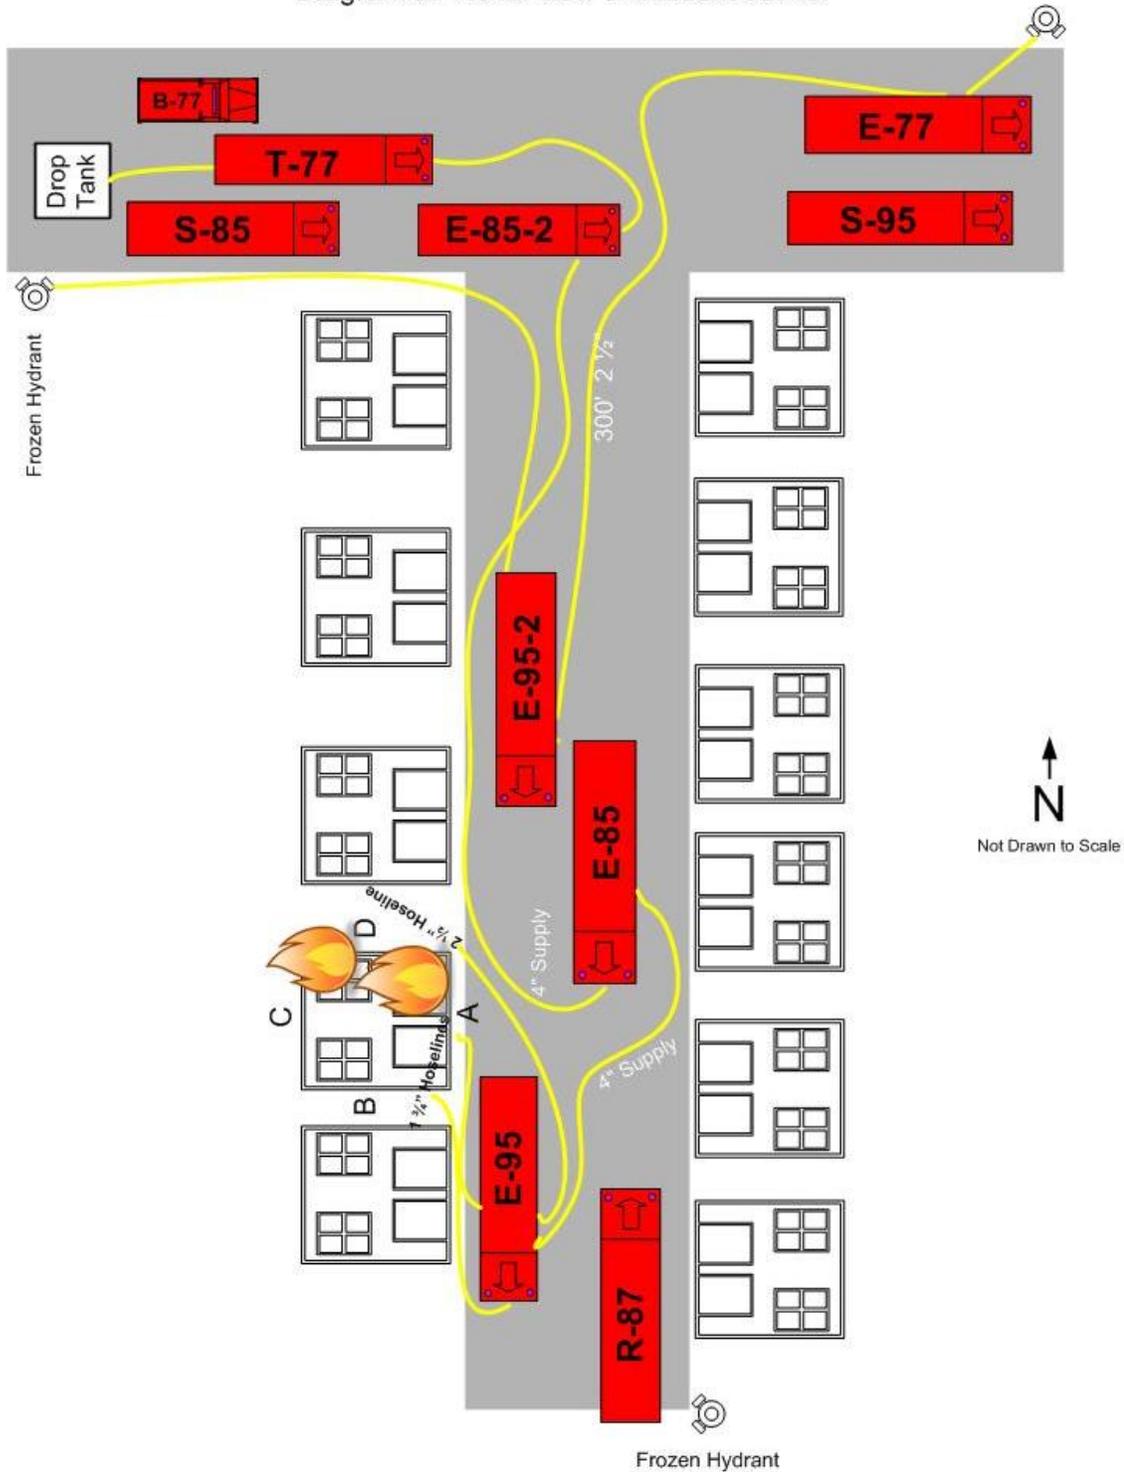
E95 arrived on scene at 0620 hours and pulled just past the burning structure (see Diagram 2). They were instructed while enroute by the IC to perform fire suppression activities. Heavy smoke and fire was coming from the 1st and 2nd story windows on the right side of the house. The crew exited the engine and deployed the pre-connected 1 ¾” hoseline to the front door and a 2 ½” hoseline to the “A-D” corner. The crew checked in with the accountability officer and gave him their accountability tags. They started to flow water with the 1 ¾” hoseline from the common foyer but could not make entry into the right unit due to heavy fire conditions. Water was also being flowed at the “A-D” corner. *(Note: No supply line had been established with a hydrant; thus the hose crews were operating from tank water).* The officer vented a large window on the “A” side first floor of the left unit to let smoke out. The officer looked in this window and did not see the civilian victim, but noticed that the ceiling light was still on. E95 members, under the supervision of their officer, supplied a second 1 ¾” line to the search crew (victim and injured Lieutenant) at this same window after they made entry through it for a primary search. The E95 officer noticed that the search crew had finished their search on the first floor and were advancing to the second floor. He then placed a ladder to the second floor on the “A” side and broke the window out at the “A-B” corner (see Photo 2). He stated that there was not much heat on the second floor because the plastic insulation on the window was not melted, but he did notice heavy black smoke beginning to bank down. After venting this window he descended the ladder because he noticed a loss in water pressure from hoselines being operated at the front entrance and “A-D” corner. Within minutes an air horn sounded for evacuation from the structure. The E95 officer then went to a “B” side window on the second floor after hearing radio traffic that the search crew could not find their way out and they were by a window. He broke out a second floor window to release more smoke and to see if he could get the search crew out. The injured Lieutenant exited the structure through the front door and advised fire fighters that the victim was on the second floor. The RIT (R87) made entry at this time and rescued the victim.

Diagram 2. Aerial view of incident scene.
