NIOSH
Fire Fighter Fatality Investigation
and Prevention Program

A summary of a NIOSH fire fighter fatality investigation

Volunteer Deputy Fire Chief Dies When Struck by Motorized Water Monitor that “Launched” Off Aerial Ladder Truck – Pennsylvania

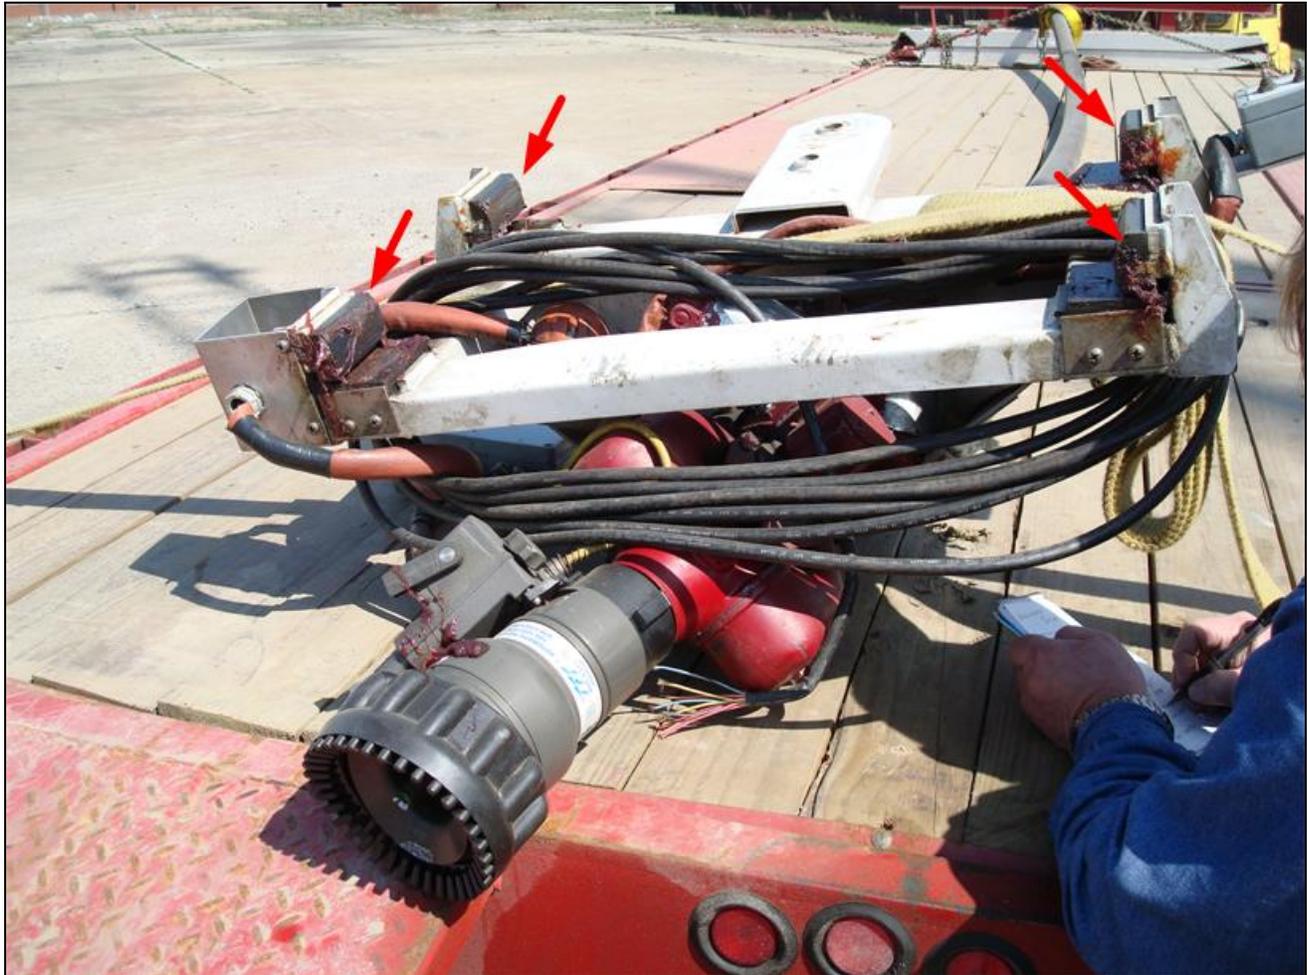
Photo 2. Waterway that “launched” during incident. Arrows depict Nylatron[®] pads that are greased to aid movement as the ladder extends and retracts. (NIOSH photo.)

- c. The monitor housing was cracked.
 - d. The waterway pipe was curved to the right and up when the unit was placed in a normal position. It appears that this may have been caused when the monitor control cable reached the end of its travel and pulled the pipe up and to the right.

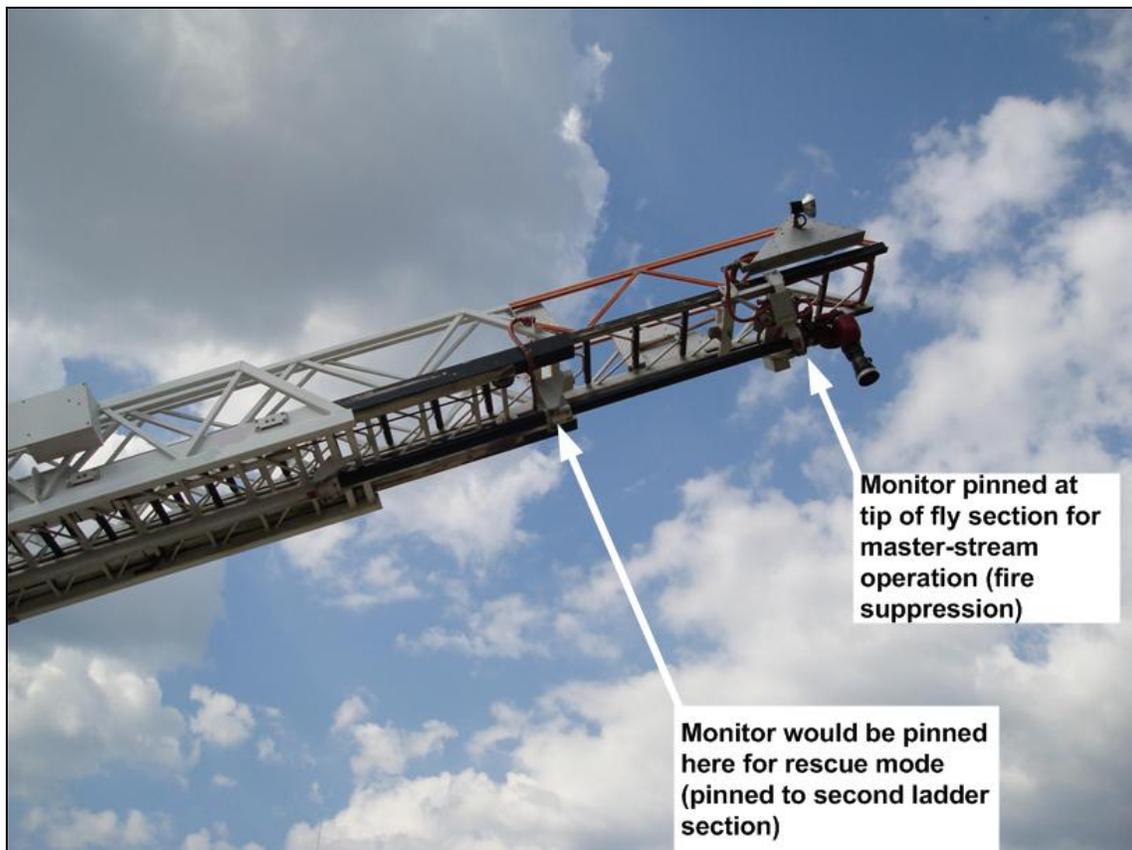
Photo 3. Water monitor at tip of aerial ladder. This is the normal position for defensive master stream operation. Arrows depict where the monitor would be pinned for master stream operation and rescue mode. Aerial ladder shown is similar to the one involved in this incident.

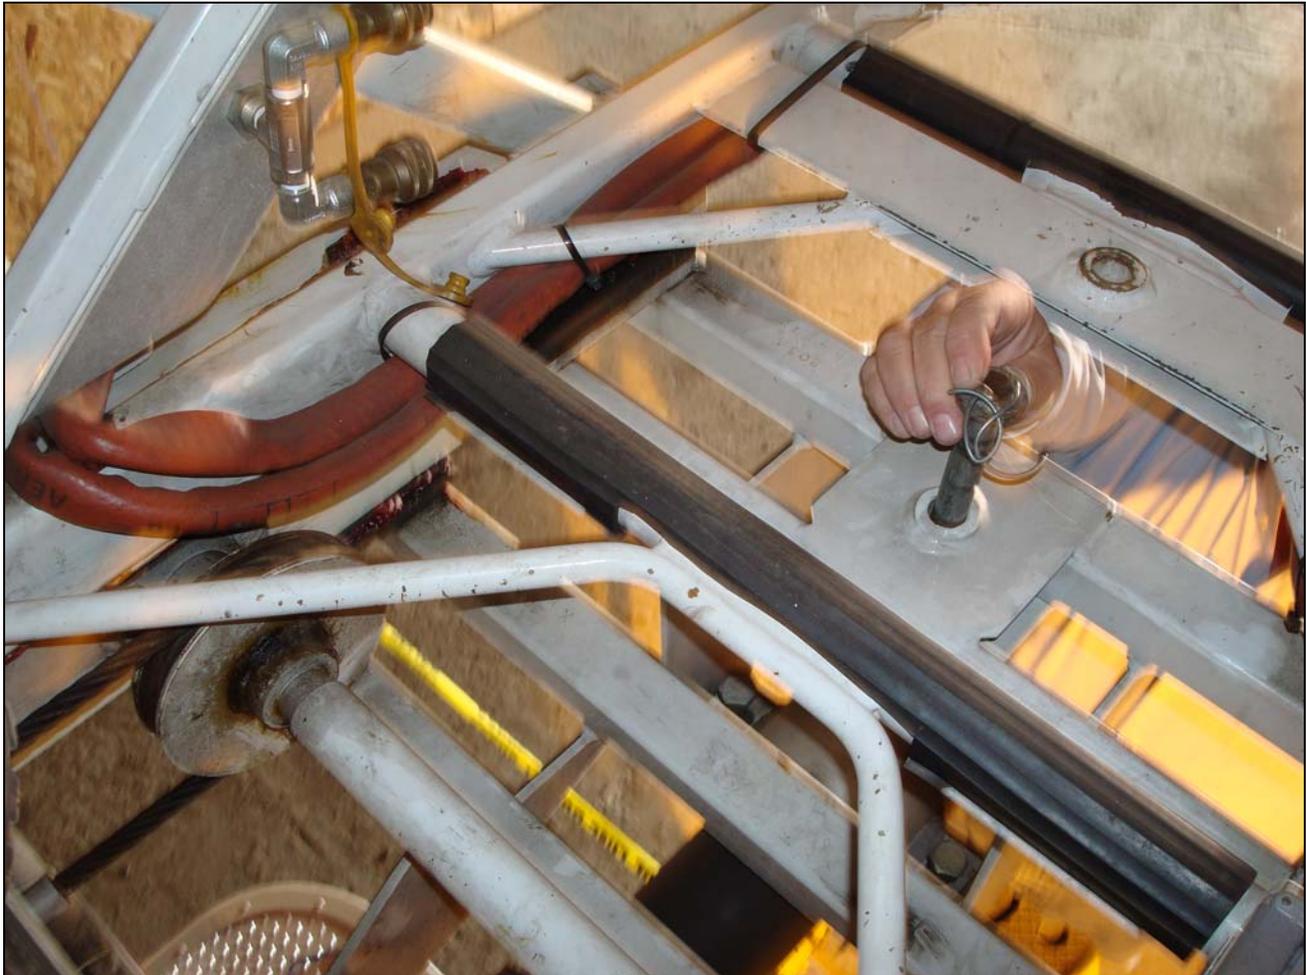
Photo 4. Aerial ladder involved in the incident. Photo shows pin being inserted into the rear or lower hole. This is the pin position for rescue operations (water monitor pinned to second section of ladder – this hole is the rear or lower of the two). (NIOSH photo.)

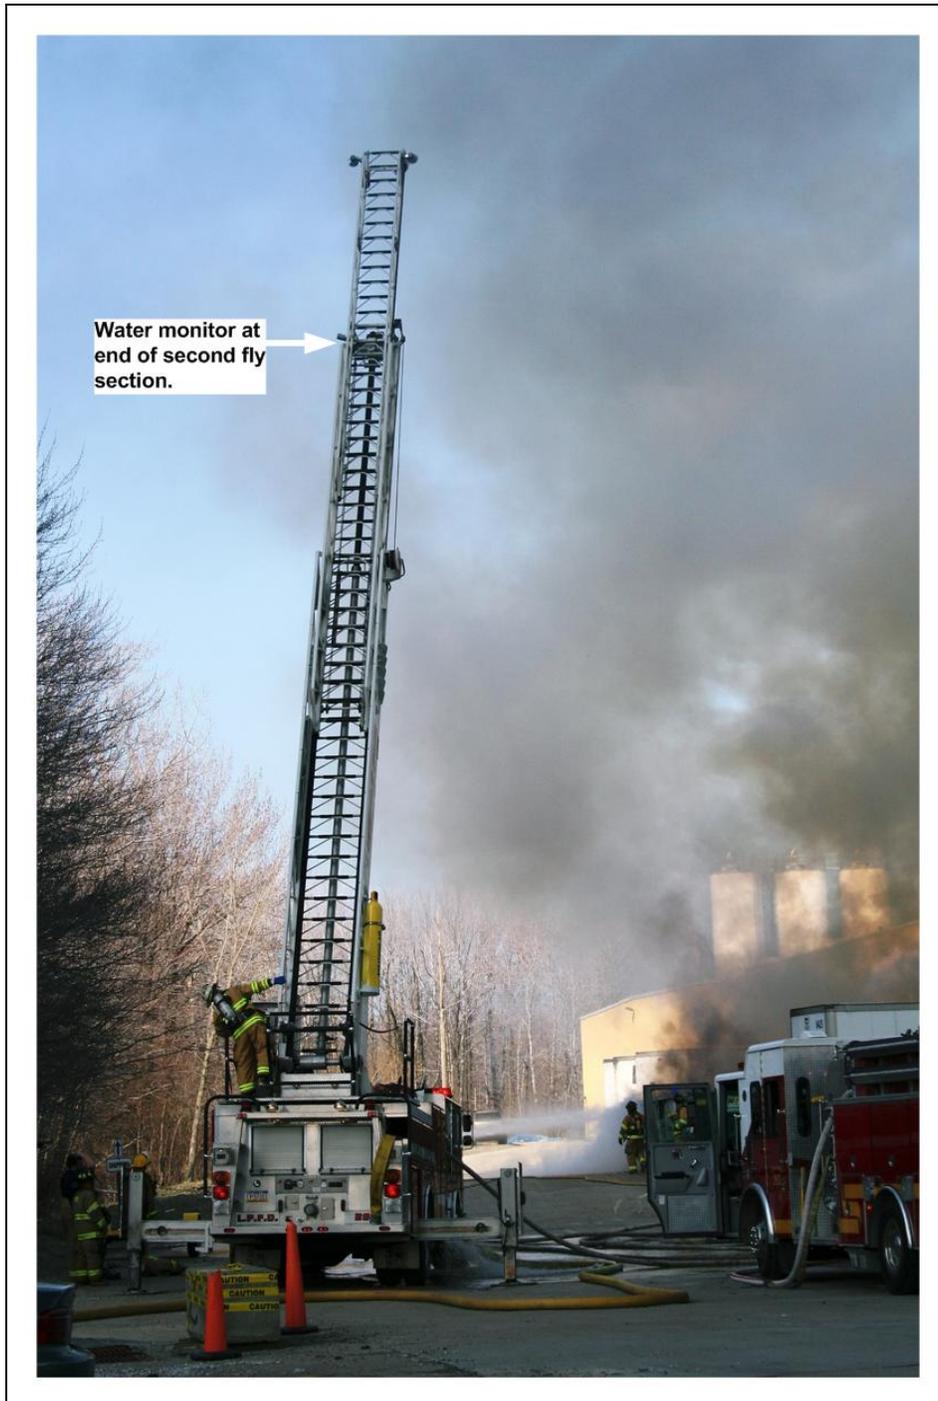
Photo 5. Photo taken just seconds before fatal launch. Note the water monitor is still in the rescue position. (Photo courtesy of Matt Skrekla.)

Since the pin intended to anchor the monitor assembly to the ladder was found on the ground in front of the truck after the incident, the NIOSH investigators concluded that it had not been properly installed.

Recommendation #1: Fire departments should ensure that Standard Operating Procedures (SOPs) and/or Guidelines (SOGs) for setting up multi-position waterways include steps to properly position the waterway and to inspect and verify that the locking mechanism (anchoring pin(s), lever, clamps, etc.) are properly installed and functioning as designed before pressurizing the waterway.

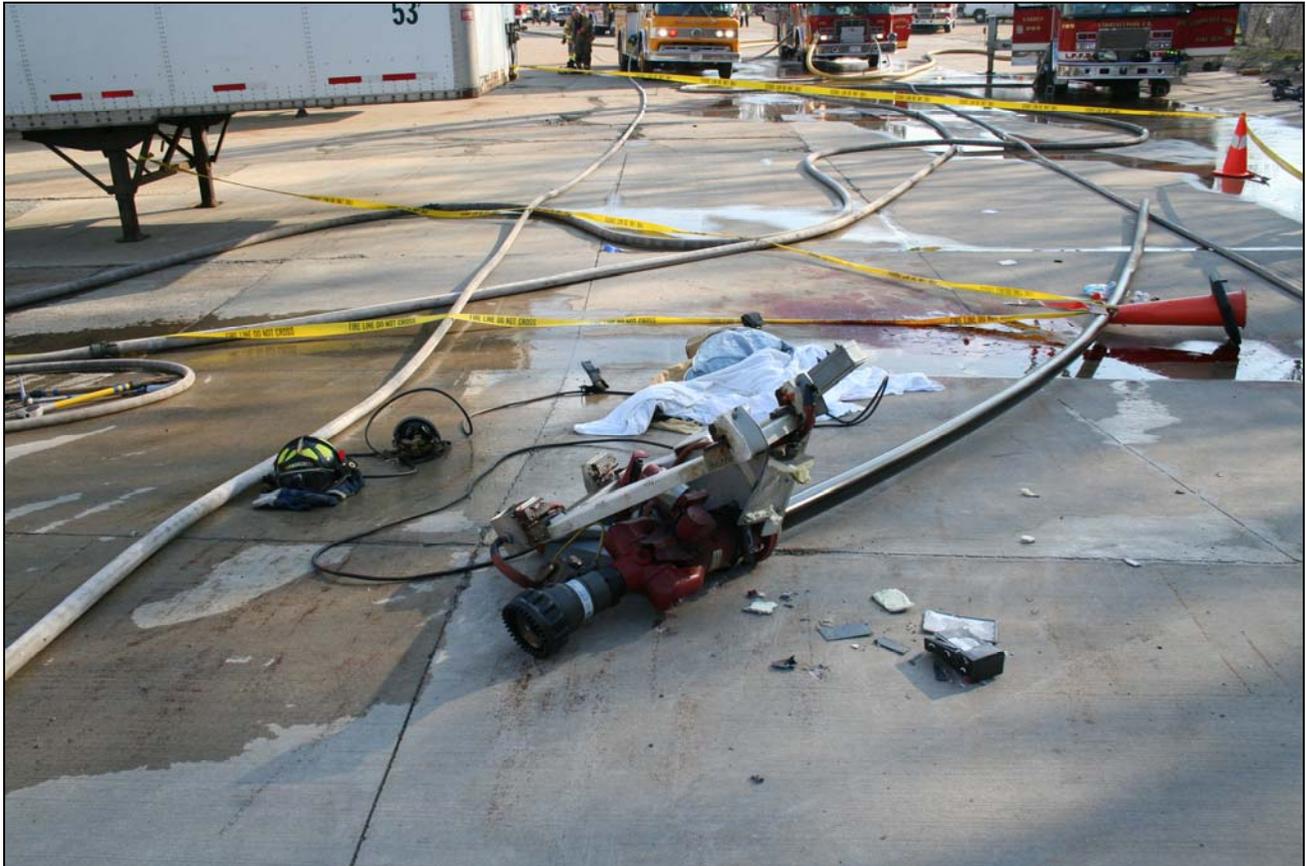
After the incident, the anchor pin was found on the ground, in front of the truck’s cab. When the water column collided with the restriction in the monitor and partially closed automatic nozzle, the waterway pipe became a large hydraulic piston. With no secondary stops to contain the unsecured slider, it was propelled up the ladder rails at an estimated 30 mph towards the tip.

Photo 6. Waterway is in foreground near the location where it struck the victim. Photo shows distance the waterway traveled after it was “launched.” Note ladder truck L-289 at top right.
(Photo courtesy of Matt Skrekla.)

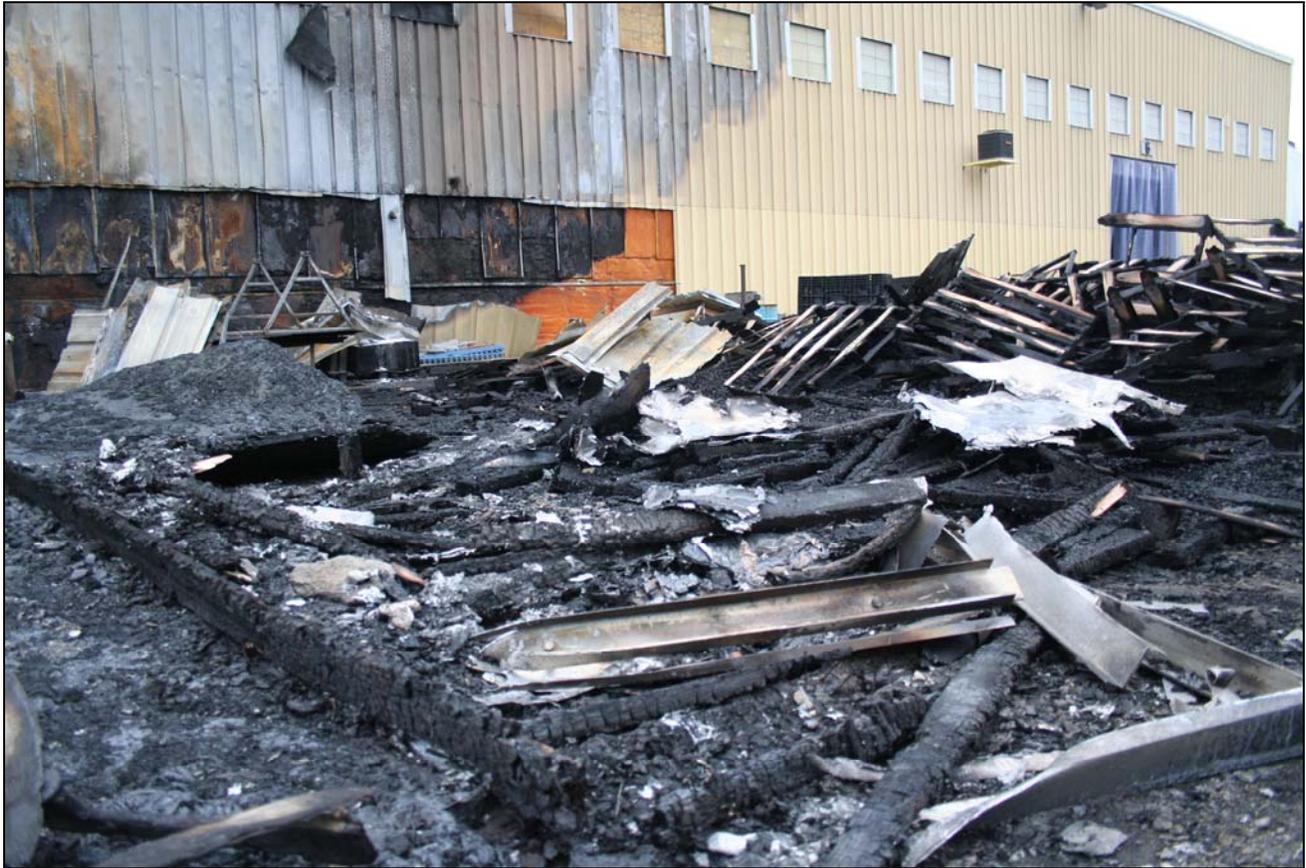
The fire started outside the structure near the loading dock in an area containing wooden and plastic pallets (Reference Photos # 7 through # 9). State fire marshal investigators determined the fire was unintentional in nature and caused by employees smoking on the loading dock. The company had a no-smoking policy in effect at the time of the incident. The fire rapidly grew on the loading dock consuming the pallets stored there. The fire extended up the exterior wall with minimal extension into the interior. The structure was equipped with an automatic sprinkler system which activated on two levels.

Photo 7. Loading dock area immediately after fire. Note the fuel load present on the loading dock consisting of wooden and molded-plastic pallets. (Photo courtesy of Matt Skrekla.)

Recommendation # 8: Business owners and property managers should address fire hazards and enforce fire prevention measures.

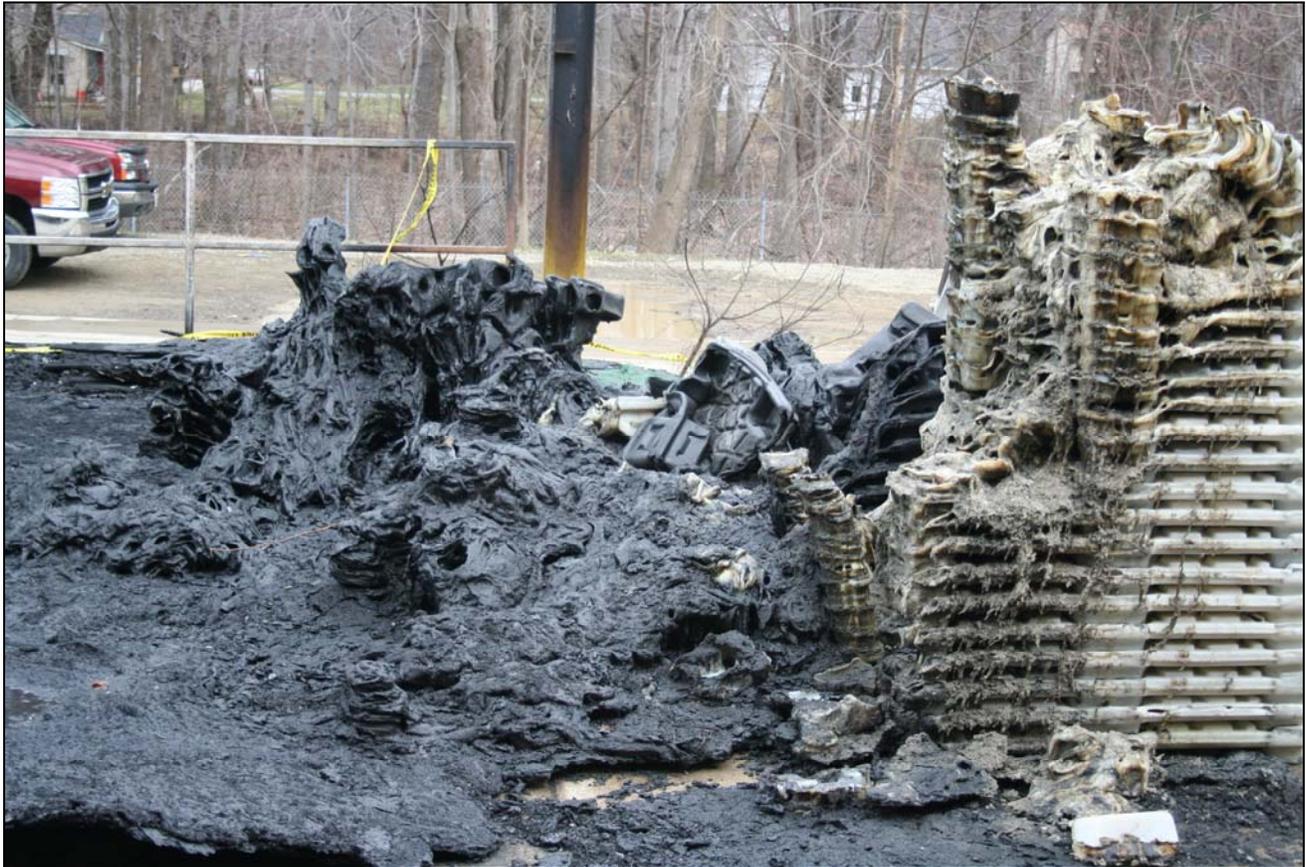
Photo 8. Plastic pallets and other plastic materials on the loading dock immediately after fire.
(Photo courtesy of Matt Skrekla)

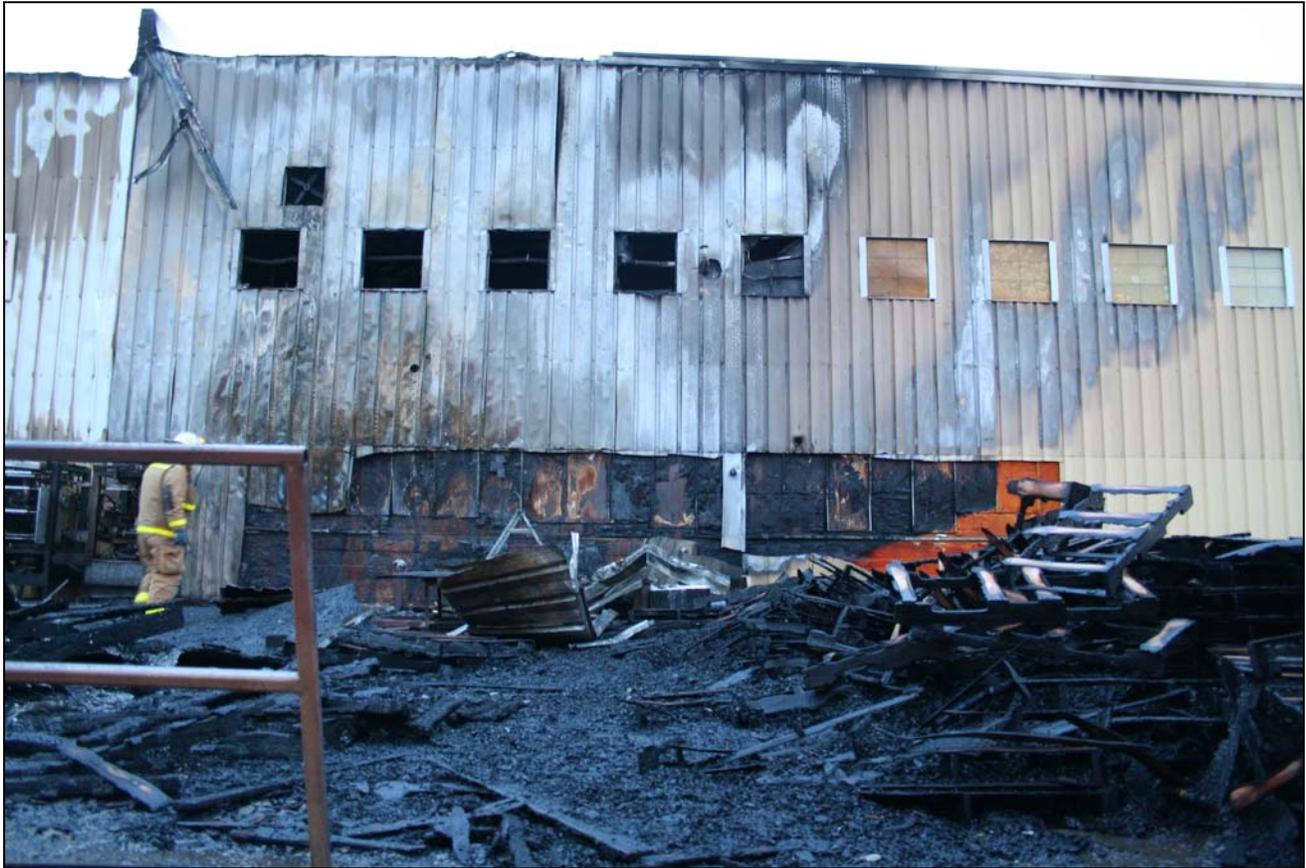
Photo 9. Photo shows the remains of the fuel load on the loading dock following the fire.
(Photo courtesy of Matt Skrekla.)
