## **Fire Fighter Dies after being Ejected from a Pumper in a Single Vehicle Rollover Crash - New York**

## Fatality Assessment and Control Evaluation Investigation Report # F2008-25

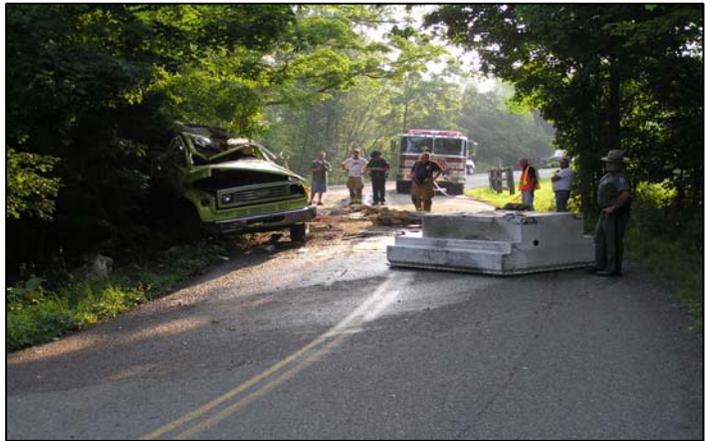
**Crash Scene Photo.**  
*(Courtesy of County Sheriff's Office)*

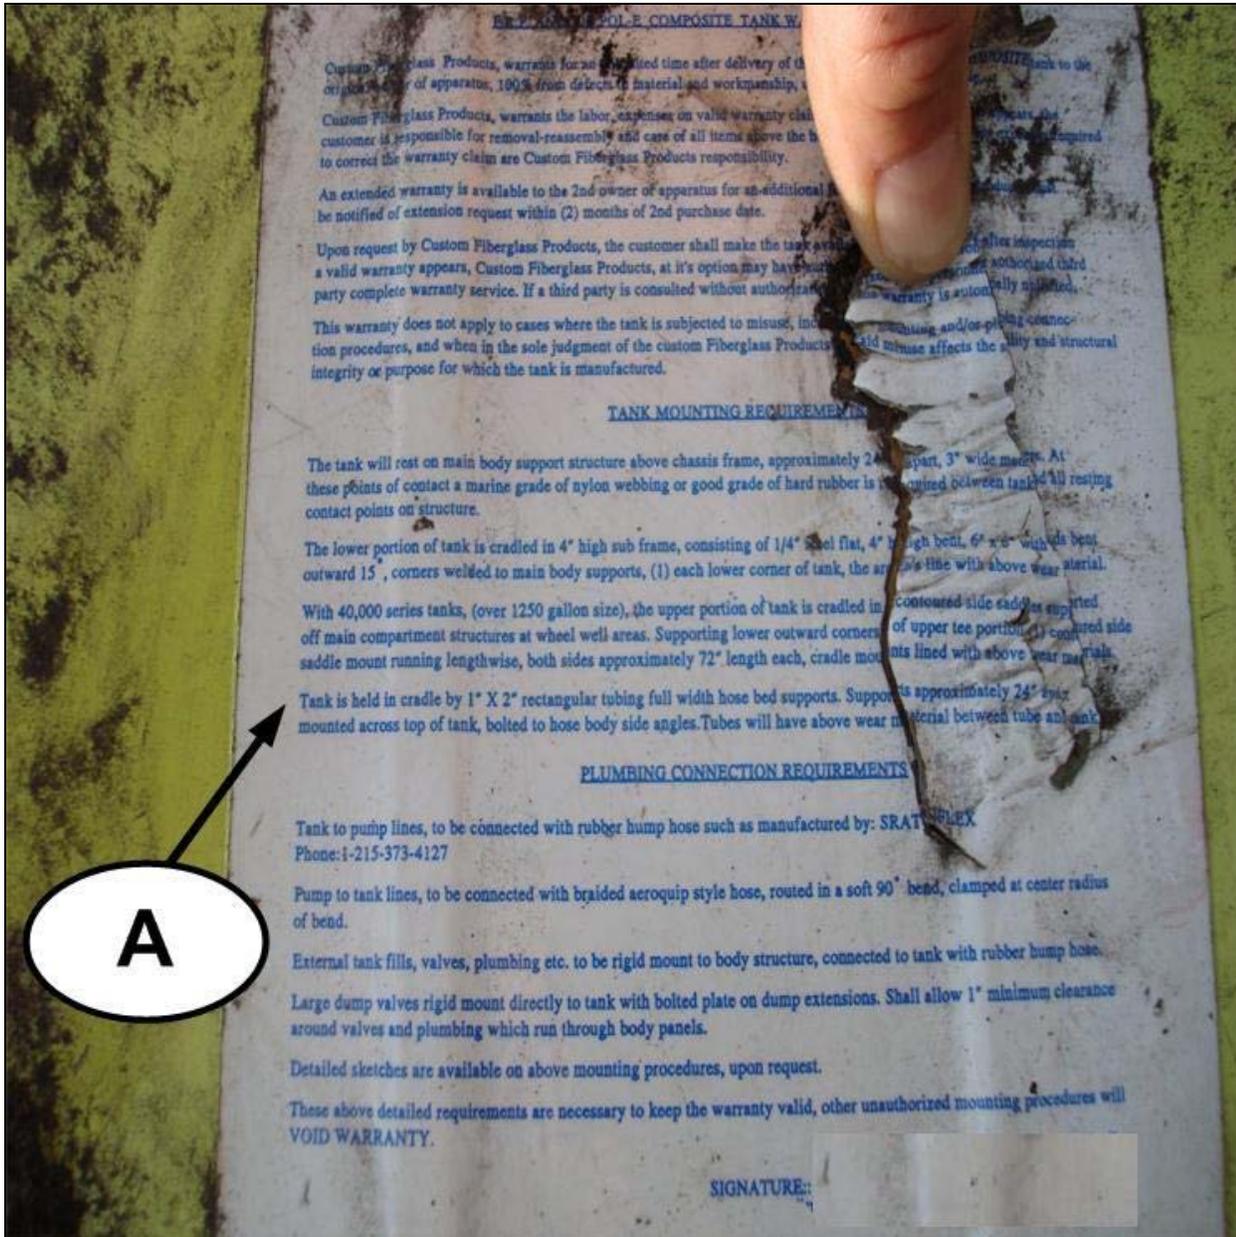
The pumper’s original 750 gallon steel water tank was replaced in 1997 with a 725 gallon baffled composite tank by a local fire apparatus repair facility. The tank manufacturer provided written instructions adhered to the tank (see photo 1), that required specific mounting hardware, brackets and spacing for the tank’s installation. The water tank was reported to be full at the time of the incident.

**Photo 1. Tank Mounting Instructions (A) from manufacturer requiring tank to: be “held in cradle by 1” x 2” rectangular tubing full width hose bed supports; have supports approximately 24” apart mounted across top of tank, bolted to hose body side angles; and have wear material between tube and tank.” NIOSH investigators found no evidence of the rectangular 1” x 2” tubing, hose body side angles, bolts or brackets or wear material for tubing.**  
*(Photo by NIOSH investigators)*

***Recommendation #3: Fire departments should ensure that replacement fire apparatus water tanks are installed according to manufacturer's instructions.***

Discussion: In this incident, the original metal water tank of the pumper was replaced in 1997 with a composite (fiberglass) water tank by a local fire apparatus repair facility. Evidence was found that suggest the installation was not per the manufacturer's instructions found on the tank. NIOSH investigators found no evidence of the 1" x 2" rectangular brackets that were required by the manufacturer's instructions to be installed on top of the tank. There were no mounting hardware or rectangular brackets found in the wreckage, and examination of the wreckage did not indicate markings on the top of the tank from a bracket, mount or brace. It is important to note that the full water tank was ejected during the crash and landed on top of the victim. It is not known if the 725 gallon water tank (lacking a securing mechanism on the top of the tank), shifted and caused a change in the handling of the apparatus prior to or during the crash. The water in the full water tank would have weighed approximately 6053 lbs.

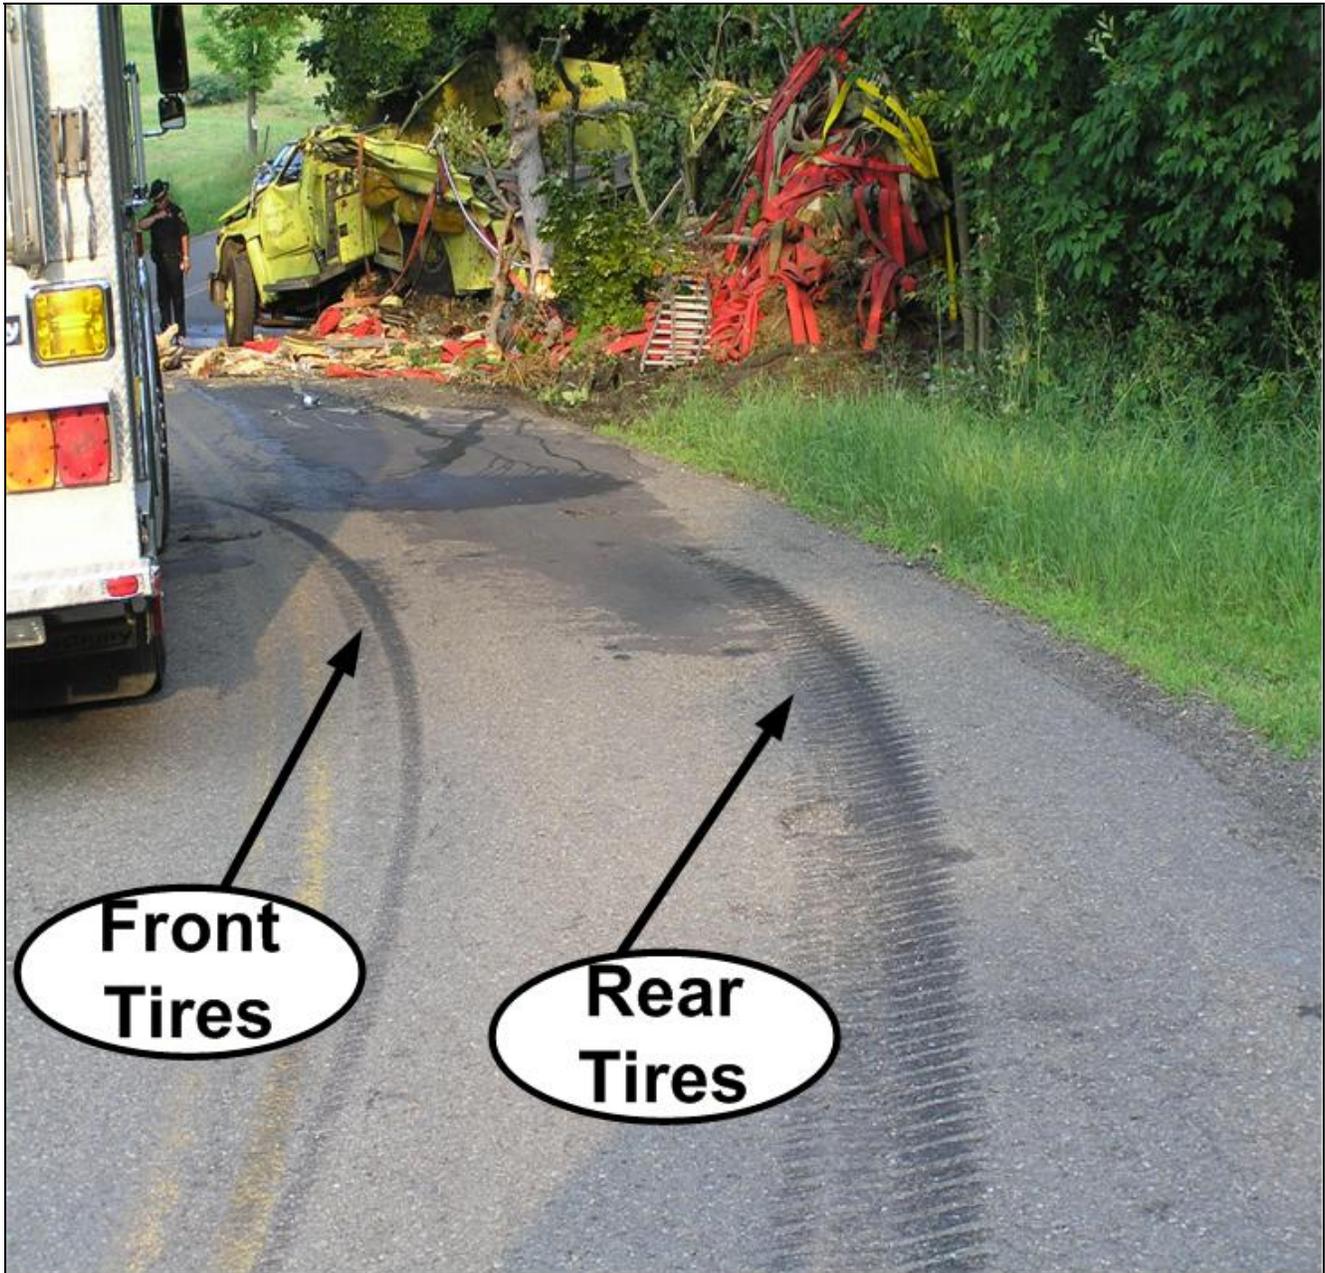
Police investigators determined from the tire marks on the road that the fire truck had swerved to the left side of the road on approach to the curve then returned to the pavement, went out of control in the S-turn, and overturned on the right side of the road. The truck tires left yaw marks indicating the rear of the truck was sliding sideways down the road grade and to the right, while the front tires were

tracking to the left (see photo 2). The victim was ejected out of the driver's side window onto the roadway with the full 725 gallon water tank landing on top of him.

**Photo 2.** Note “yaw” marks on roadway. Marks on the right are from the rear tires and marks on the left are from the front tires just prior to the rollover. Tire yaw marks occur when a vehicle slides sideways while still moving forward. In a true yaw, where the vehicle’s rear is attempting to pass the vehicle’s front, each rear tire tracks outside the corresponding front tire.<sup>12</sup>  
*(Photo Courtesy of County Sheriff’s Office)*

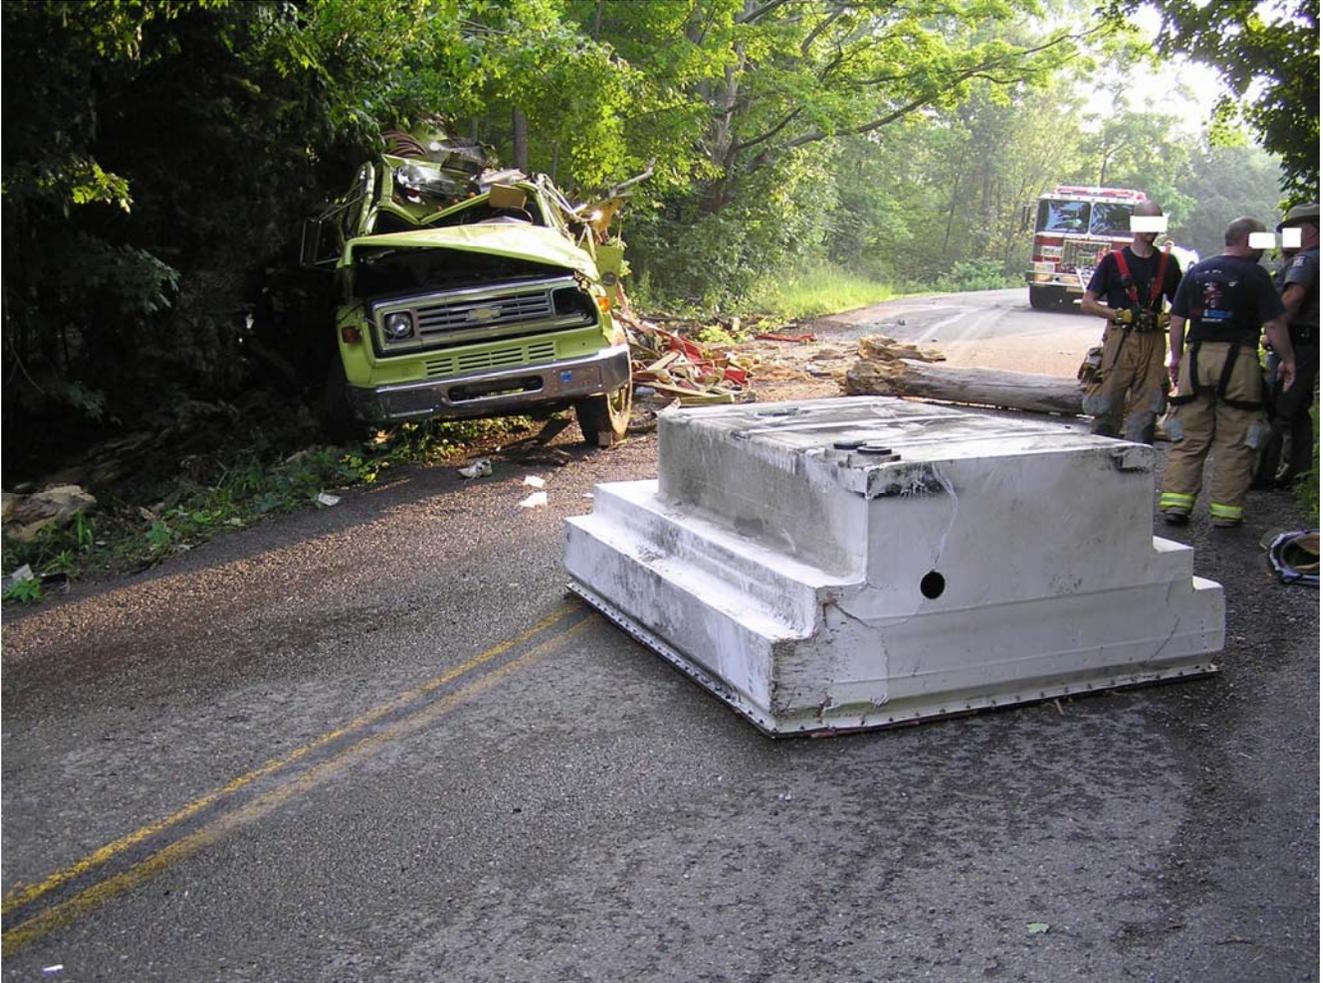
The fire truck had rolled over during the crash, ejecting the driver onto the roadway, with the full water tank landing on top of the victim. The water tank separated from the fire truck during the rollover and landed upright in the roadway. It is not known if the water tank separation was secondary to the crash or contributed to the inability of the driver to bring the truck back under control. Once the tank was drained of enough water, fire fighters were able to move the tank off of the victim (see photo 3). The victim was transported to a local hospital where he died from his injuries.

**Photo 3. Photo of the tank upside down in roadway after being flipped over to rescue fire fighter who was pinned underneath. The tank was ejected during the rollover and landed on the victim, right-side up.**

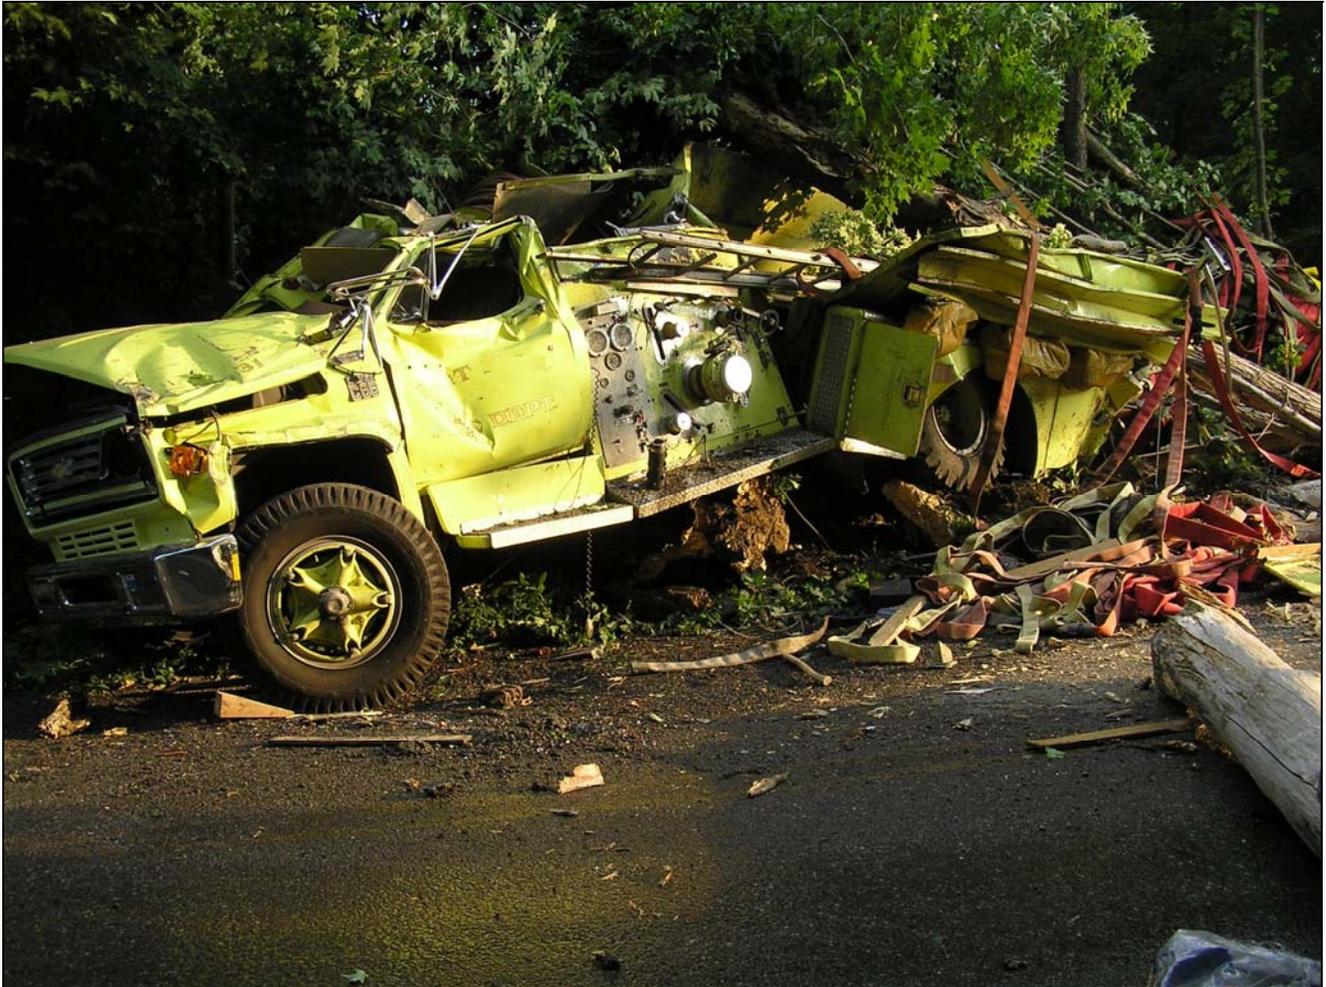
- An older apparatus with minimal safety features. This fire apparatus was purchased new in 1978 (see photo 4), and did not have safety features that are standard on newer apparatus, such as automatic transmissions, disc brakes, traction control systems, and three-point seat belts. The sheriff's office found no evidence of brake failure after the incident. The fire department had utilized a local service facility to inspect the truck annually and no fire fighters had reported any problems with the brakes or steering. There were several comments from members regarding the difficulties in shifting gears in the truck, although the transmission and clutch had not been reported for repair or replaced. During initial interviews with department members, it was not known if the manual transmission was synchronized or non-synchronized, however the practice of this fire department was to double clutch the transmission to achieve a successful gear change.

**Photo 4. Fire truck rollover.**  
*(Photo Courtesy of County Sheriff's Office)*

***Recommendation #5: Fire departments should consider replacing fire apparatus over 25 years old. In addition it is recommended that apparatus manufactured prior to 1991 that are less than 25 years old, that have been properly maintained, and that are still in serviceable condition should be placed in reserve status and upgraded to incorporate as many features as possible of the post-1991 fire apparatus edition.***

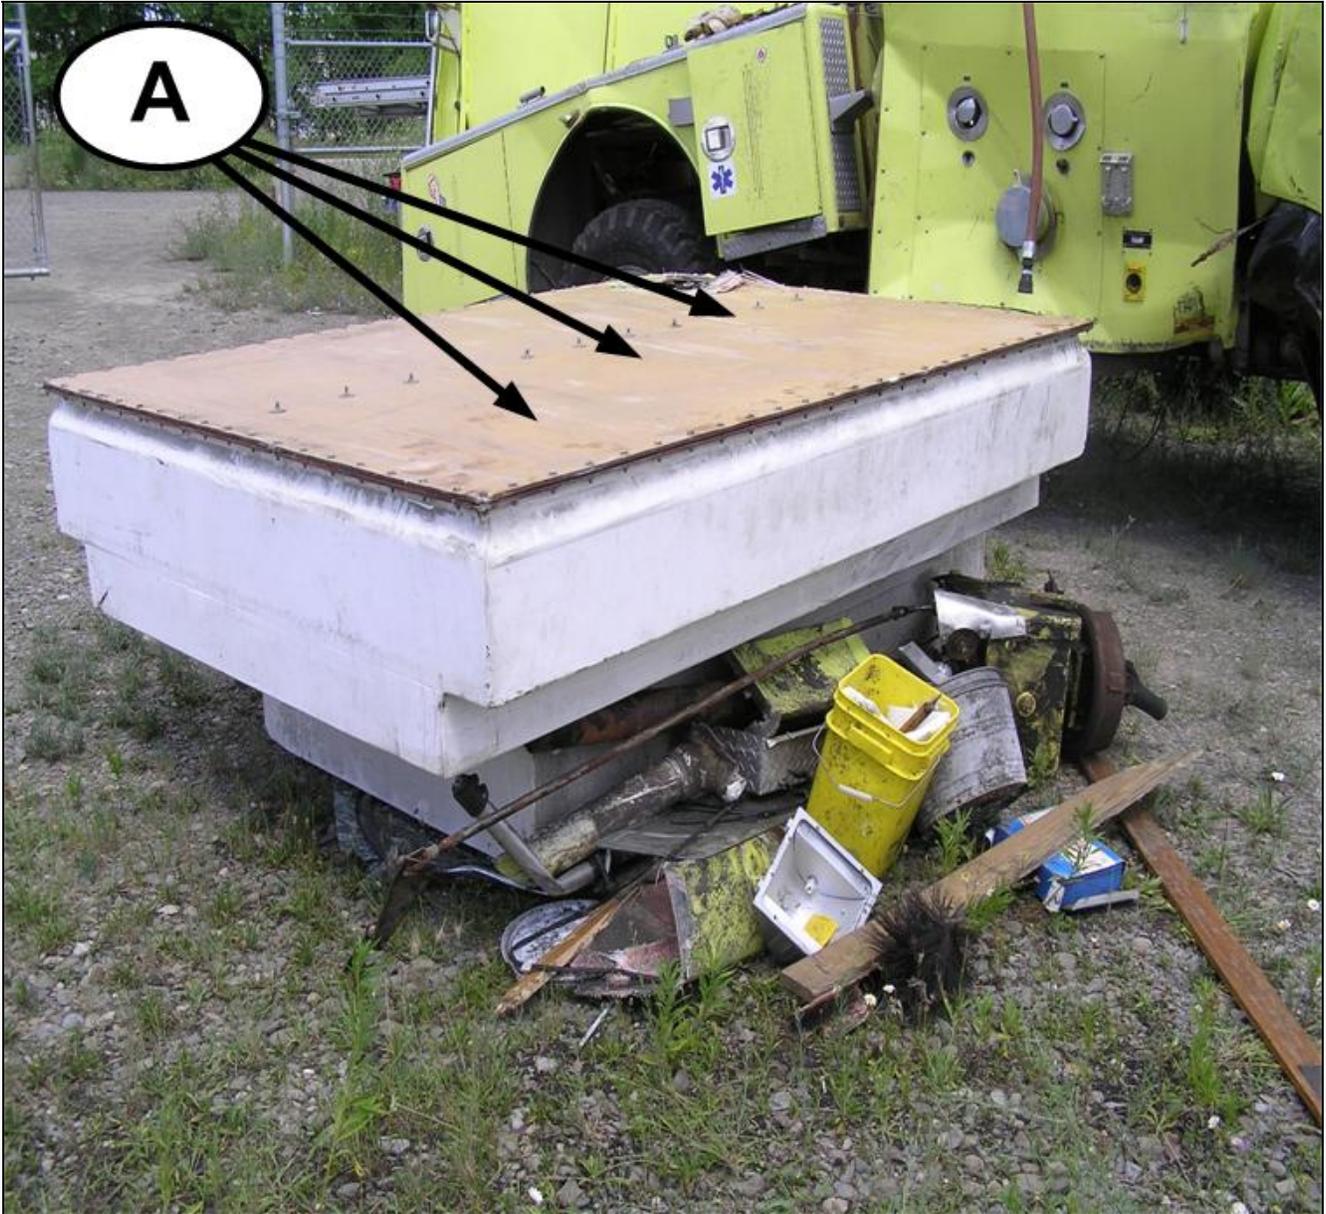
- Potentially incorrect installation of the water tank. The truck's original steel water tank was replaced in 1997 with a composite tank. Findings from the investigation suggest that the tank was not installed per the manufacturers instructions found on the tank (photo 1). No evidence was found of the required 1" x 2" rectangular brackets that were referenced to be installed on 24" centers on top of the tank. There were no mounting hardware or rectangular brackets found in the wreckage, and examination of the wreckage did not indicate markings on the top of the tank from a bracket (see photos 5 & 6), mount or brace. It is important to note that the full

water tank was ejected during the crash and landed on top of the victim. It is not known if the 725 gallon water tank (lacking a securing mechanism on the top of the tank), shifted and caused a change in the handling of the apparatus prior to or during the incident.

**Photo 5. Top of water tank, note the lack of trace markings or evidence of brackets or bracing hardware (A in photo)**  
*(Photo Courtesy of County Sheriff's Office)*

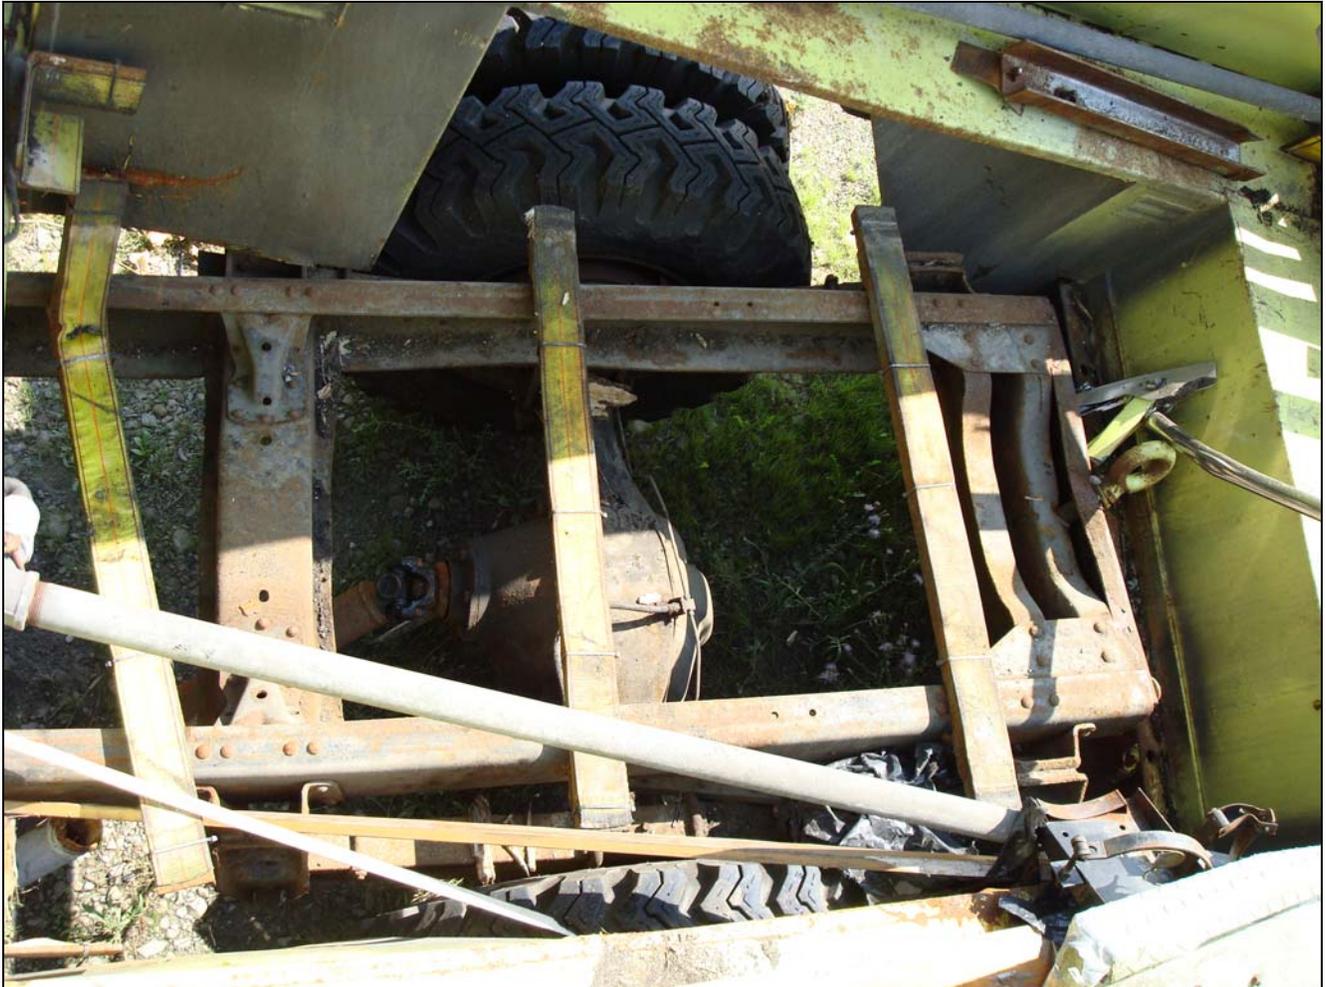
**Photo 6. Tank main body supports. Note that the forward right support is pushed up by the right side body of the apparatus. This suggests that the tank was not in place when the bracket was bent.**
