A summary of a NIOSH fire fighter fatality investigation

February 26, 2010

## A Career Lieutenant Dies and Three Fire Fighters are Injured in Ladder Truck Crash – Massachusetts

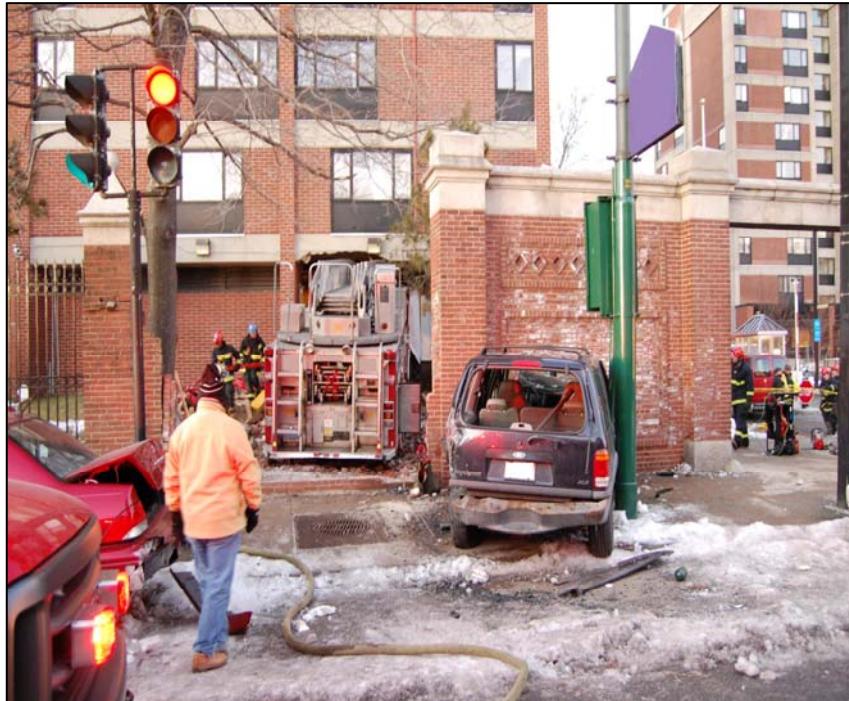
**Incident scene.**

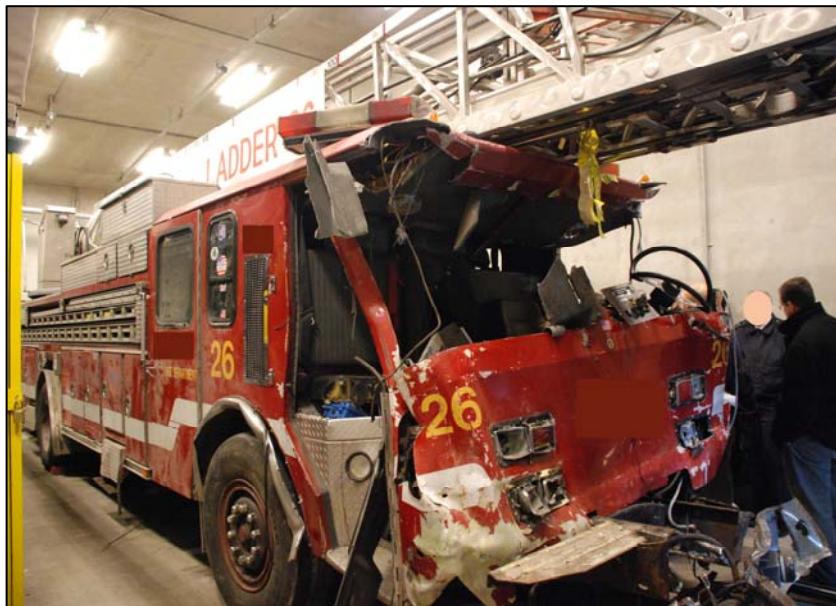
**Photo 1. Aerial ladder truck following the incident.**  
(Photo courtesy of fire department.)

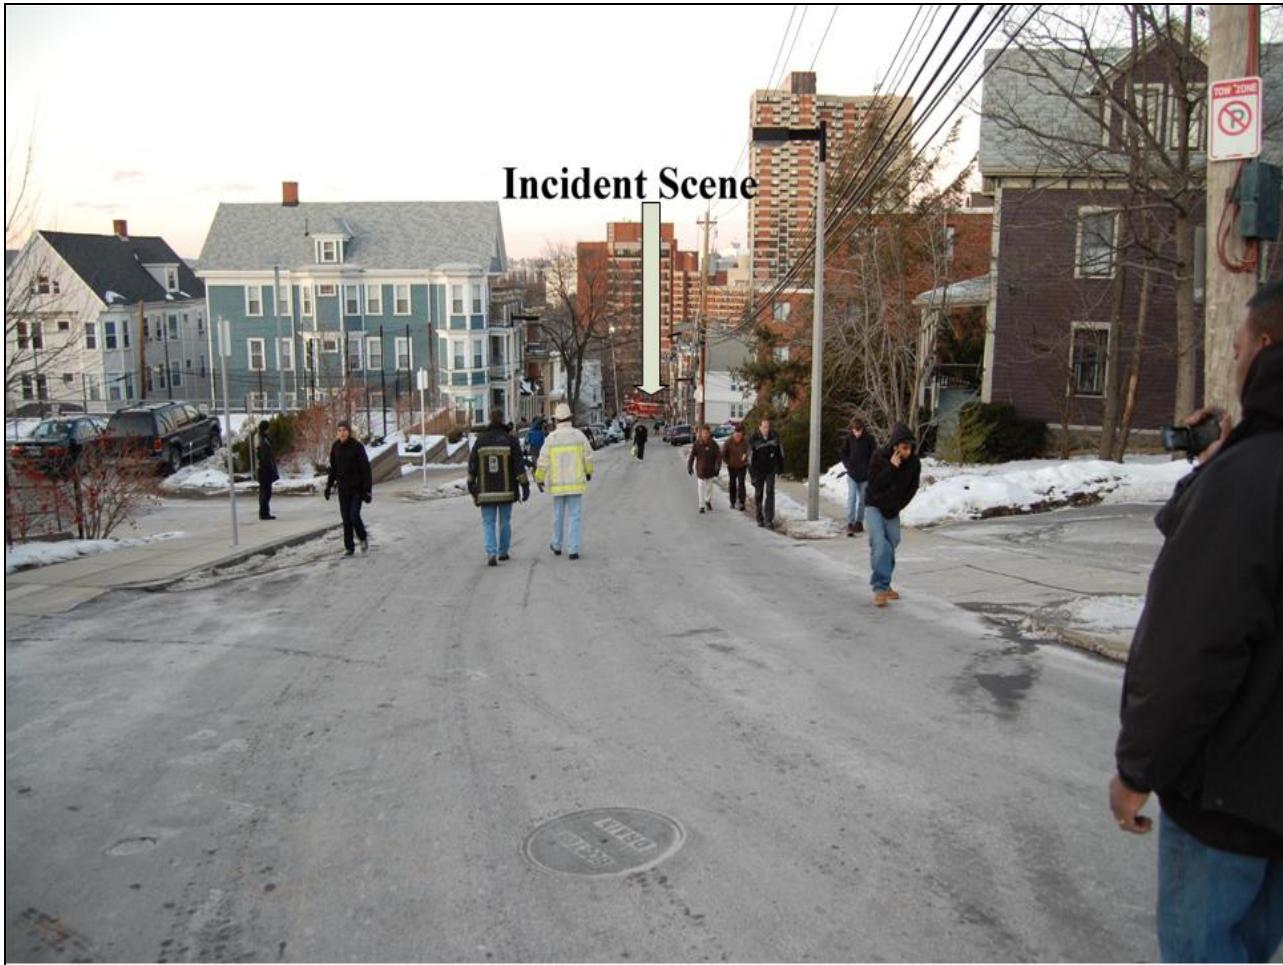
**Photo 2. View from atop the hill after the incident.**  
*(Photo courtesy of fire department.)*

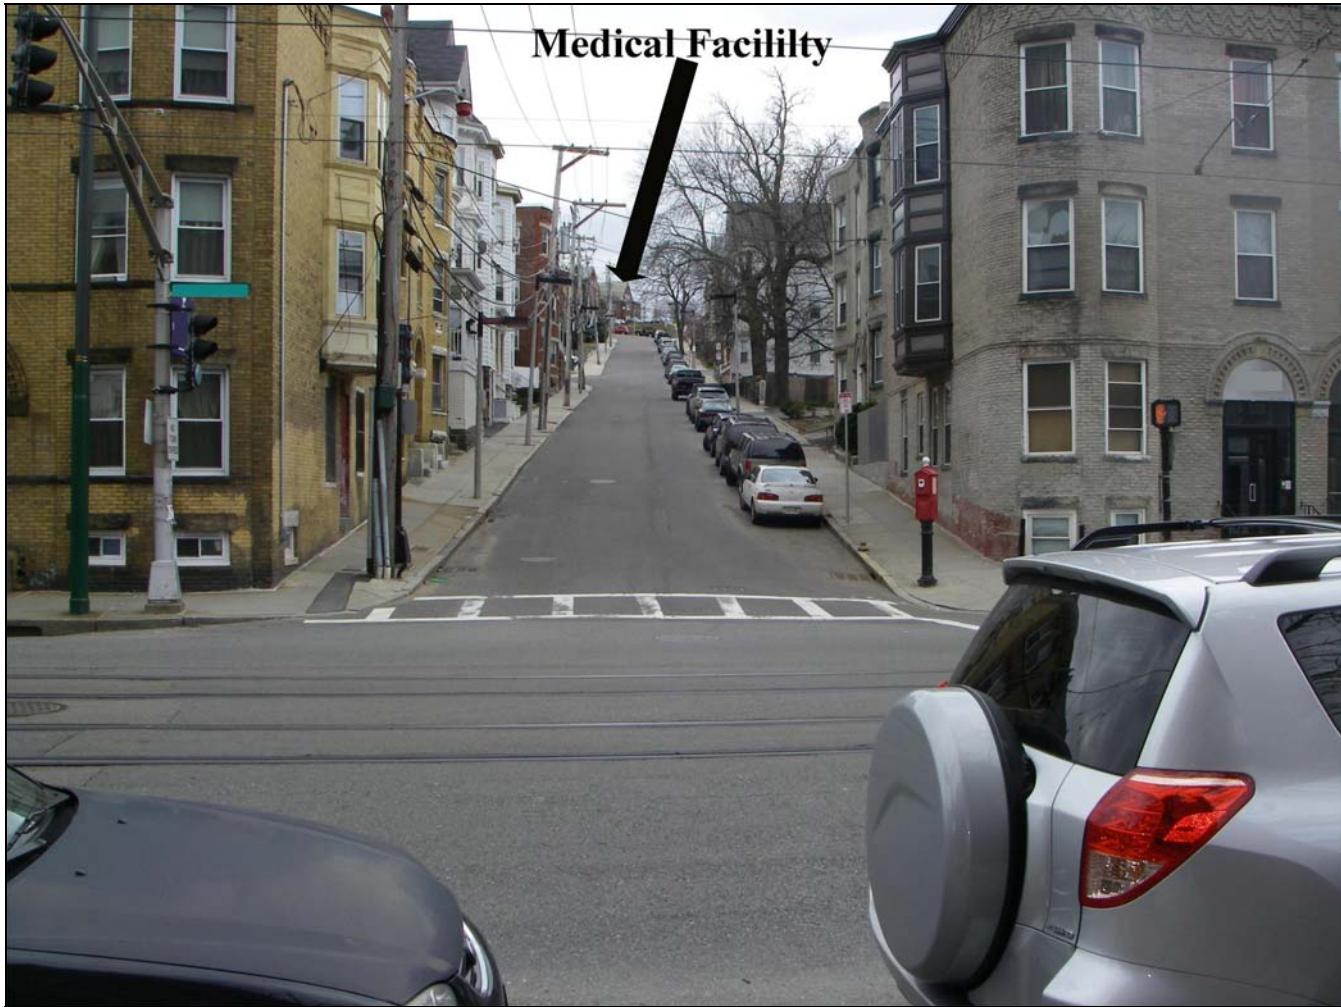
**Photo 3. View from the bottom of the hill; taken after the fatal incident.**  
*(Photo courtesy of fire department.)*

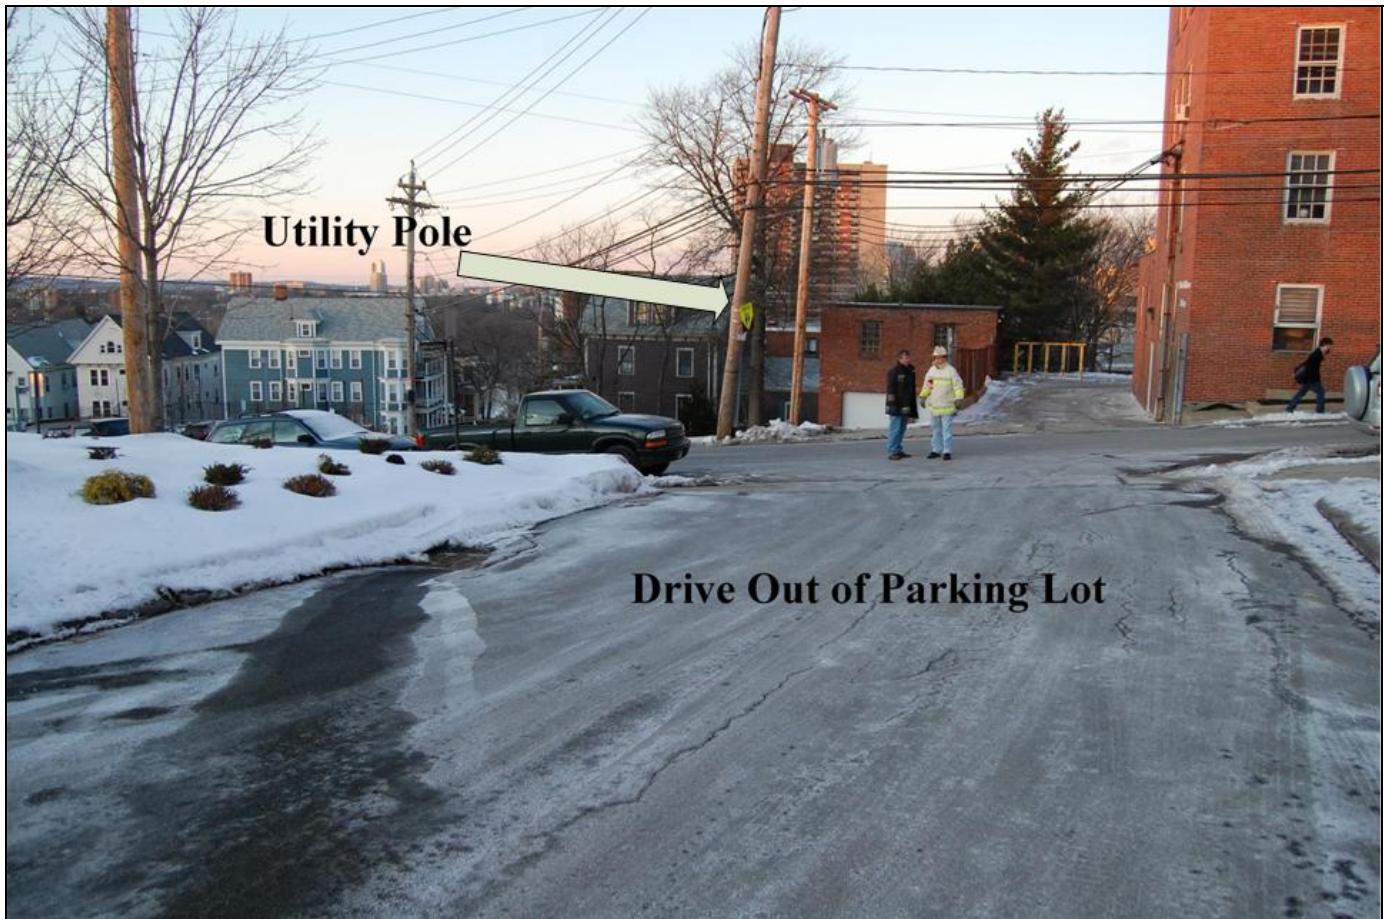
When preparing to leave the medical call, the chauffeur placed the ladder truck in “drive” and released the parking brake. The chauffeur pulled forward and turned left out of the parking lot, immediately stopped, and then backed up to reposition the ladder truck so that the ladder did not strike a utility pole (see Photo 4). He pulled forward again and carefully negotiated the ladder truck away from the utility pole.

**Photo 4. Shows the left hand turn the chauffeur had to make when exiting the parking lot.**  
**Photo taken on the day of the incident following the incident.**  
*(Photo courtesy of fire department.)*

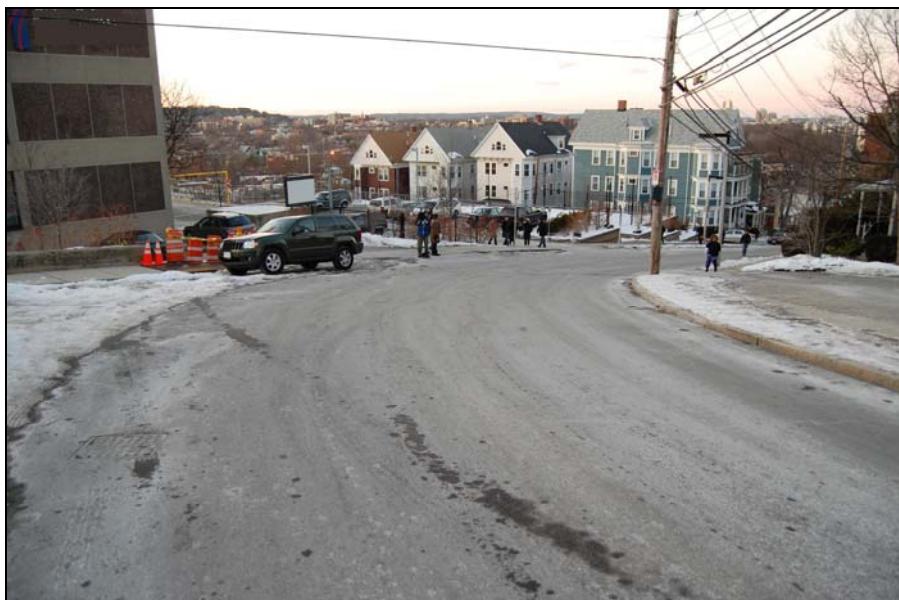
After this maneuver, the chauffeur had to immediately negotiate the aerial ladder through a right hand, downward curve (see Photo 5). Once the ladder truck was straight and descending the hill, the chauffeur applied pressure with his foot to the brake pedal and had no response. The brake pedal went to the floor without resistance. He quickly began pressing the brake pedal in an attempt to get the brakes to actuate as he advised the victim that he had “no resistance or pressure” when applying his foot on the brake pedal.

**Photo 5. Right downward curve negotiated by ladder truck chauffeur.**  
(Photo courtesy of fire department.)

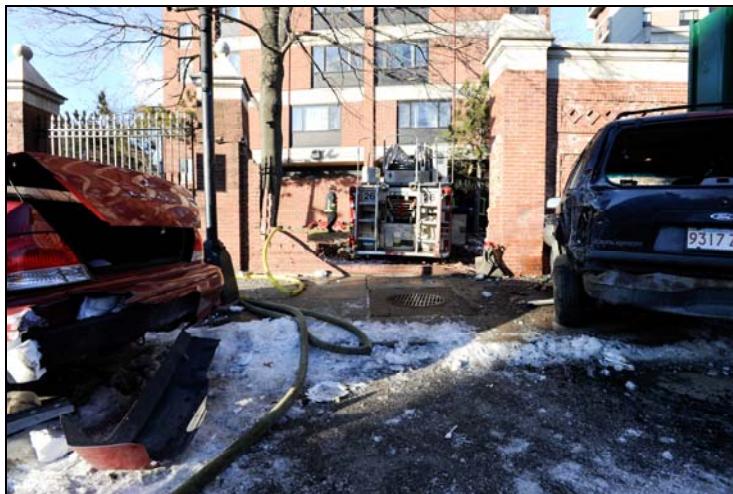
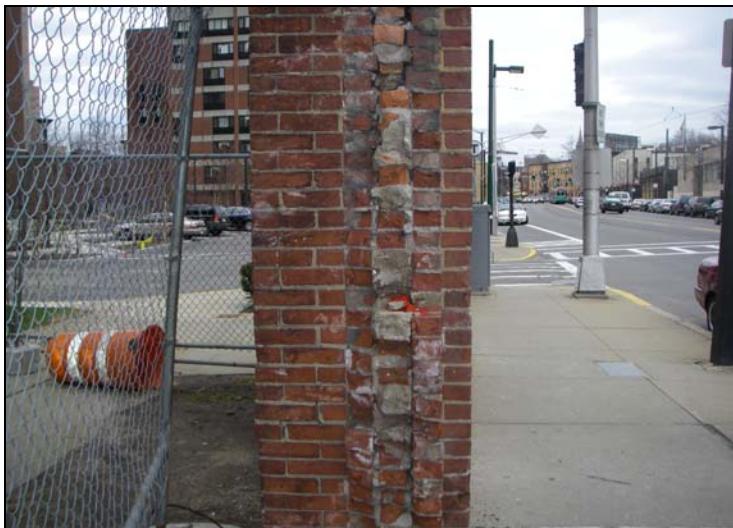
With emergency lights on and electronic siren sounding, the chauffeur was able to negotiate the ladder truck through a busy intersection before he struck two parked cars, went through an 8-ft tall, three course thick brick wall, and came to rest within a multi-story residential building (see Photos 6, 7, and 8). The victim died minutes following the impact and the chauffeur had to be extricated by arriving fire department personnel. *Note: The victim, chauffeur, and one of the fire fighters were not wearing a seat belt when the incident occurred. The second fire fighter buckled his seat belt just prior to the ladder truck colliding with the parked cars. The Commonwealth of Massachusetts exempts operators and passengers of fire vehicles from having to wear a seat belt.*<sup>7</sup>

**Photos 6 and 7. Photo at top shows damage received to parked cars and exterior view of brick wall. Photo at bottom shows the thickness of the wall that the apparatus went through.**  
*(Photos courtesy of fire department.)*

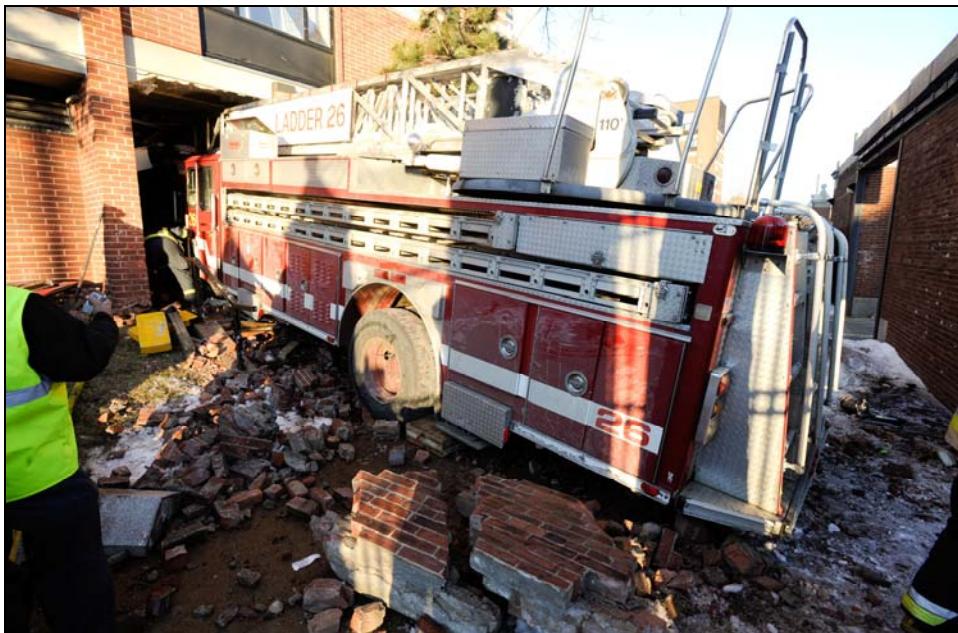
**Photo 8. Damage sustained to multi-story building and final apparatus resting position.**  
*(Photo courtesy of fire department.)*
