## Volunteer Fire Fighter Drowns After Being Thrown From His Swiftwater Rescue Boat – West Virginia

### Executive Summary

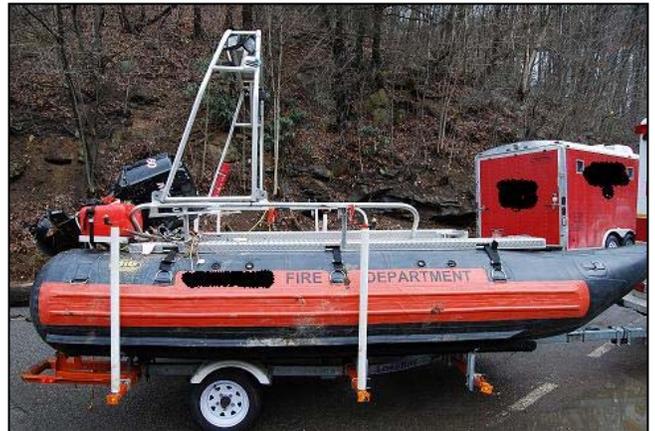
**Rescue boat involved in incident.**  
(Photo courtesy of WV State Fire Marshal)

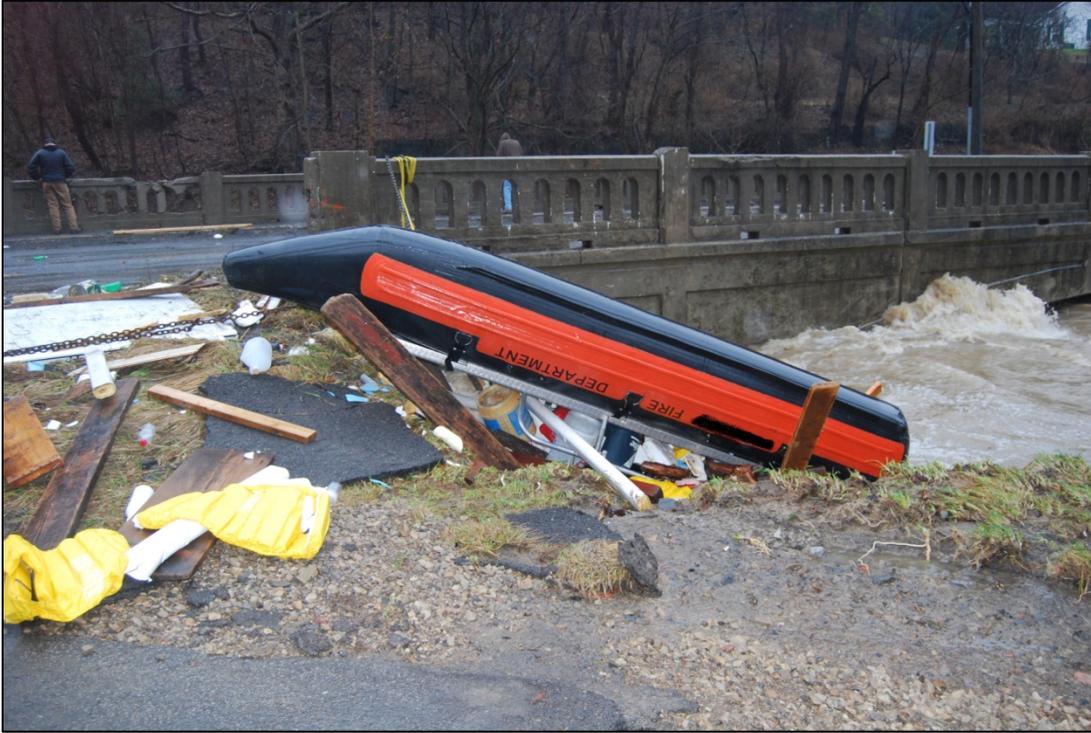
**Position of rescue boat when initially pulled from river.**  
*(Photo courtesy of WV State Fire Marshal)*

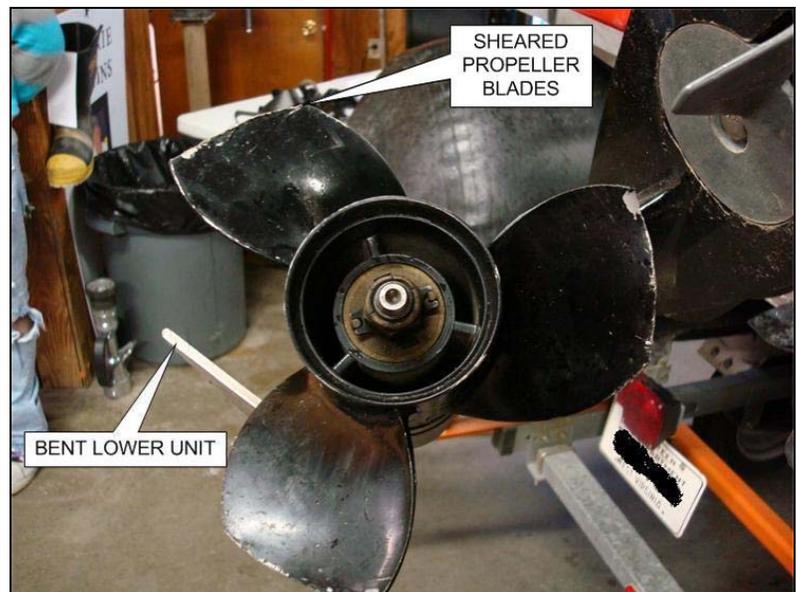
During this incident the engine suffered major damage. The boat was transported to the manufacturer for repair. The manufacturer reported that the driveshaft was bent and the lower unit and propeller were damaged (see Photo 1).

**Photo 1. Picture of damaged lower unit and propeller.**

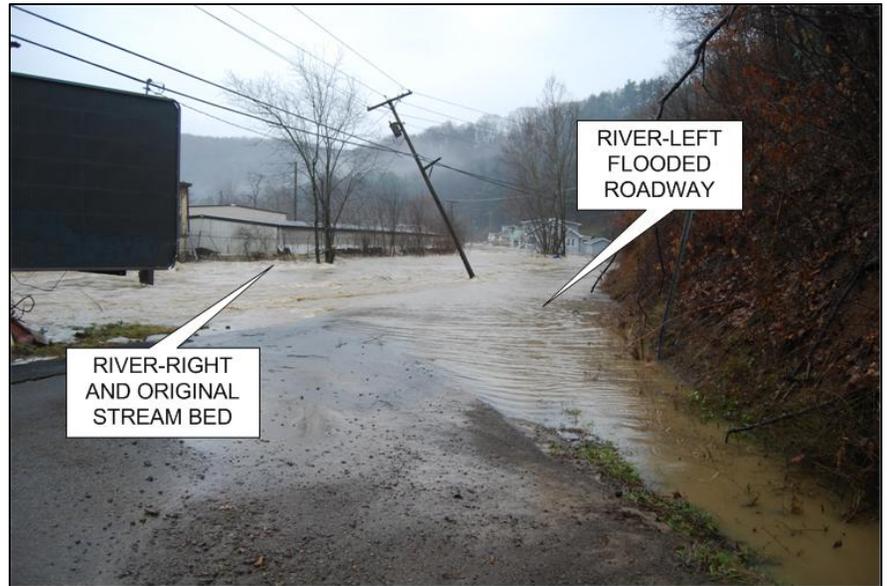
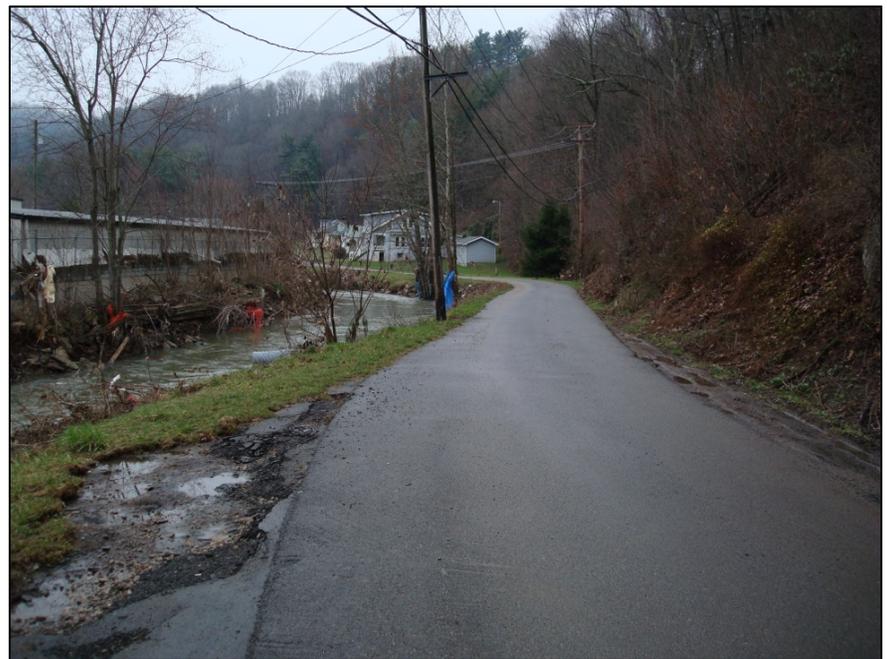
**Photo 2 & Photo 3. The fire department had designated river-right and river-left from the downstream perspective. Both photos show view looking upstream at insertion point for rescue crews. Photo 3 was taken two weeks after incident. Houses in the background are where the residents were trapped.**
