Volunteer Captain Runs Low on Air, Becomes Disoriented, and Dies While Attempting to Exit a Large Commercial Structure – Texas

Executive Summary

On July 3, 2010, a 30-year-old male volunteer Captain died while attempting to locate and extinguish a late night fire in the back of an egg processing plant. The seat of the fire was located in a dry storage area at the back of the plant that housed paper and styrofoam products for packaging the eggs. When the fire department arrived, flames were visible from the roof of the dry storage area. The victim's crew attempted to breach a wall for more direct access to where they thought the seat of the fire was located. The access was blocked by stacks of wooden pallets. Two captains made entry with an uncharged hoseline through the front door to find and extinguish the fire. The front of the plant was charged with heavy dark smoke and high heat conditions. They became disoriented in the thick smoke, lost the hoseline and called a Mayday that was not heard and acted upon. While searching for the handline, the captains ran out of air, got more disoriented and were separated. One captain attempted to kick out a section of wall and was heard by

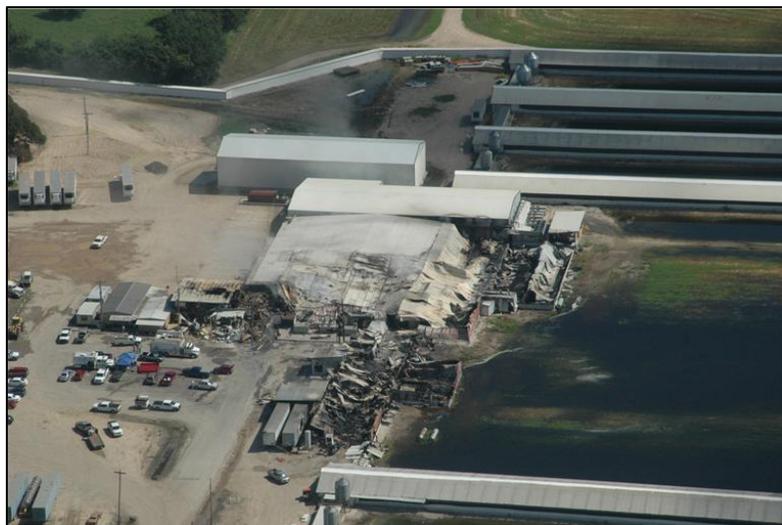
Aerial view of egg processing plant.
(Photo courtesy of Texas State Fire Marshal)

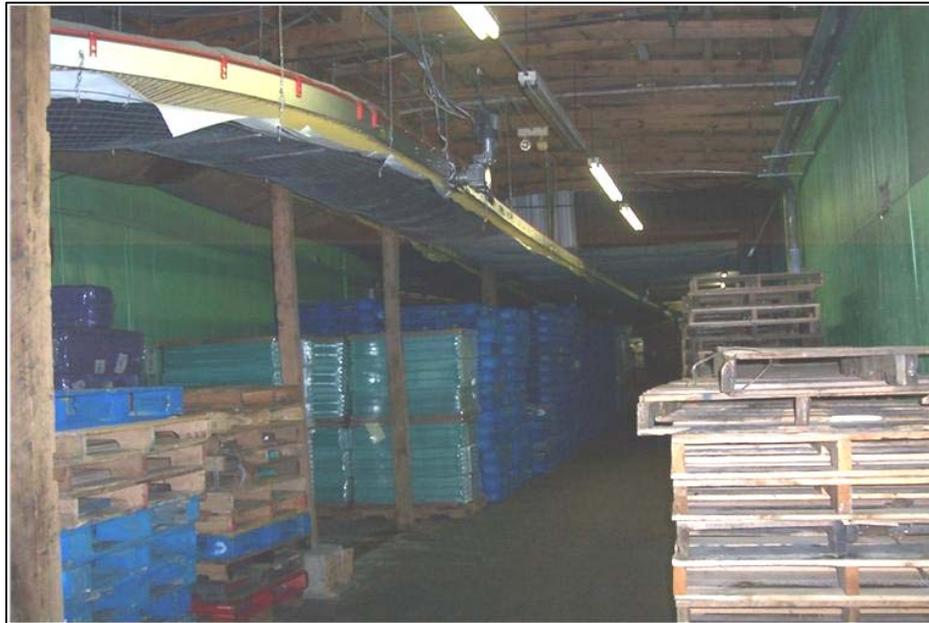
The commercial egg processing plant was classified as Type II construction which encompassed large open areas totaling more than 58,000 square feet. The building's primary use was to process eggs and pack them for shipment after they arrived via a conveyor belt from laying houses that were attached to the building (Photo1).

Photo 1. Conveyor belt that transported eggs for processing.
(Photo courtesy of Texas State Fire Marshal)

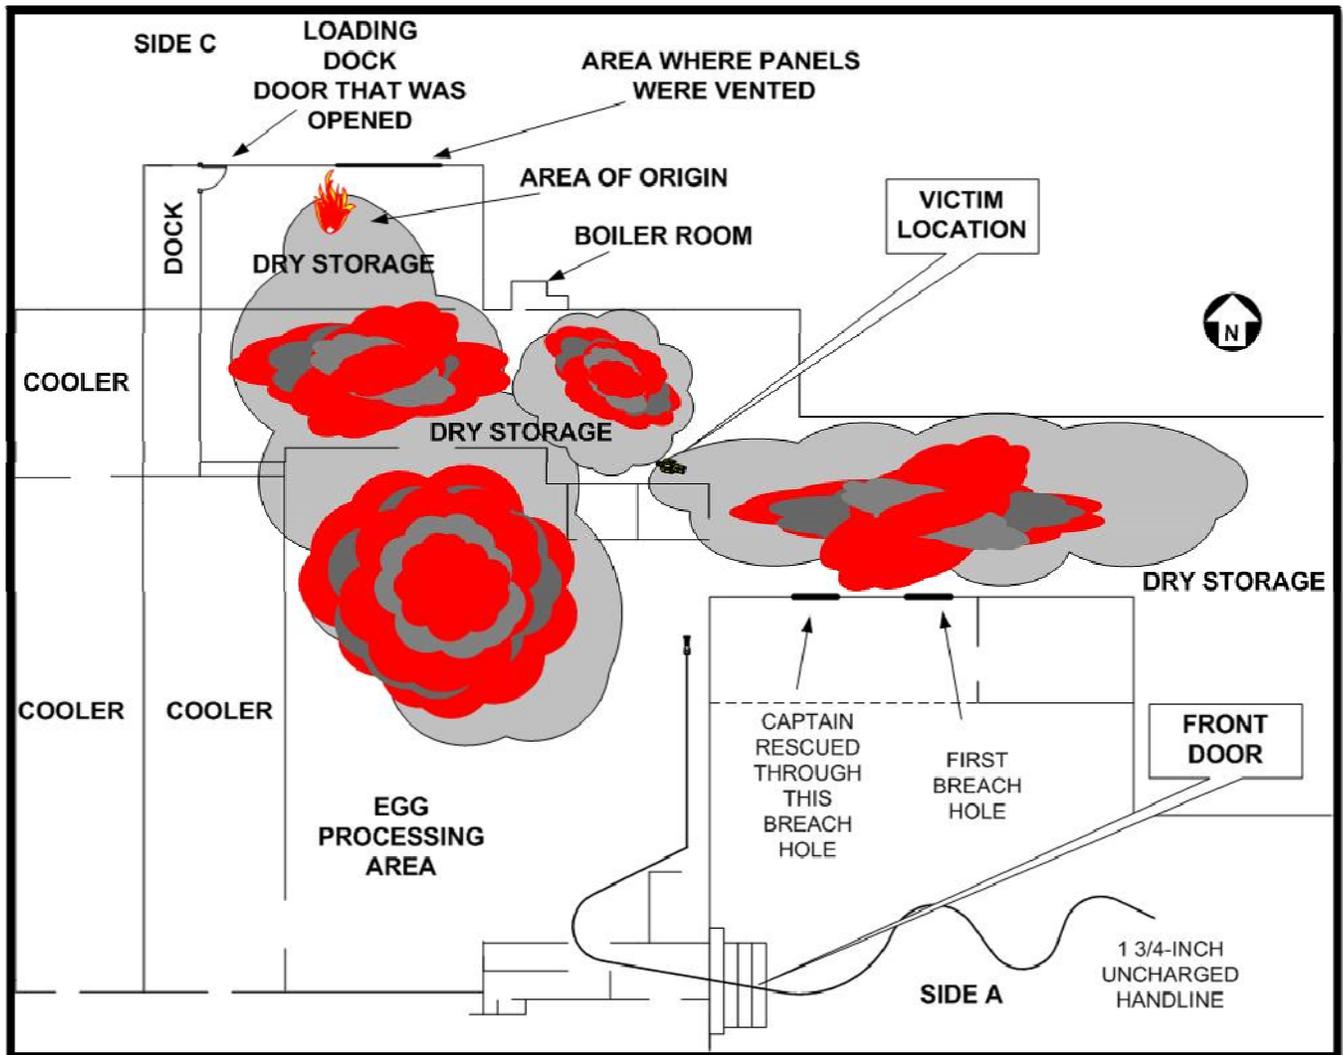
Diagram. Aerial view of plant where fire fighting operations took place.

The Chief was met by another plant employee who told the Chief that the fire had originated in the boiler room and that they thought it would be easier to access it by breaching the sheet metal wall of the dry storage area from the front of the building. The victim and a captain from E1130 and a mutual aid crew were attempting to breach the wall for access inside the structure to find and extinguish the seat of the fire. The victim and the captain were both on air while cutting the tin with a cut-off saw. They made a 3-foot “X” and bent the triangular sections to make an opening in the structure (see Diagram). There were rows of pallets stacked up against the wall inside. They noticed very little smoke and heat coming from inside the structure. The victim was attempting to move the pallets when the Chief stopped them and told them to go to the front door and meet with one of the employees who could open it for entry (see Diagram).

The captain told his rescuers that the victim had just been with him and was possibly only 10 to 15 feet away. Crews immediately entered through the opening where they had rescued the captain (see Diagram). A crew made several entries through the opening and made multiple searches following the captain’s directions, but was unsuccessful. The fire conditions became untenable and the crew was forced to abandon rescue efforts from this location.

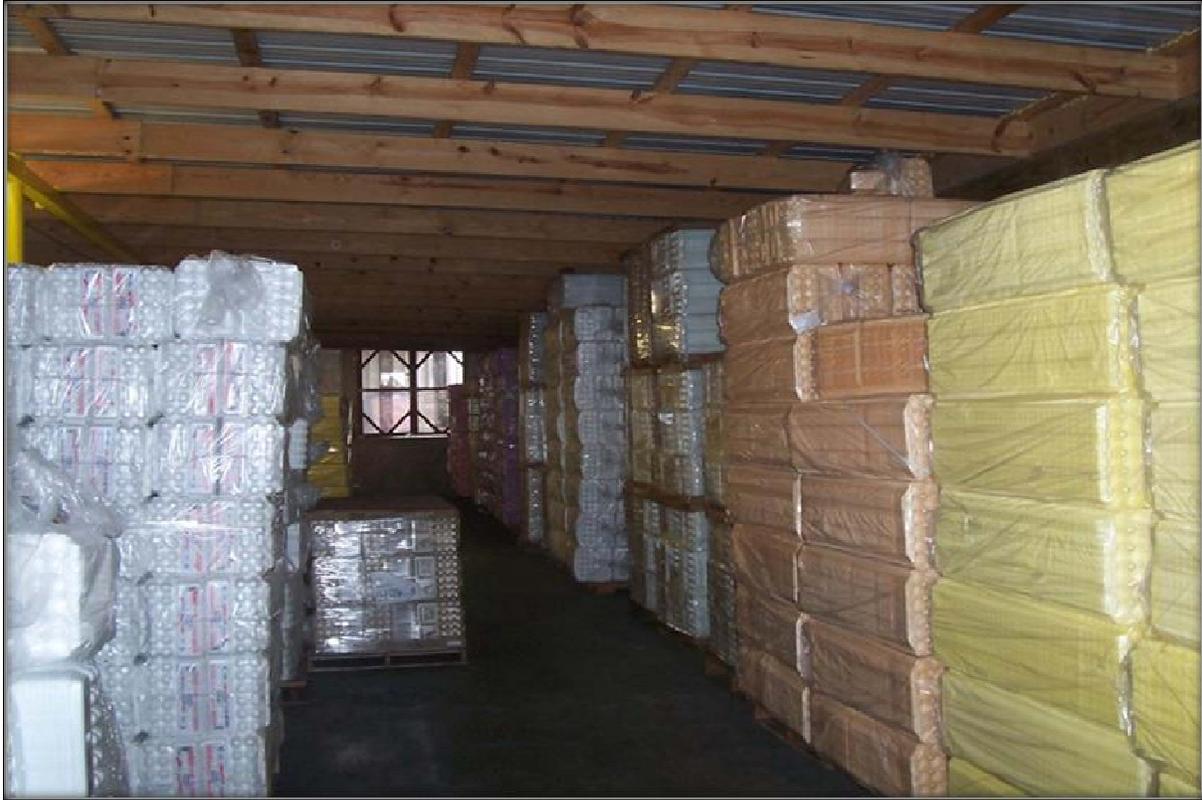
Photo 2. Typical dry storage area and room of origin prior to fire.
(Photo courtesy of Texas State Fire Marshal)
