## Volunteer Fire Captain Dies from Injuries Received after a Brush Truck Undergoing Maintenance Strikes and Pins Him Against a Wall—Indiana

### Executive Summary

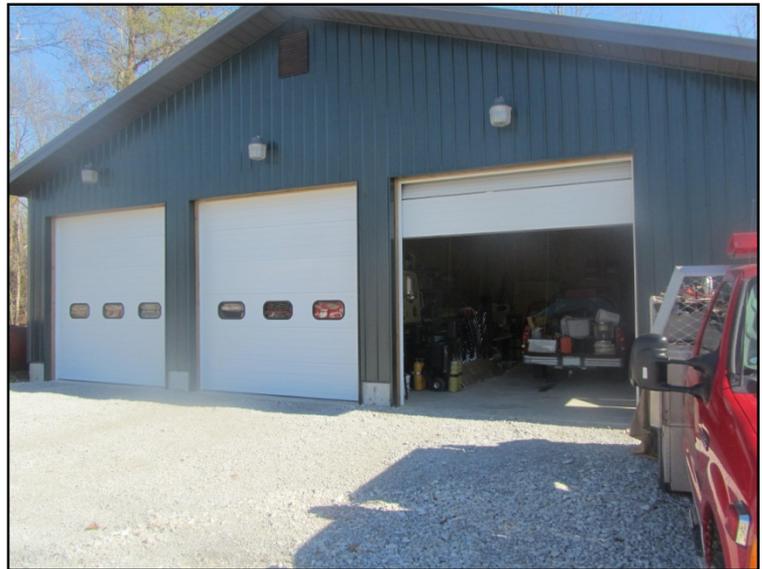
**Open overhead door showing the vehicle and bay where the incident occurred four days prior.**

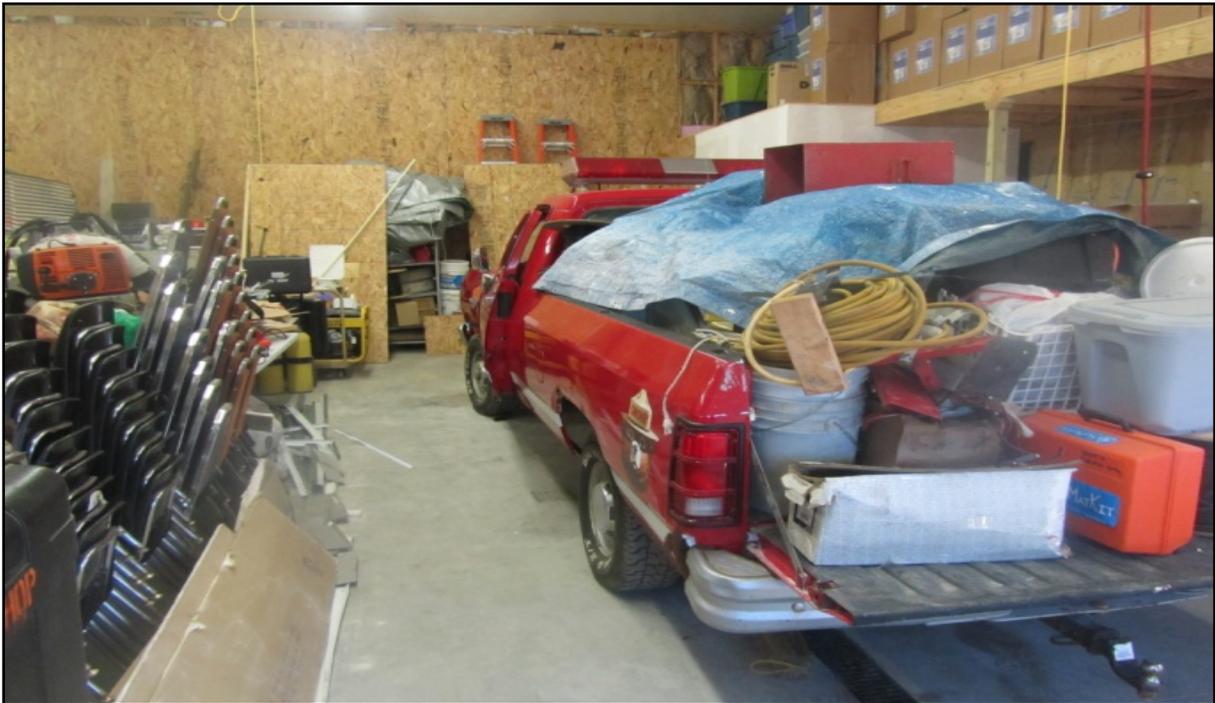
**Incident scene.**  
*(Photo courtesy of Indiana OSHA.)*

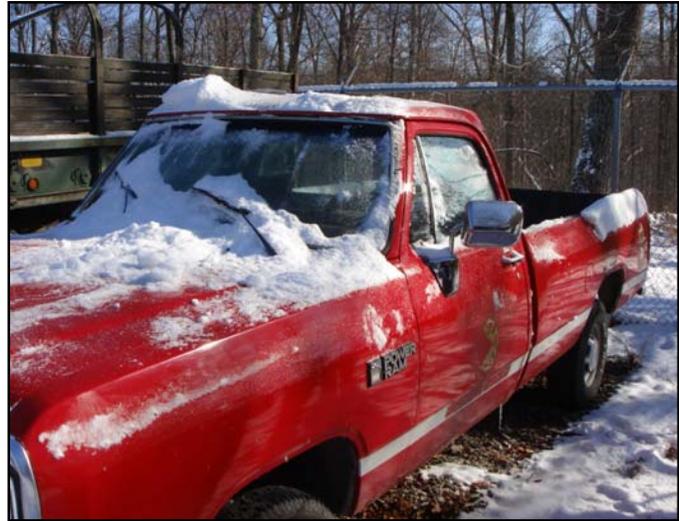
**Photo 1. Photo taken at IDNR surplus yard following the incident.  
(NIOSH photo.)**

The vehicle involved in this incident was a 1990 4-wheel drive work pickup truck that was later converted into a brush truck by the fire department (see Photo 1). The truck had a gross vehicle weight rating of 6,400 pounds and a payload rating of 1,800 pounds. The truck had a 4-speed manual transmission, 4-wheel anti-lock brakes, and a lap/shoulder restraint system. At the time of the incident, the truck had approximately 27,200 miles on the odometer.

The brush truck had a 4-speed manual transmission with one reverse gear. The NIOSH investigator noted that it was possible to start the truck in neutral without depressing the clutch pedal. The brush truck would sit and idle until the vehicle was placed into gear and the clutch pedal was engaged. Also, the truck could be started in gear without depressing the clutch pedal. *Note: The fire chief, fire*

Upon examination, the NIOSH investigator did not see a clutch pedal interlock switch on the brush truck. Also, there was no obvious indication that one had been placed on the brush truck and then tampered with. The NIOSH investigator believes this vehicle was manufactured without this safety device.

***Recommendation #4: Fire departments should ensure that fire department vehicle operators and vehicle maintenance personnel are aware of available manufacturer pre-market and aftermarket installed safety devices on apparatus.***

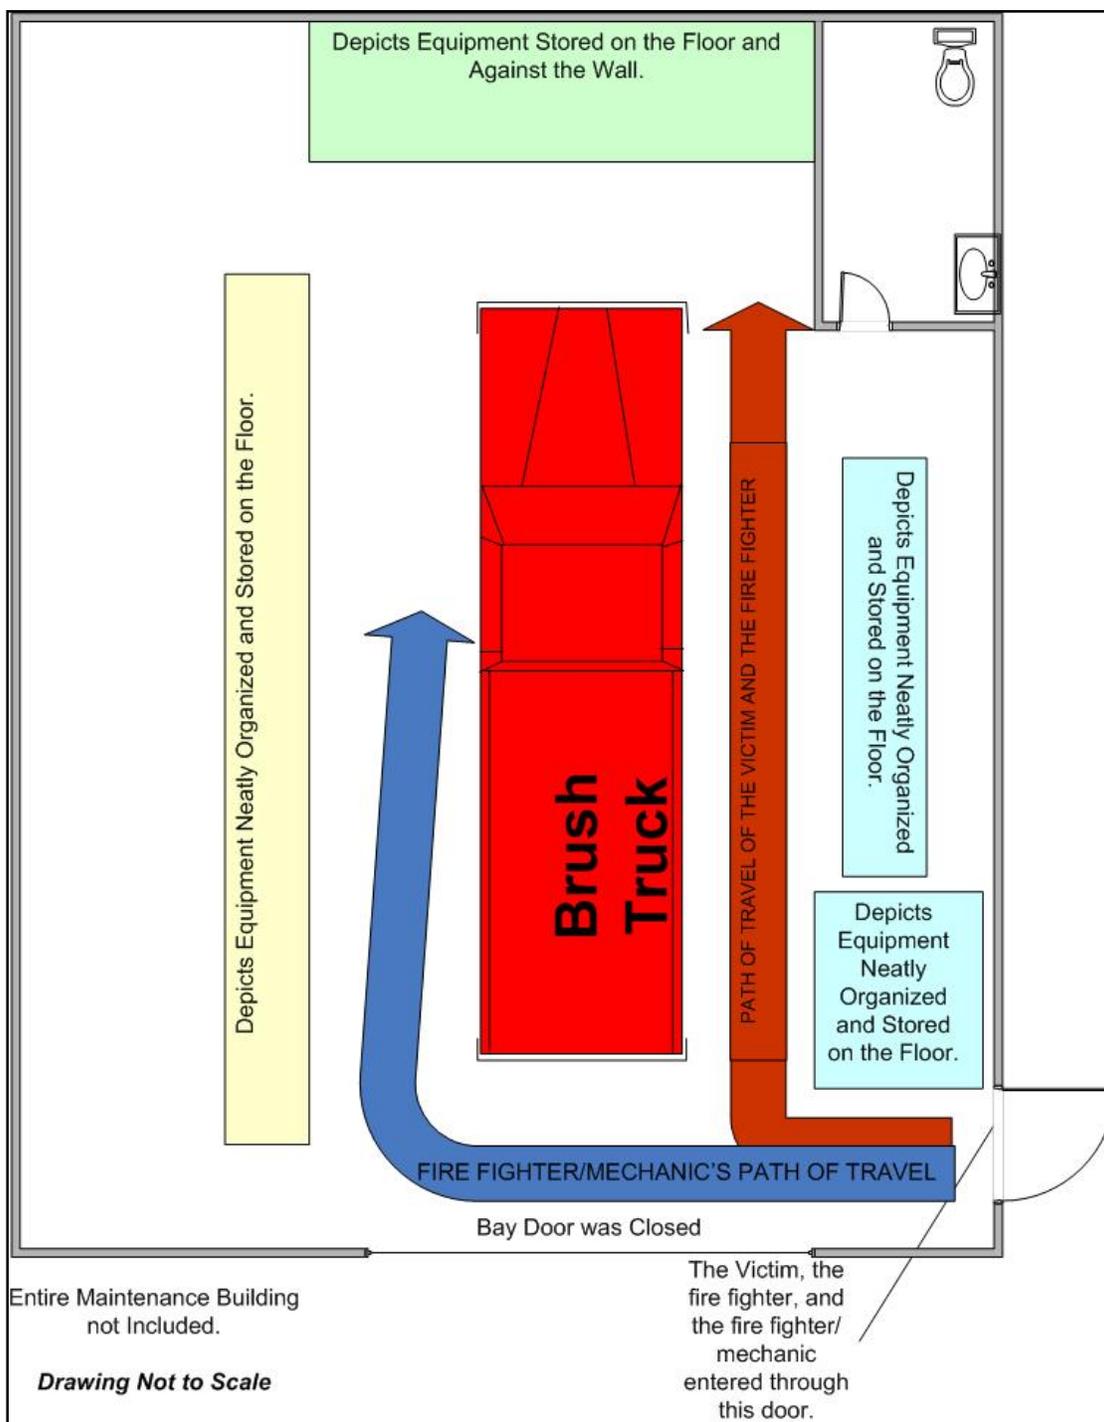
Diagram. Layout of incident scene.
