# ***Death in the line of duty...***

**NIOSH**  
Fire Fighter Fatality Investigation  
and Prevention Program

June 22, 2012

## **Career Fire Fighter/Paramedic Dies from Injuries Following an Unexpected Ceiling Collapse – California**

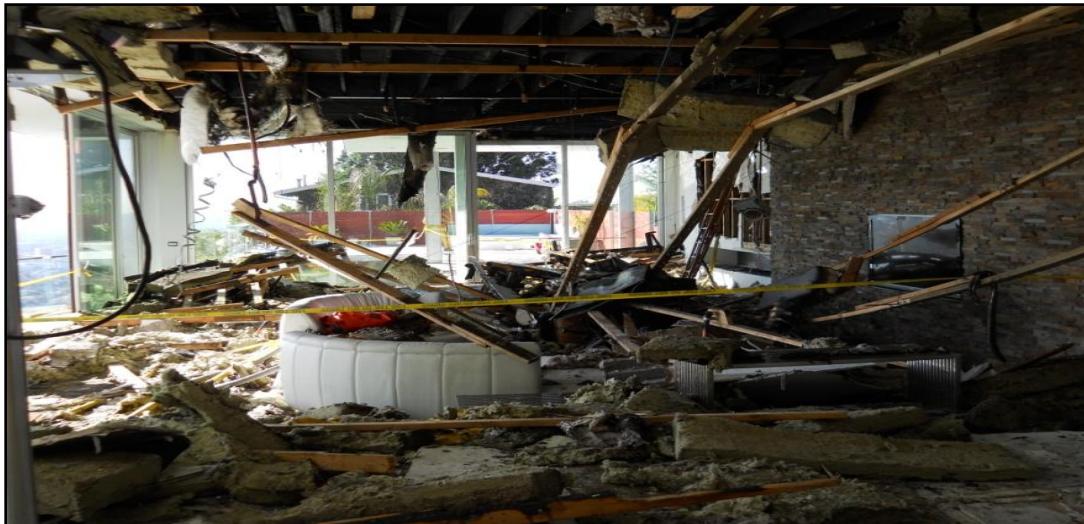
**Collapsed ceiling within house where victim and fire fighters were found.  
(Photo courtesy of mutual aid fire department.)**

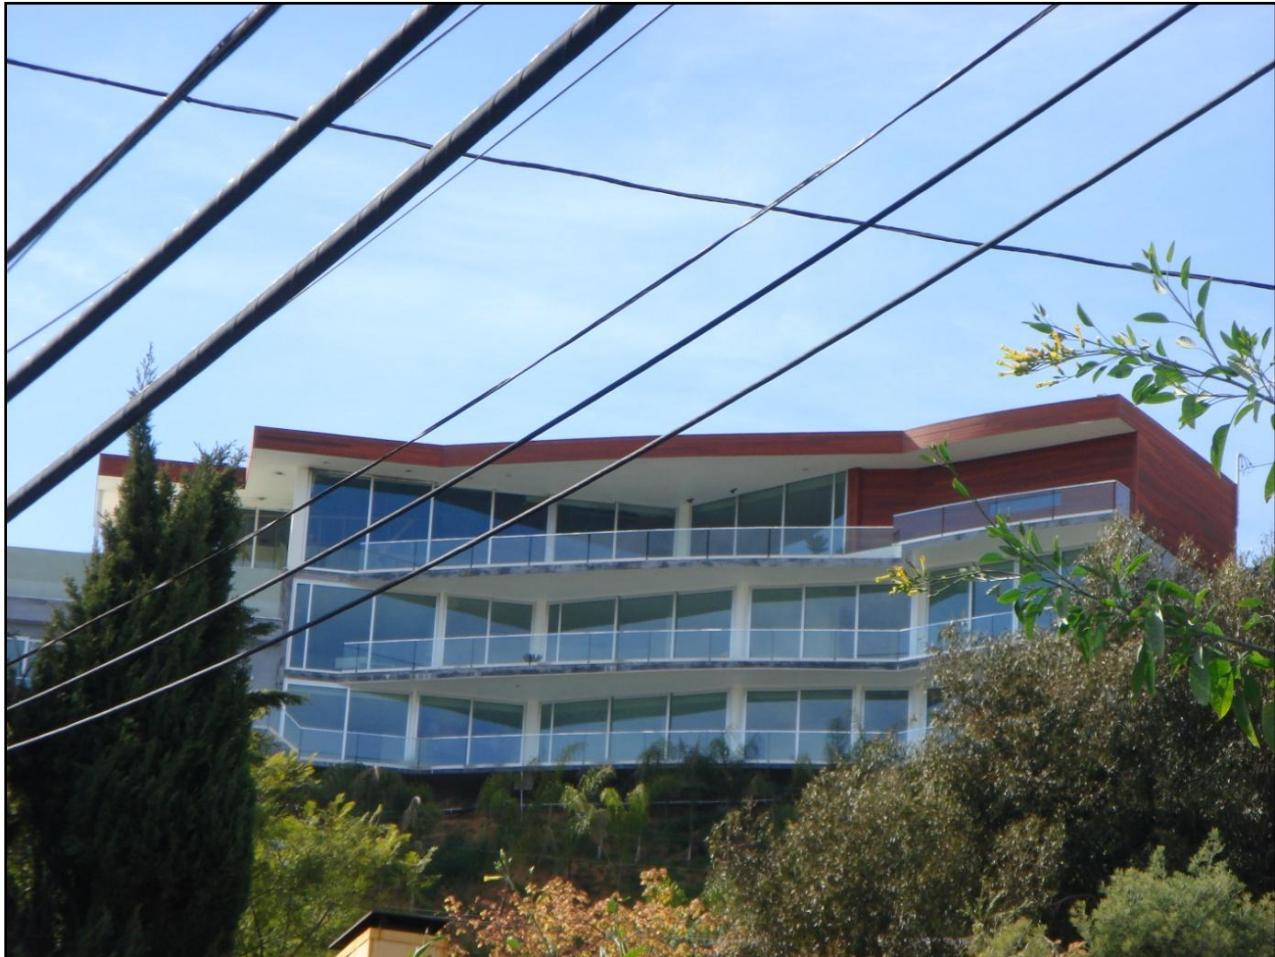
**Photo 1. Photo taken from a neighborhood street below the residence showing the B-side of the structure, which was not accessible or able to be viewed from street level.**

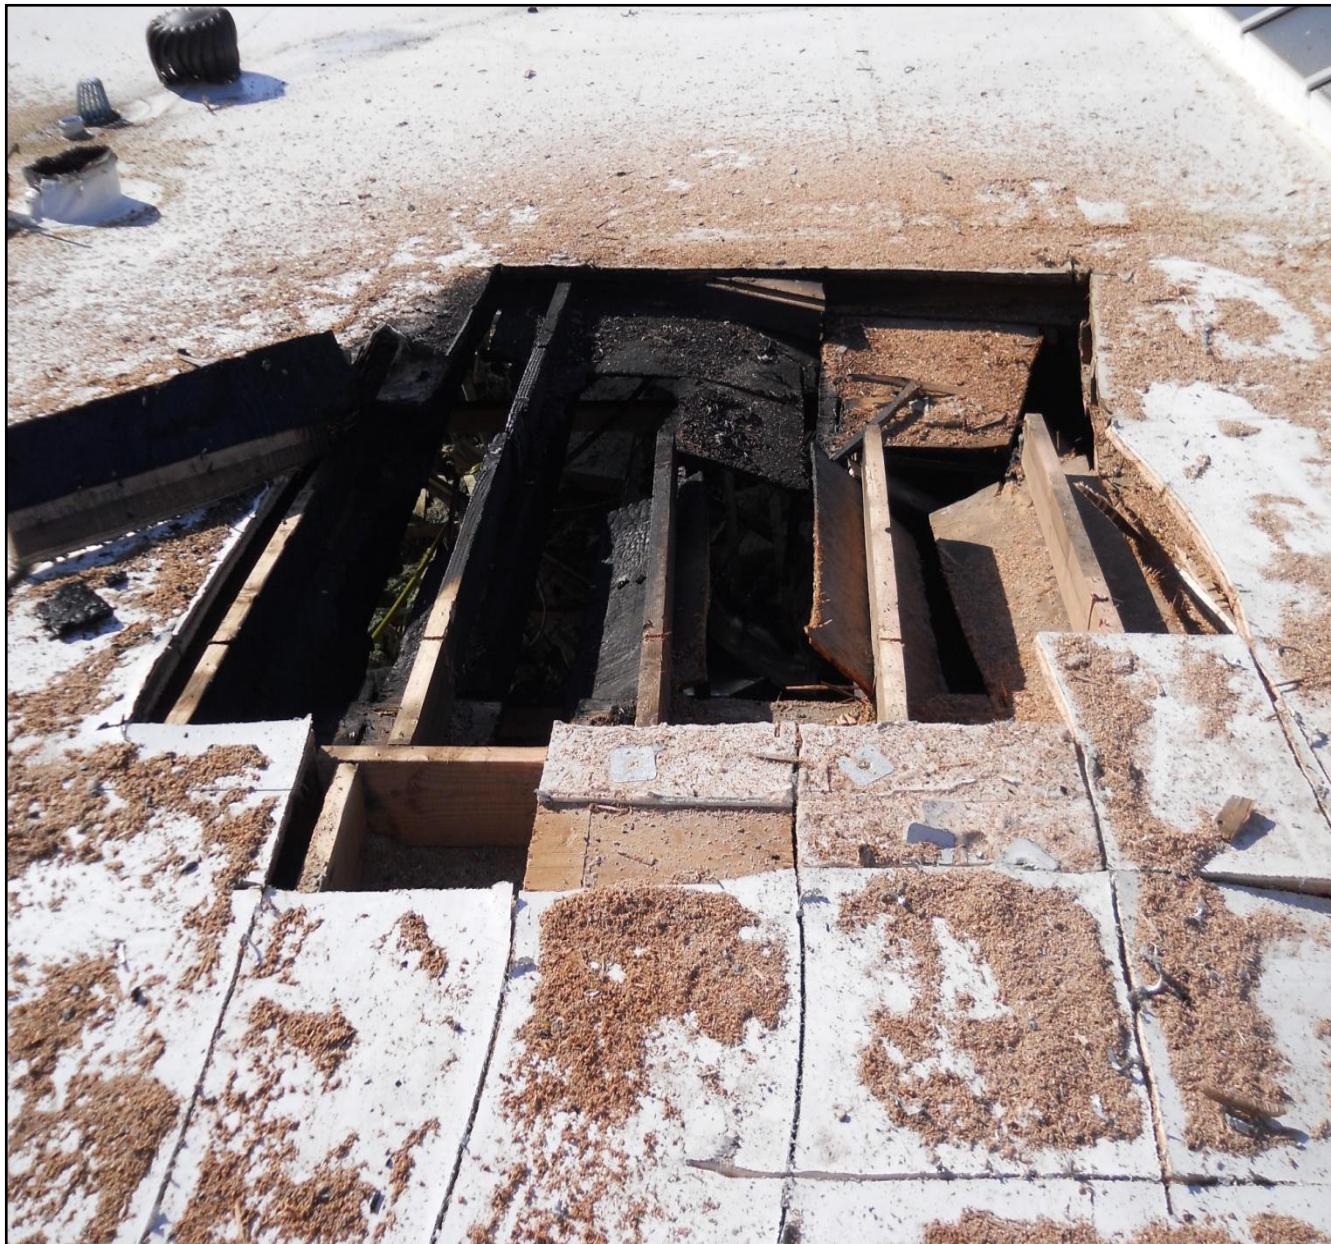
**Photo 2. Photo shows roof construction and materials. Photo shows ventilation hole cut above the collapse area by the fire department the night of the incident.**

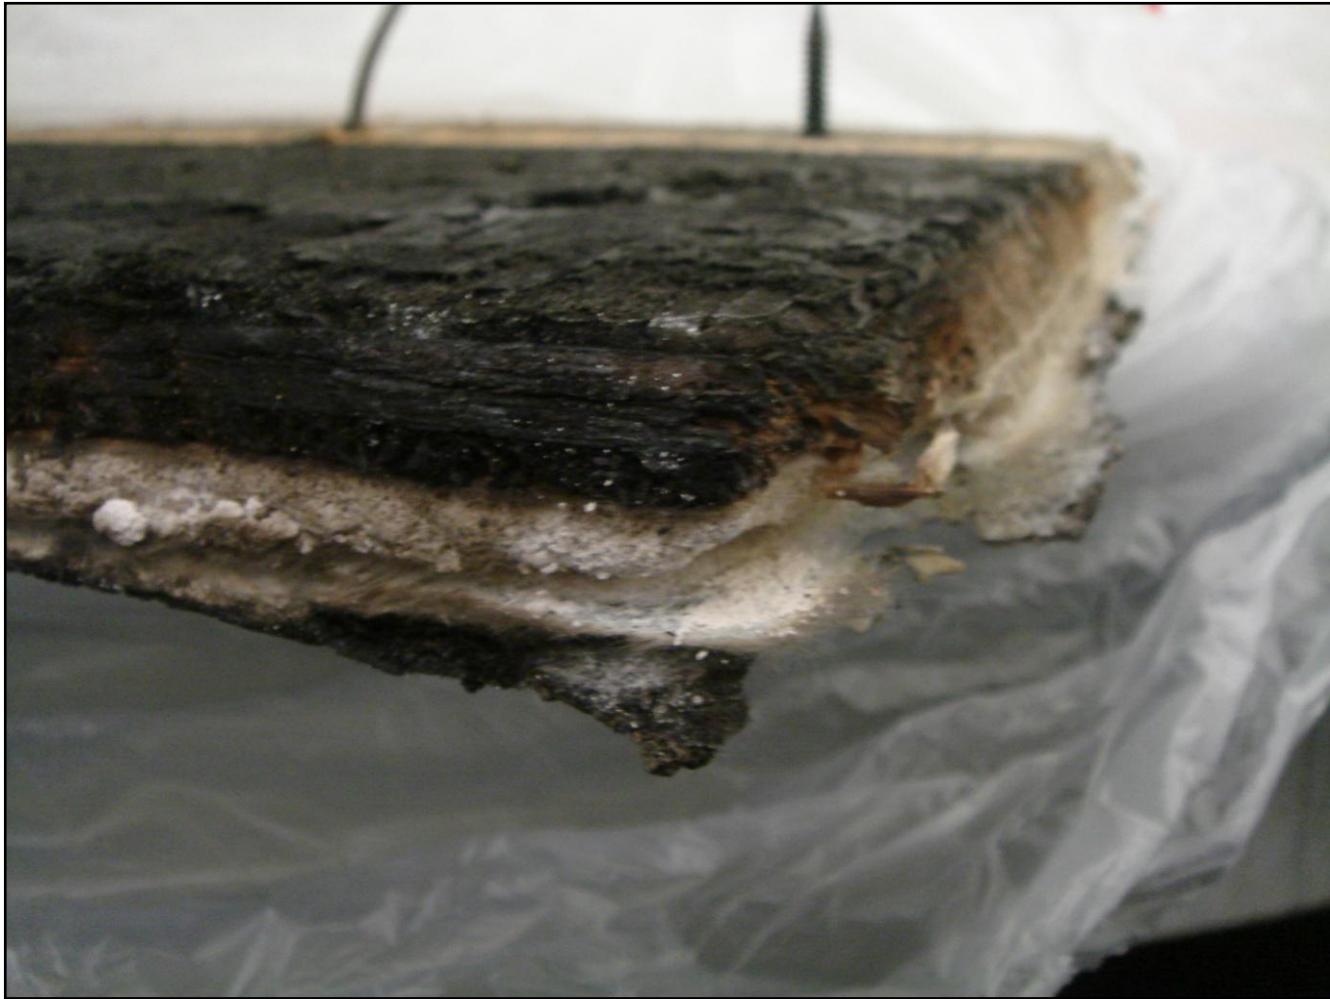
**Photo 3. Photo shows the layers associated with constructing the home's roof membrane.  
(NIOSH photo.)**

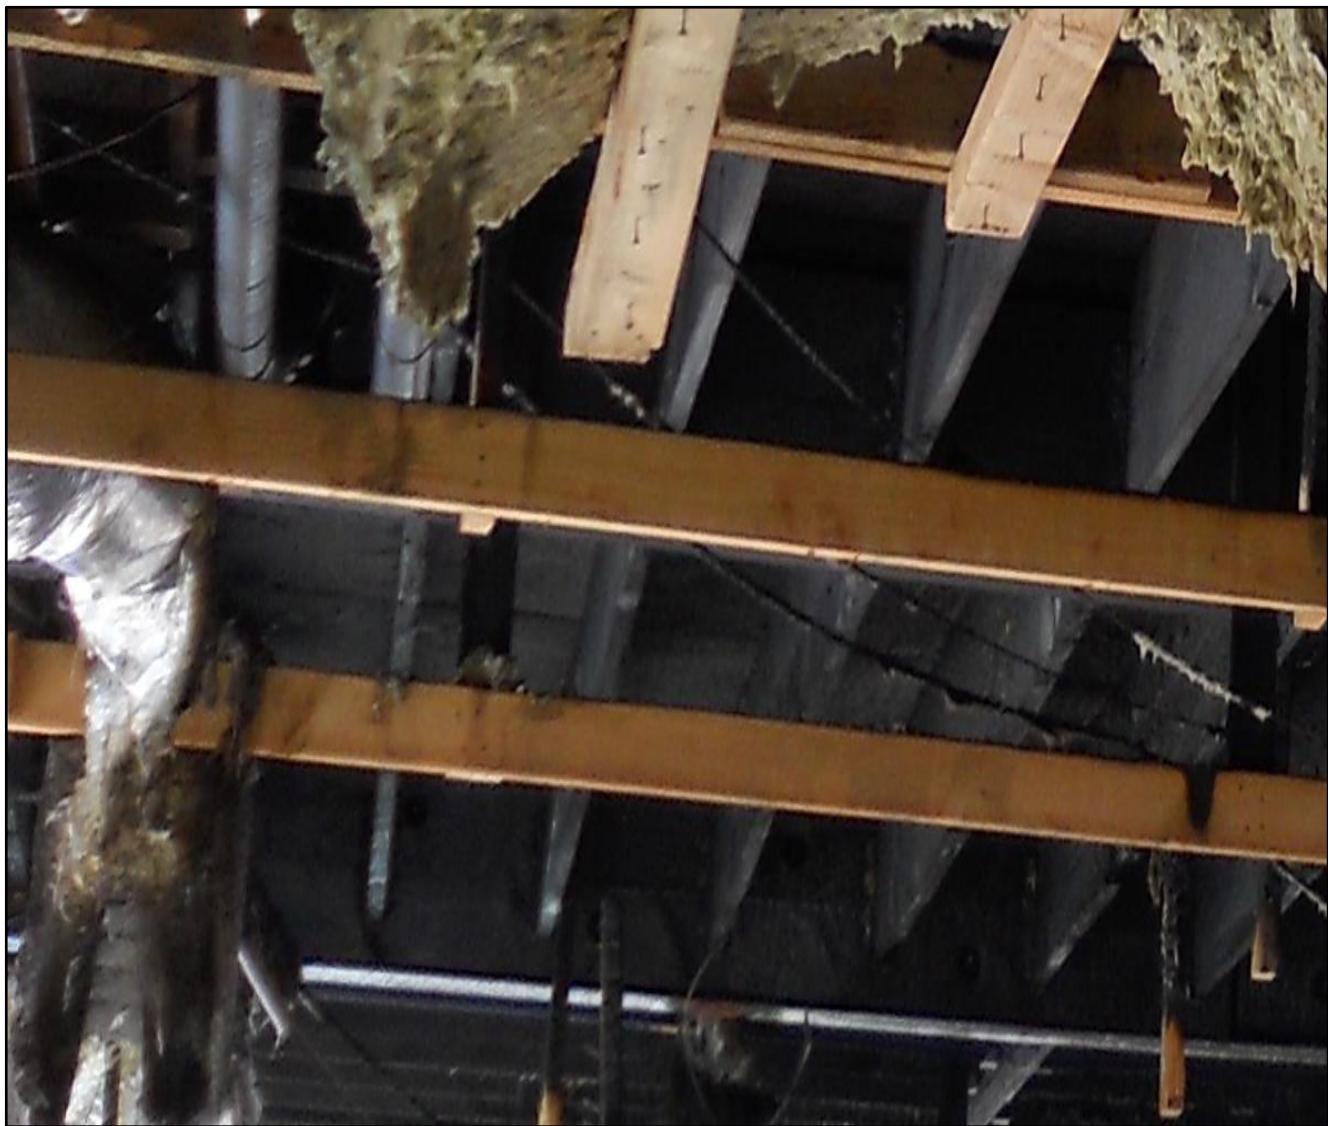
**Photo 4. Close up of ceiling construction.**  
*(Photo courtesy of mutual aid fire department.)*

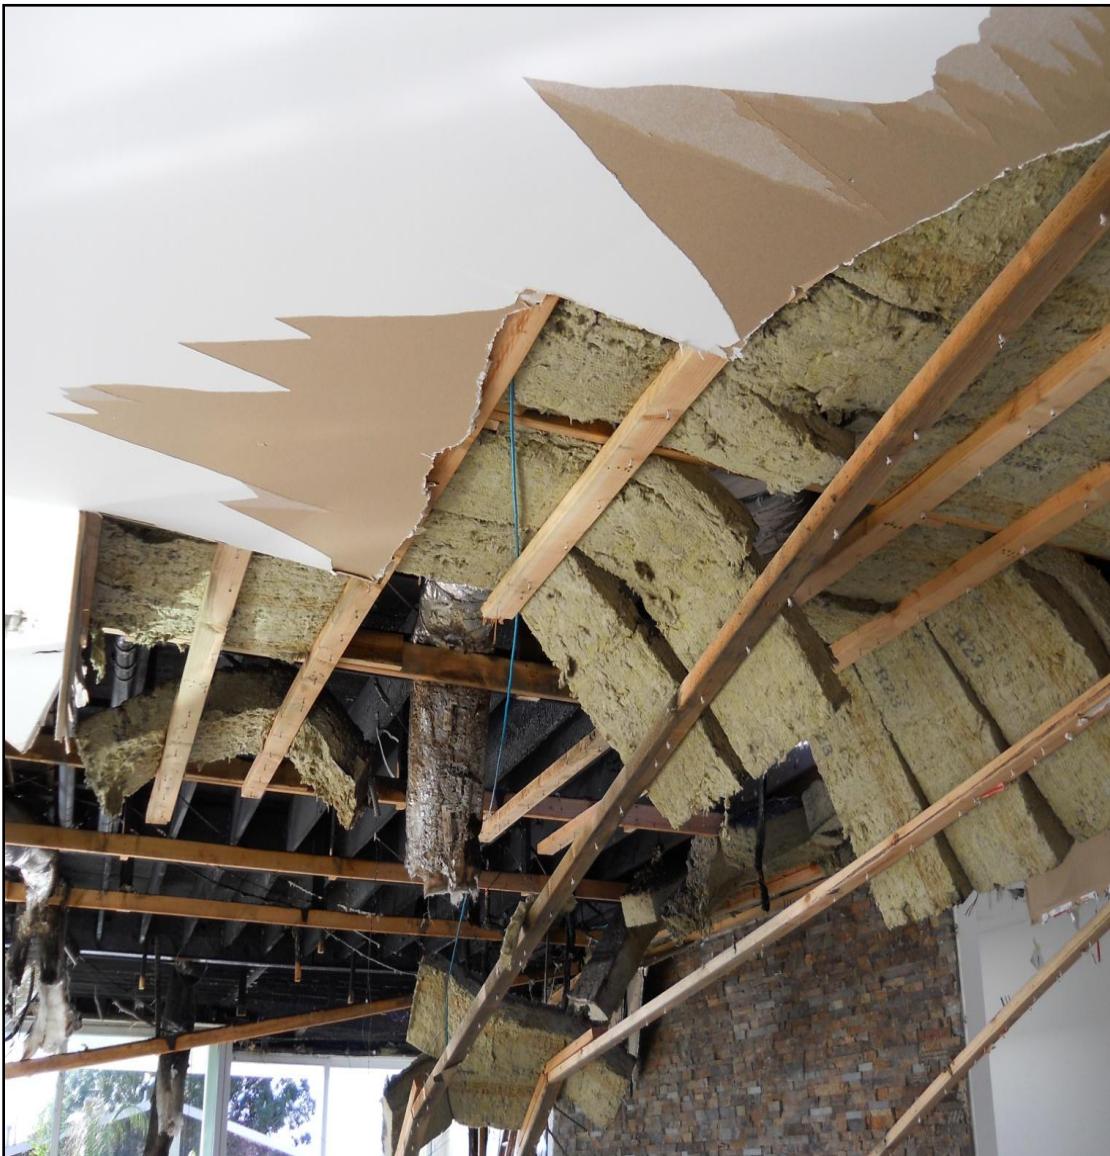
**Photo 5. Photo shows ceiling construction of the drop ceiling where the collapsed occurred.**  
*(Photo courtesy of mutual aid fire department.)*

A typical  $\frac{5}{8}$ -inch-thick sheet of drywall that is 4 feet by 8 feet weighs approximately 70 pounds (2.2 pounds per square foot);  $\frac{5}{8}$ -inch drywall is also sold in larger sheets as wide as 4½ feet or as long as 16 feet (application and use dependent), making a single sheet of drywall weigh as much as 140 pounds or more. Including the weight of multiple sheets, the compromised structural support system, ceiling fixtures (e.g., fans, lights), insulation, and water from suppression activities resulted in making a potential collapse weight in upward of 1,000 pounds or more. According to the fire department's fire investigation report, the portion of the wide area ceiling which collapsed onto fire fighters measured approximately 27 feet by 45 feet (1,250 square feet). The ceiling height was approximately 11 feet, 3 inches where the collapse occurred.

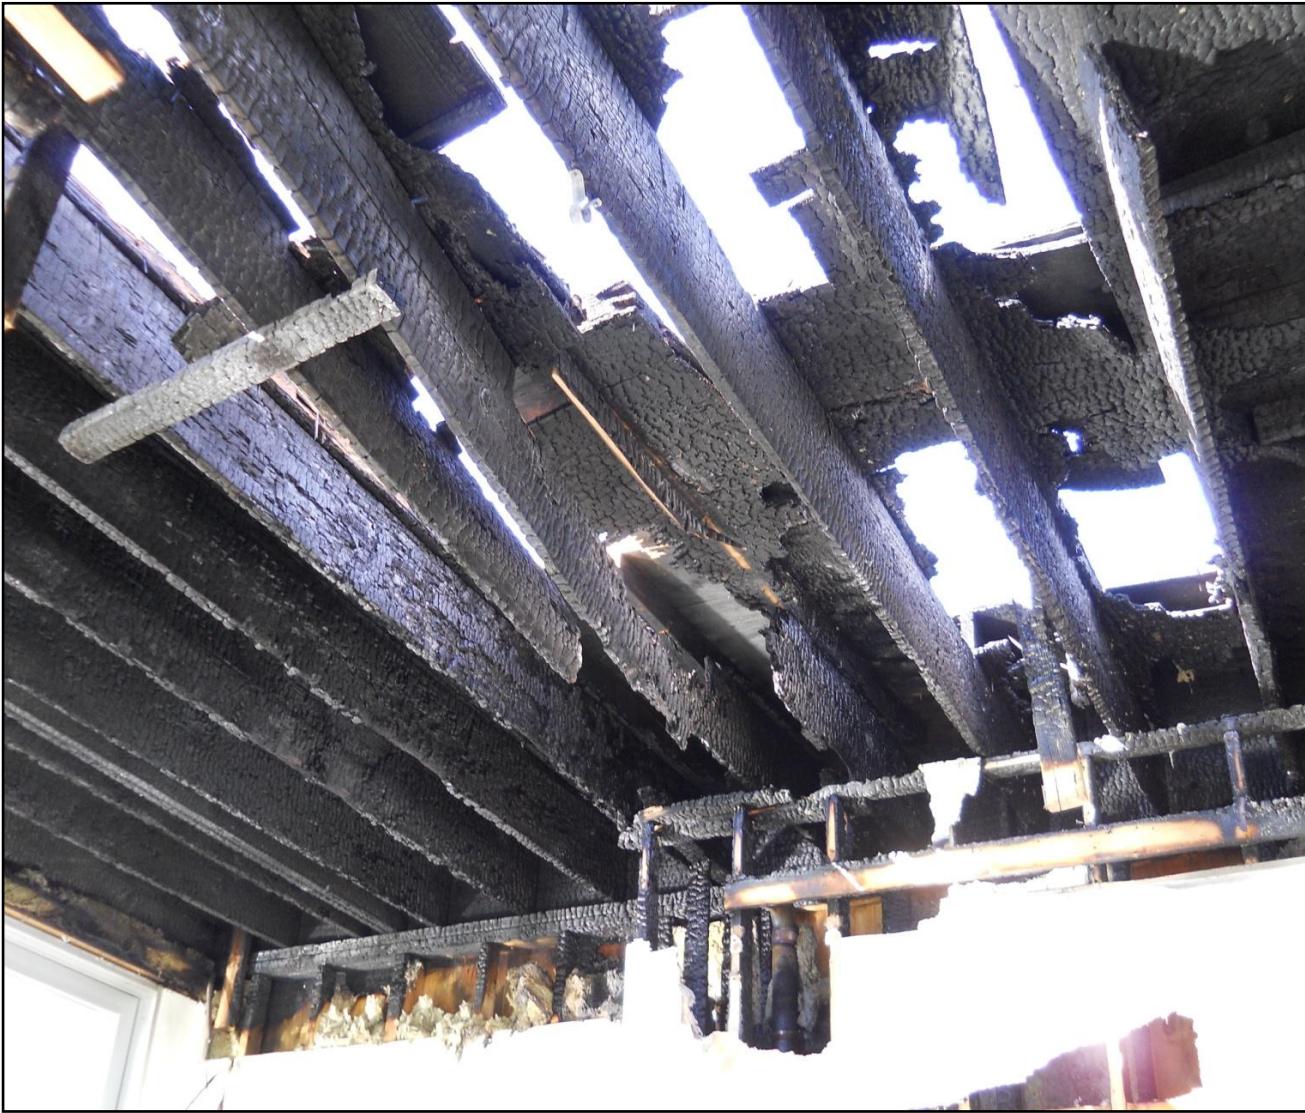
The first-floor dropped ceiling comprised of a large unsupported open space was nailed to the 2-inch by 12-inch rafters (running north/south). Hanging down from the rafters were 2-inch by 4-inch wood hangers measuring approximately 26 inches in length that were attached to every third rafter east/west and every 5 feet north/south. Additional 2-inch by 4-inch wood boards were then nailed to the bottom of the hangers. These boards ran east/west spanning the ceiling in the living room and were 5 feet apart. Attached to the bottom of those boards were 2-inch by 4-inch boards approximately 16 inches apart running north/south and running the length of the living and dining room ceiling. *Note: Photo 4 shows a close-up for the ceiling construction.* Then  $\frac{5}{8}$ -inch type "X" fire code drywall was attached to these boards, and then finished with smooth plaster (see Photo 5). The drop ceiling created an approximate 28-inch void space between the underside of the roof decking and the ceiling drywall, where 6-inch thick R-23 insulation, plastic sprinkler piping, electrical conduit, and air conditioning duct work was placed (see Photo 6).

**Photo 6. Photo shows void spaces between rafters.**  
*(Photo courtesy of mutual aid fire department.)*

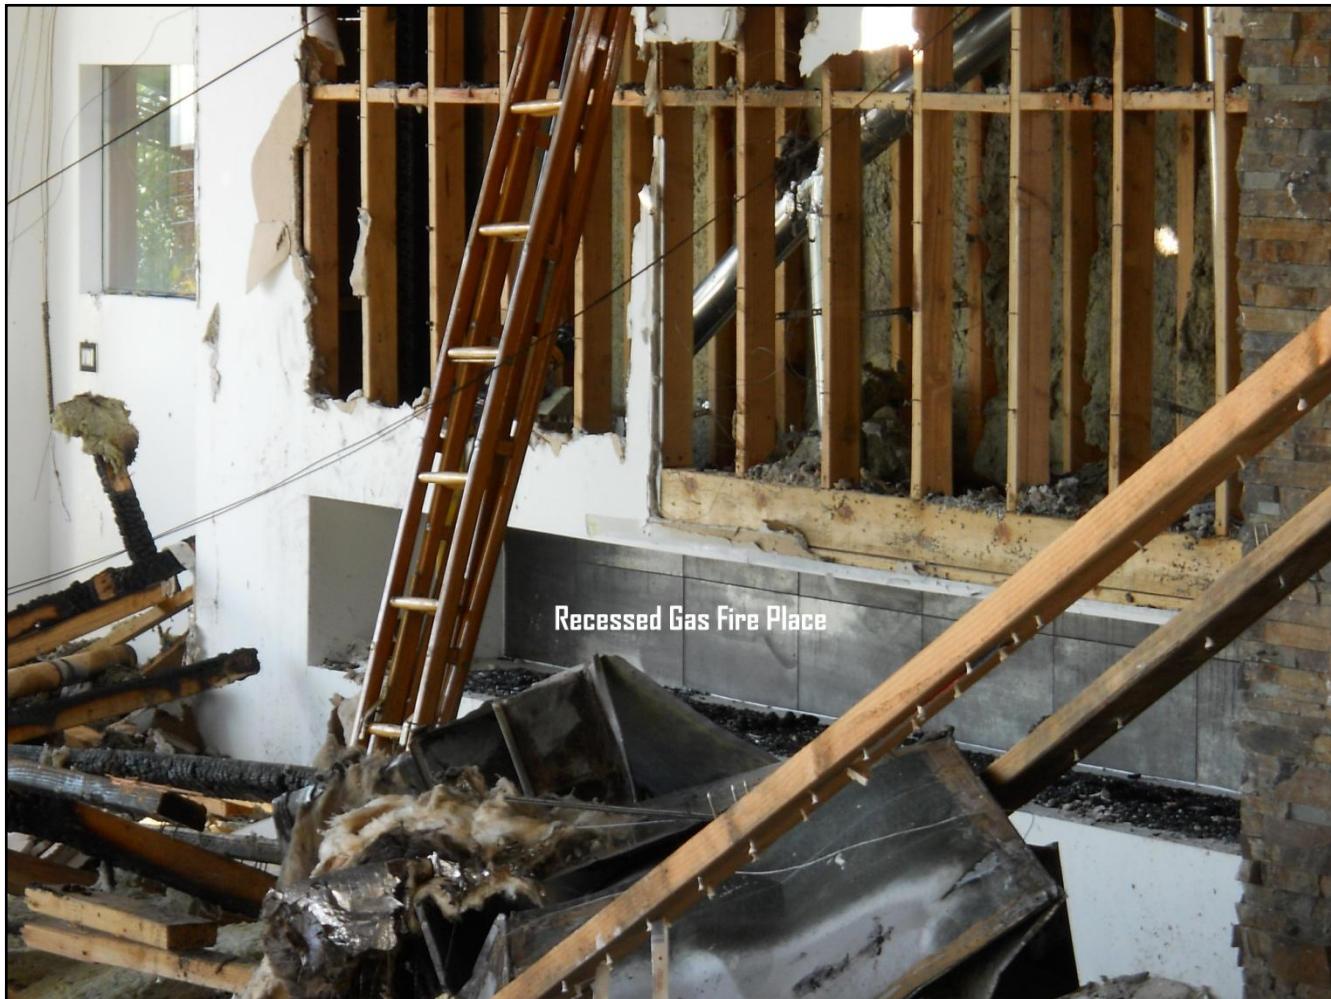
The living room also contained a recessed fire place measuring approximately 18 feet wide by 2 feet deep by 18 inches in height. The fire place enclosure was constructed of drywall, backer board, and tile. The back wall was backer board and covered with tile. The top and side walls were constructed of drywall and the floor was constructed with backer board. Within the fire place enclosure was a gas-burning appliance. Within the floor of the fire place were two stainless steel troughs measuring 6 inches by 15 feet that contained two ½-inch pipes connected to two blowout boxes (north and south ends of fire place). The pipes and troughs were covered with dark colored glass chips and lava rocks. In the void space below the fire place floor were two control boxes (north and south ends of fire place) that were rated for 300,000 BTUs each. *Note. Fire was first observed by arriving units on the D-side exterior wall of the house in area of north blowout/control boxes (see Diagram 1).* Above the fire place was a void space that extended up into the ceiling (area of collapse). This void space measured approximately 2 feet deep by 20 feet wide and was constructed of 2-inch by 4-inch sawn wood and then enclosed with drywall. Within the void space were three, 4-inch diameter sheet metal vent ducts above the fire place that connected to a single vent duct that appeared to lead to the roof. Photo 7 and Photo 8 show construction of the gas fire place and void space. There were no observed draft or fire stops at the top of the void space below the roof. *Note: Specifics of the gas fire place were obtained from investigative reports provided to NIOSH investigators from the city's district attorney. The fire places within the home did not have a permit and were never inspected prior to use.*

**Photo 7. Picture shows the recessed gas fire place and opened void space above the fire place where some fire was discovered.**

### ***Recommendation #3: Homeowners, contractors, and governing municipalities (federal, state, regional, and local) should ensure compliance with current building and fire codes found within their jurisdiction.***

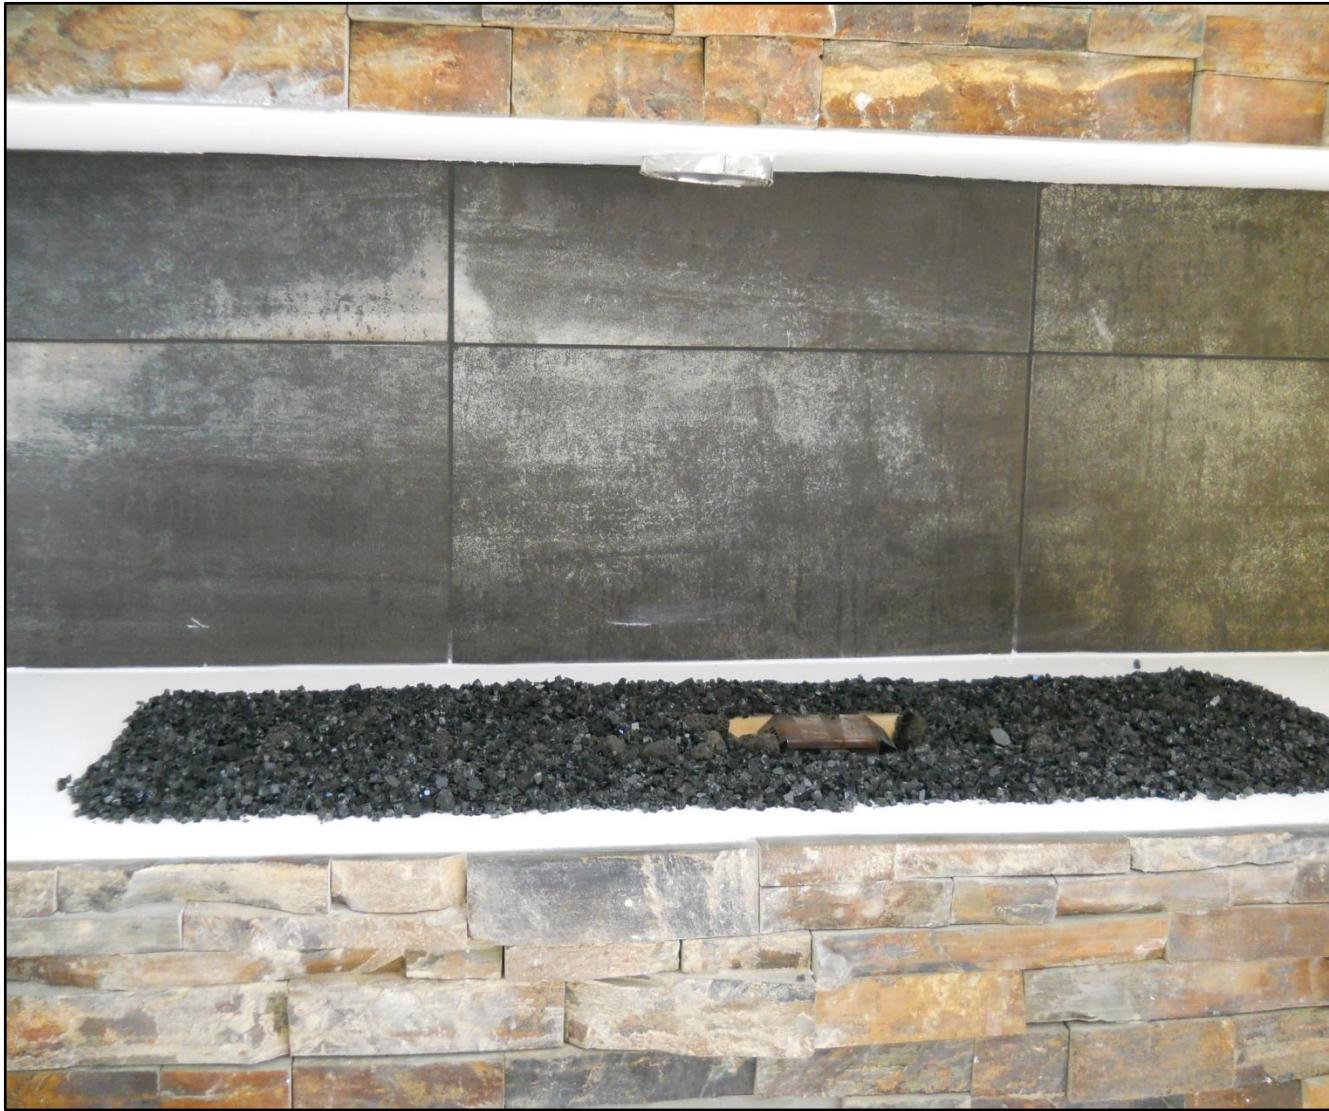
**Photo 8. Photo taken of another recessed gas fire place within the house which is believed to be similar in construction.**  
*(Photo courtesy of mutual aid fire department.)*

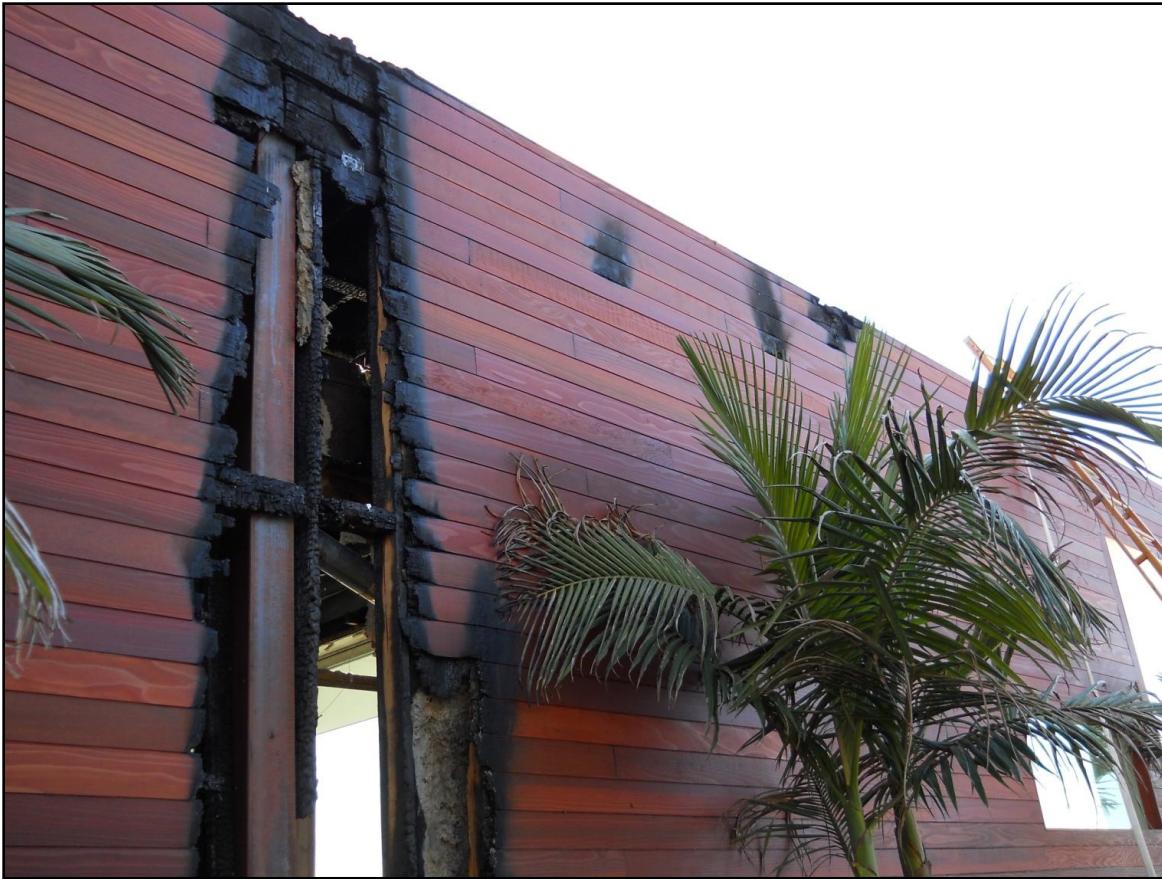
**Photo 9. Photo shows burn pattern where fire was first observed by first arriving units. Photo taken after the incident was under control.**  
*(Photo courtesy of mutual aid fire department.)*

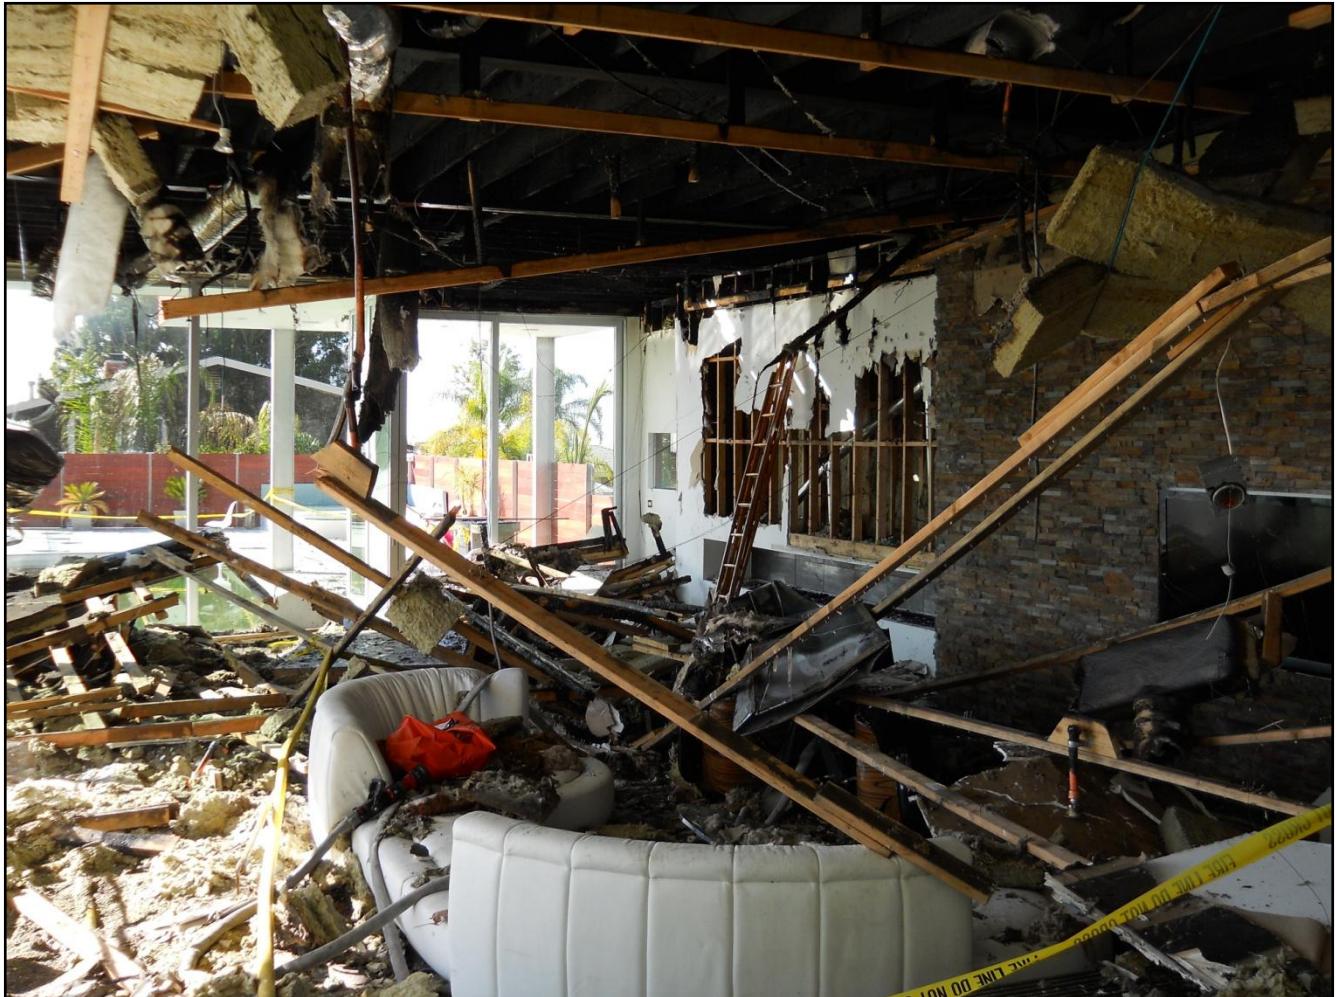
At 0002 hours, a large section of the drop ceiling fell on the interior crews while they were attempting to pull the drywall down from the ceiling. Emergency traffic from several interior fire department members was immediately initiated. The ceiling came down as a single piece that included drywall, water saturated insulation, lumber, and other structural material (see Photo 10). Many fire fighters were struck by or buried by the debris. Most were able to self-extricate, but three interior crew members, including the victim, required extensive extrication through the use of saws.

**Photo 10.** Photo shows the span of ceiling and debris that collapsed onto the interior fire fighters.  
*(Photo courtesy of mutual aid fire department.)*

At this fire, crews were operating under a large area of ceiling space. The fact that this large area was not supported by vertical walls put it at high risk for a large area collapse. During this incident, the drop ceiling posed an immediate threat to anyone working below it due to its structural support system being deteriorated directly by fire, the constructed weight of the drop ceiling, the effects of fire suppression (which included the application of water from hose streams and the leaking sprinkler system), and forces applied by fire fighters using pike poles to pull the ceiling downwards while attempting to remove drywall from the drop ceiling. All of these factors together potentially set forth the sequence of events that led to the collapse of the drop ceiling. Maintaining situational awareness throughout a fire incident is paramount, particularly, the timelines since arrival on scene and the effects of fire on structural integrity. Situational awareness is a highly critical aspect of human decision-making from an individual's perception and includes understanding what is happening around you, projecting a future situation at events, comprehending information and its relevance, and being realistic.<sup>8</sup>

***Recommendation #1: Fire departments should be aware of potential hazards associated with ceiling and roof structural elements that have been exposed to fire or other factors for an extended period of time and acknowledge the potential for a collapse within a structure.***

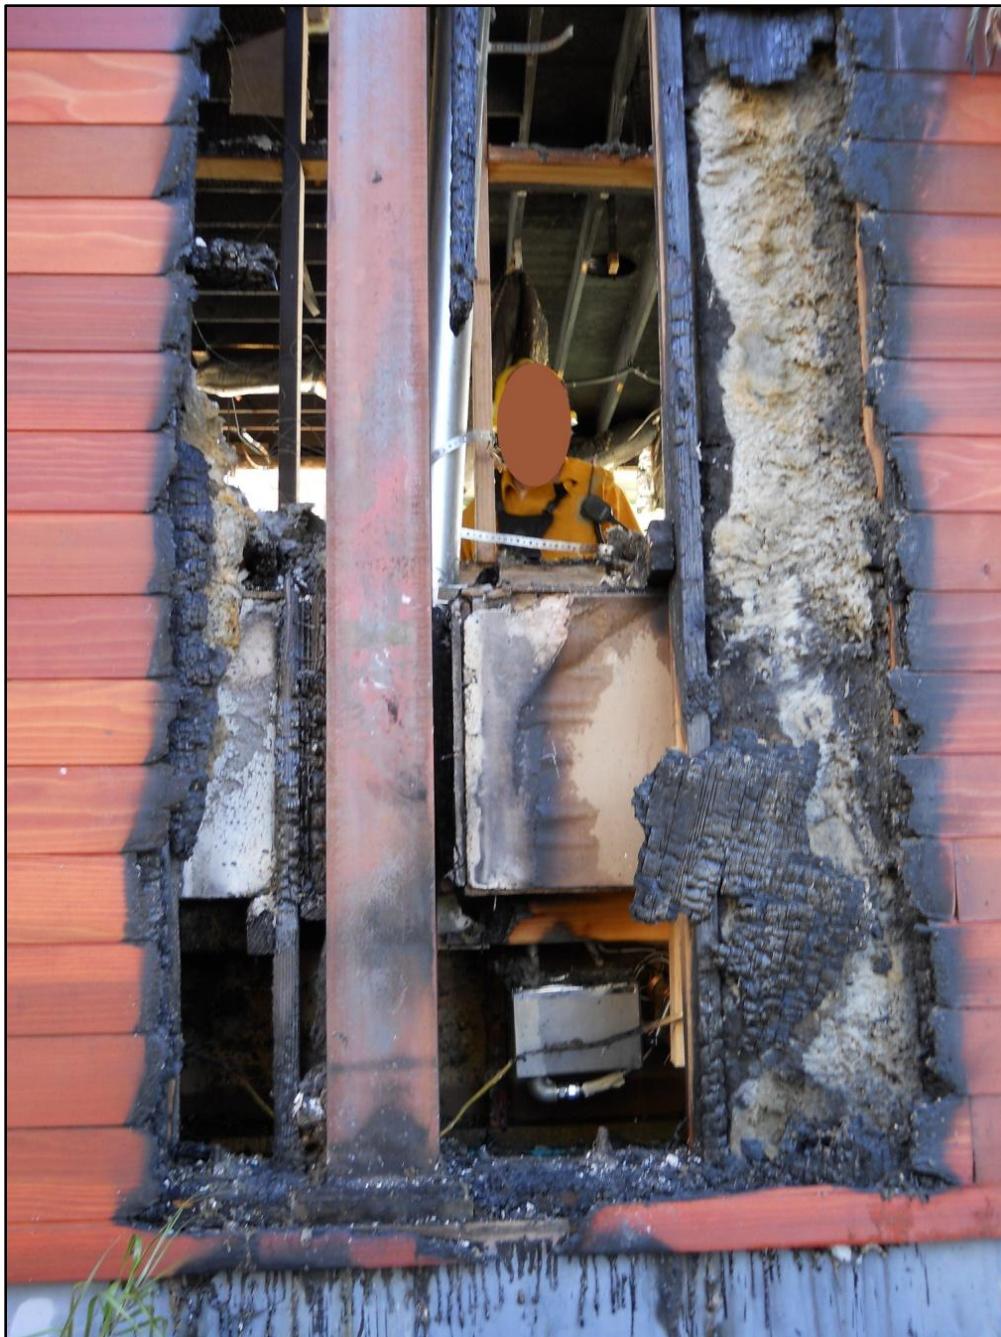
When the gas-burning fire place was installed, the manufacturer's instructions and building codes were not followed, permits were not obtained, and the fire place(s) was never inspected by local building

**Photo 11. D-side exposure wall that was first observed showing fire by arriving units. Void space directly below fire place shows control box and charring to the combustible wood members.**  
*(Photo courtesy of mutual aid fire department.)*
