## **Volunteer Captain Dies While Participating in Advanced Dive Training at Quarry—Ohio**

### **Executive Summary**

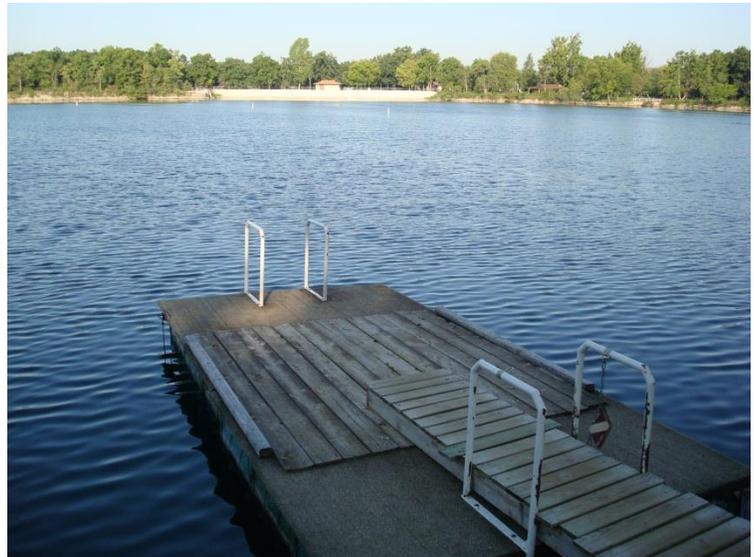
**Dock where victim was pulled from quarry.**  
*(NIOSH Photo)*
