NIOSH
Fire Fighter Fatality Investigation
and Prevention Program

January 21, 1999

Two Career Fire Fighters Electrocuted After the Aluminum Extension Ladder They Were Using Contacted a 7,620-volt Overhead Powerline - Kansas

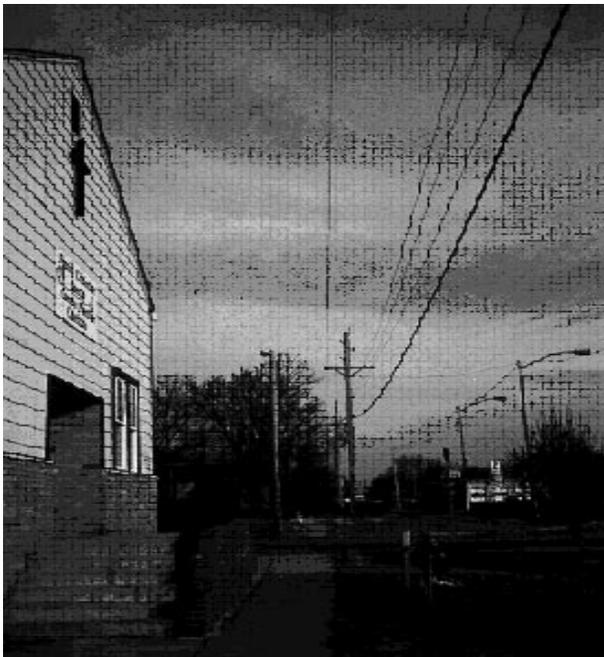
Figure 1. Incident Scene

On November 24, 1998, the wife of the pastor of a local church telephoned City Hall and requested the use of an aerial ladder. The aerial ladder was to be used by a painting contractor to finish painting the upper section of the church (see Figure 1), which was about 30 feet from the ground and could not be reached from the ladders the painters were using.

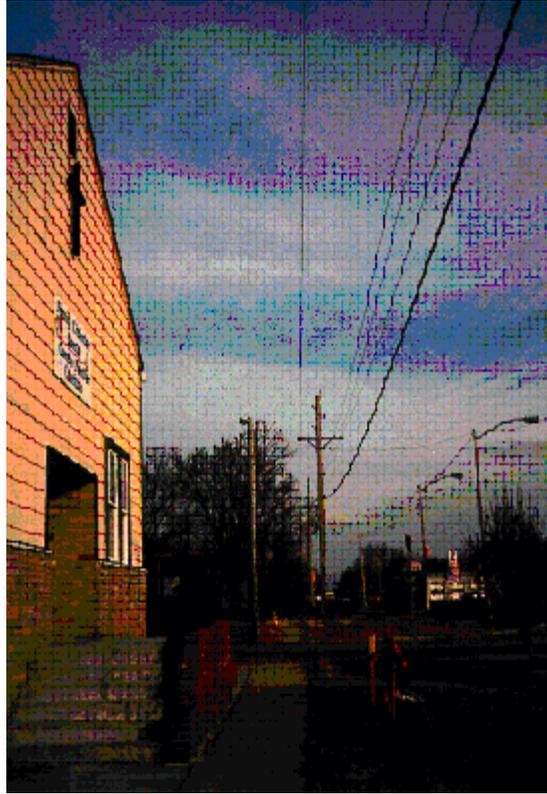
of the ladder on the ground about 13 feet horizontally from the east side of the church (see Figure 1). *NOTE: A 7,620-volt, three-phase overhead powerline was located 34 feet, 3 inches above the ground and 12 feet 6 inches horizontally from the east side of the church; however, the location of the powerline as it related to the ladder's positioning was never discussed among the fire fighters and Captain.*

Figure 1. Incident Scene where ladder contacted overhead powerline.

Recommendation #2: Fire departments should consider eliminating the use of conductive ladders in proximity to energized electrical conductors¹ (powerlines).

Discussion: In some cases the use of conductive ladders may be unavoidable, but when work projects are not of an emergency nature, fire departments should consider eliminating the use of conductive ladders (aluminum) in proximity to energized electrical conductors (powerlines). Although all fire departments are not subject to Occupational Safety and Health Administration (OSHA) Standards, OSHA Standard 29 CFR 1926.1053(b)(2) states that “portable metal ladders shall not be used for electrical work or where they may contact electrical conductors.” Ladders made of non-conductive materials, e.g., fiberglass, should be used for work near energized conductors.

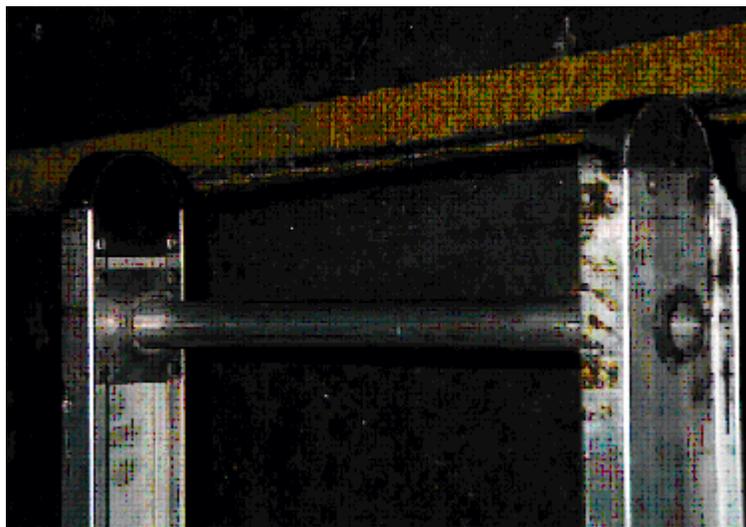
The Captain oversaw the ladder raising and positioning as three fire fighters steadied the ladder (one on each side rail and one in the middle). The fourth fire fighter used the halyard to raise the ladder. The crew first raised the ladder to about 30 feet and laid it against the side of the church below the peak of the roof. Since the top of the ladder was contacting the frame of a 2-foot by 3-foot vent, which made the ladder unsteady, a decision was made to pull the ladder back, raise and reposition it. The ladder was pulled back to a nearly vertical position a second time, raised to about 35 feet and laid back against the side of the church. This time the ladder was extending over the peak of the church's roof and again was not in the correct position for use by the painters. A decision was made to reposition the ladder a third time by lifting and sliding the butt section a couple of feet and then pulling the ladder back to a vertical position before again positioning it against the side of the church. The Captain, who had been overseeing the operation, moved to the ladder and grasped a side rail to help steady it. The top of the ladder was resting against the side of the church, and its feet on the ground directly under a single phase of an overhead powerline, which was 34 feet 3 inches from the ground. The crew then attempted to reposition the ladder. One fire fighter was grasping the halyard (rope), while the remaining three fire fighters and Captain steadied the ladder and pulled it back to a vertical position. As the ladder was being repositioned, the top of the ladder contacted the 7,620-volt overhead powerline (see Figure 2).

Electrical current passed through the ladder, and through the fire fighters and Captain who were in contact with the ladder, to the ground. Three fire fighters and the Captain were knocked to the ground. The fire fighter who was holding the halyard was uninjured. The uninjured fire fighter ran to the engine and called 911 for assistance. The Police Department heard the call and dispatched personnel who arrived on the scene within 2 minutes. The police personnel, along with the uninjured fire fighter and a slightly injured firefighter, checked for vital signs and provided CPR to the Captain and one fire fighter, who were in cardiopulmonary arrest. An ambulance arrived shortly thereafter and paramedics continued CPR while transporting the injured to the hospital. About 1 hour later the Captain and one fire fighter were pronounced dead, one fire fighter was hospitalized in serious condition, and the other fire fighter was treated and released. The fire fighter hospitalized in serious condition was subsequently discharged from the hospital.

Figure 2. Top section of ladder with burn marks.

Recommendation #3: Ladder manufacturers should consider incorporating non-conductive materials in the manufacture of aluminum ladders.²

Discussion: The use of nonconductive materials in the manufacture of aluminum ladders could provide passive protection to all affected workers in the event of an inadvertent contact with an electrical conductor. One possibility to consider is the placement of a fiberglass link in the side rails of new aluminum ladders. This link would provide isolation so electricity does not have a path to ground. Additionally, incident data from the U.S. Consumer Product Safety Commission suggest that approximately 42% of ladder contact with powerlines occurs within the top 3 feet of the ladder.² Therefore, consideration should be given to insulating the ladder’s top few feet with a material that is non-conductive (e.g., heavy Teflon).
