NIOSH
Fire Fighter Fatality Investigation
and Prevention Program

May 16, 2000

Volunteer Fire Fighter Dies After Coming into Contact With a Downed Power Line - Arkansas

Fatality Assessment and Control Evaluation Investigative Report #99F-46

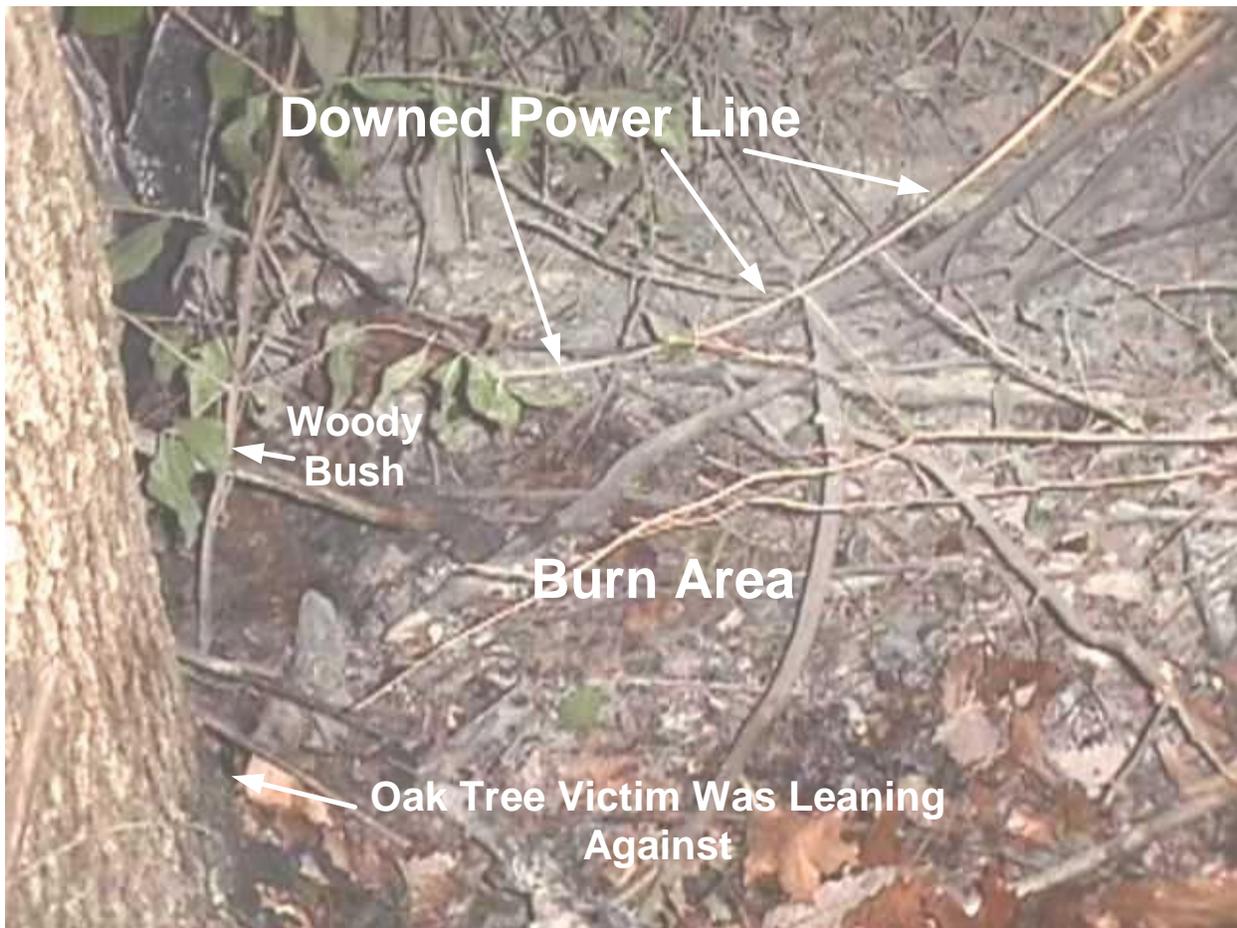
Photo 1. Incident Site Immediately After Victim Was Removed

Discussion: As stated in the Fundamentals of Wildland Fire Fighting, when downed power lines come in contact with the ground, current flows outward in all directions from the point of contact (ground gradient). The energized area can extend several feet from the point of contact; therefore, fire fighters could be electrocuted by walking into this area (Step Potential). To avoid this hazard, fire fighters should keep an ample distance away from the downed power line (equal to one span between poles) until the power is de-energized. If, upon arrival, the fire has not burned past the distance equal to one span between poles, fire departments should delay their attack until the fire has burned past this recommended span. Based upon past experiences involving this utility easement and downed power lines within their area, the fire fighters believed that the fire may have been caused by a downed power line. However, not seeing a downed power line during the initial size-up or during subsequent searches, the fire fighters believed the brush fire was started by hot embers falling from the tree that was leaning against the three power lines. The single-phase, 7,200-volt line—gray in color and fairly small diameter—blended with the dead brush and leaves found at the incident site (see Photo 1). The occurrence of the incident at night also made it difficult to see.

Recommendation #1: Fire departments should ensure that fire fighters are kept away from downed power lines at a distance equal to at least one span between poles until the line is de-energized.^{1,2}
