NIOSH HEALTH HAZARD EVALUATION REPORT

**HETA 90-226-2281
ALASKA AIRLINES
SEATTLE, WASHINGTON**

**HETA 90-226-2281
JANUARY 1993
ALASKA AIRLINES
SEATTLE, WASHINGTON**

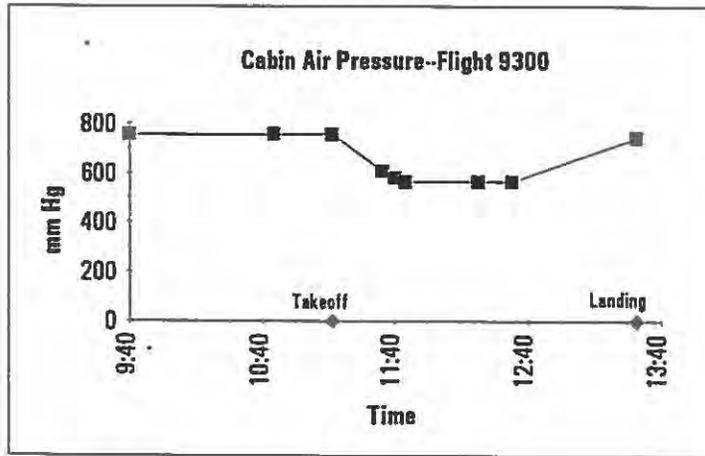
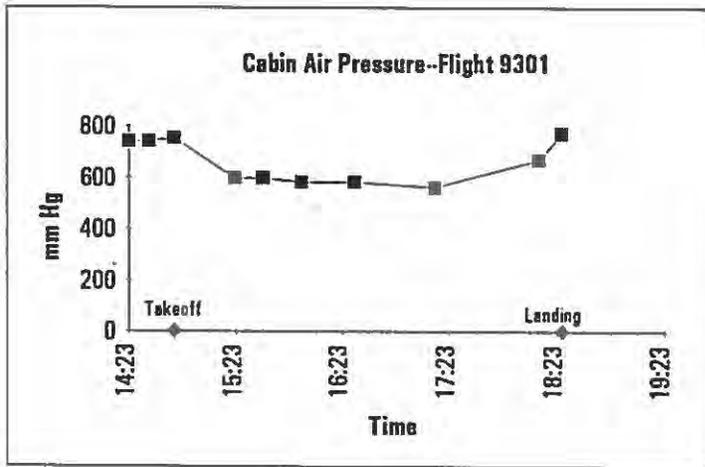
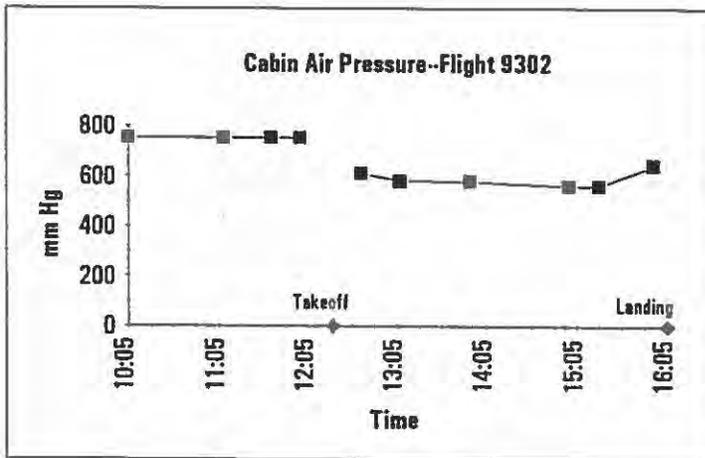
Figure 3
Cabin Air Pressure Measurements for Three Test Flights
July 10-11, 1990

Results for cabin air pressure measurements taken with a pocket altimeter are presented in Figure 3 (chart) and Table 4 (in-flight averages). The altimeter was calibrated to ground elevation and barometric pressure at take off. Mean air pressures during the three flights were similar: flight 9300, 654 mm Hg (range: 564-755 mm Hg); flight 9301, 660 mm Hg (range: 564-770); and flight 9302, 654 mm Hg (range: 560-752). Not all of these values may be exact, since altimeter readings are affected to some degree by large changes in relative humidity. The air pressures appeared to be relatively constant, except during ascent and descent. The lowest air pressures measured during the flights, 560 and 564 mm Hg, were equivalent to altitudes of 8218 ft and 8064 ft. The maximum cabin altitude according to the airplane cabin altimeter readings during the test flights was 8000 ft. The discrepancy between NIOSH measurements and airplane altimeter readings is due to the fact that the airplane altimeter readings were relative to standard sea level pressure (760 mm Hg), whereas NIOSH readings were relative to actual ambient air pressures at take off.

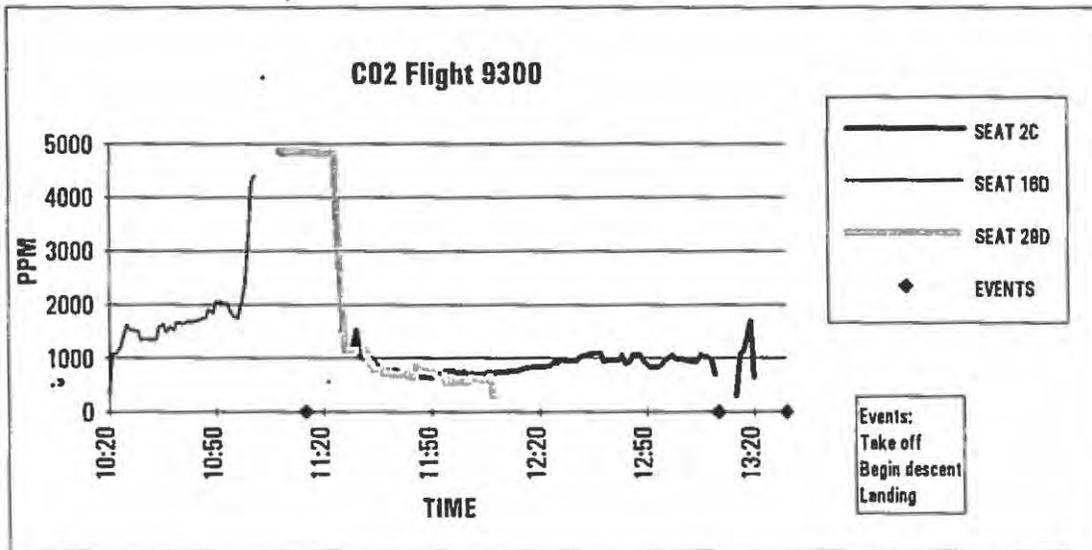
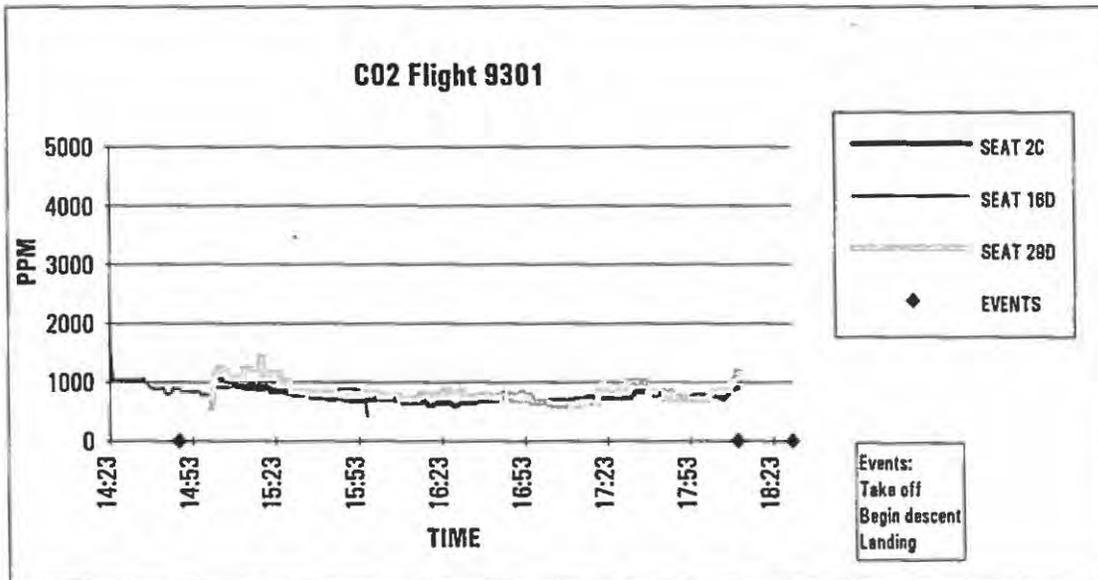
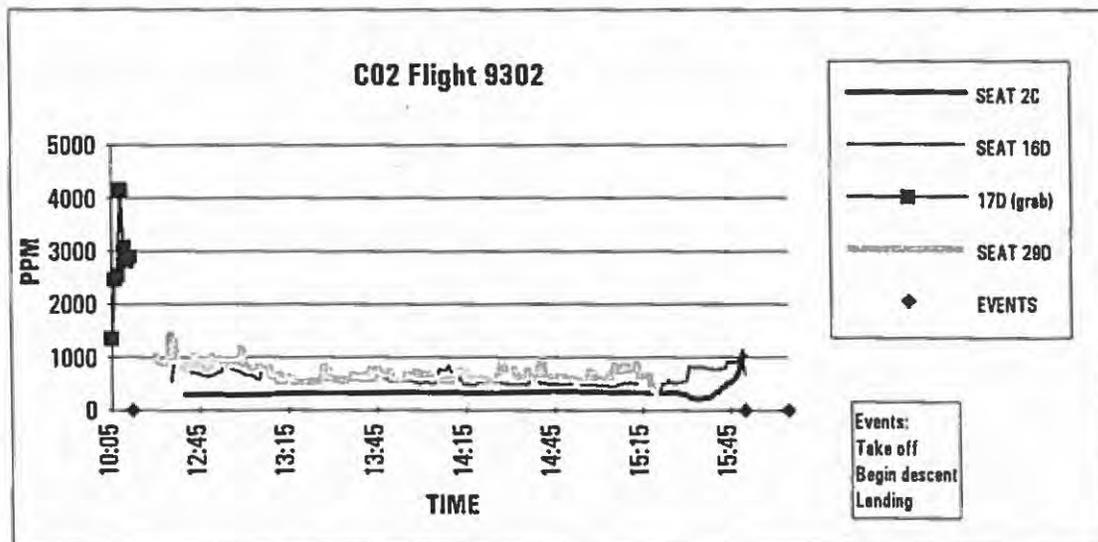
Figure 4
 CO2 Measurements by Seat Location--Test Flights
 July 10-11, 1990
 Alaska Airlines HETA 90-226

CO₂ results are presented in Figure 4 (continuous monitoring by seat location) and Figure 5 (continuous monitoring--in-flight averages). The maximum readings on flight 9300, shortly before and after takeoff (> 4820 ppm) may have been instrument maximums; they were within 3% of the manufacturer's reported instrument maximum (4975 ppm). Some readings that would have been used to compute averages are missing due to battery failure. Due to instrument battery limitations discovered on flight 9300, the continuous monitoring for the second and third test flights (9301 and 9302) was not initiated until near, or shortly after, take off. Instantaneous (grab sample) readings were made with the direct-reading instrument prior to take off at seat 17D on flight 9302; these are included in Figure 4.

TWA CO₂ levels on flights 9301 and 9302 were within the ASHRAE guideline. Flight 9300 was the only flight with both an average CO₂ level exceeding the ASHRAE guideline and reported symptoms (among three of four flight attendants); however, CO₂ levels above the guideline have been found to be typical on commercial airplanes.^{1,2} The TWA CO₂ levels measured on the test flights were well below the occupational health criteria and FAA regulations for CO₂.

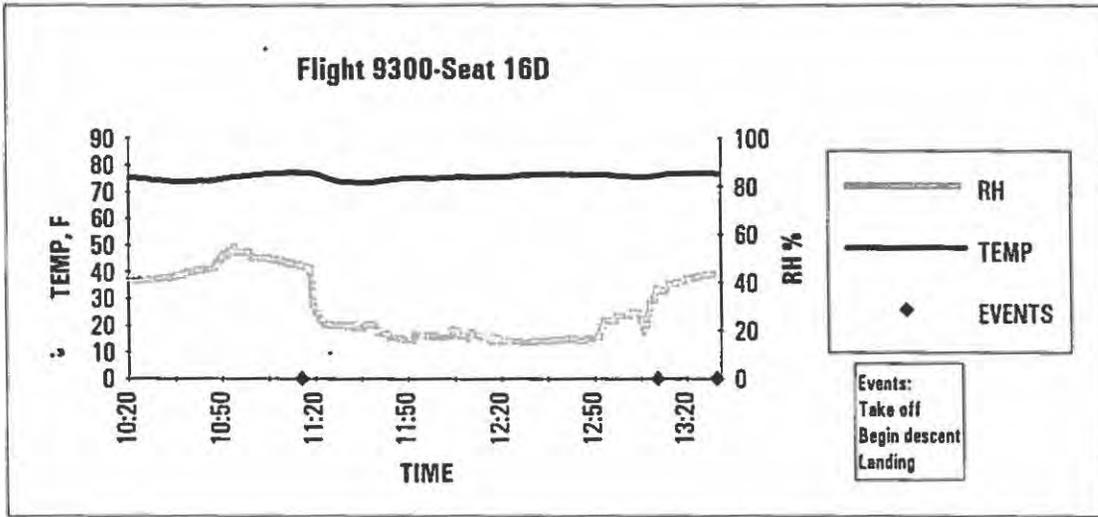
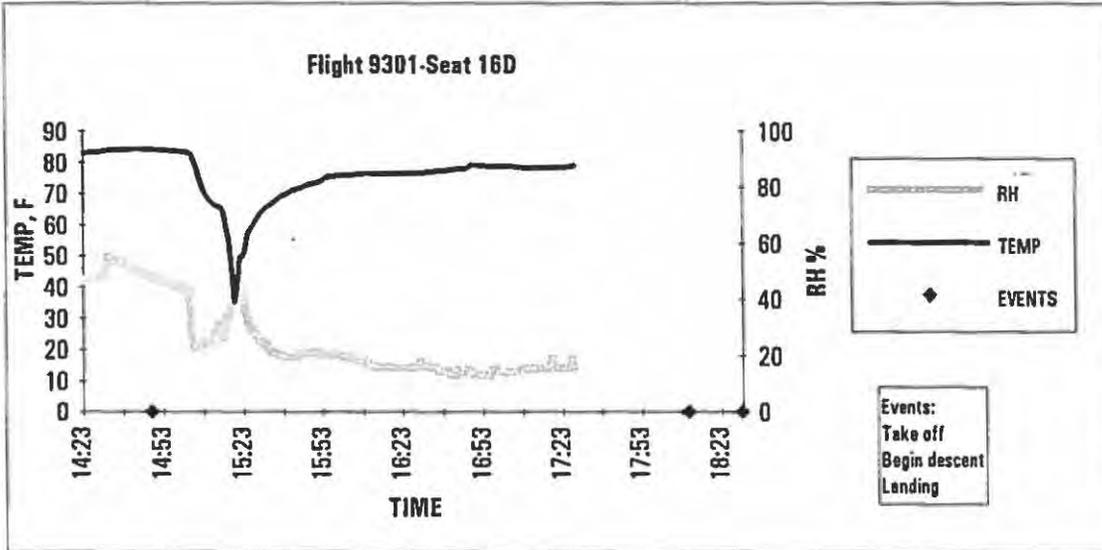
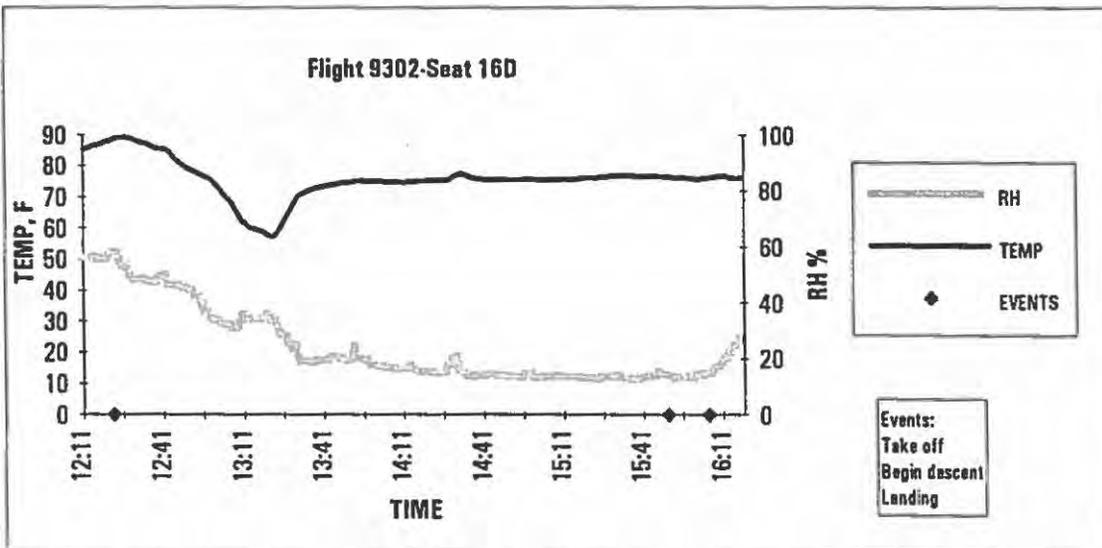
Figure 8
 Temperature and Relative Humidity Measurements--Test Flights
 July 10-11, 1990
 Alaska Airlines HETA 90-226

The results of direct-reading continuous monitoring of temperature and relative humidity at seat location 16D on the test flights are presented in Table 4 (in-flight averages), Table 6 (means and ranges, including gate time) and Figure 8 (chart). For ease of comparison to ASHRAE criteria, temperatures are reported in °F. Average in-flight temperature and relative humidity (RH) results did not vary significantly among the three test flights (range: 74-75°F and 20-21% RH). During each of the flights the highest temperature and RH readings were during gate time prior to take-off, so the averages reported in Table 6 (which include gate time) are somewhat higher (range: 75-76°F and 21-27% RH) than the in-flight averages. Wide variations in both temperature and relative humidity were measured, with maximum ranges for temperature and RH of 49°F (flight 9301) and 41% RH (flight 9302)--see Table 6.

At the measurement location (seat 16D), the temperature was relatively constant on flight 9300 (range: 4°F); but during flights 9301 and 9302 there were large temperature variations (ranges: 49°F and 32°F, respectively)--see Figure 6. For thermal comfort during temperature cycling, ASHRAE recommends that the temperature change rate not exceed 4°F/hr. On two of the three flights the temperature change rates immediately after take off (at seat 16D) greatly exceeded the ASHRAE recommendation: on flight 9301 the temperature fell from 81°F to 41°F in 16 minutes (rate: 160°F/hr), and on flight 9302 the temperature fell from 88°F to 57°F in 60 minutes (rate: 31°F/hr).

According to a representative of McDonnell Douglas, the observed temperature variations after take off were likely due to occupant adjustments of overhead "eyeball" vents. The air supplied to these vents comes directly from the air conditioning units, and can be as cold as -70°F at cruising altitude. For example, for flights 9301 and 9302, when the airplane was on the ground the cabin temperatures were warm (maximums of 84 and 89°F, respectively), and passengers probably opened nearly all the eyeball vents. After take off, vents left open over seat 16D probably created the rapid local decrease in temperature as the airplane approached cruising altitude. When nearby passengers felt a cold

Average temperatures were within the ASHRAE acceptable range of 74-80°F for occupant thermal comfort in the summer season (at 30% relative humidity). However, the low relative humidities in the cabin during flight, and relatively rapid temperature changes after take off, may be associated with passenger and crew discomfort. The temperature and relative humidity measurements were consistent with a 1989 DOT study of airplane cabin air quality, which found 90% of flights had an average RH <25%, and 60% of flights had average temperatures from 23 to 25°C (73-77°F).¹

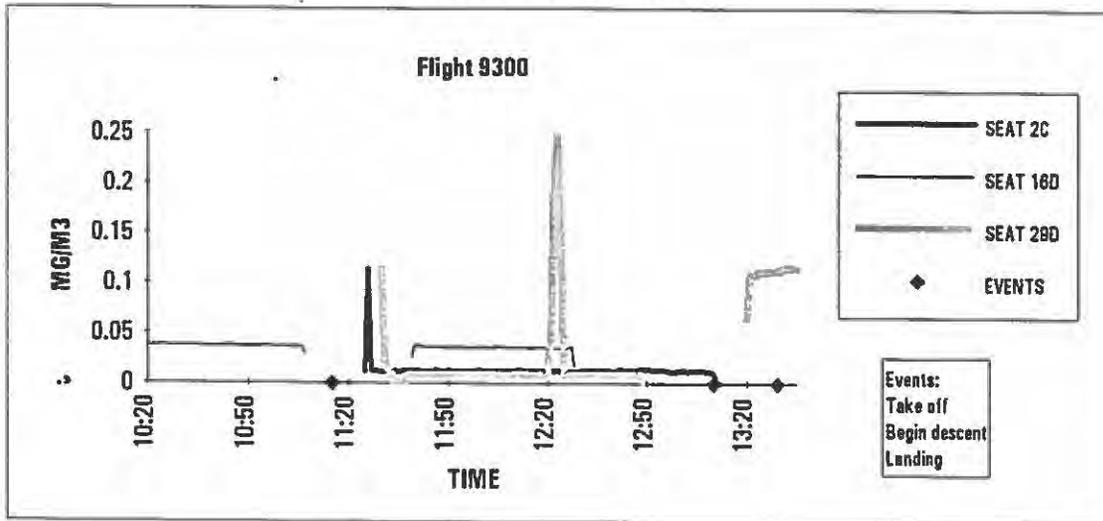
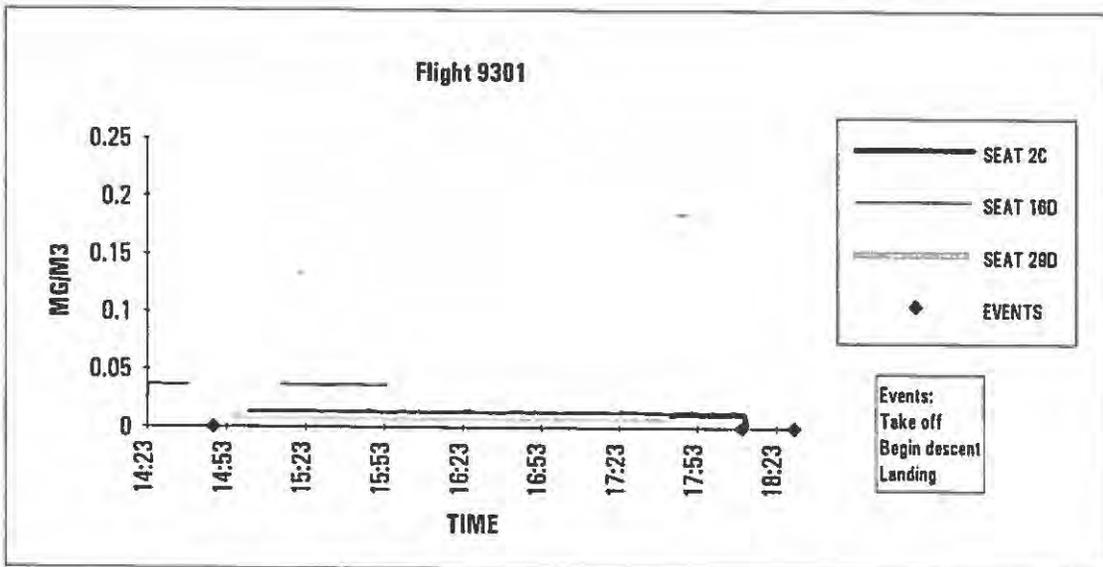
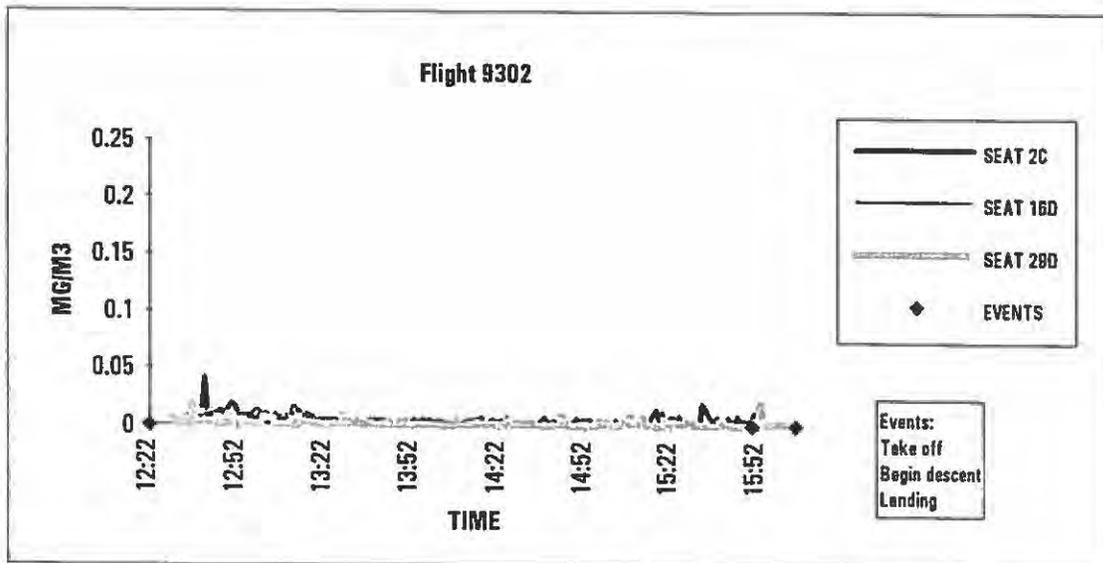
Figure 9
 Total Particulate Measurements by Seat Location--Test Flights
 July 10-11, 1990
 Alaska Airlines HETA 90-226

The results of direct-reading continuous monitoring of total particulates (optical sensor) are presented in Table 4 (in-flight averages), and Figures 5 (charted averages) and 9 (charted by seat location). The average total particulate concentrations for the three test flights were low (range: 0.003-0.027 mg/m³), and within ASHRAE guidelines. There was no cigarette smoking (a common source of particulates) on the flights monitored. For acceptable indoor air quality, ASHRAE recommends that supplied air at minimum meet the Environmental Protection Agency National Ambient Air Quality Standards: 0.075 mg/m³ (annual geometric mean) and 0.260 mg/m³ (maximum 24-hr TWA).²⁰

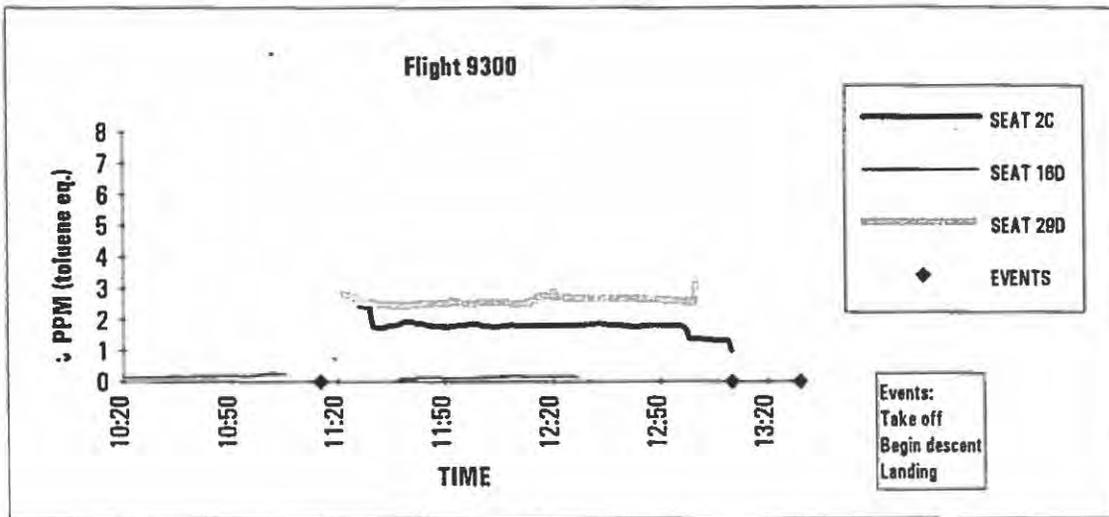
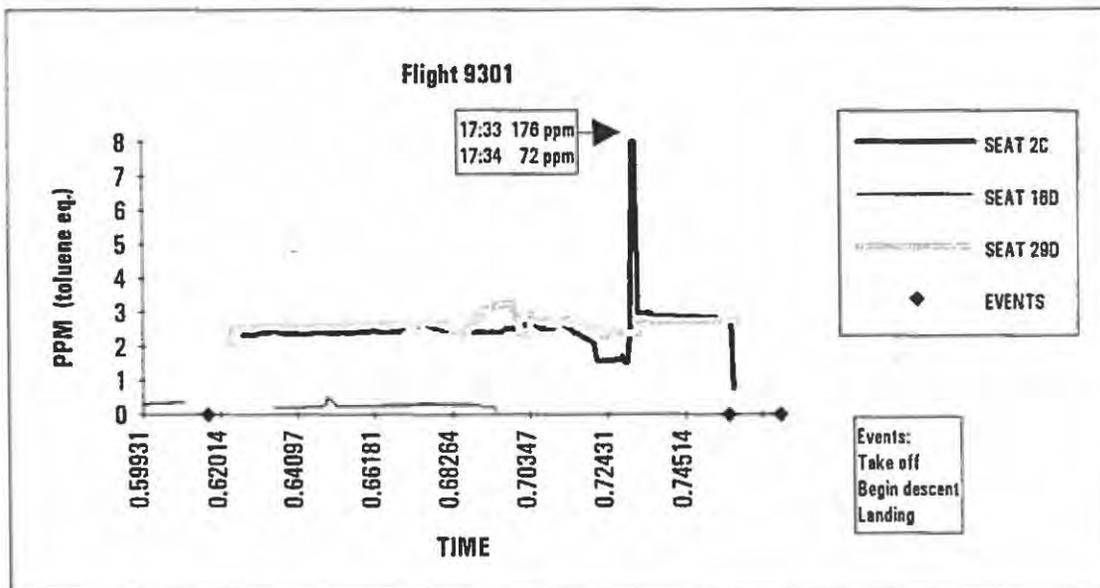
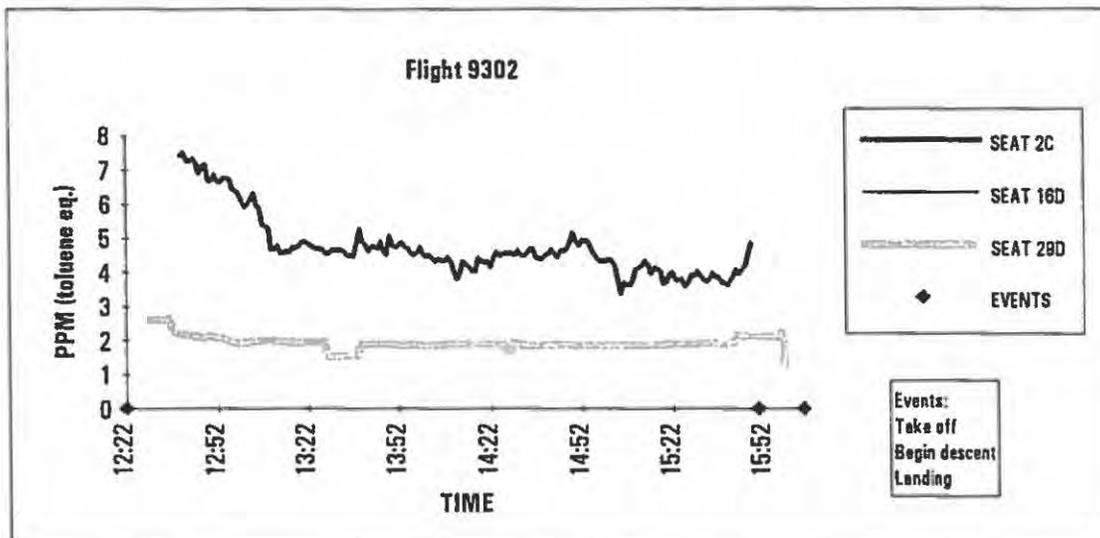
Figure 10
 VOCs Measurements (PID) by Seat Location--Test Flights
 July 10-11, 1990
 Alaska Airlines HETA 90-226

The results of direct-reading continuous monitoring of VOCs with a photo-ionization detector (PID) are presented in Table 4 (in-flight averages) and Figure 5 (charted averages) Figure 10 (charted by seat location). Results are expressed as total VOCs in ppm, toluene equivalent (the instrument was laboratory calibrated with 7.5 ppm toluene). It should be noted that the PID does not distinguish between potentially toxic and non-toxic VOCs; it measures all gases and vapors with an ionization potential below 10.5 electron volts.

other time during the three test flights was less than 8 ppm. The reason for these brief high concentrations is unknown, but no unusual odors or events were reported or observed on flight 9301. The readings may have been due to instrument interference, or an occupant activity in close proximity to the sensor, such as pouring an alcoholic beverage, opening a container of perfume, or using a (solvent-based) marking pen.

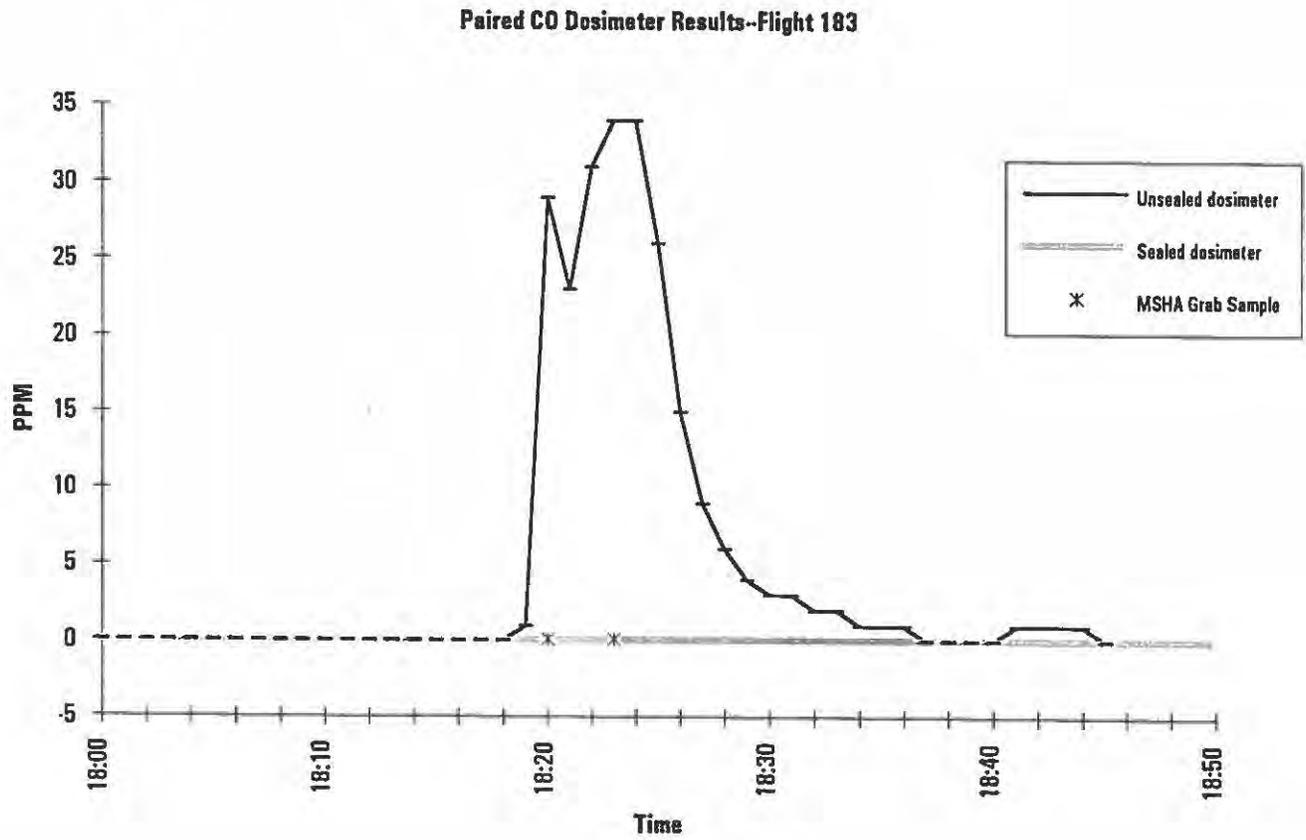
Figure 11
Paired Dosimeter and Grab Sample Results for CO
Main Cabin Flight Attendant-Flight 183
November 19, 1990
Alaska Airlines HETA 90-226

A potential source for the apparent CO peaks found in both area and personal dosimeter sample data was not identified; however, the consistent finding of apparent CO peaks up to 25 ppm on all flights monitored indicated an

interference problem with the instruments, or a common CO source. A representative of the dosimeter manufacturer indicated that certain radio frequencies or other gases or vapors could have caused the peaks.
