## **NIOSH HEALTH HAZARD EVALUATION REPORT**

**HETA #2000-0400-2956**

**Glen Canyon National Recreation Area  
Arizona and Utah**

**January 2005**

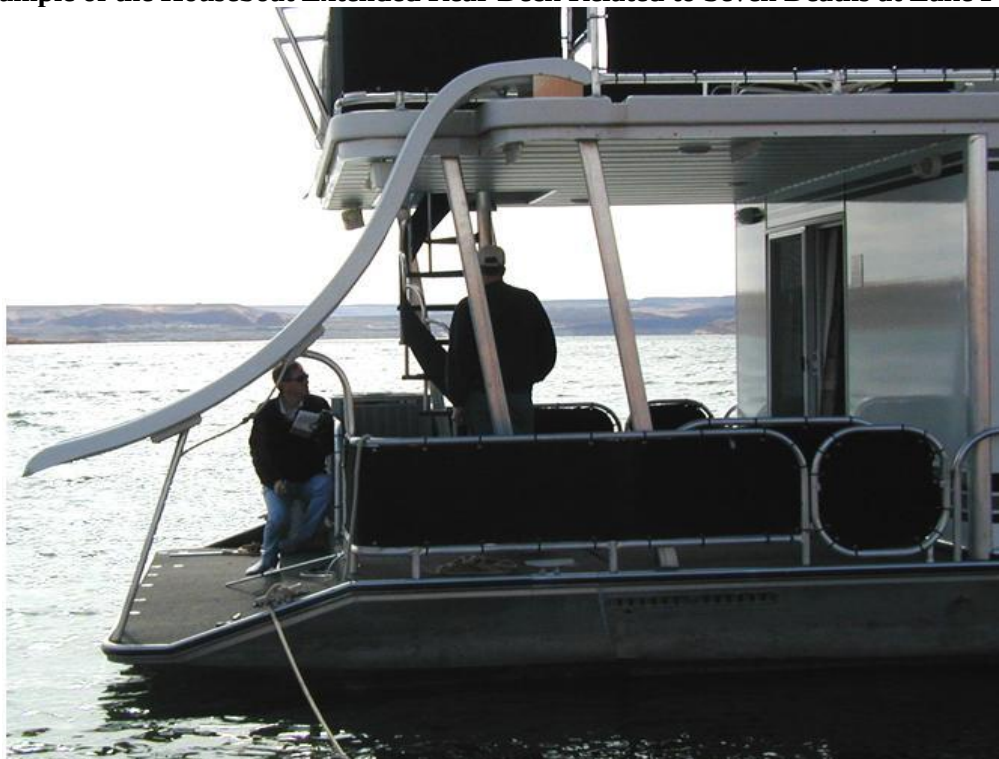
**Figure 1. Example of the Houseboat Extended Rear Deck Related to Seven Deaths at Lake Powell**

DOI attached three letters to the request: two were from NPS to the Commandant of the US Coast Guard (dated 1994 and 1999). The third was a letter of response from the Coast Guard (1999). In the first letter, NPS expressed concern about CO exposure hazards related to a houseboat design and asked for help in effecting a design change to relocate onboard generator exhaust ports. The letter referred to a recent death on such a boat and two prior non-fatal incidents. The design of these boats is shown in Figures 1–3.

This initial air sampling investigation related to houseboats with extended rear decks and gas-powered generators with exhaust terminus exiting the boat transom under the deck (shown in pictures and diagram in Figures 1–3). The generators supply the boat with electrical power to operate on-board appliances (i.e., air-conditioner, refrigerator, lights, charging batteries, etc.

NIOSH sampling on September 19, 2000 documented three severely hazardous situations requiring immediate attention. The environment in the open space under the swim platform of houseboats with an extended rear deck can be lethal under certain circumstances and should not be entered by anyone for any reason as demonstrated by measurements as high as 30,000 ppm in that space, and a concurrent oxygen deficiency of 12% in the space. The environment above and around the swim platform may be hazardous as was demonstrated when immediately

Without doubt, the cavity below the swim platform of houseboats with an extended rear deck presents a severe, sometimes fatal hazard that must be immediately addressed through design changes and public education. In all, we know of 21 people nationwide who have been poisoned by entering this airspace (14 on Lake Powell and 7 on other bodies of water), 13 of whom died (7 on Lake Powell, 6 on other bodies of water). This hazard is present during the operation of on-board generators housed in the engine compartment and exhausting into the cavity, as well during the operation of propulsion engines. Exhaust lingers in this airspace for an extended period following deactivation of either type of engine.

3. Manufacturers should examine options for modifying houseboat design to prevent the buildup of hazardous CO concentrations from any engine exhausting into the airspace under the deck. Design changes could include modification of the structure of the stern deck and/or sufficient pressurization of the airspace to reduce CO concentrations to safe concentrations within 1 minute of engine deactivation.

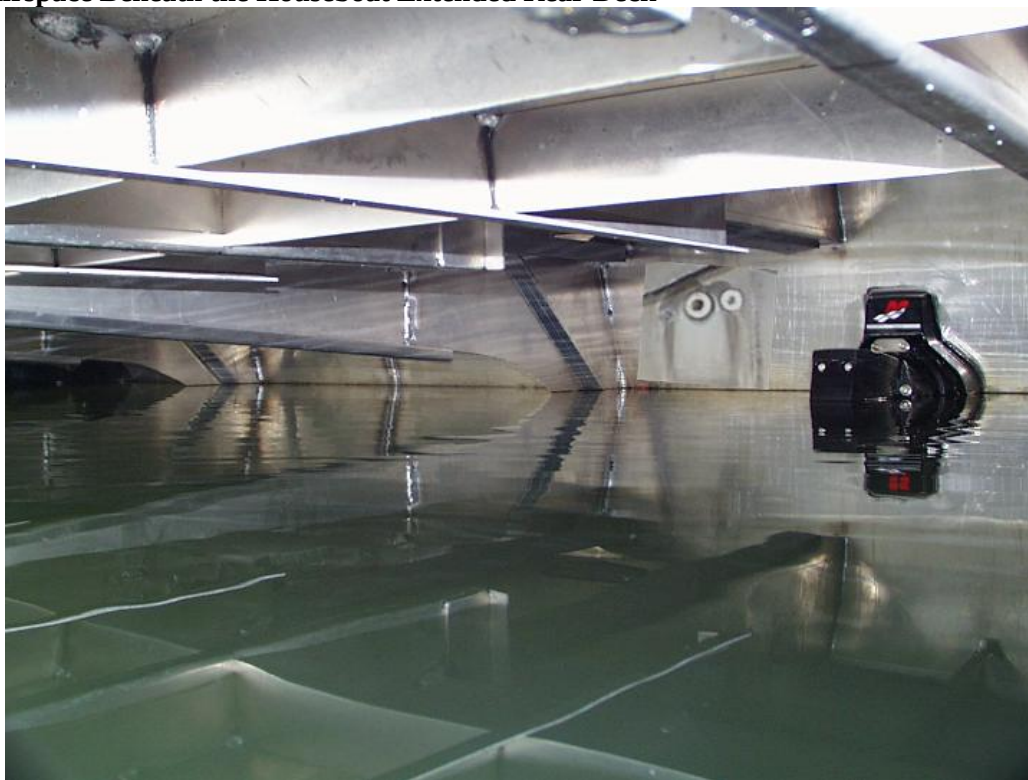
**Figure 2. Airspace Beneath the Houseboat Extended Rear Deck**

This investigation confirmed the issues of concern regarding CO on houseboats expressed in the first report, again documenting that when generators are in operation, the area beneath the rear deck and around the back of the swim platform (near water level) contains extremely hazardous CO concentrations. These hazardous conditions also exist when the engines are in operation on the boats. CO concentrations measured with three separate methods (i.e., real time instruments, evacuated containers, and detector tubes) indicated concentrations well above the NIOSH established IDLH value of 1,200 ppm. Individuals swimming or working in the area under the swim platform, or around the area directly behind the swim platform (near the water level), with the generator or motors in operation could experience CO poisoning or death within a short period of time.

Initial recommendations contained in interim reports for this project were that the airspace beneath the extended rear deck of houseboats should never be entered for any reason. Unfortunately, the current design of this type of houseboat necessitates entry into the airspace to access the propulsion engine outdrives (to conduct maintenance and repair) or propellers that often get fouled by anchor ropes. CO concentrations measured in the airspace of these types of boats, and related fatalities associated with this airspace, confirmed the need: 1) for manufacturers to immediately address the placement of the generator exhaust terminus (get it out of that space and up to an location that is not accessible by swimmers or boat occupants); 2) for manufacturers to develop safe entry procedures for boaters until this space can be redesigned; and 3) to educate boaters about exercising extreme caution when entering this airspace.
