NIOSH HEALTH HAZARD EVALUATION REPORT

**HETA #2004-0246- 2979
Cherokee County Fire Station
Ball Ground, Georgia**

Evaluation of Indoor Air Quality

Health Hazard Evaluation Report 2004-0246-2979 Cherokee County Fire Station 21 Ball Ground, Georgia

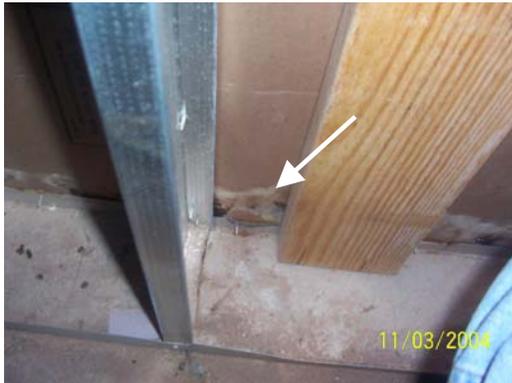
Prior to the NIOSH walkthrough, mold was discovered in the plumbing chase/wall cavity between the bathrooms and kitchen in Station 21. We found evidence of water damage and some visible mold at floor level to a height of approximately 6 inches on the interior of the bathroom wall in Fire Station 21 (Figure 1). Inspection of the plumbing chase in Fire Station 23 found similar evidence of water damage and mold.

Figure 1. Visible mold and water damage in wall cavity (plumbing chase)

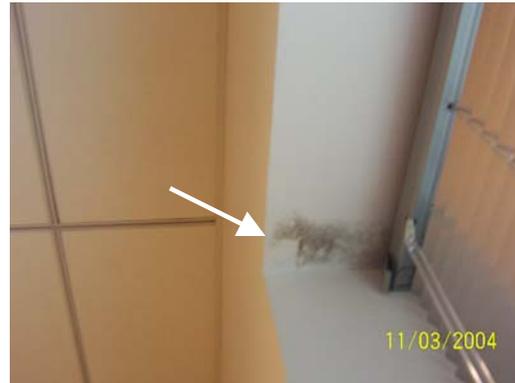
Additional areas in Fire Station 21 found to have evidence of water infiltration or mold included interior drywall around an office window (Figure 2). We found evidence of excessive condensation in the air conditioning supply duct covers in several stations, some with signs of rust or visible mold on the metal grill surface and on drywall ceiling around the duct (Figure 3). Some firefighting equipment stored in the turn-out gear room had surface evidence of mold (Figure 4). Cherokee County personnel placed a stand-alone dehumidifier in this room during our site visit.

Figure 2. Visible mold on interior drywall at window header in Station 21 office.

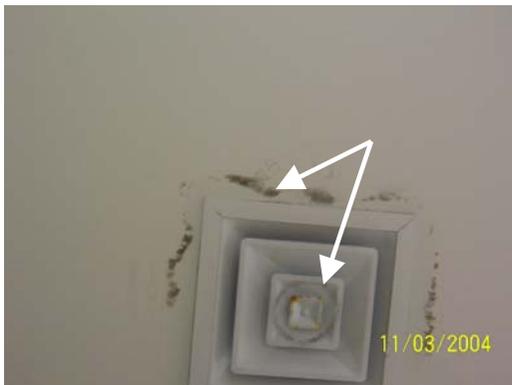
Figure 3. Rust and visible mold on bathroom air supply vent

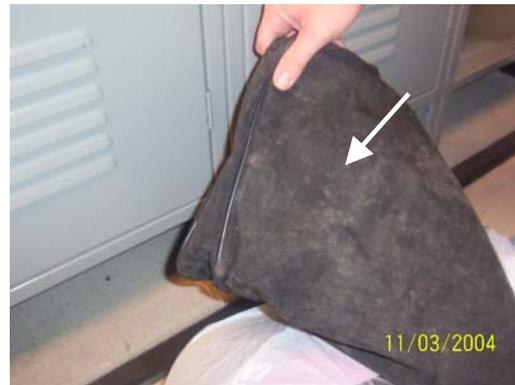
Figure 4. Visible mold on firefighting clothing in turnout gear room.

- Ventilate turnout gear rooms to allow for proper exhaust and to prevent excessive humidity
- Follow the Environmental Protection Agency guidance¹² for cleaning or removing building materials, furnishings, or other items that have been previously wetted

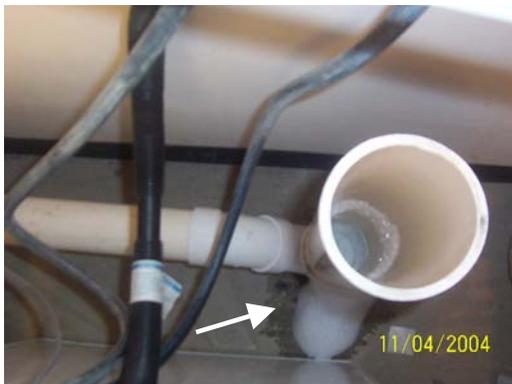
and bleach solution. During these activities, the door connecting the living quarters to the garage bay was often open with the garage doors also open. The laundry equipment was being used at Fire Station 21. Soapsuds were observed at the wastewater drain for the washing machine (Figure 5) and also appeared at the laundry room floor drain (Figure 6) raising questions about whether sewer drainage was adequate. The exhaust from the industrial-sized dryer is not direct to outdoors and routes into a metal box that surrounds an opening to the outside fitted with a filter (Figure 7). It was unclear whether this configuration allows adequate exhaust of moisture from the dryer.

Figure 5. Washing machine sewer drain open to the laundry room. Soap bubbles and water leaking from joints and running onto floor.

- Hire a licensed, qualified plumber to evaluate sanitary and run-off sewer systems and ensure proper operation
- Implement a reporting system for conditions or concerns that may adversely affect indoor air quality

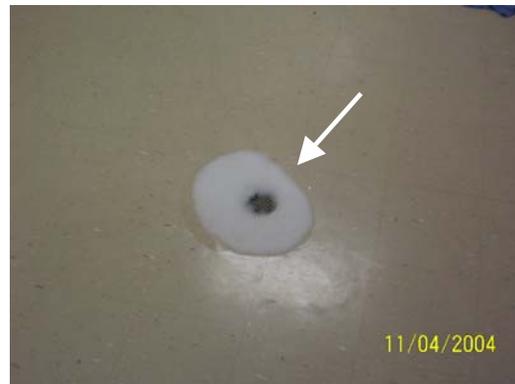
Figure 6. Soap bubbles exiting floor drain during washing machine operation.

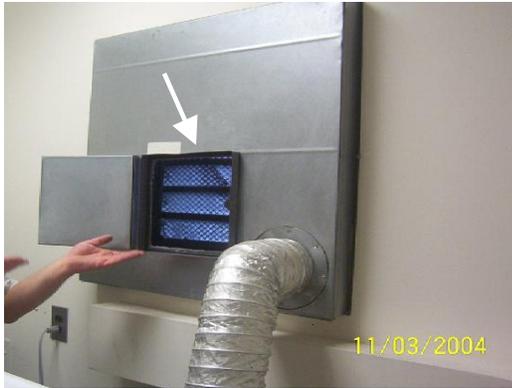
Figure 7. Dryer exhaust configuration. Dryer exhausts into metal box, exits at filter (arrow).

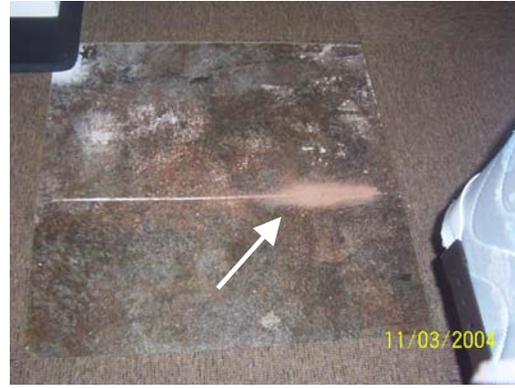
Other observations that indicated moisture issues in the buildings included characteristics that were specific to the construction. The concrete slab is the sub-floor for the occupied areas. Some moisture measurements of the concrete slab under the carpeting in the sleeping quarters were higher than measurements in other parts of the slab. Small amounts of sand were observed in the stress control joints under the carpet and appeared to be coming from below the building (Figure 8). No other building materials had above normal moisture content as determined by the moisture meter. Another indicator of high moisture conditions was firefighter reports that millipede-type insects were present in large numbers inside the building during certain times of the year. These insects are known to favor damp conditions.

Figure 8. Concrete slab sub-floor with carpet tiles removed. Sand accumulation in the stress control joint.

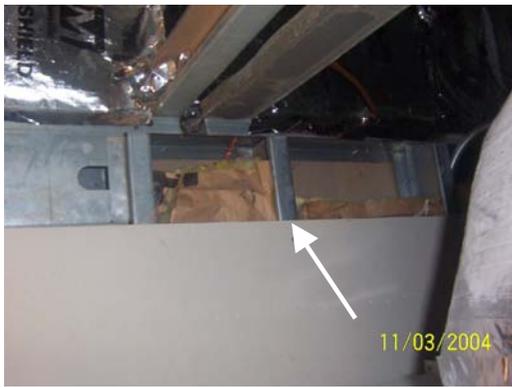
Examination of the building structure above the acoustic tile ceiling found evidence of non-continuous insulation in the exterior wall cavity (Figure 9) and no clear evidence of a vapor barrier in the exterior walls. Rust was observed on the roof rafters of Fire Station 21 (Figure 10) but not on rafters in other stations. The roof itself appeared to be a multi-layer construction with a continuous metal sub-roof and the exterior finished metal roof overlaid upon it. It was not possible to determine what was between the two layers although the videotapes filmed during construction indicated that there was at least a tarpaper overlay on the sub-roof.

Figure 9. Exterior wall at roof viewed from inside the building above the drop ceiling. Insulation is not continuous to roof.

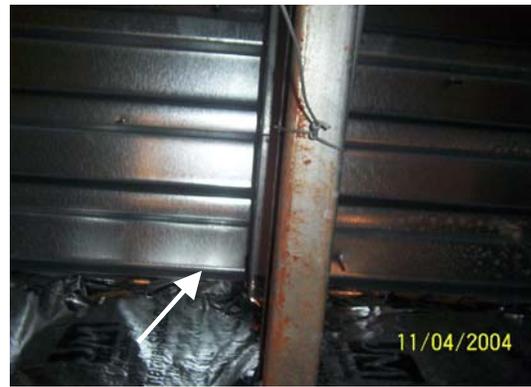
Figure 10. Station 21 - Underside of roof. Roof support with visible rust.

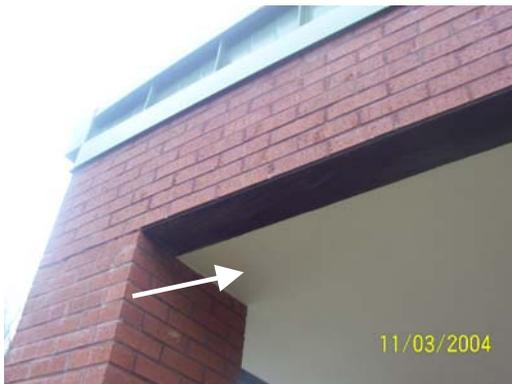
Fire station 21 also exhibited signs of moisture build-up due to insufficient drainage. What appeared to be drywall intended for interior use was applied as the exterior ceiling for the porch area (Figure 11). Staining was observed at some roof downspouts (Figure 12). It was reported that downspouts connect to a sub-surface drain system that transported the water to a storm water-runoff holding pond for each location. Each station was equipped with a lawn sprinkler system with the sprinkler head locations appearing to be appropriate and to point away from the buildings.

Figure 11. Drywall applied as outdoor porch ceiling

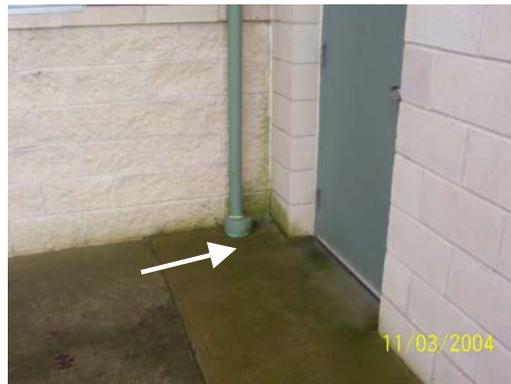
Figure 12. Roof downspout with evidence of puddling and moisture accumulation.
