Evaluation of Odors and Surface Residues in a Medical Center Research Facility

Health Hazard
Evaluation Program

HHE Report No. 2013-0117-3247
March 2016

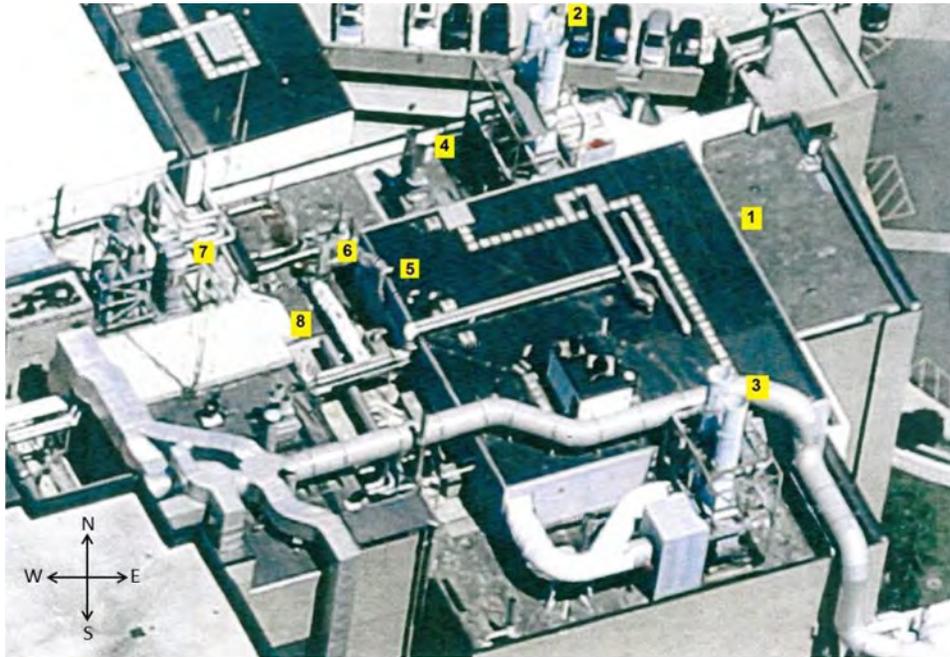
Figure 1 shows a rooftop view of the research building complex, locations of AHUs, and exhaust stacks from the research buildings. At the time of our evaluation, the facilities department did not have performance guidelines or standards for the HVAC system of the research building complex. They relied on institutional knowledge among facilities employees about how the system had operated in the past.

1. Supply air intakes for NRB air handling units 1, 2, and 3.
2. NRB exhaust – north and east
3. NRB exhaust – south and west
4. Animal cage wash wet exhaust
5. Unidentified exhaust stack
6. NRB common restroom exhaust
7. General veterinary research exhaust
8. Supply air intake for air handling unit NRC-AHU-5

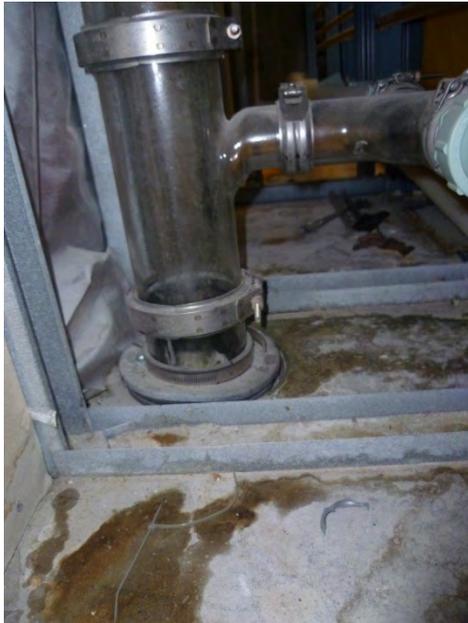
Ventilation smoke testing under the laboratory bench cabinets along the exterior wall in laboratory 3032 demonstrated that air flowed into the space under the laboratory bench cabinets from a gap between the floor and a utility drain pipe, which ran vertically between floors along the outside wall (Figure 2). Additionally, we observed that air from the gap around the utility drain pipe moved through the laboratory bench cabinet space into the laboratory through gaps around the laboratory bench cabinet drawers, doors, and access panels. Because of the differential between exhaust and supply rates in laboratory 3032 the gap around the utility pipe was an unanticipated supply air pathway from neighboring laboratories on other floors.

Figure 2. Photo of gap between utility drain pipe under laboratory cabinet and floor provided unplanned pathway for movement of air from floor below. Photo by NIOSH.

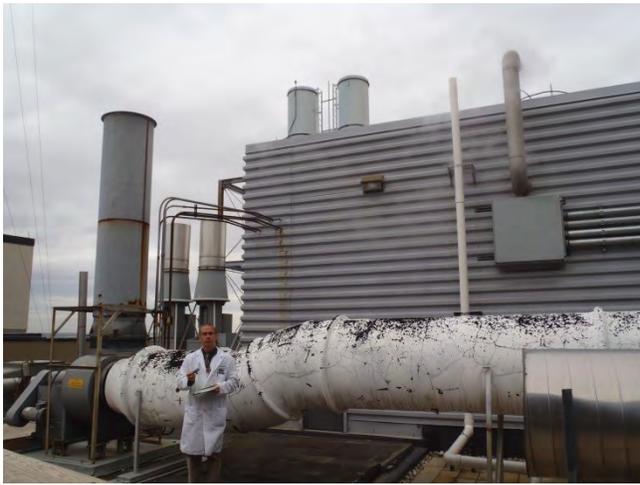
During our site visit on November 15, 2013, we noted an “animal cage” odor while we were taking air samples on the roof. Facilities staff also noted the odor and reported that it was similar to the “animal cage” odors previously reported on the second, third, and fourth floors of the NRB. We also saw re-entrainment of exhaust on the penthouse roof from an unidentified exhaust pipe into NRC-AHU-5. HVAC staff were unsure where the pipe exhausted from. Figure 3 shows the exhaust pipe, and Figure 4 shows NRC-AHU-5.

Figure 3. Rooftop penthouse exhaust pipe (shown in the upper right corner of the figure), which was located adjacent to NRC-AHU-5. Prevailing winds carried exhaust from the pipe toward the NRC-AHU-5 supply air intake. Photo by NIOSH.

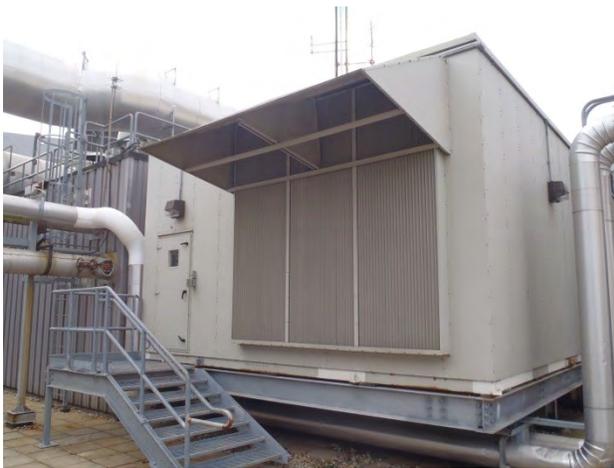
Figure 4. Photo of a supply air intake for rooftop air handling unit, NC-AHU-5, where building exhaust air was observed being captured by the intake. Photo by NIOSH.

The mixtures of chemicals, including anesthetic gases, were similar across sample locations. These data, along with our observations of re-entrainment on the roof suggest that building exhaust air is being captured by a building air intake, NRC-AHU-5 and circulated throughout the NRB. On the third floor of the building we found that the supply airflow and exhaust air flow did not meet the reported design specifications. We also found that pressure differentials between third floor hallways, laboratories, and offices were not as designed. Specifically, many laboratories were under positive pressure relative to adjacent hallways and this can lead to unplanned migration of air contaminants and odors from one area to another. We found unplanned pathways of air movement into a laboratory through floor gaps around a drain pipe. All of these findings may be contributing to the occasional odor in laboratory 3032. Our analysis of residue from shelving in some third floor laboratories indicates that the residue is likely composed of a synthetic polymer produced by degradation of the shelving laminate rather than deposition of something onto the surface of the shelving.

- Modify the roof exhaust stacks to reduce re-entry of exhaust air into the building.
- Establish and follow performance guidelines for the heating, ventilation, and air-conditioning system.
- Test and balance the heating, ventilation, and air-conditioning system. Repeat testing regularly and after any major renovation.

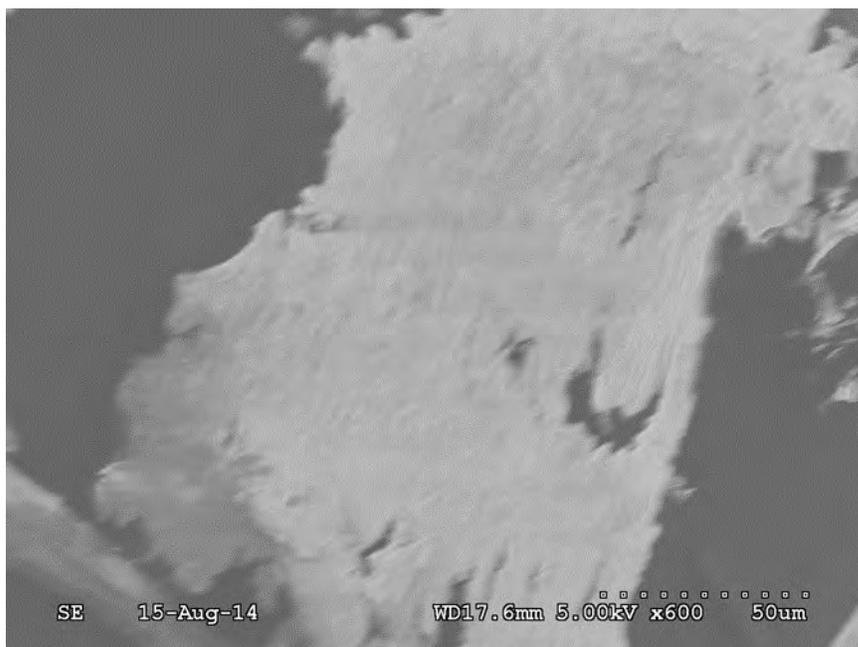
Analysis via stereomicroscopy, scanning electron microscopy and polarized light microscopy revealed the residue is likely a synthetic polymer with plastic-like characteristics and some synthetic fiber and glass fiber contamination. The bulk samples contained colorless (cellulose) and dark (synthetic) fibers. The residue matrix was translucent brown and displayed properties associated with polymers or plastic. The sample had an uneven thickness and a stretched look which typically comes from smearing or attempting to grind or flatten a plastic or plastic-like material. Organic material is difficult to analyze by scanning electron microscopy because contrast is almost impossible to obtain while maintaining image quality and interpretability. The scanning electron microscope image (Figure 5) shows an area near the center where the sample has thinned and appears stretched. Linear features parallel to the stretching indicate that the substance is a polymer.

Figure 5. Scanning electron microscope image of a residue sample. Photo by NIOSH.

On the basis of GC-MS, elemental, and microscopic analyses, we concluded that the residue on shelving is more likely a product of laminate degradation rather than deposition of something from the environment. Some laboratory employees we spoke with noted that after the residue was cleaned off shelves in laboratory 3032, the residue was found on the shelves a month later, even though the ventilation supply air diffusers and exhaust air grilles were covered to prevent air flow. This finding is further support for our conclusion. However, the cause of the degradation cannot be completely determined using these results. Oxidative degradation of the laminate could be caused by age, environmental parameters (temperature and relative humidity), or other factors.
