Coal Bumps and Odd Dynamic Phenomena - A Numerical Investigation

Jeffrey K Whyatt, Mining Engineer
NIOSH Research Laboratory
Spokane, WA

Marc C Loken, President
M&K Consulting
Shoreview, MN

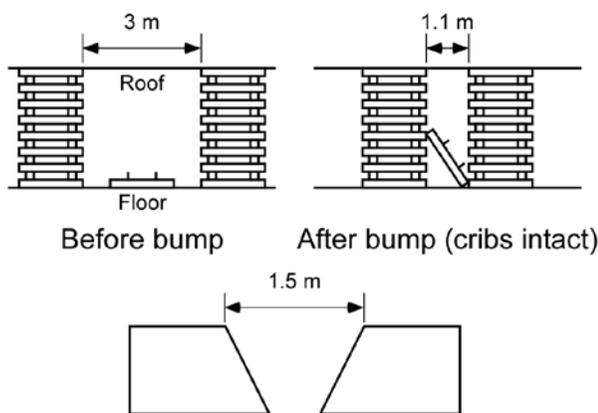
1. Two men were mining a pillar when a bump occurred. The rescue party found the “roof, floor and ribs, so far as visual indications were concerned, in their normal conditions, but the cogs, instead of being 10 ft. apart were only 3 ½ ft apart yet were intact.” (Figure 1) Track running between the cogs (packs) was nearly on edge. Further mining revealed a “channel or crevice 5 ft wide at the top and about 2 ft wide at the bottom” within the pillar.

Figure 1. Displacement of packs and track attributed to a bump event that also appeared to have created a 1.5 m split in a pillar (after Ashmead, 1924).

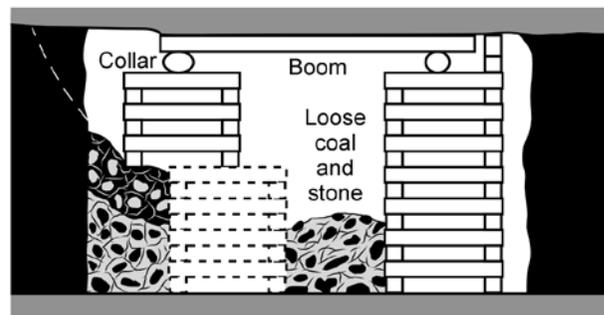
McCall (1934) updated Herd’s descriptions of Springhill Mine observations, including particular instances. In the first (Figure 2), “all east side chocks in this place have been moved about two feet westward.” Also, with few exceptions, “individual sticks have not been displaced.” Finally, “the booms and the collar boom which supports the booms between chocks have not moved but the lower portion has moved as a unit.” In the second location, this same event displaced empty and full mine cars without other damage (Figure 3).

Figure 2. Section of a timber pack displaced as a unit during a coal bump (after McCall, 1934).

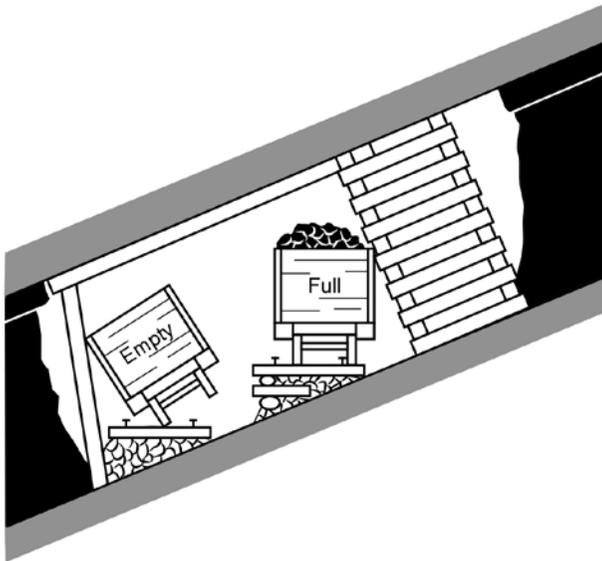
Figure 3. Displacement of mine cars by a coal bump (after McCall, 1934).

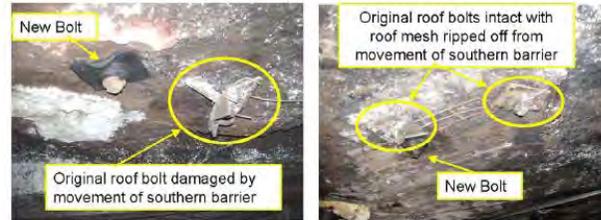
Gates et al., (2008) reported observations made during efforts to re-establish the No. 1 Entry. The first of these was that “as loading advanced inby crosscut 123, rescuers observed that part of the barrier south of the No. 1 entry had moved northward as a result of the August 6 ground failure. The barrier rib had shifted northward as a unit, as much as 10 feet. In some areas, the displaced barrier slid along the immediate roof and tore loose the original roof mesh”

(see Figure 4). “In other areas, the immediate roof was carried northward and damaged the original installed roof bolts” (Figures 4 and 5).

Figure 4. Damaged roof bolts and torn mesh after August 6 accident resulting from northward movement of southern barrier (after Gates et al., 2008).

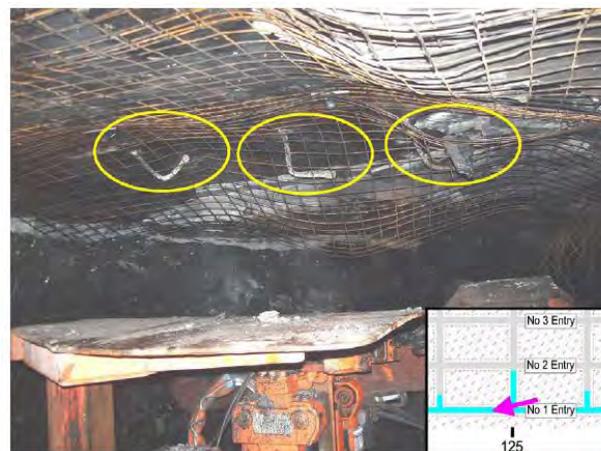
Figure 5. Damaged roof bolts in No. 1 entry after August 6 accident resulting from northern movement of southern barrier. Mesh shown was installed during rescue operations, over damaged original bolts. Camera view is indicated by arrow in index map insert (after Gates et al., 2008).

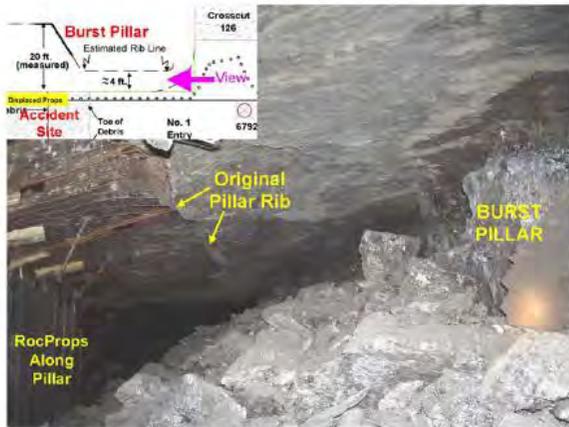
Gate et al., (p. 27) described a “void up to 20 feet deep into pillar at the roof line” (see Figures 6 and 7) created by the bump that ended rescue efforts. Gates et al., also mention that “coal was thrown violently across the No. 1 entry.” And finally, that this “dislodged coal threw eight RocProps, steel cables, chain-link fence, and a steel channel toward the left side of the entry, striking rescue workers and filling the entry with about four feet of debris.” One injured miner was found “entangled in chain-link fencing.”

Figure 6. Damage to outby portion of pillar on right side of No. 1 entry, outby August 16 accident site (After Gates et al., 2008).

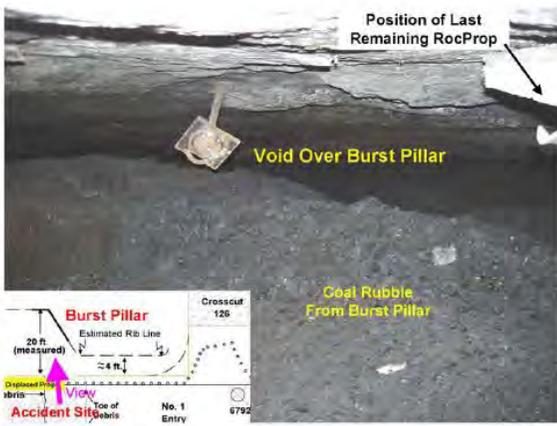
Figure 7. 20-ft deep void over pillar on right side of No. 1 entry following August 16 accident (After Gates et al., 2008).

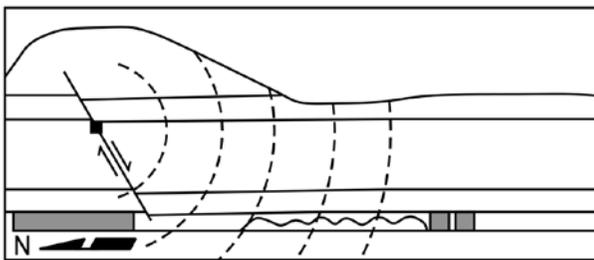
The Book Cliffs case study by Boler et al., 1997, reviewed previously, provides a convenient test case. Seismic records analyzed by Boler et al., indicated slip on a normal fault somewhere above the damaged panel, most likely in the overlying Castlegate Sandstone, was the most likely cause (Figure 8).

Figure 8. Preferred failure mechanism for the Book Cliffs mine case proposed by Boler et al., (1997).

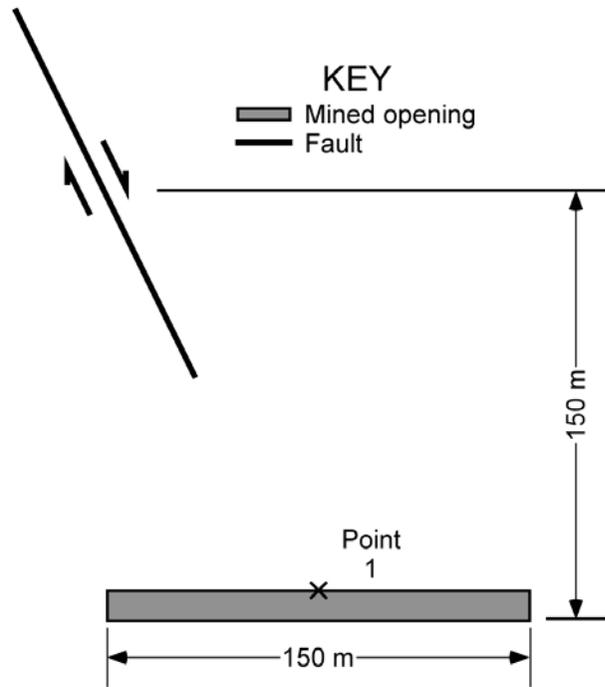
A simple model of this geometry was formulated, consisting of a slip surface with a sudden shear displacement and a simple panel without pillars (Figure 9). The assumed material properties of the elastic medium were: mass density $\rho = 2700 \text{ kg/m}^3$, longitudinal wave velocity $\alpha = 5367 \text{ m/s}$, and transverse wave velocity $\beta = 3267 \text{ m/s}$. The boundaries of the fault surface and the mined opening were approximated by equally-sized square boundary elements of dimension 3 m by 3 m. A 1 m slip was assumed. While this value is relatively large, it’s convenient for scaling results to any desired slip magnitude. That is, a 10 cm slip would realize 10% of the modeled motion. The total simulation time was 0.5 s, using 200 time steps of equal time step length (0.025 s).

Figure 9. Simplified model geometry. Closure was tracked at point #1, located at the midpoint of the panel.

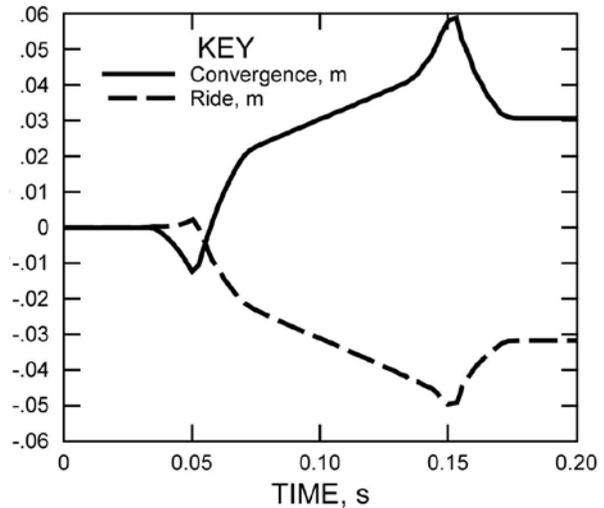
The calculated relative displacement history (closure) at the center of the panel is plotted in Figure 10. It consists of an initial dilation followed by closure to a short-lived maximum and then rebound to the static closure value. Dilation, or opening of the panel, is roughly 15% of maximum dynamic closure and nearly half the resulting static closure. Relative horizontal displacement (ride) is also plotted. Ride is very small during initial dilation but is significant at later times.

Figure 10. Calculated dynamic closure and ride (relative lateral displacement) between roof and floor at mid-panel.
